Ruins Stabilization in the Southwestern United States

Publications in Archeology 10

National Park Service

U. S. Department of the Interior
Washington 1974

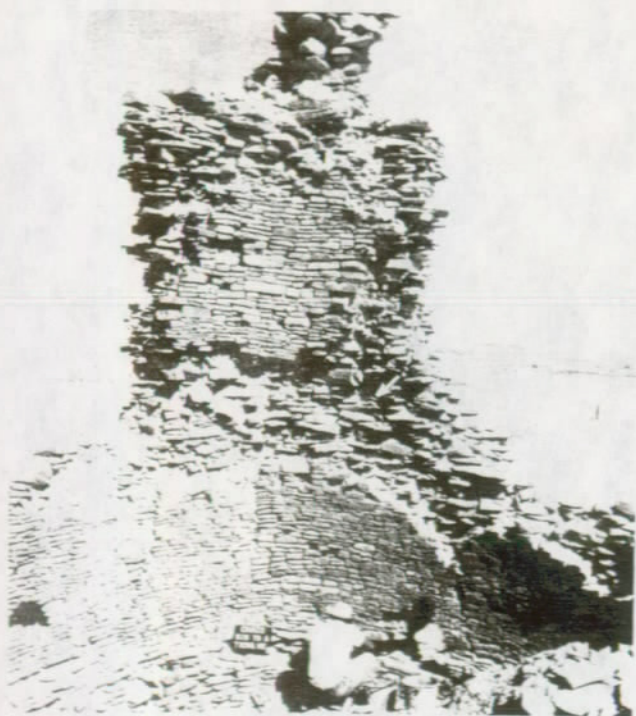
FIGURE 103. General view of northeast interior of Tower Kiva at start of project. The circular wall is stepped back or inset at two points: (1) at narrow ledge or bench where workman is beginning repairs, and (2) where facing is gone, exposing core (arrow).

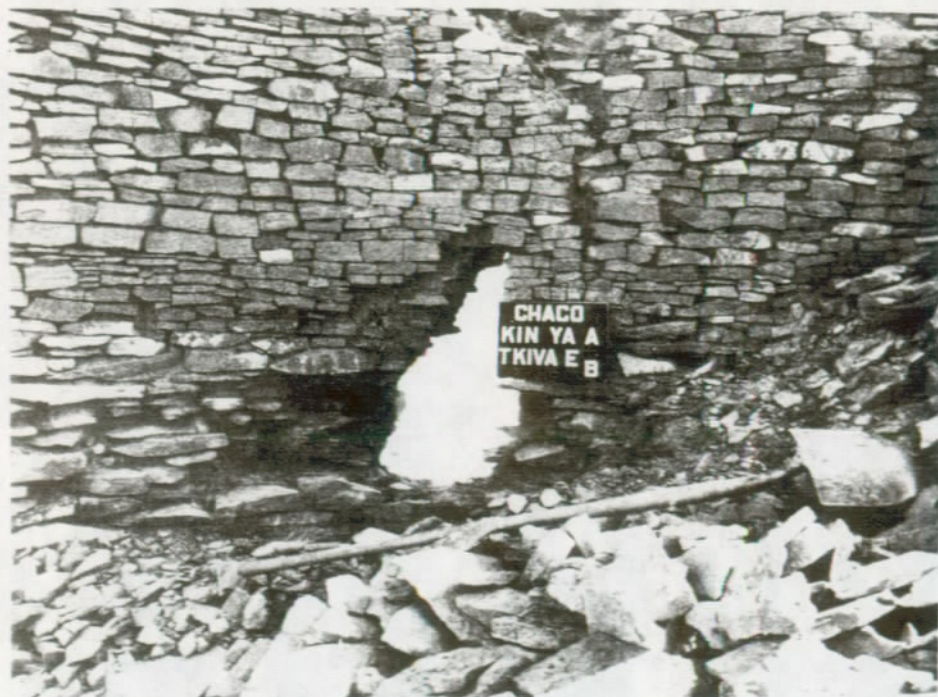
FIGURE 105. Detail of hole in Tower Kiva caused by breakdown of savino sockets. The beams for the sockets extended part way into this wall from the opposite side, and originally supported the ceiling of the adjacent room.

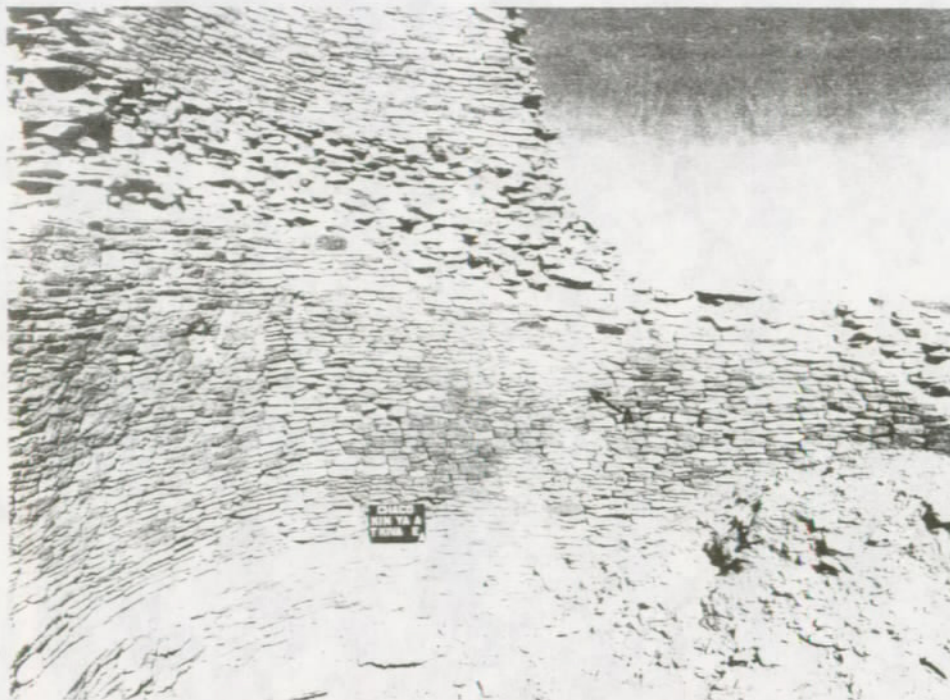
FIGURE 106. Lower portion of Tower Kiva, north and east segments, after stabilization. Offset ledges repaired, holes filled with repair masonry, facing reset (arrows A), top capped and inset core (arrow B) grouted.

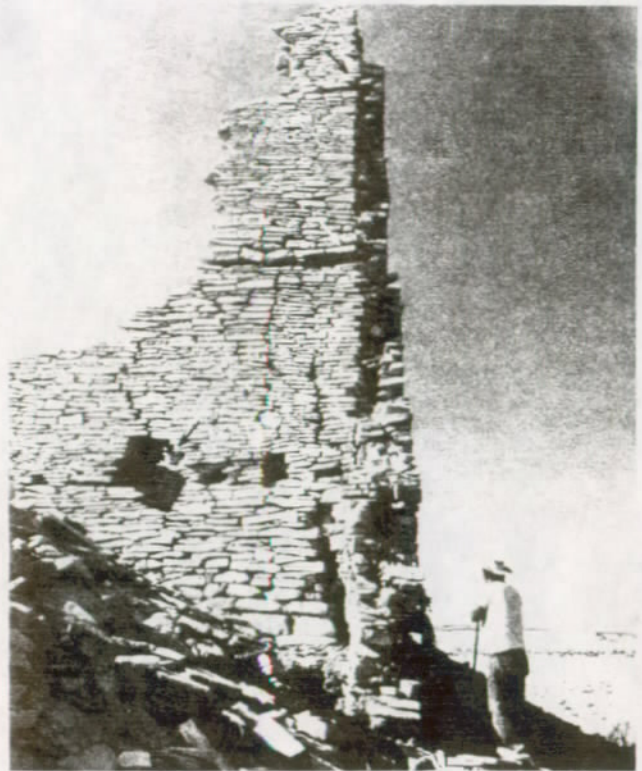
FIGURE 112. Tower Kiva, east wall exterior at juncture with north wall stub (at sign). Note the vertical cracks, eroded savino sockets (arrows) and loose, fragile spire. Portions of 4 stories are visible.

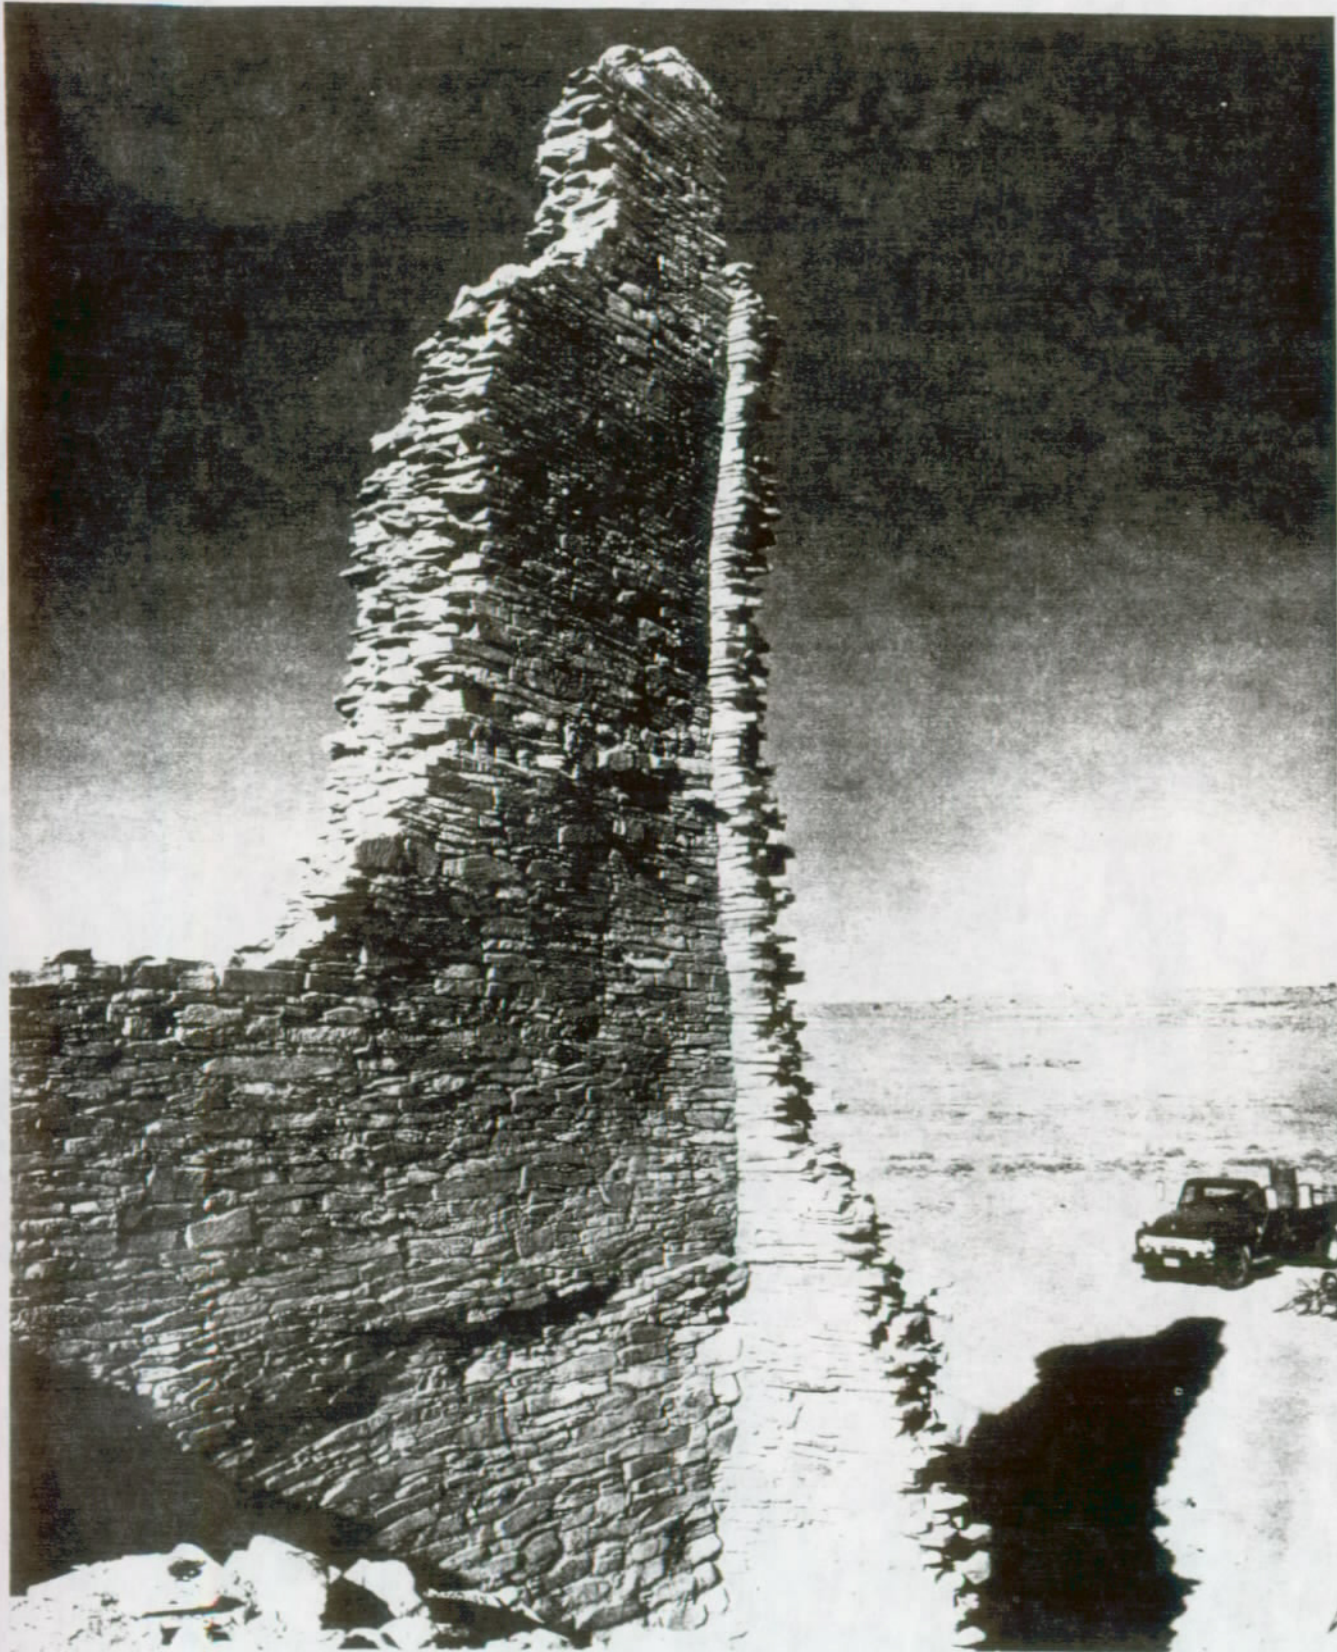
FIGURE 114. View of Tower Kiva showing north wall stub buttressed, cracks repaired, savino sockets re-molded, and facing grouted.
