Blue Ridge Parkway
Saunders Farm
Historic Structures Report

June 2005

Historical Architecture, Cultural Resources Division

Historic Structure Report

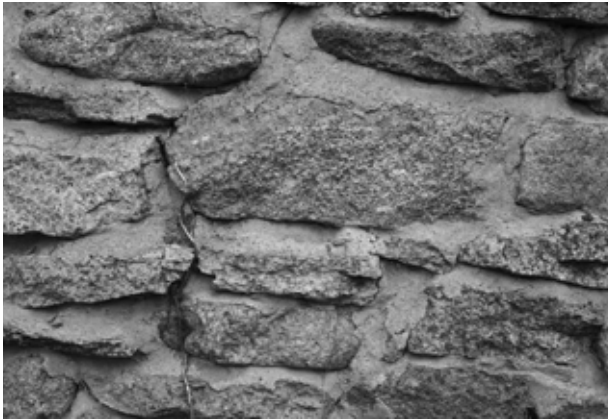
FIGURE 20. View of historic masonry near the southwest corner that has not been repointed. (NPS, 2005)

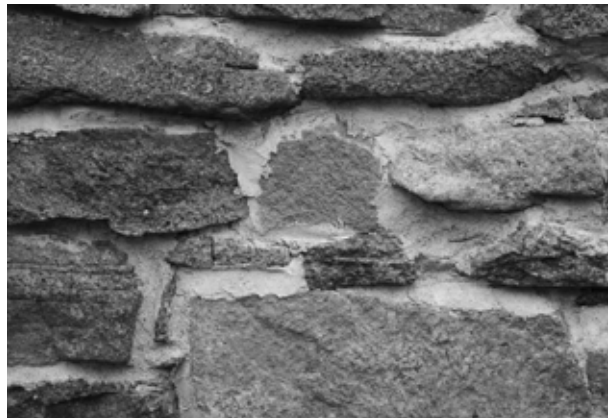
FIGURE 21. View of historic masonry that has been repointed with Portland cement. (NPS, 2005)

There has been no laboratory analysis of the mortars, but visual analysis distinguishes three separate mortars. The oldest that has not been repointed is that found on the west side of the cellar door and along the front of the house. This mortar is relatively

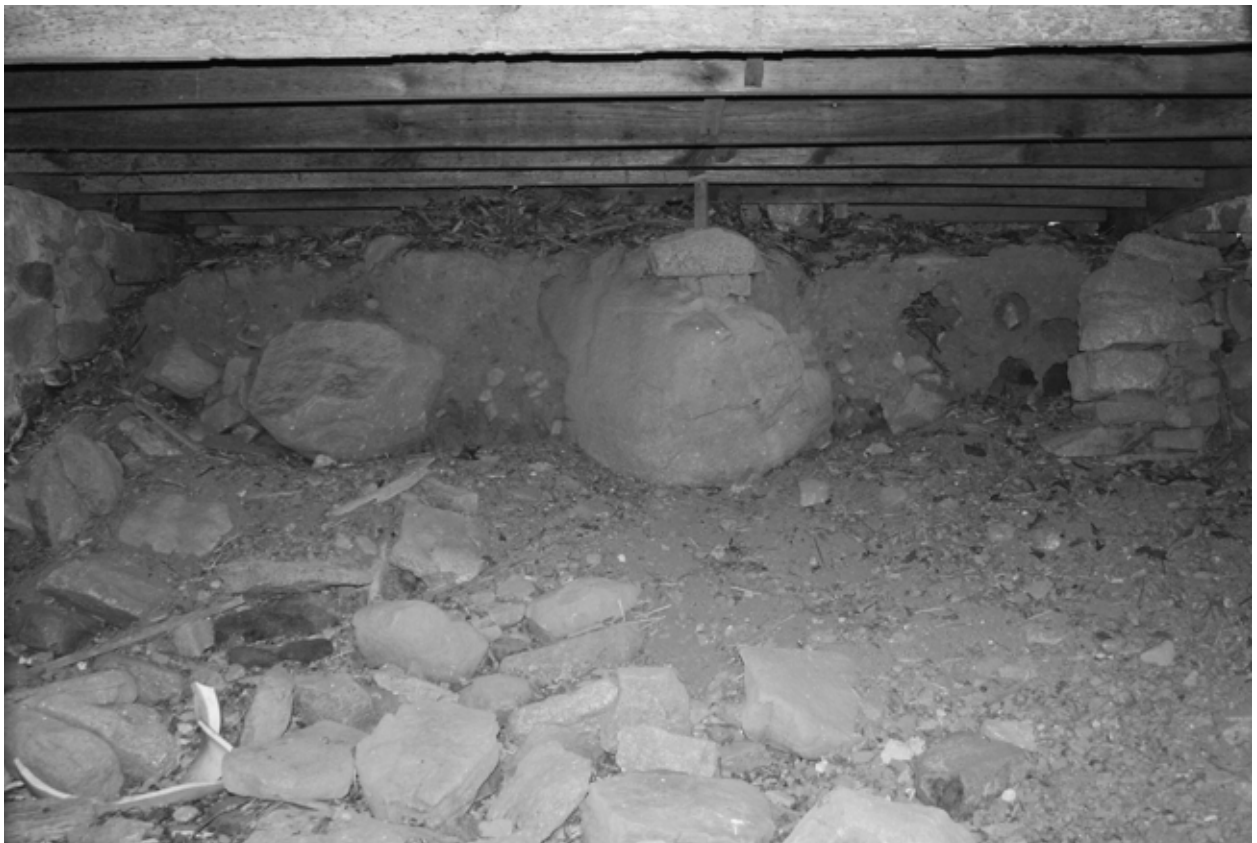
FIGURE 24. View north in cellar, with rocks from collapsed north wall in foreground. (NPS, 2005)

There appears to have been some excavation to create or enlarge the cellar, but it is not clear if the floor was ever level. It was probably never paved. The cellar extends about 13' under the log pen of the house and ends at some large boulders, some of which may form the foundation for the fireplace and chimney. The west, south, and east walls of the cellar are formed by the stone foundation under the log pen, and the north side of the cellar appears to have originally been closed by another stone wall that has now mostly collapsed.

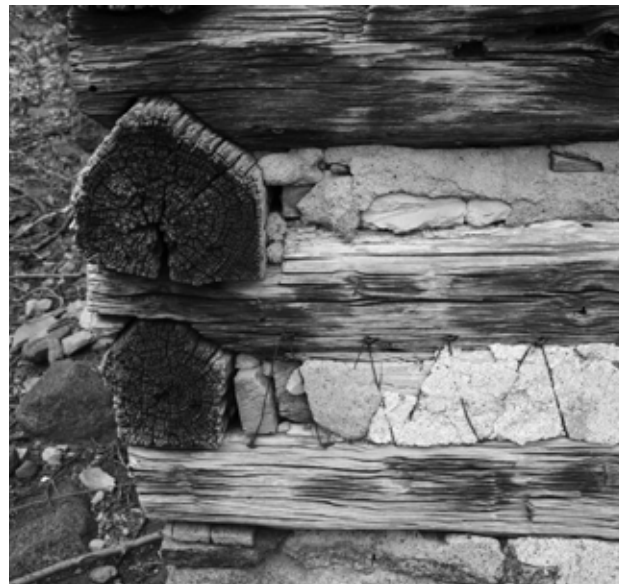
FIGURE 28. View of northwest corner of house, showing typical V-notch corners, all three generations of mortar chinking, and wire lath. (NPS, 2005)

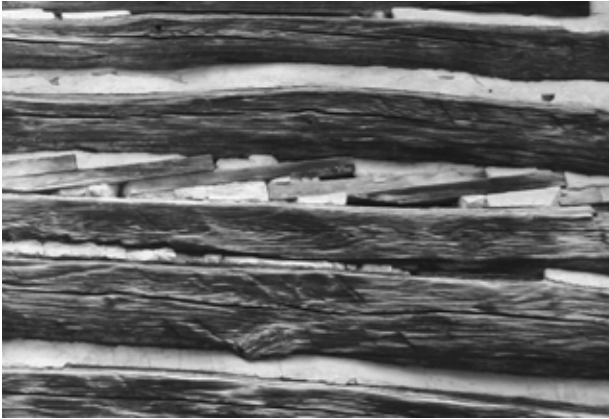
The relatively large gaps that exist between most of the logs were filled with short lengths of milled lumber, lapped in a diagonal fashion. Chinking was completed using a hard cement mortar, similar to that used to mortar the rock foundation, and would have covered all of the blocks of lumber between the logs.

FIGURE 29. View of a portion of south wall, showing typical treatment of gap between the logs. (NPS, 2005)

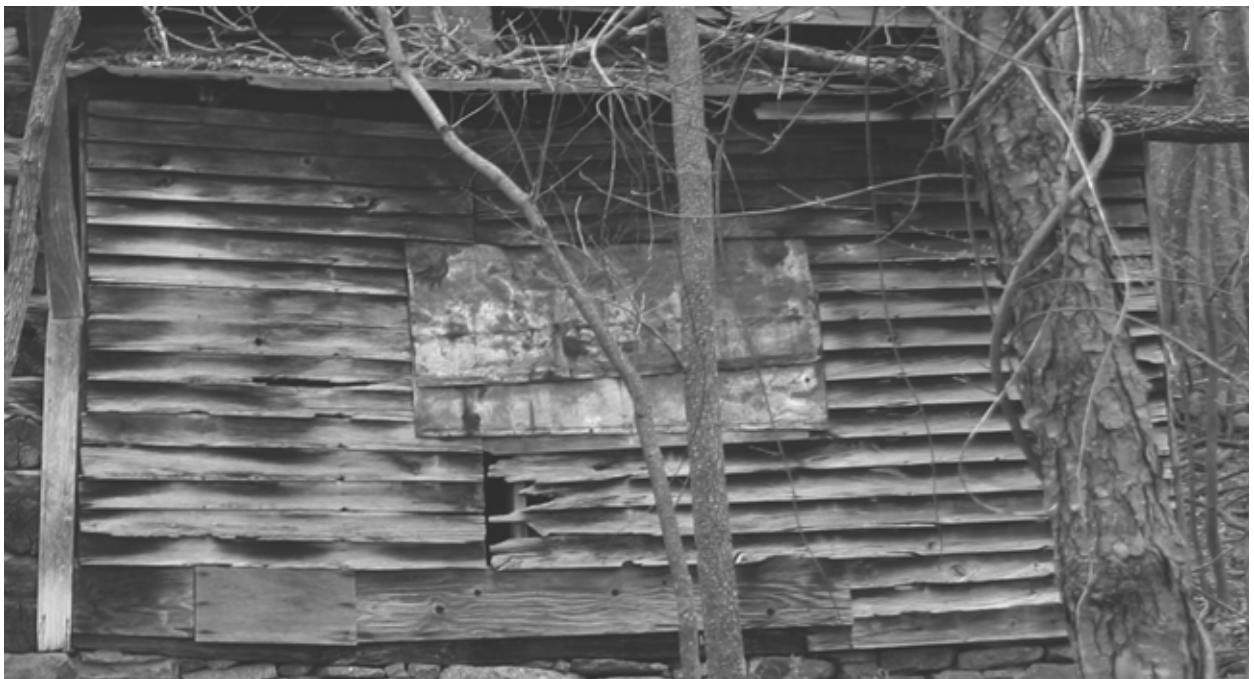
FIGURE 55. View of exterior of enclosed porch, showing two generations of siding. (NPS, 2005)

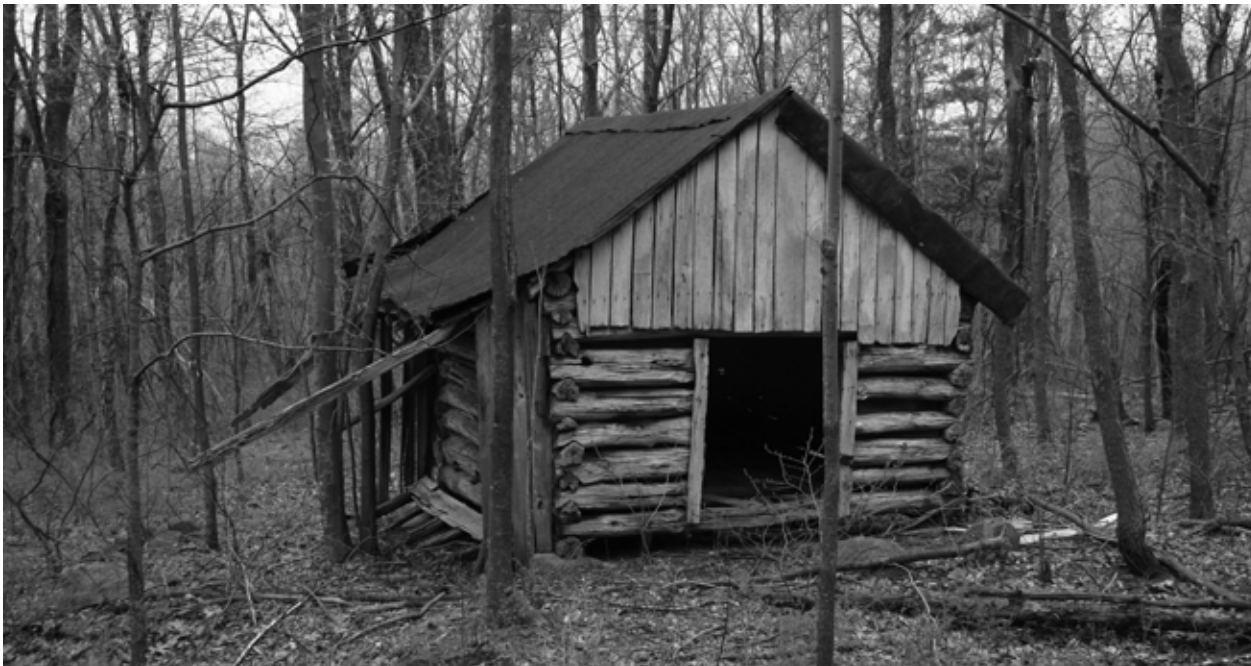
FIGURE 57. View of front and east side of meat house. (NPS, 2005)

The roof is covered with 24"-wide panels of corrugated steel, which are badly rusted but still without major leaks. The end gables are finished with vertically installed, circular-sawn boards, 6" to 8" wide and attached with wire nails. Floor boards are circular-sawn, 10"-14" wide, but several are missing or only loosely attached to the joists.

- Repair roofing on Meat House
- Reconstruct Meat House door
- Replace missing flooring in Meat House
- Reconstruct shed on Meat House
- Preserve stone foundations of ruins in place
- Reconstruct ruined buildings only if deemed necessary for interpretation

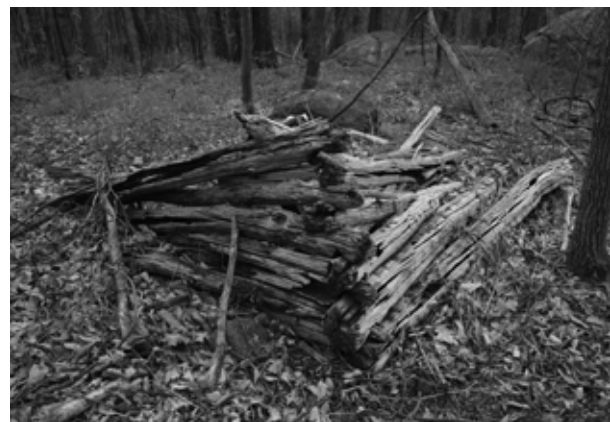
FIGURE 62. View southeast of chicken house ruin. (NPS, 2005)

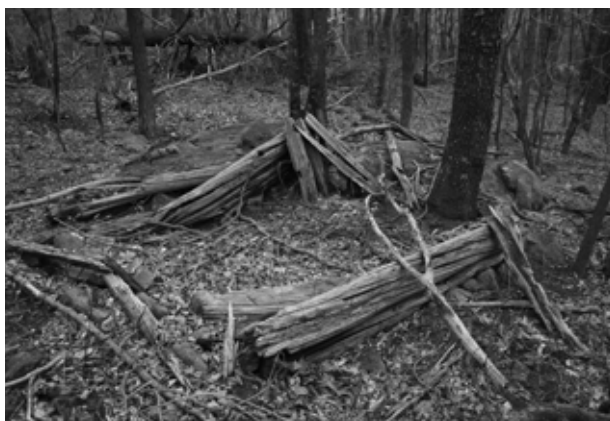
FIGURE 63. View southeast of ruins of hog house. (NPS, 2005)
