Cape Hatteras National Seashore
Bodie Island Life- Saving Station & Boat House
Historic Structure Report

2005

Joseph K. Oppermann - Architect, P.A.

2005
Historic Structure Report
Bodie Island Life- Saving Station & Boat House
Cape Hatteras National Seashore
Manteo, NC
LCS#: Life- Saving Station #07243
Boat House #091897

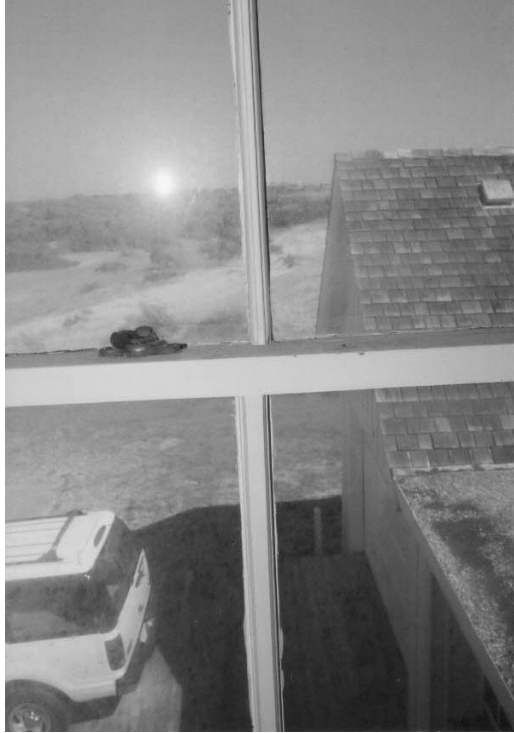
Figure C-16 Window muntins in Room 201

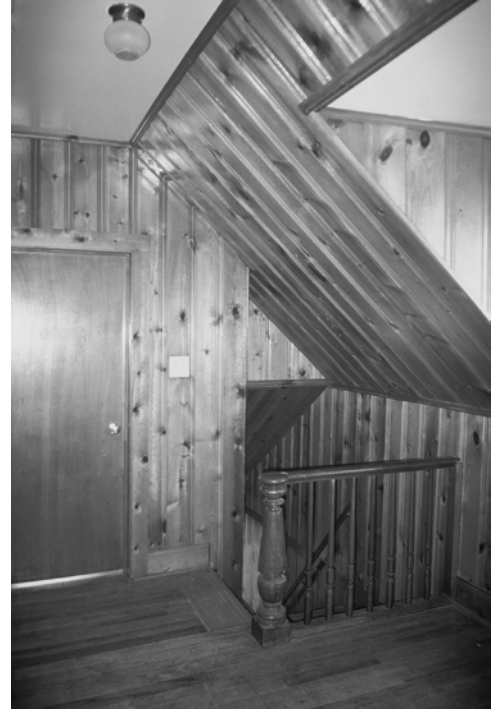
Figure C-17 Room 202

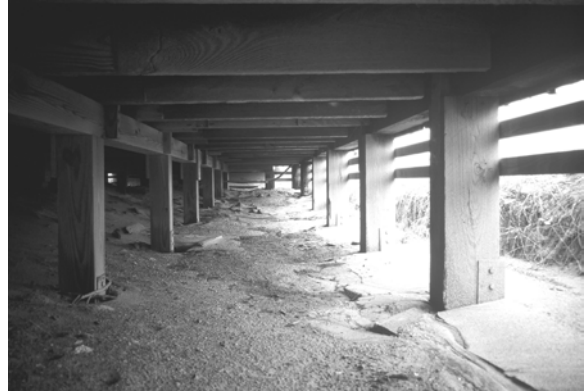
Figure C-22 Foundation and floor structure of the boat house, looking west

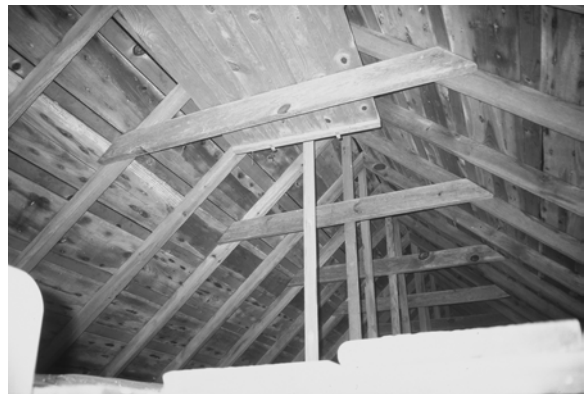
Figure C-23 Attic of boat house
