**BUILDING 1, FORT TILDEN  
HISTORIC STRUCTURES REPORT**

**Prepared by:**  
**QUINN EVANS ARCHITECTS**  
1214 Twenty-Eighth Street, NW  
Washington, DC

Project Number: 06256

# BUILDING 1, FORT TILDEN - DRAFT HISTORIC STRUCTURES REPORT

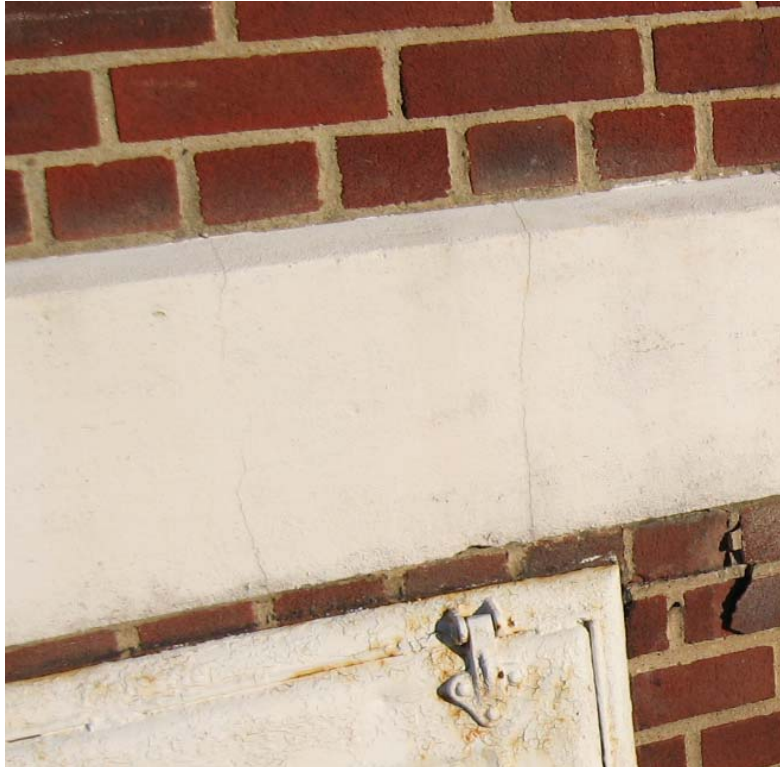
Photo of the cast stone water table. The cast stone features (water table and window sills) have been painted. The integral color of the concrete matrix would have been the intended period finish. Photo is dated November 2006. (QUINN EVANS | ARCHITECTS)

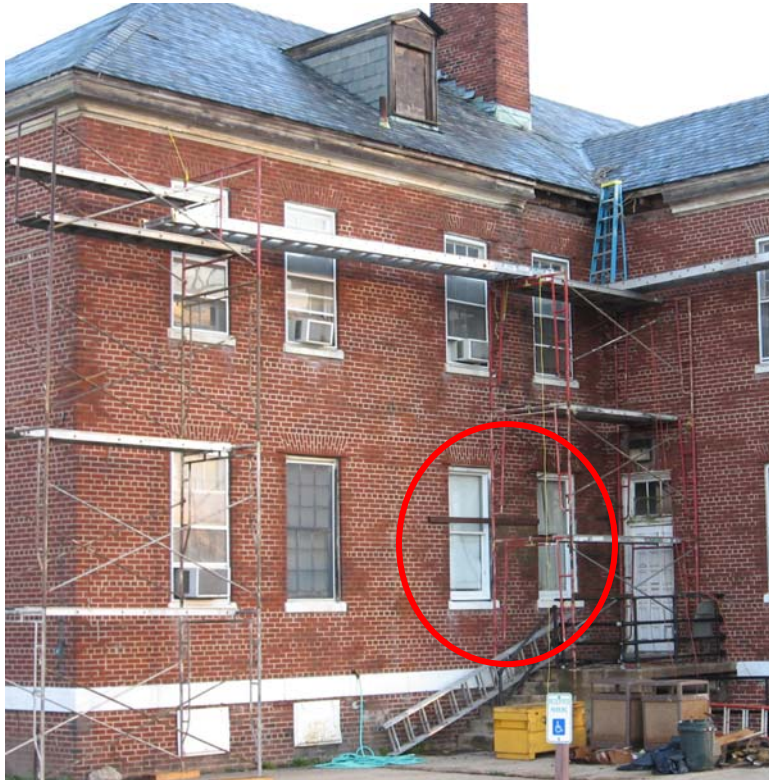
Photo of western corner of Building 1. Windows that have been replaced with a non-contributing and incompatible aluminum sash are circled. Photo is dated November 2006. (QUINN EVANS | ARCHITECTS)

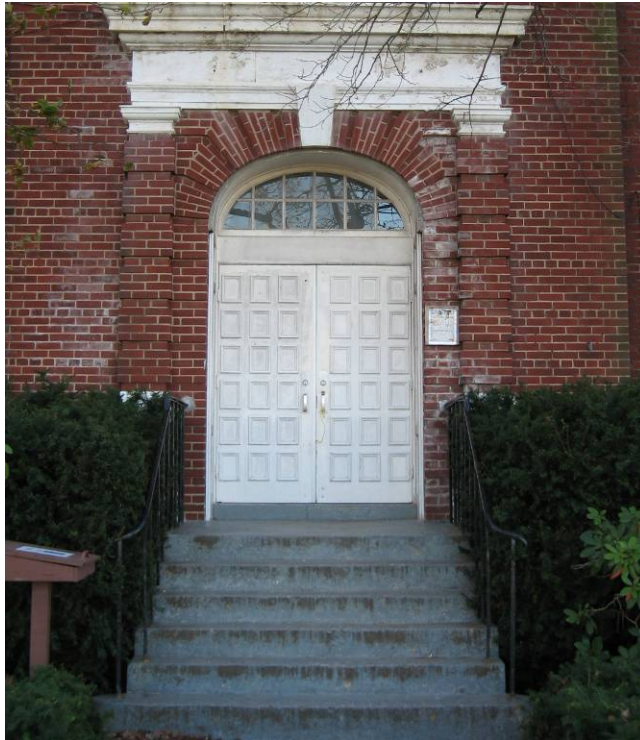
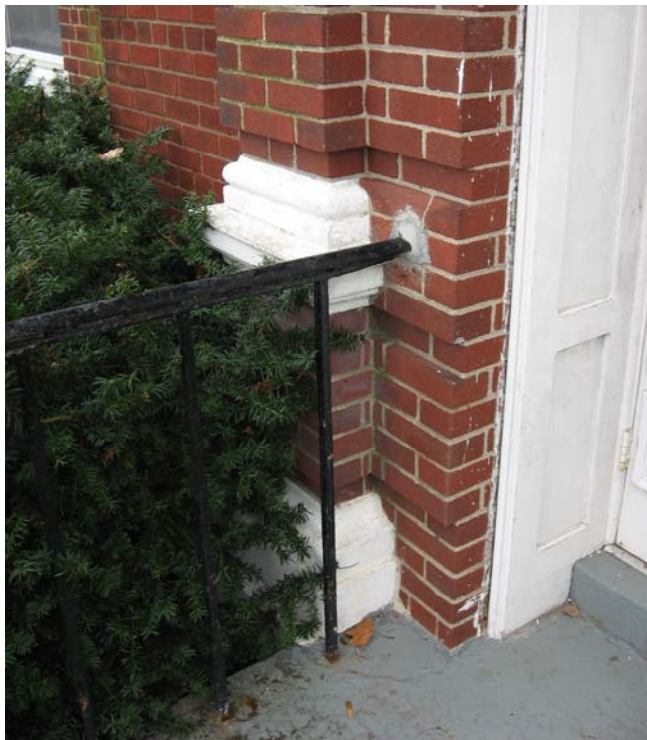
Photo of main entrance to Building 1. The cornice, door, transom, and stair are in fair condition and have peeling paint and visible wear. The wrought iron stair railing is original. In the detail photo below, deteriorated sections of railing are visible and may require repair or replacement. Photos are dated November 2006. (QUINN EVANS | ARCHITECTS)

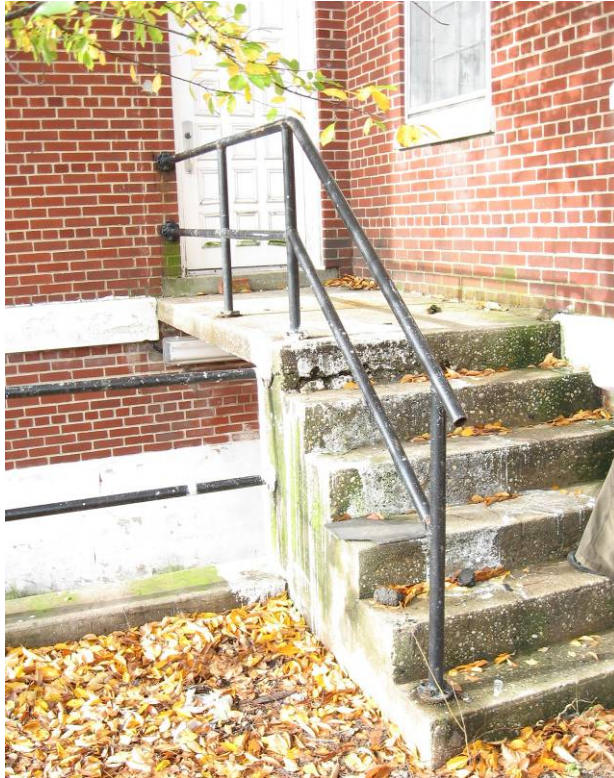
**Figure 4.2**

Photo of the east entrance on the south elevation. The rail, which is galvanized steel, has peeling paint. The concrete steps and landing is cracked and spalling. Photo is dated November 2006. (QUINN EVANS | ARCHITECTS)

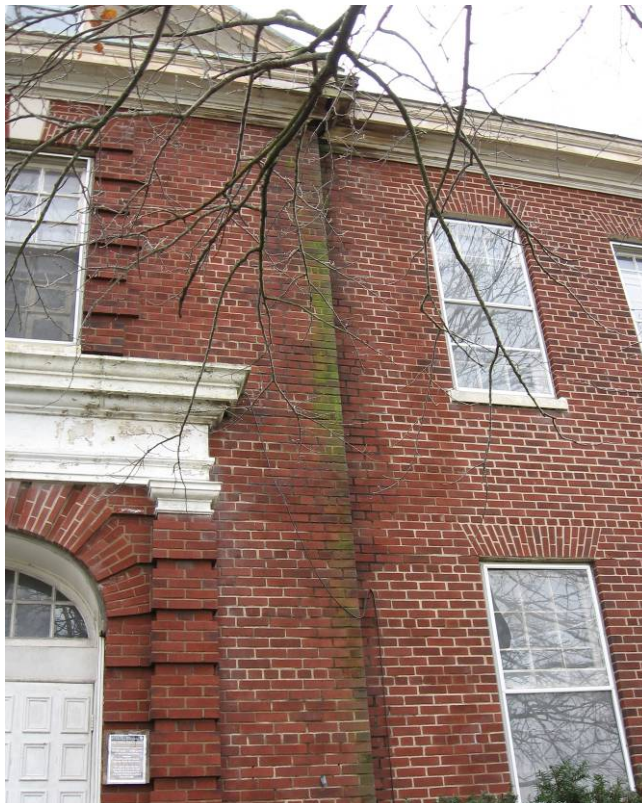
**Figure 4.3**

Wall condition showing some biological growth and damp brick on the west side of the main entrance. Photo is dated November 2006. (QUINN EVANS | ARCHITECTS)

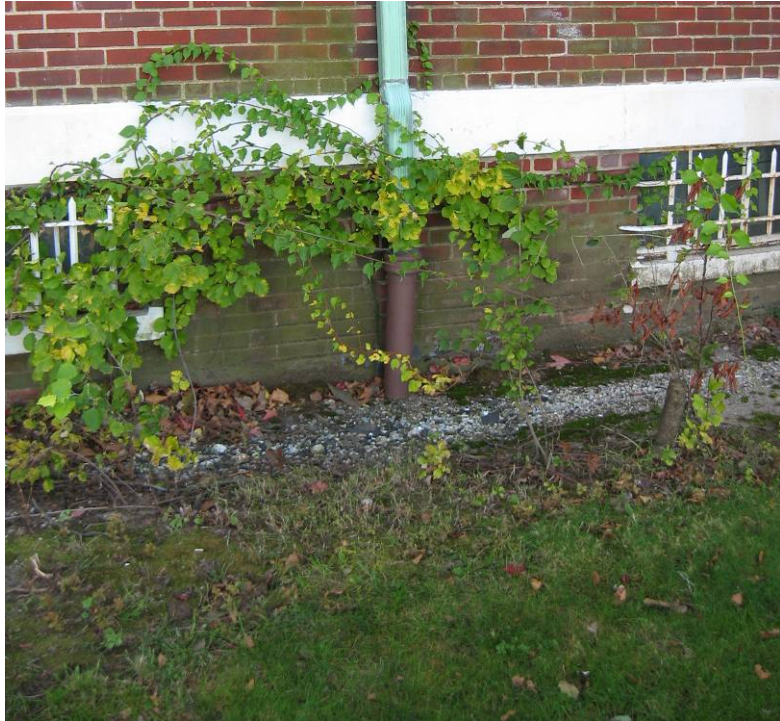
**Figure 4.4**

The building foundation walls have been poorly maintained and ivy and biological growth is present on the brick at these locations. In some locations water ponding is common where there is not positive drainage away from the building. Photo is dated November 2006. (QUINN EVANS | ARCHITECTS)

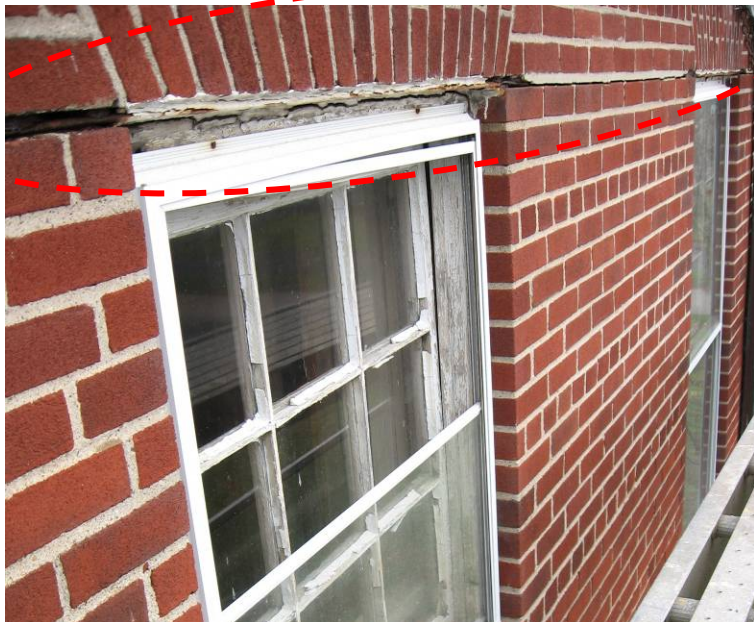
**Figure 4.5**

This photo illustrates the continuous nature of the window head cracking and lintel corrosion that extends between windows in some locations. Photo is dated November 2006. (QUINN EVANS | ARCHITECTS)

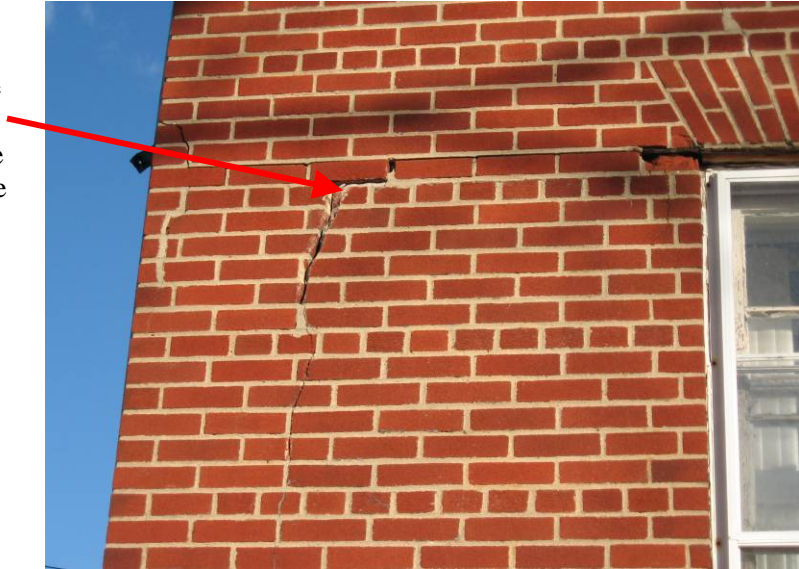
**Figure 4.6**

A large crack and open joint on the southwest corner of the building permits water infiltration, contributing to the deterioration of the brick. The cause of the cracking should be confirmed before any masonry repairs are undertaken. Photo is dated November 2006. (QUINN EVANS | ARCHITECTS)

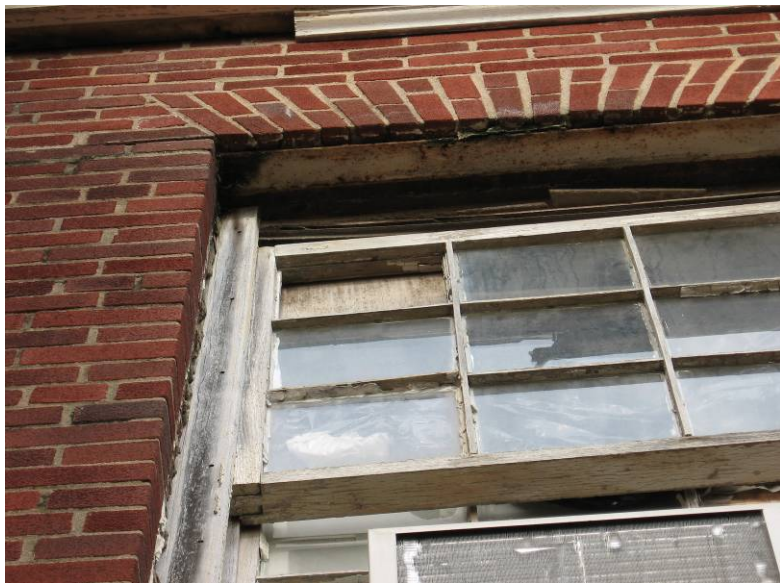
**Figure 4.7**

Typical nine-over-nine wood window. This particular top sash is no longer staying in place and there are pieces of glazing missing. Brick molding is typically in poor condition. Photo is dated November 2006. (QUINN EVANS | ARCHITECTS)

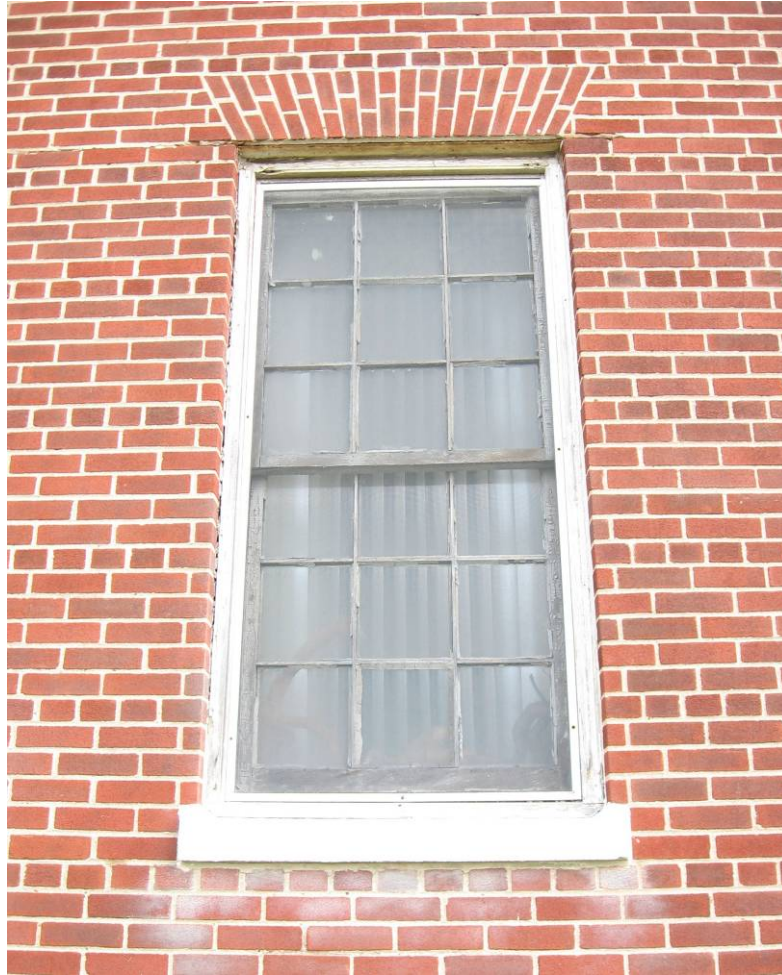
**Figure 4.8**

Photo of typical nine-over-nine wood. This particular example has a modern storm window attached to the period wood window frame beyond. The wood window is heavily weathered, there is minimal paint remaining, the steel header is rusted, and paint from the cast stone sill is washing off and staining the brick. Photo is dated November 2006. (QUINN EVANS | ARCHITECTS)

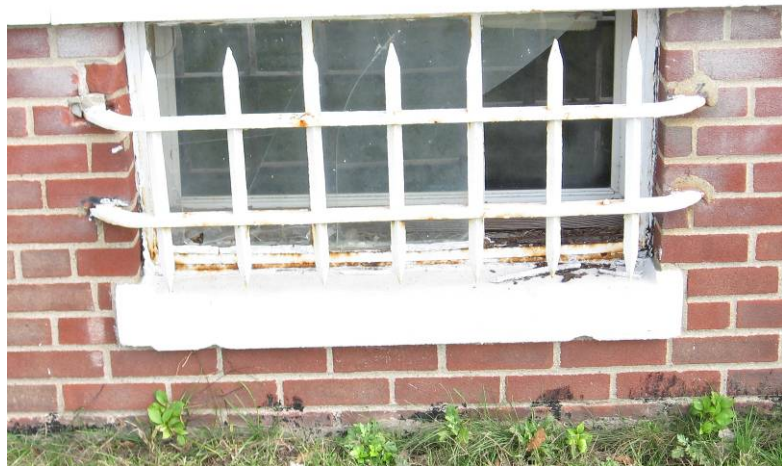
**Figure 4.9**

Photo of typical steel hopper window, illustrating a unit with missing glazing. Significant corrosion, like that shown in this photograph, is common. Replacement windows are the recommended treatment. Historic window details have not been uncovered, but the existing windows can be used to design a compatible replacement matching the historic sightlines. Photo is dated November 2006. (QUINN EVANS | ARCHITECTS)

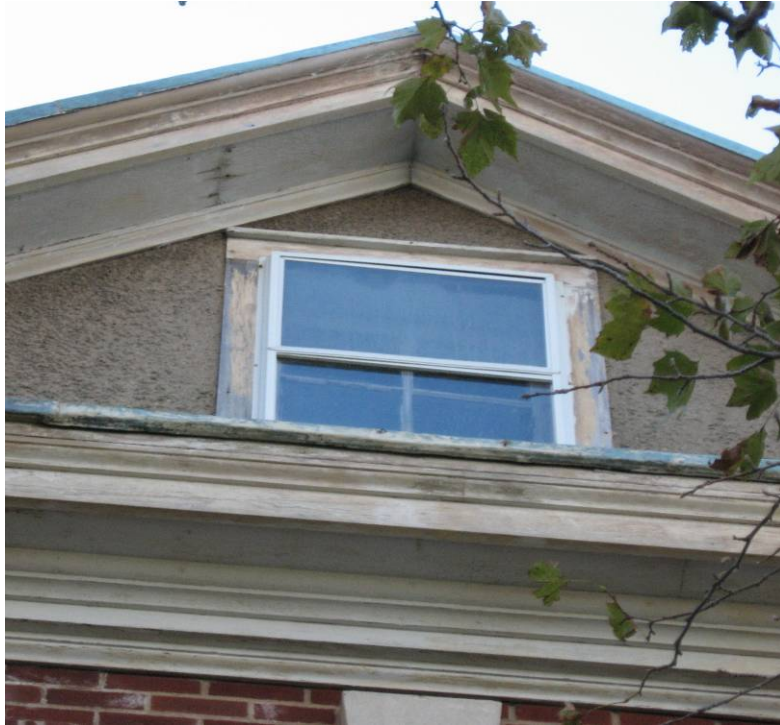
**Figure 4.10**

Photo of the wood casement window in the attic. The condition of this window was hard to assess because of the storm window, but the glazing putty appears to be deteriorated and the sash has failing paint. Photo is dated November 2006. (QUINN EVANS | ARCHITECTS)

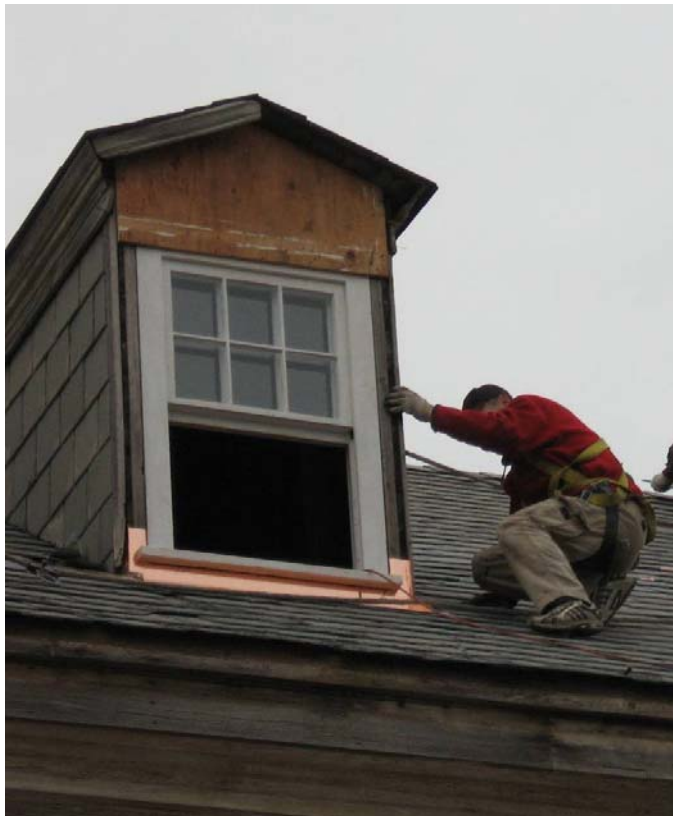
**Figure 4.11**

A current roofing repair project being undertaken by the National Park Service includes repair of the rear elevation dormers. New window sash, matching the historic sash appearance, are being installed. Photo is dated February 2007. (NPS, Barbara Judy)

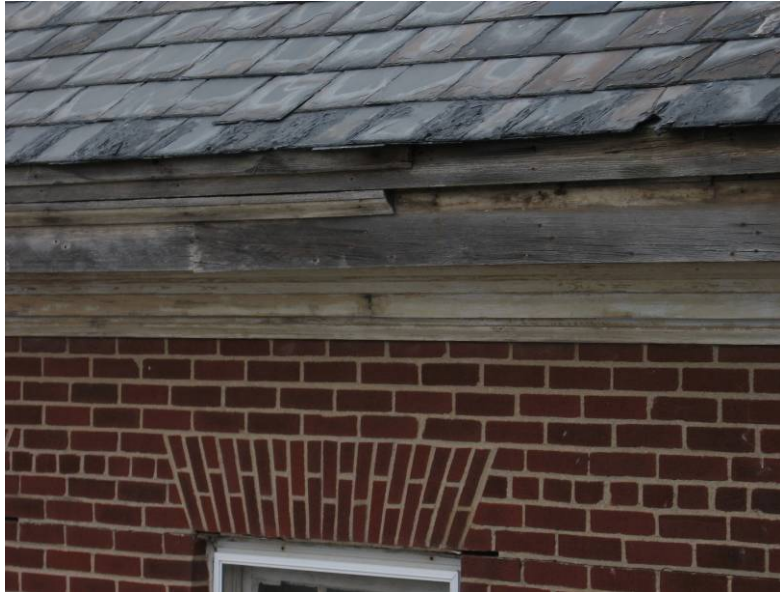
**Figure 4.12**

This photo illustrates common problems found on many areas of the slate roof: broken and shifted. Photo is dated November 2006. (QUINN EVANS | ARCHITECTS)

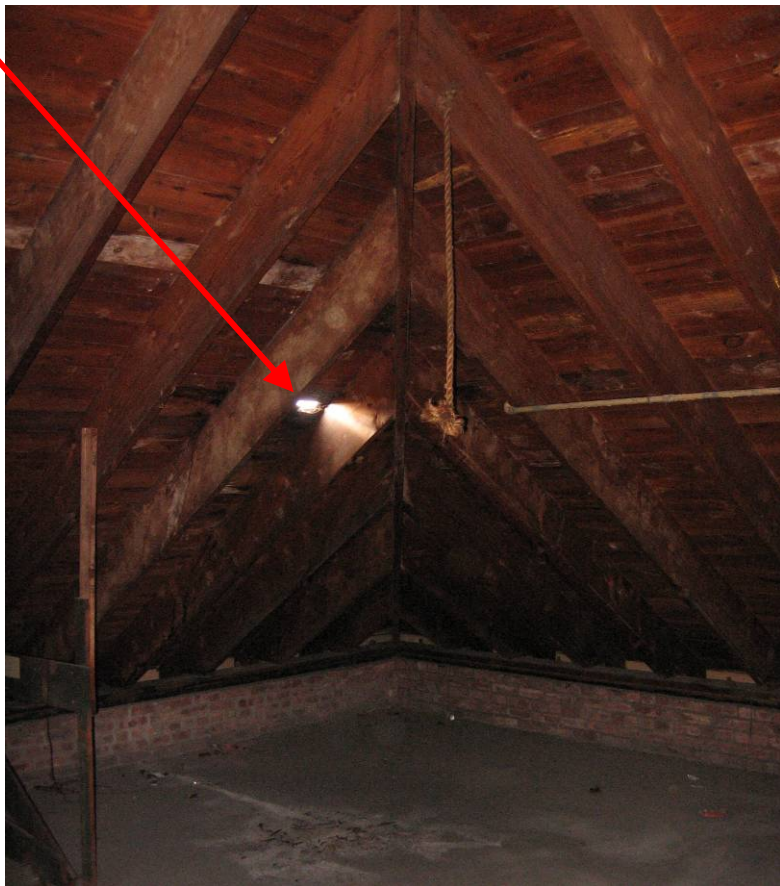
**Figure 4.13**

Hole in roof structure allowing water infiltration and animal intrusions. This condition is being addressed by the current roofing project. Photo is dated November 2006. (QUINN EVANS | ARCHITECTS)

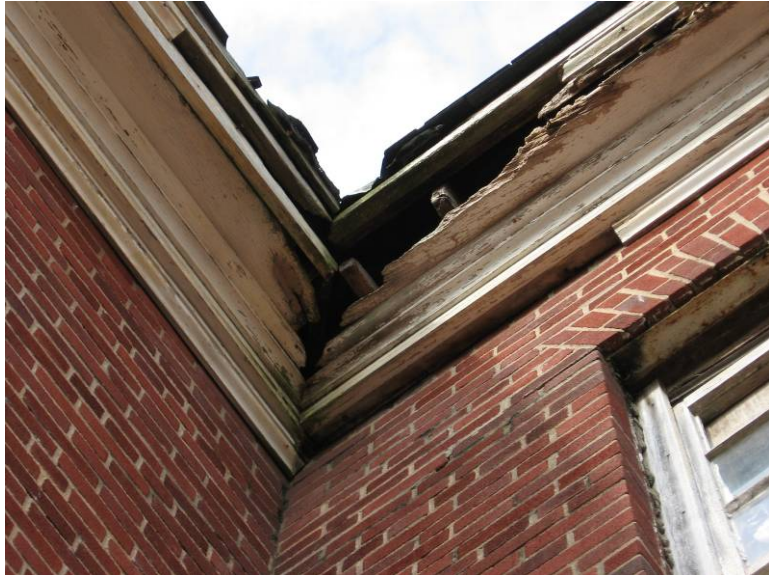
**Figure 4.14**

Photograph of typical eave deterioration. This condition is being addressed by the current roofing project. Deterioration of the wood eave is exacerbated by the missing gutters and downspouts. Photo is dated November 2006. (QUINN EVANS | ARCHITECTS)

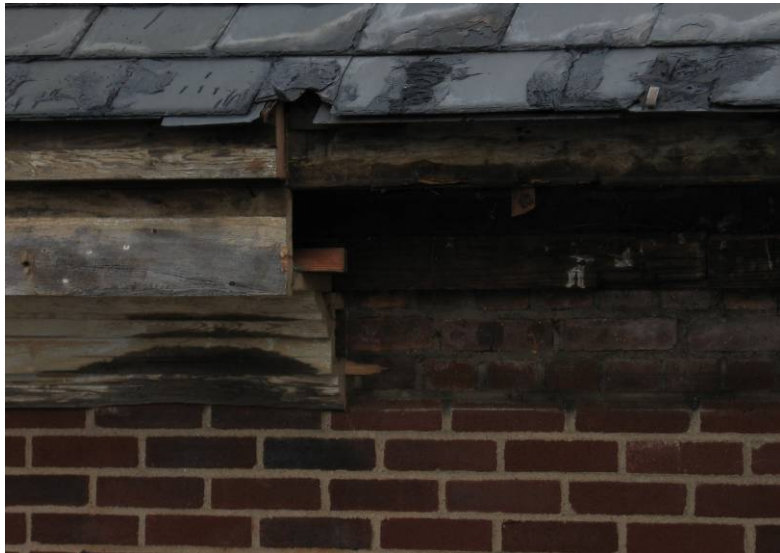
**Figure 4.15**

This photograph illustrates a section of wood eave that is being removed and replaced to address rotted and missing wood. Photo is dated November 2006. (QUINN EVANS | ARCHITECTS)

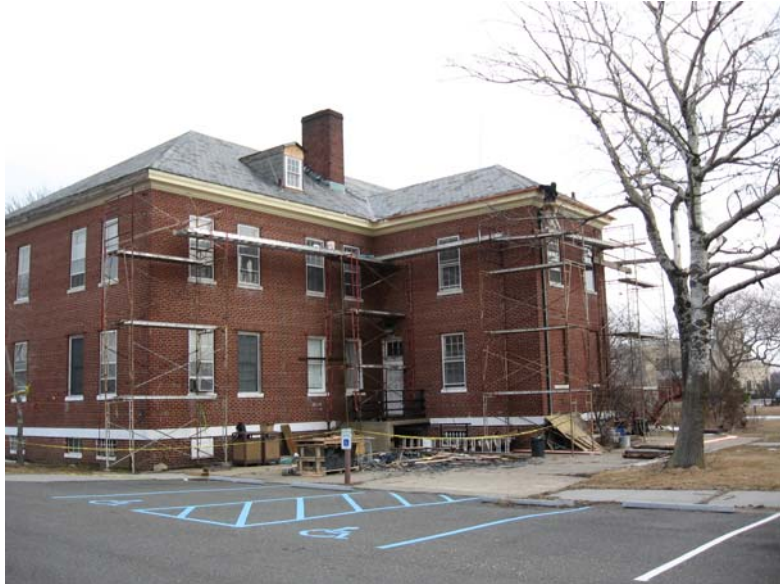
A roofing project is currently underway. Progress to replace broken and missing slate tiles, repair deteriorated sections of the wood eaves, replace roof flashing, and replace missing copper gutters and downspouts is shown at right. A section of wood eave that has recently been replaced to address rotted and missing wood is visible. Photo is dated February 2007. (NPS, Barbara Judy)

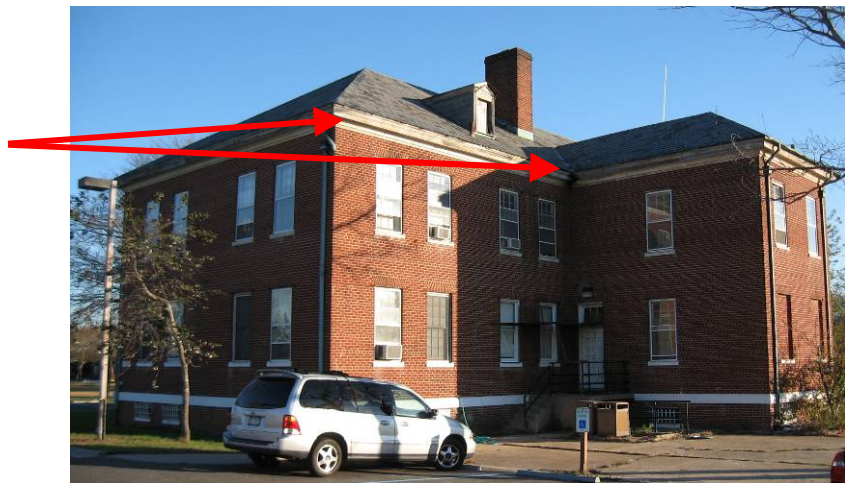
**Figure 4.17**

This image shows where lengths of gutter and downspouts are missing. Photo is dated November 2006. (QUINN EVANS | ARCHITECTS)

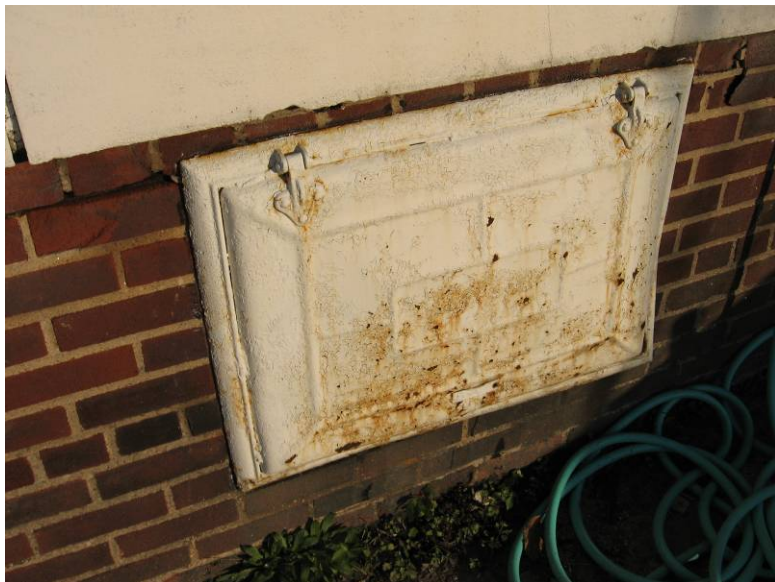
**Figure 4.19**

Corrosion on the period cast iron coal chute cover. Photo is dated November 2006. (QUINN EVANS | ARCHITECTS)

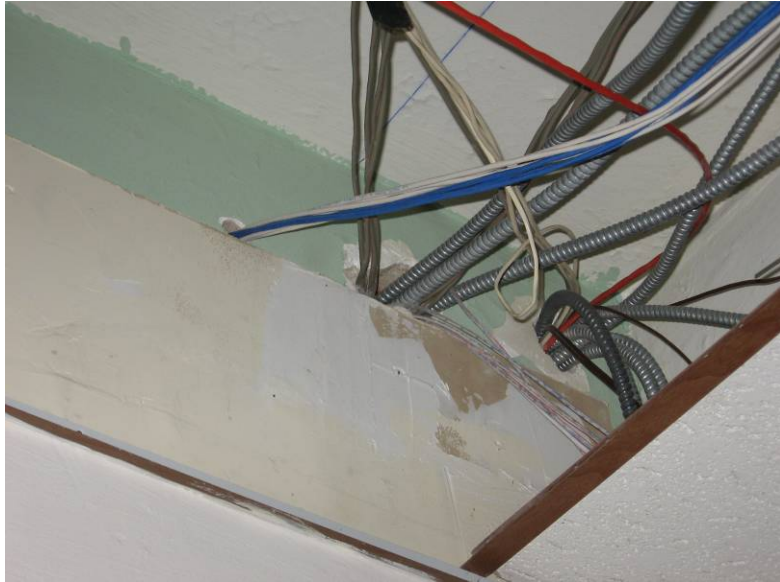
This image illustrates the layering effect on the interior walls (wallboard over plaster). Photo is dated November 2006. (QUINN EVANS | ARCHITECTS)

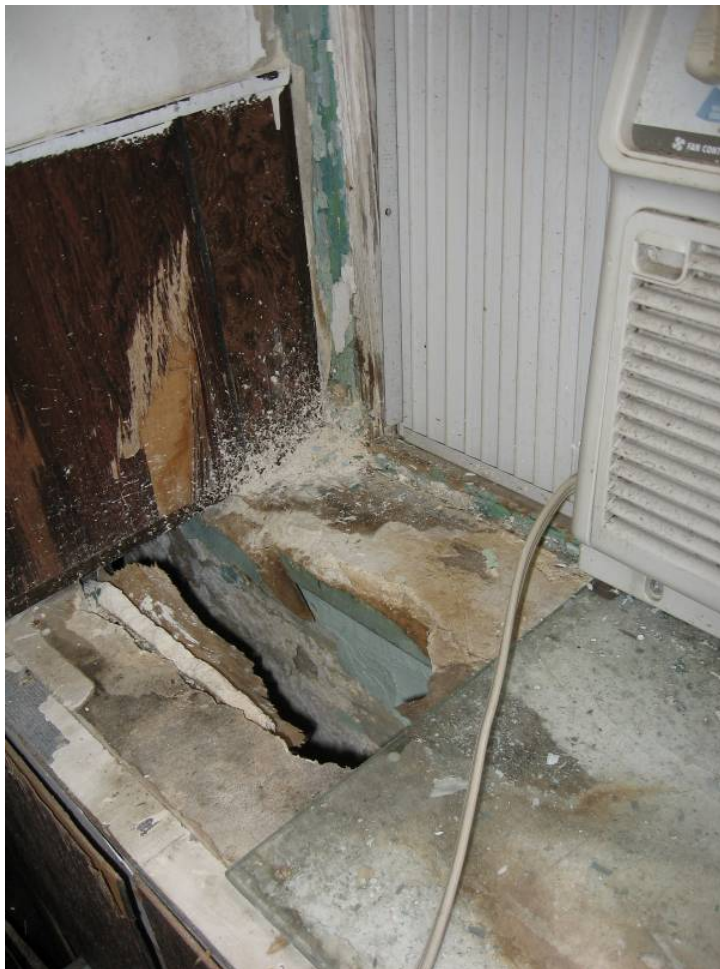
**Figure 4.23**

Example of typical water damage around window openings. Wood stools are deteriorated and plaster is water damaged. Photo is dated November 2006. (QUINN EVANS | ARCHITECTS)

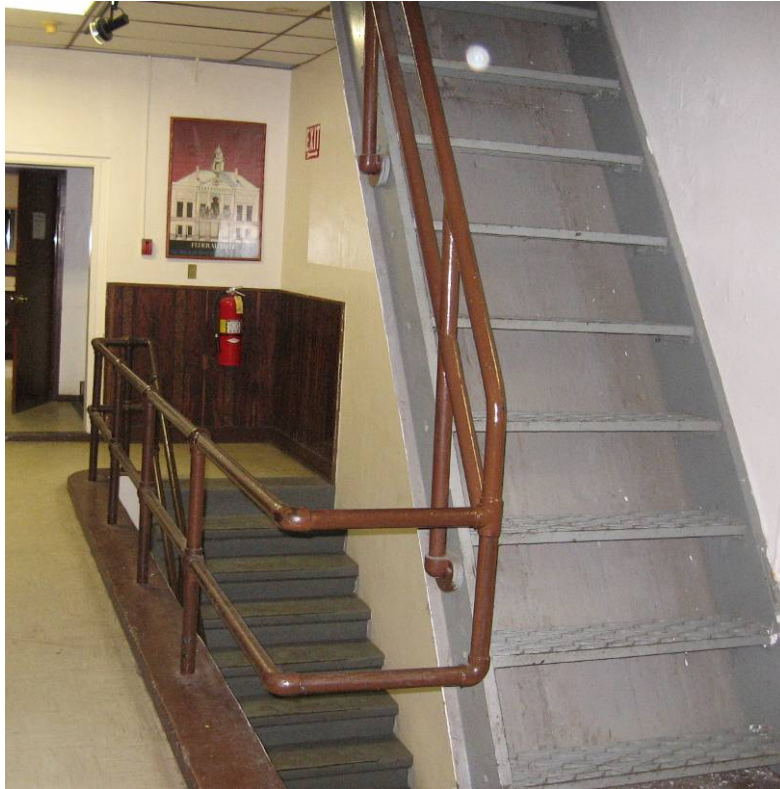
**Figure 4.26**

The period concrete stairs connecting the first and second floor and interior railing are in fair condition. At right is the steel ships ladder that connects the second floor to the attic. Photo is dated November 2006. (QUINN EVANS | ARCHITECTS)

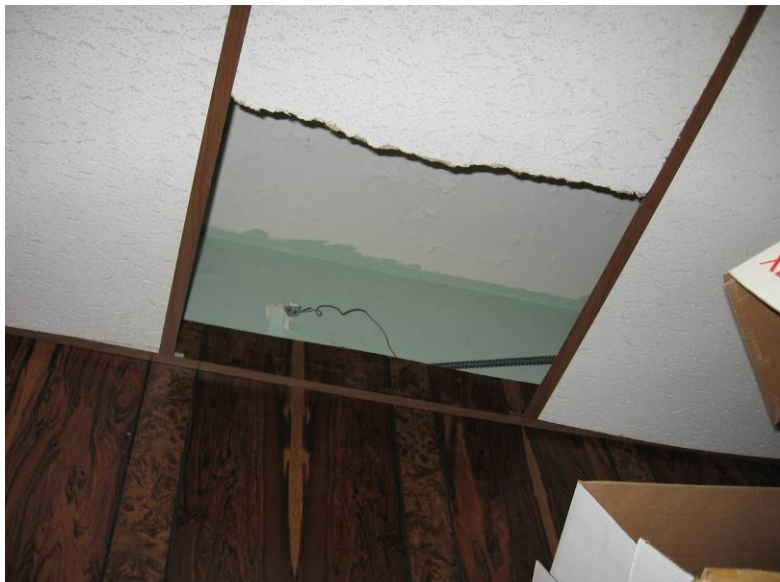
**Figure 4.27**

This photograph illustrates the common damage to existing suspended ceiling; note the period ceiling and wall finishes beyond. Photo is dated November 2006. (QUINN EVANS | ARCHITECTS)
