THE ADMINISTRATION BUILDING (THE RYAN CENTER)

Gateway National Recreation Area
Floyd Bennett Field Unit
Brooklyn, New York

Historic Structure Report

By
Judith A. Quinn

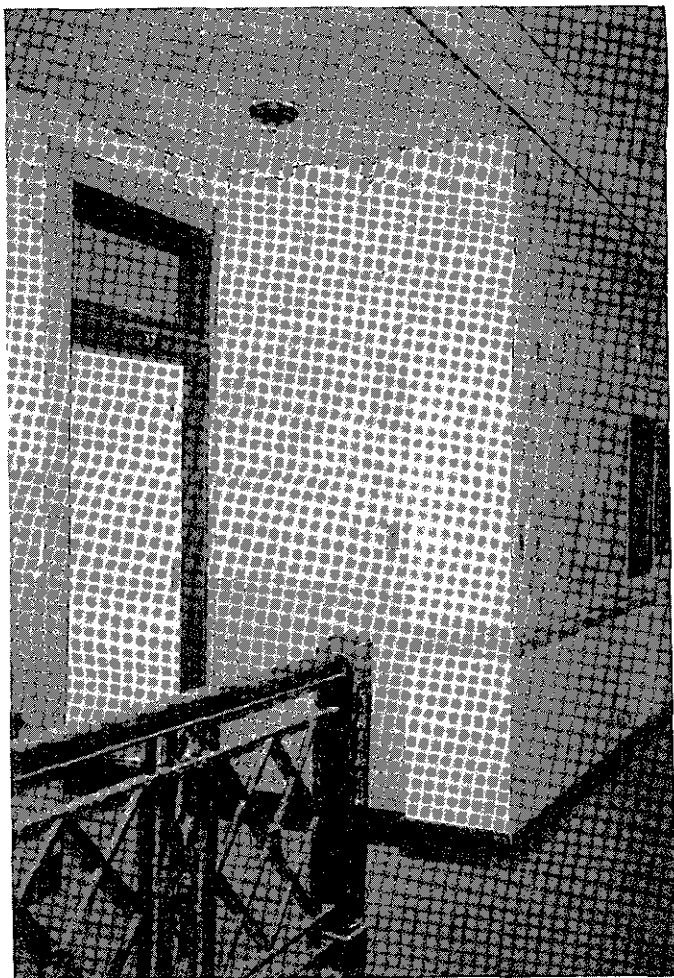
Figure 29. North corridor, east wall: former window wall looking into Room 110, plate glass now replaced with plywood.

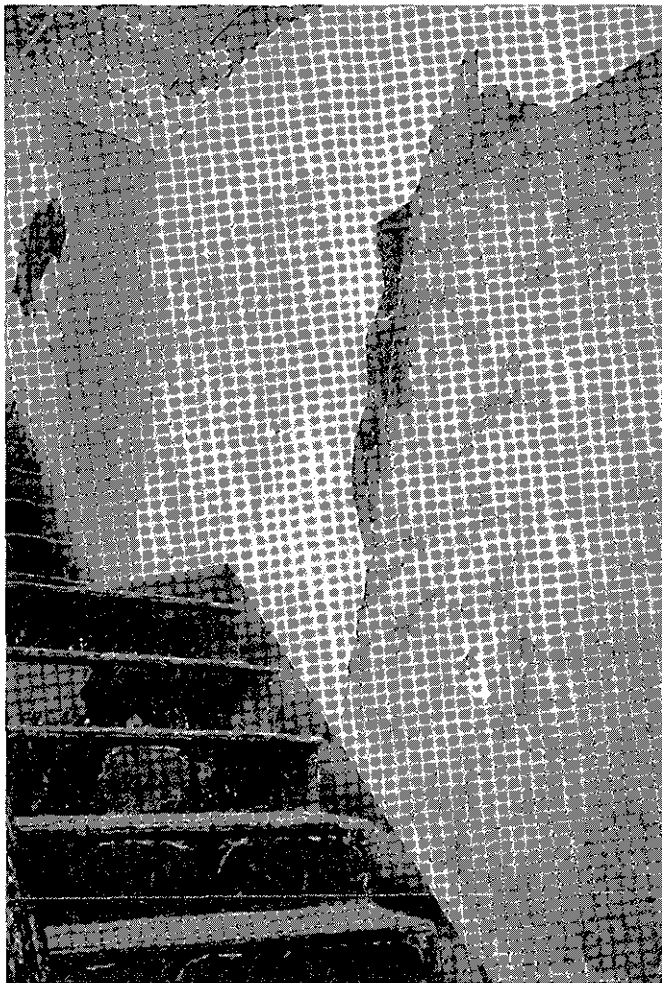
Figure 46. Imitation Caen stone on wall of Stairway #5 between second and third floors, showing pargeting spalling from scored cement brown coat.

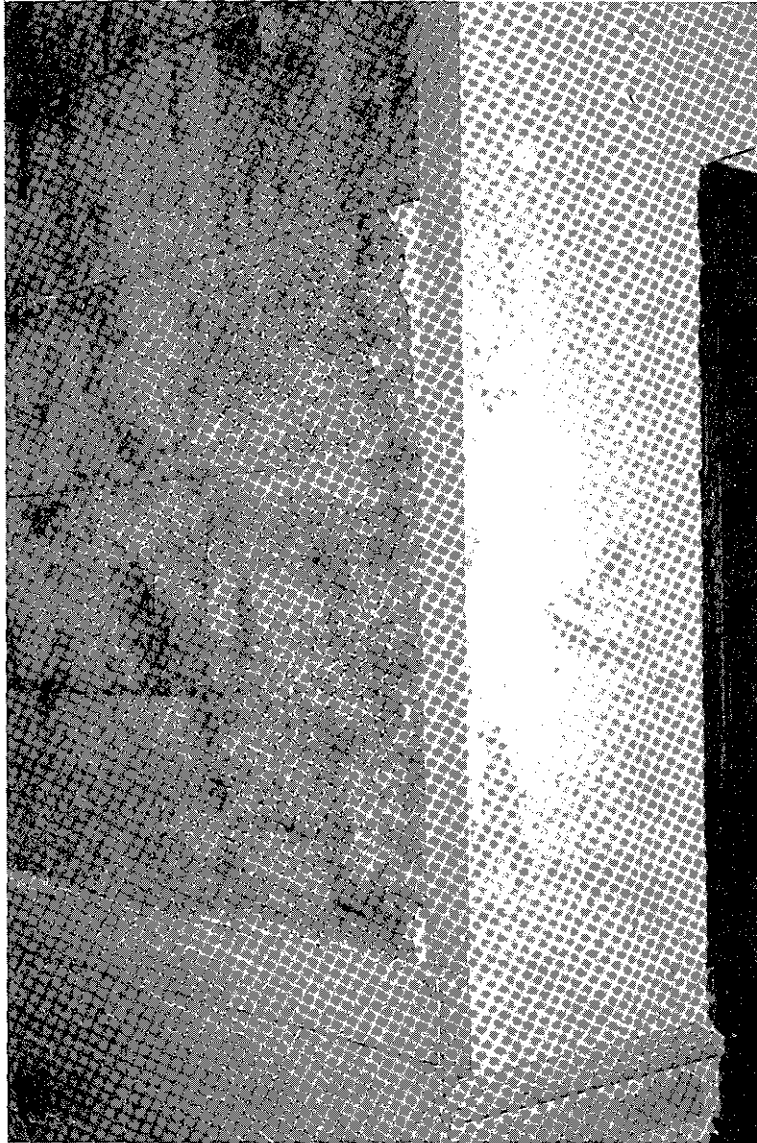
Figure 47. Imitation Caen stone at juncture of wall of Stairway #5 and east wall of south corridor, second floor. Exposed cement brown coat of imitation stone on left, scored plaster on right.
