400 + 641 / D-515

National Park Service
U.S. Department of the Interior

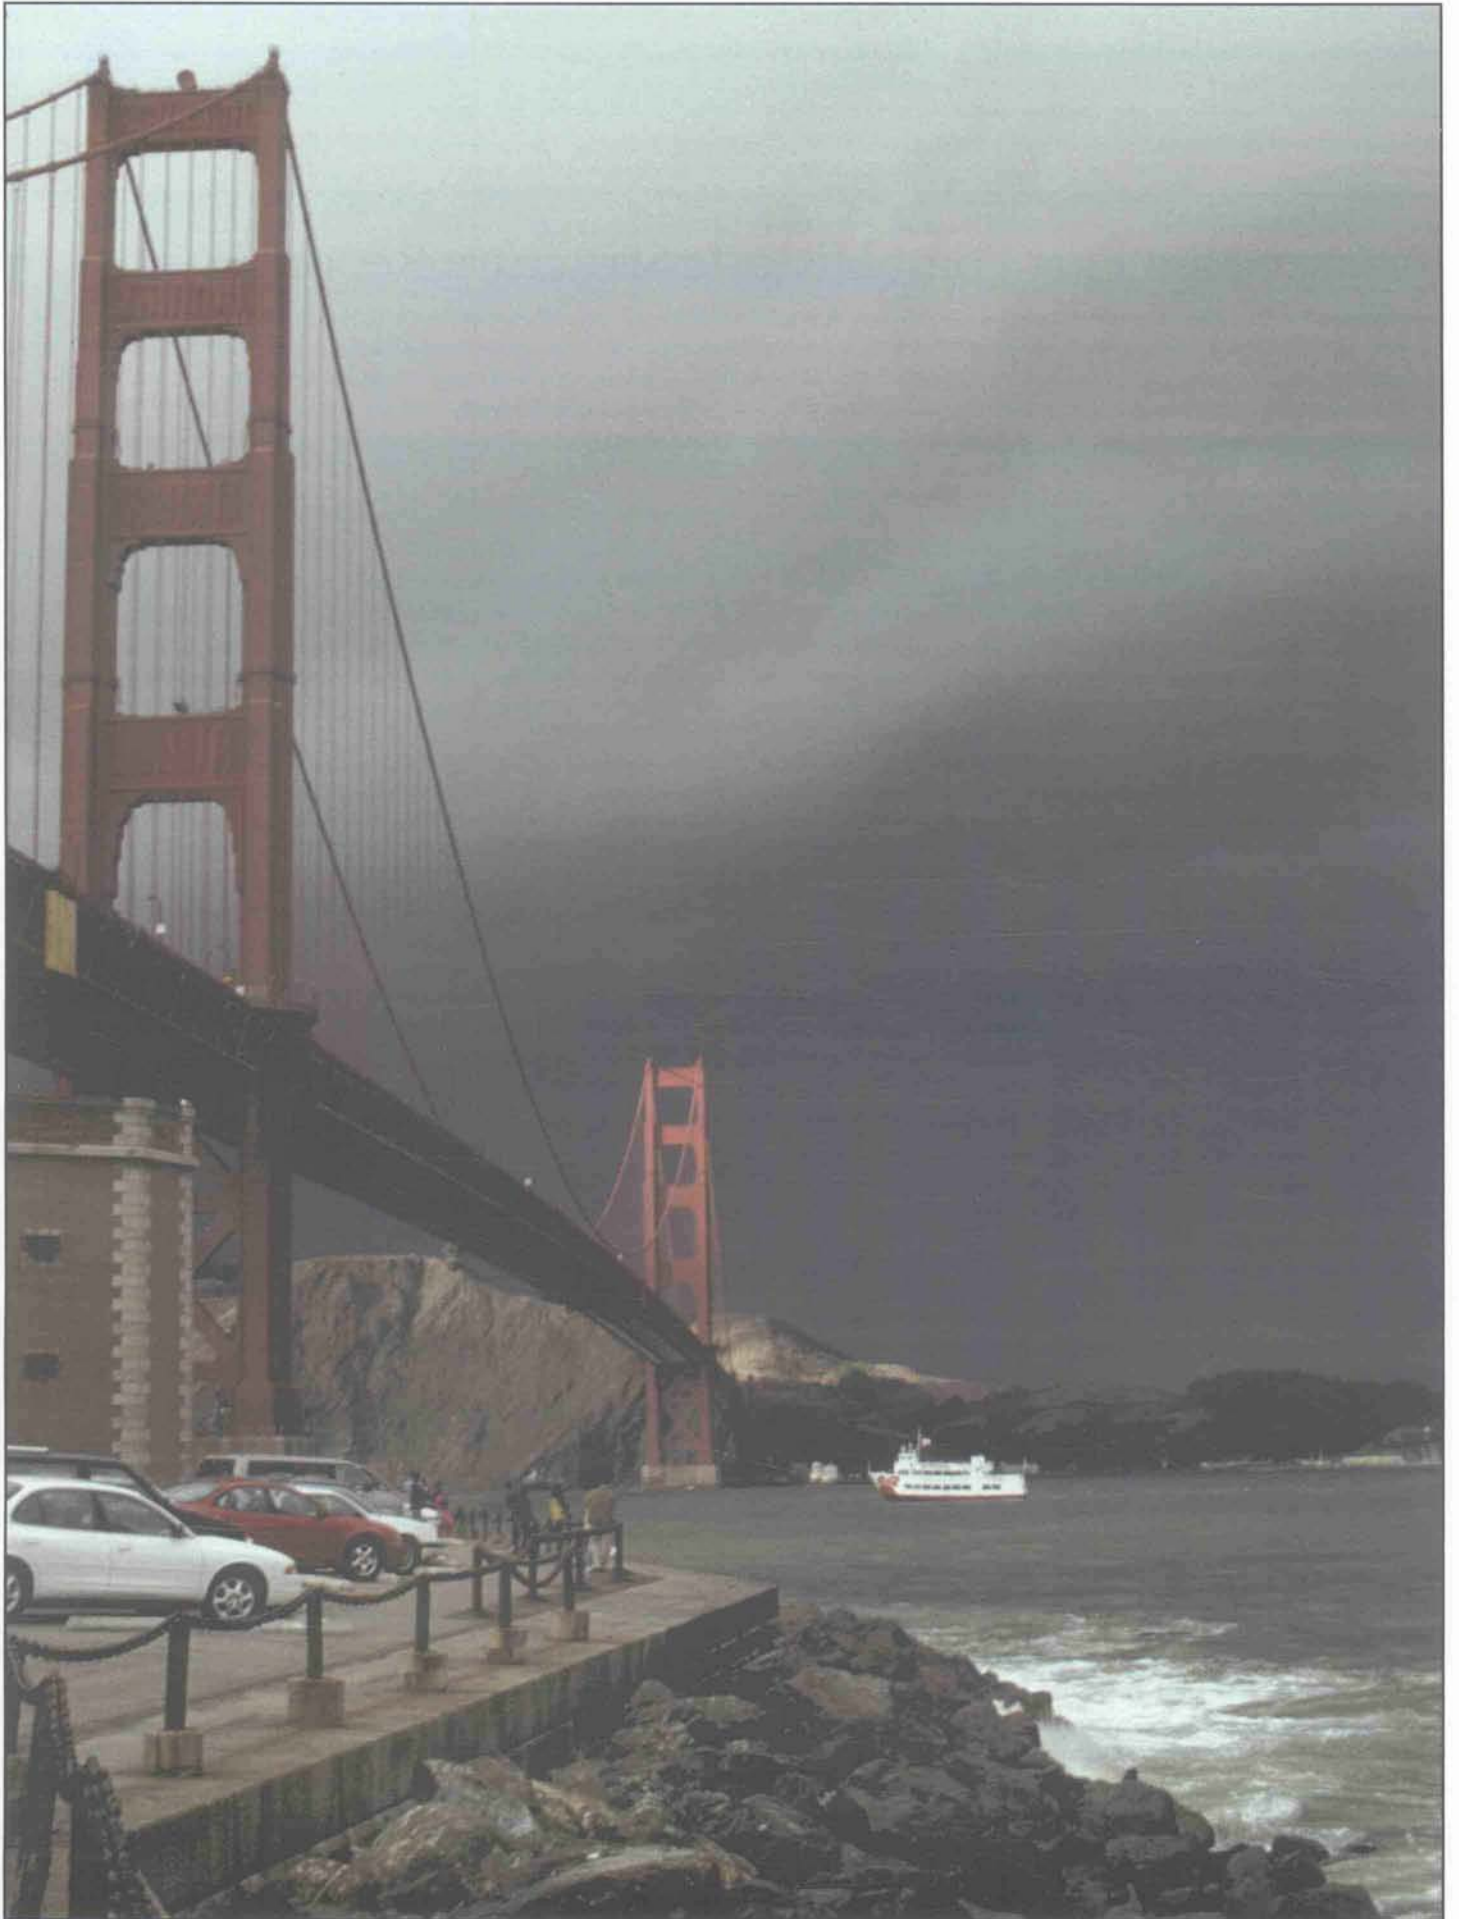
This photo, dated 1910, shows the Fort Point lighthouse keeper's residences located at the south of the fort. Credit: Fort Point NHS Collection, Golden Gate National Recreation Area.

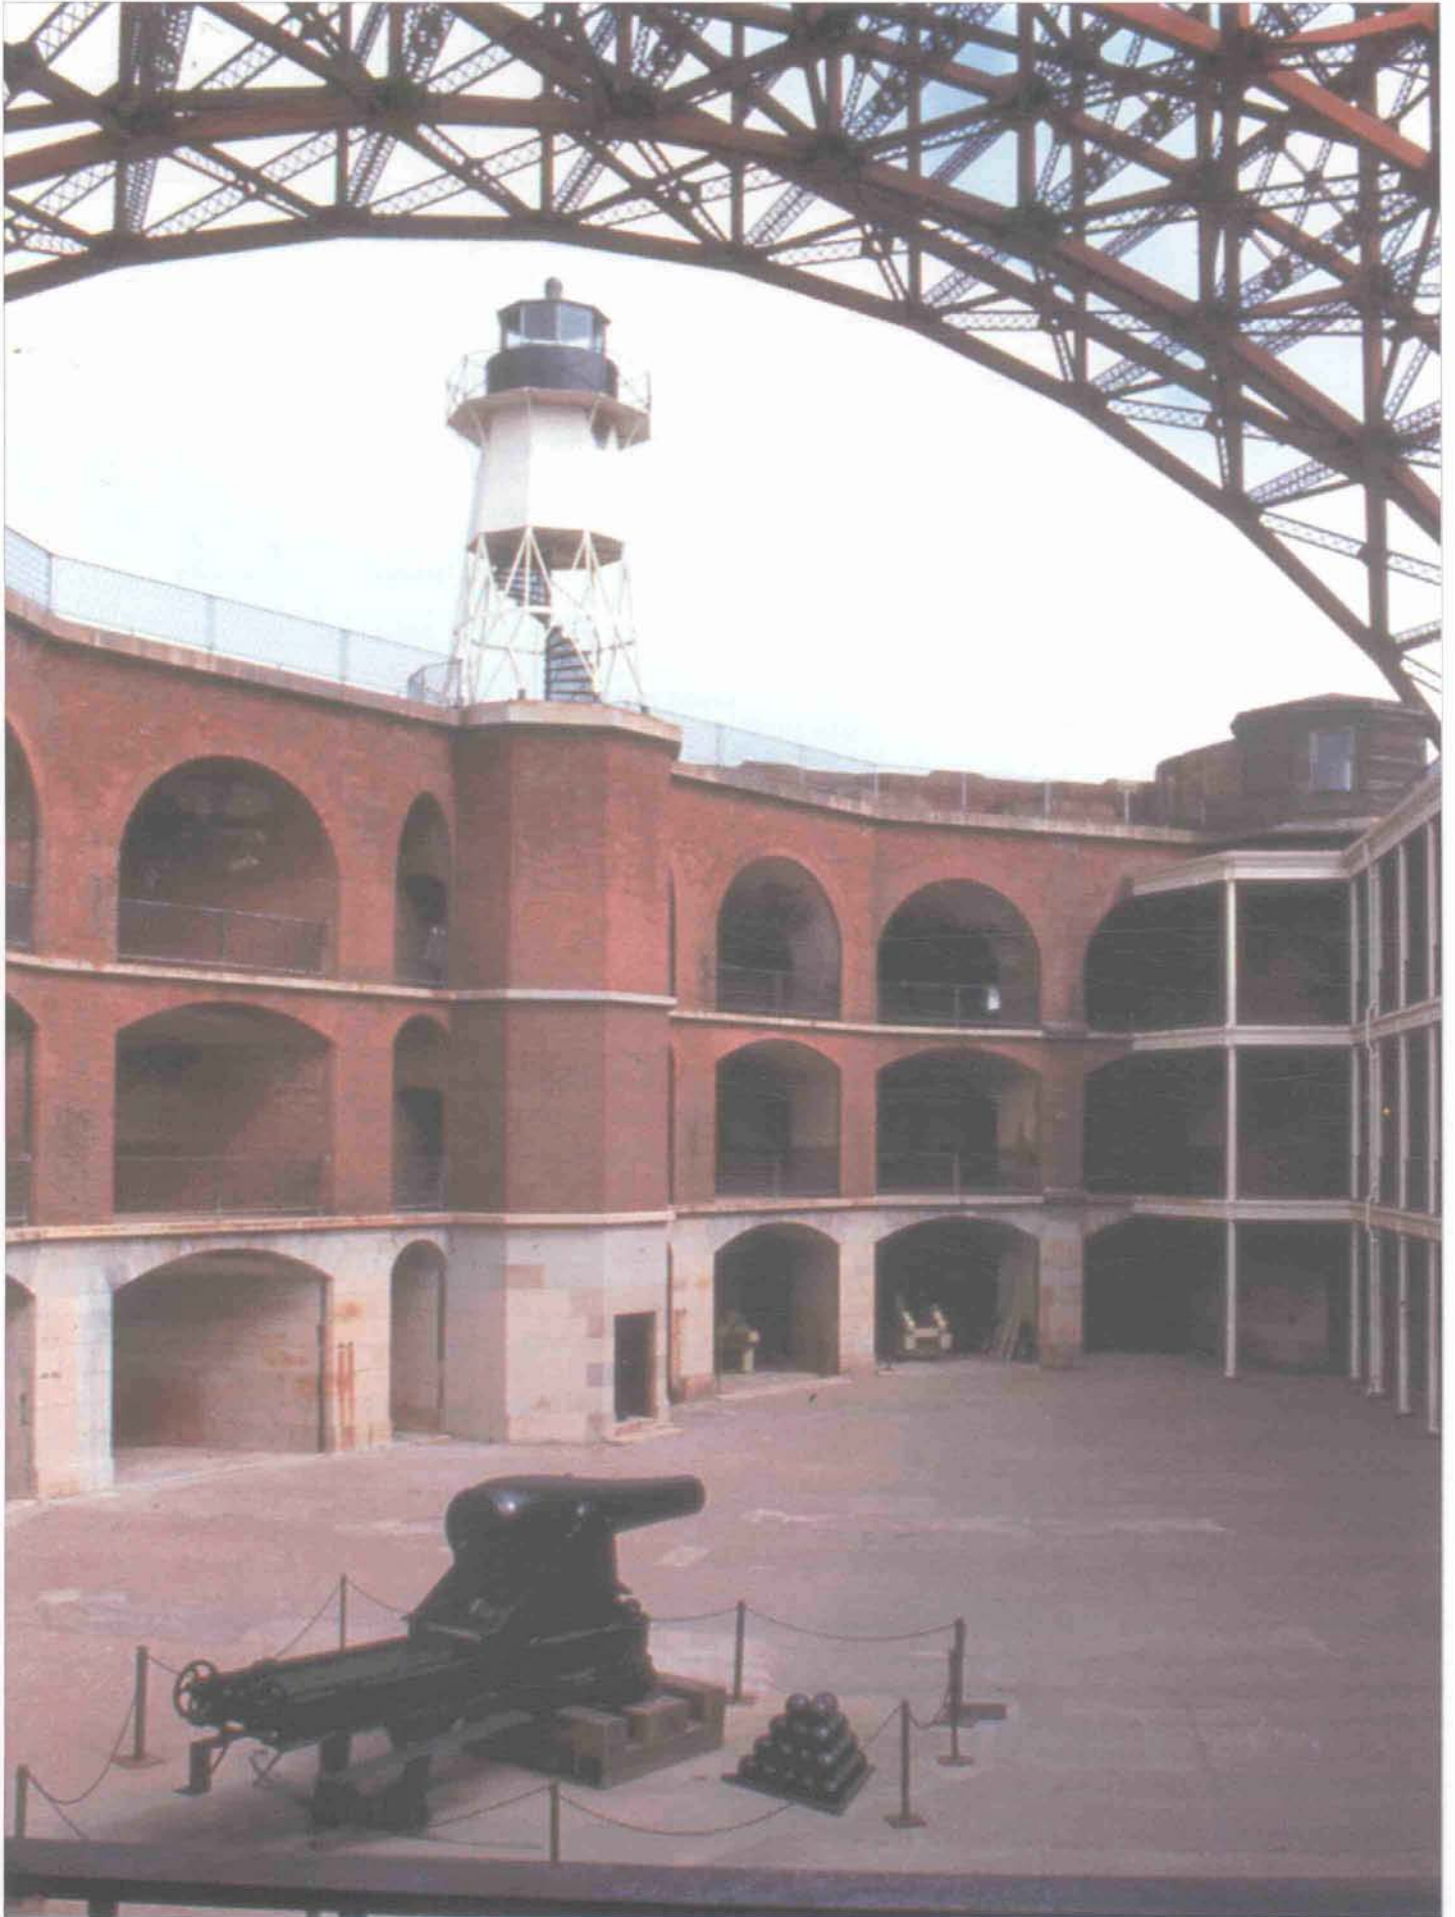
Appendices C: Supplemental Record of Work Performed	152

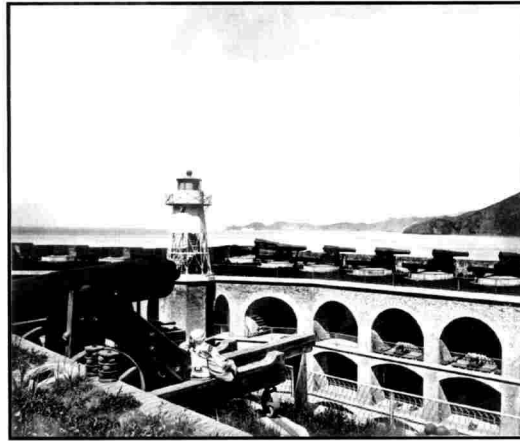
entire tip of the hundred-foot-high peninsula would have to be cut down nearly to sea level to provide a platform for the huge casemated fort.

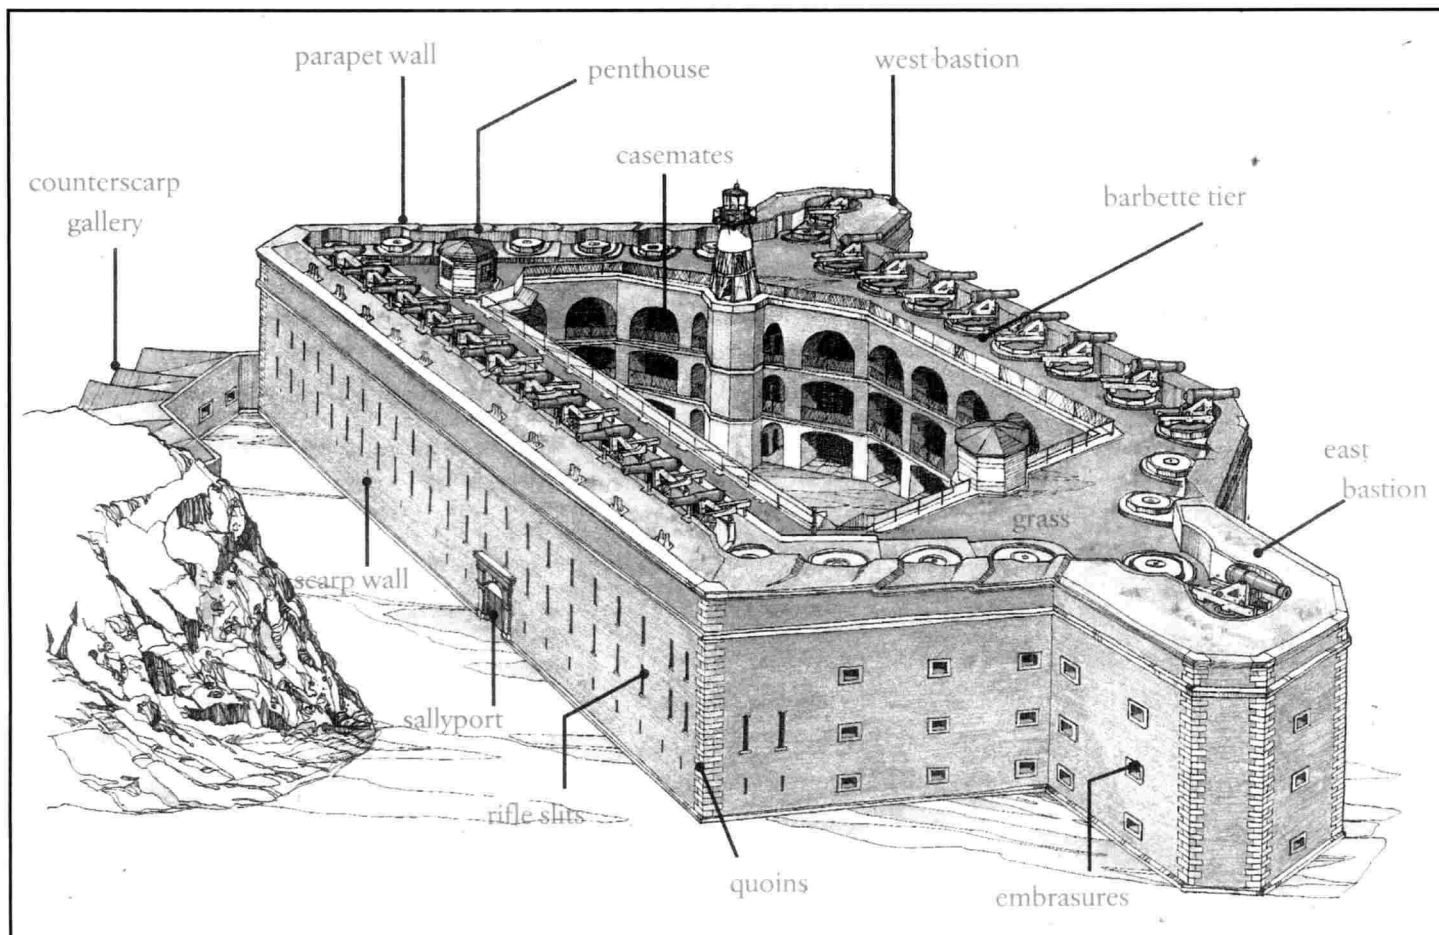
Illustration circa 1991. Courtesy of Lawrence Orsmy.

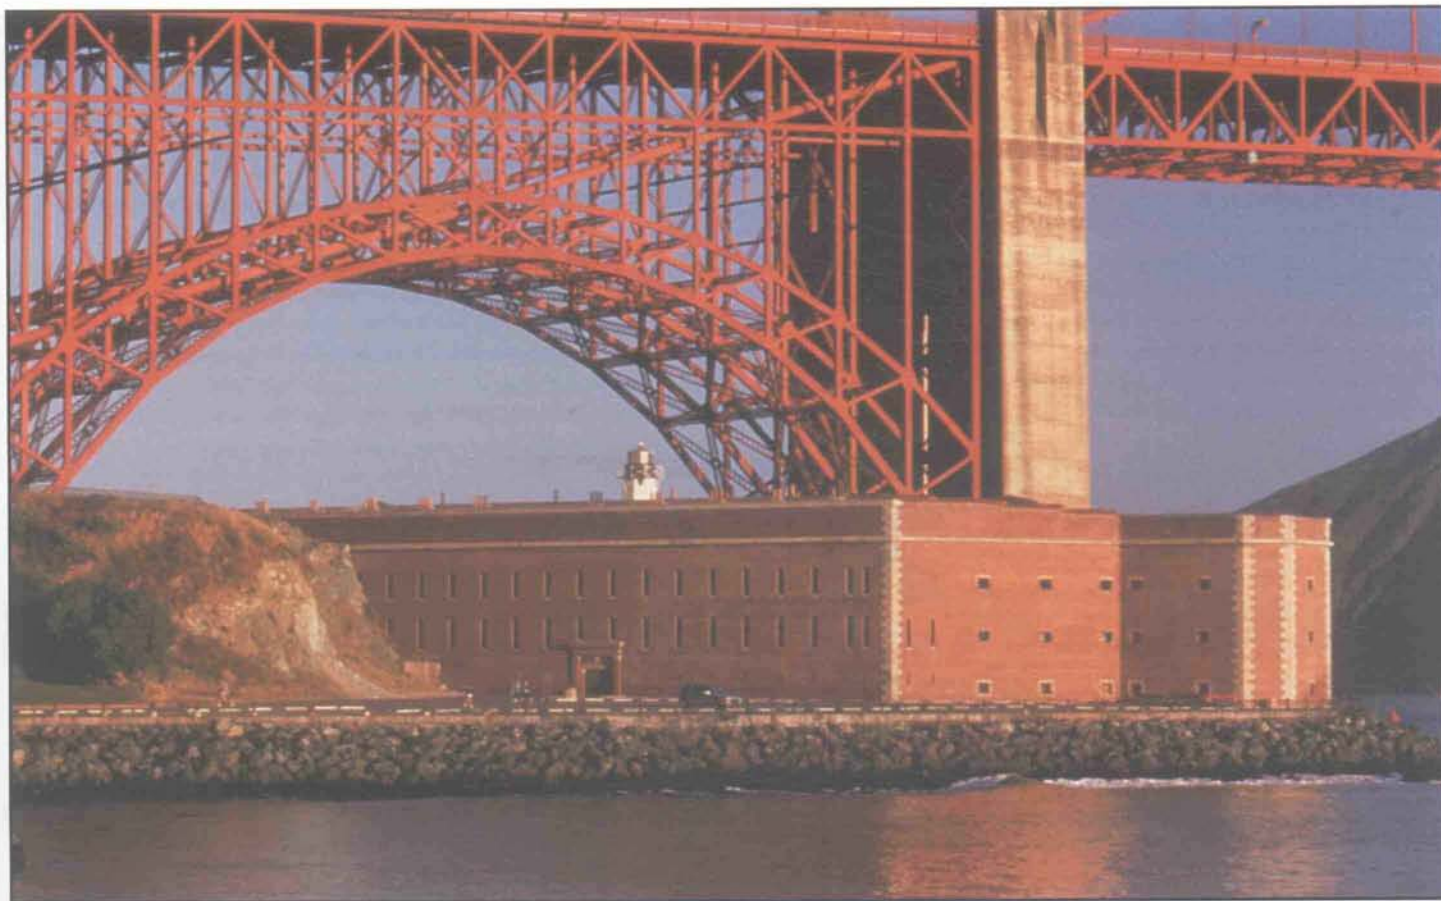
Contemporary view of Fort Point, circa 2000. Credit: Golden Gate National Parks Conservancy.

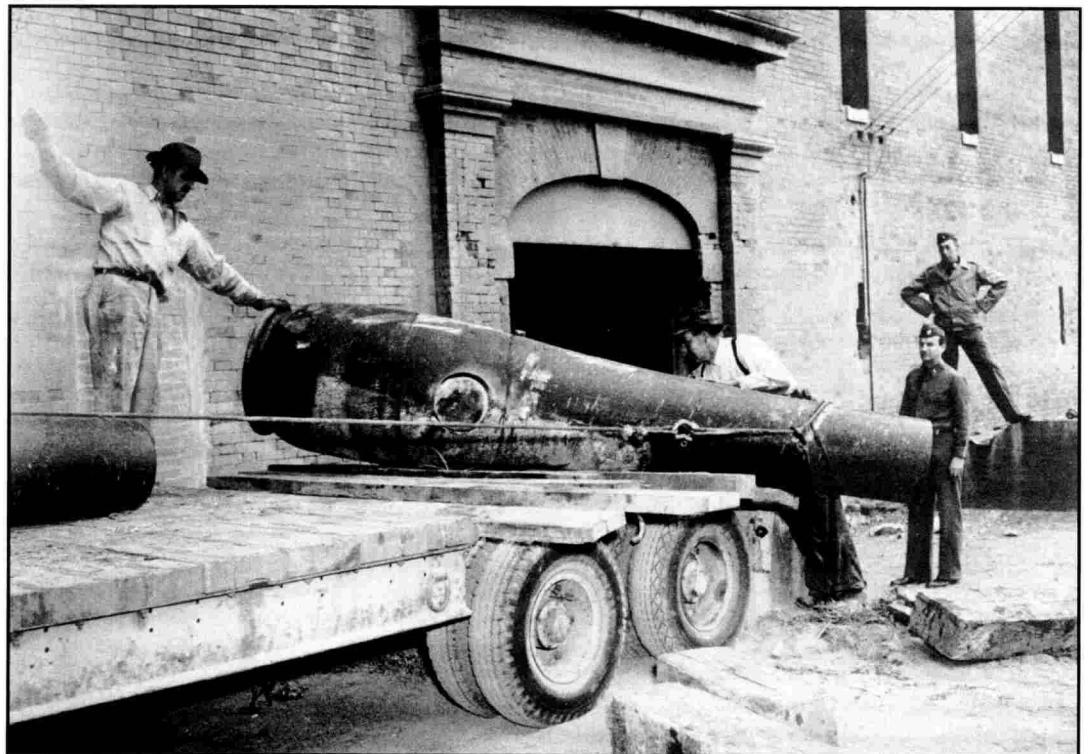
tance to salt corrosion. The fort was soon enveloped in a maze of wooden scaffolding as the huge steel arch was erected over the barbette tier.

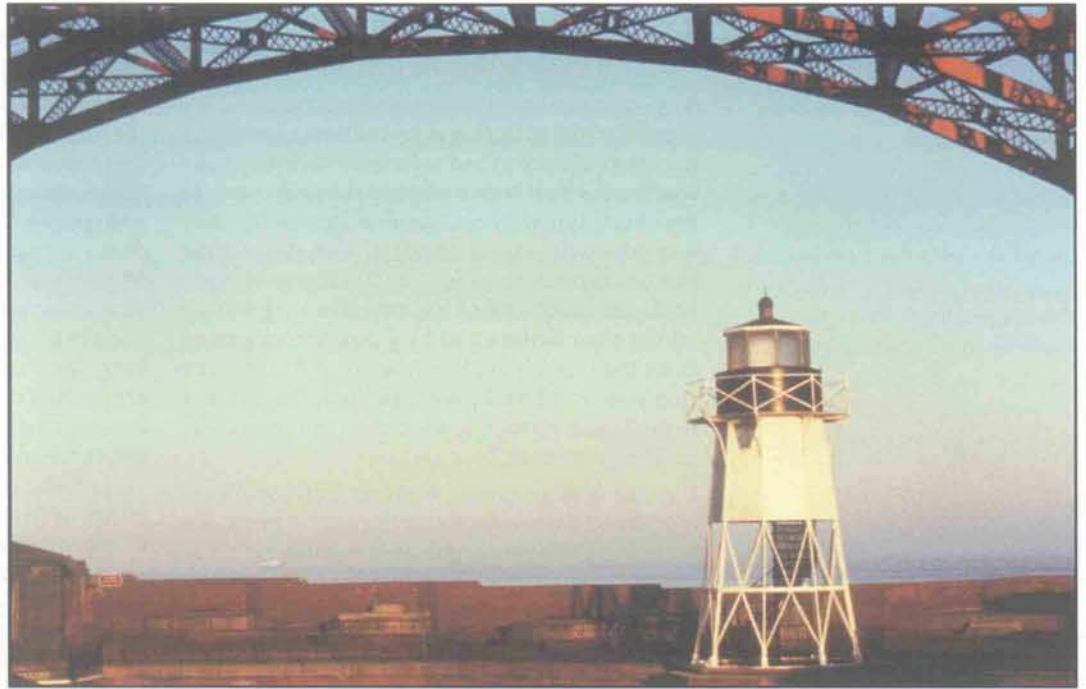
Right: Contemporary view of the Fort Point Lighthouse. Photo circa 2000. Credit: Golden Gate National Parks Conservancy.

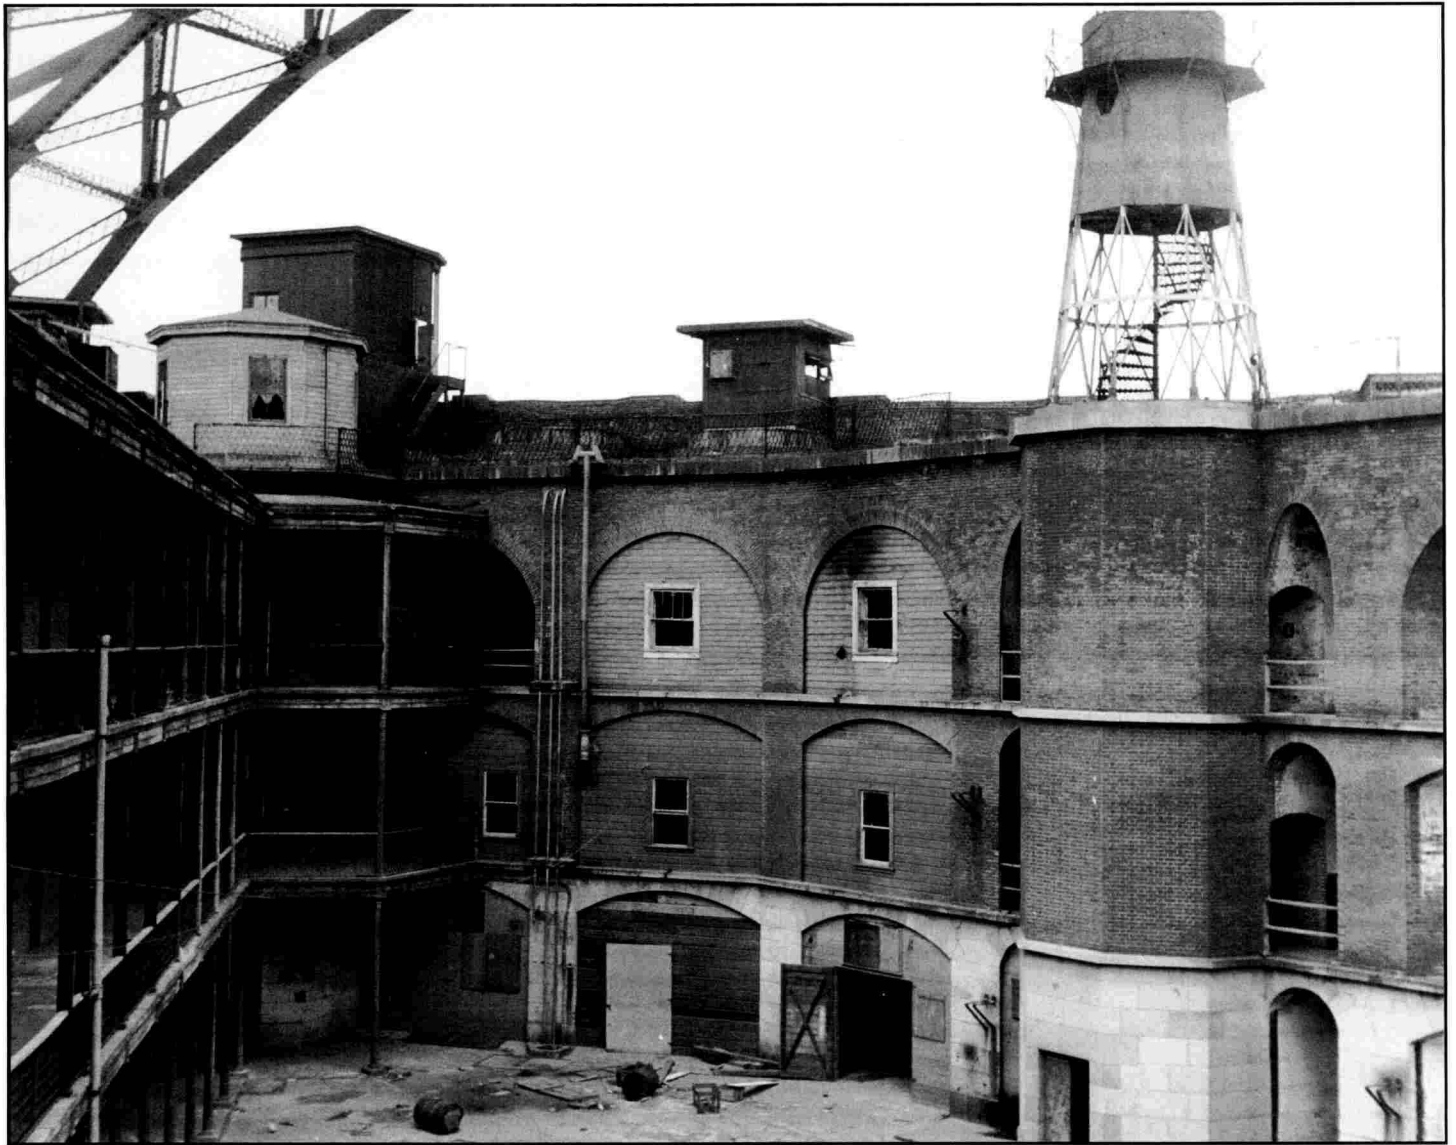
This photo shows the fort in an unoccupied state after World War II. Photo circa 1948. Credit: Fort Point NHS Collection, Golden Gate National Recreation Area.

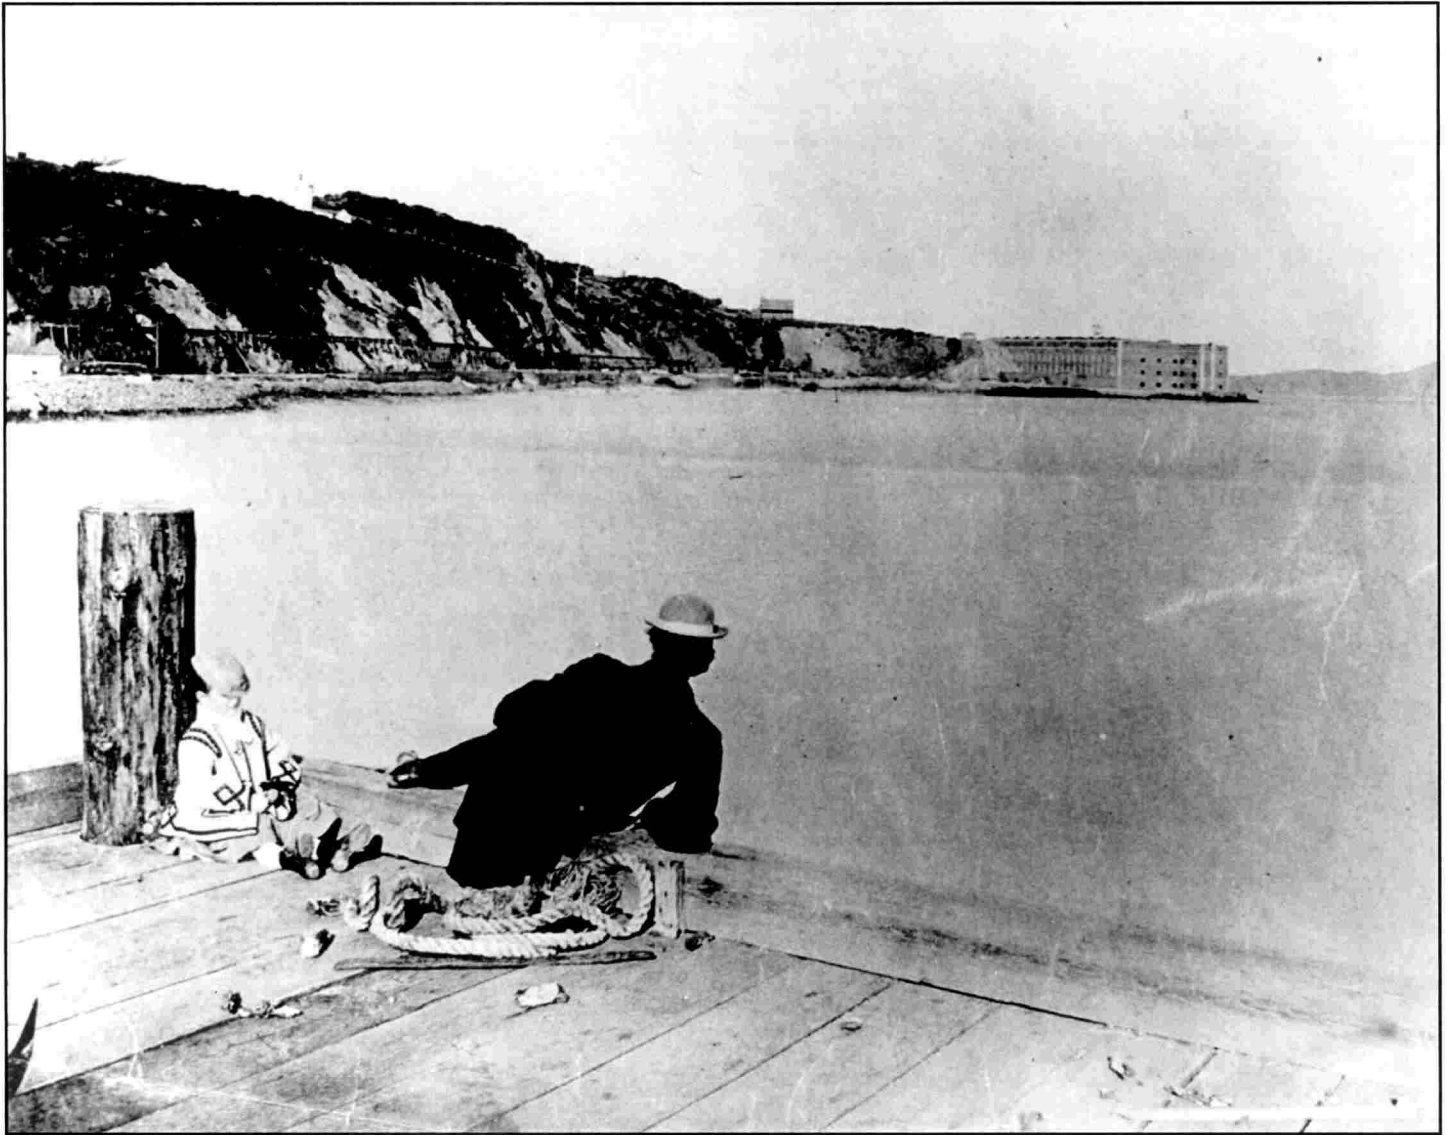
Figure 6. Photograph: Photograph of Fort Point taken by Eadweard Muybridge. Photo circa 1870. Credit: Fort Point NHS Collection, Golden Gate National Recreation Area.

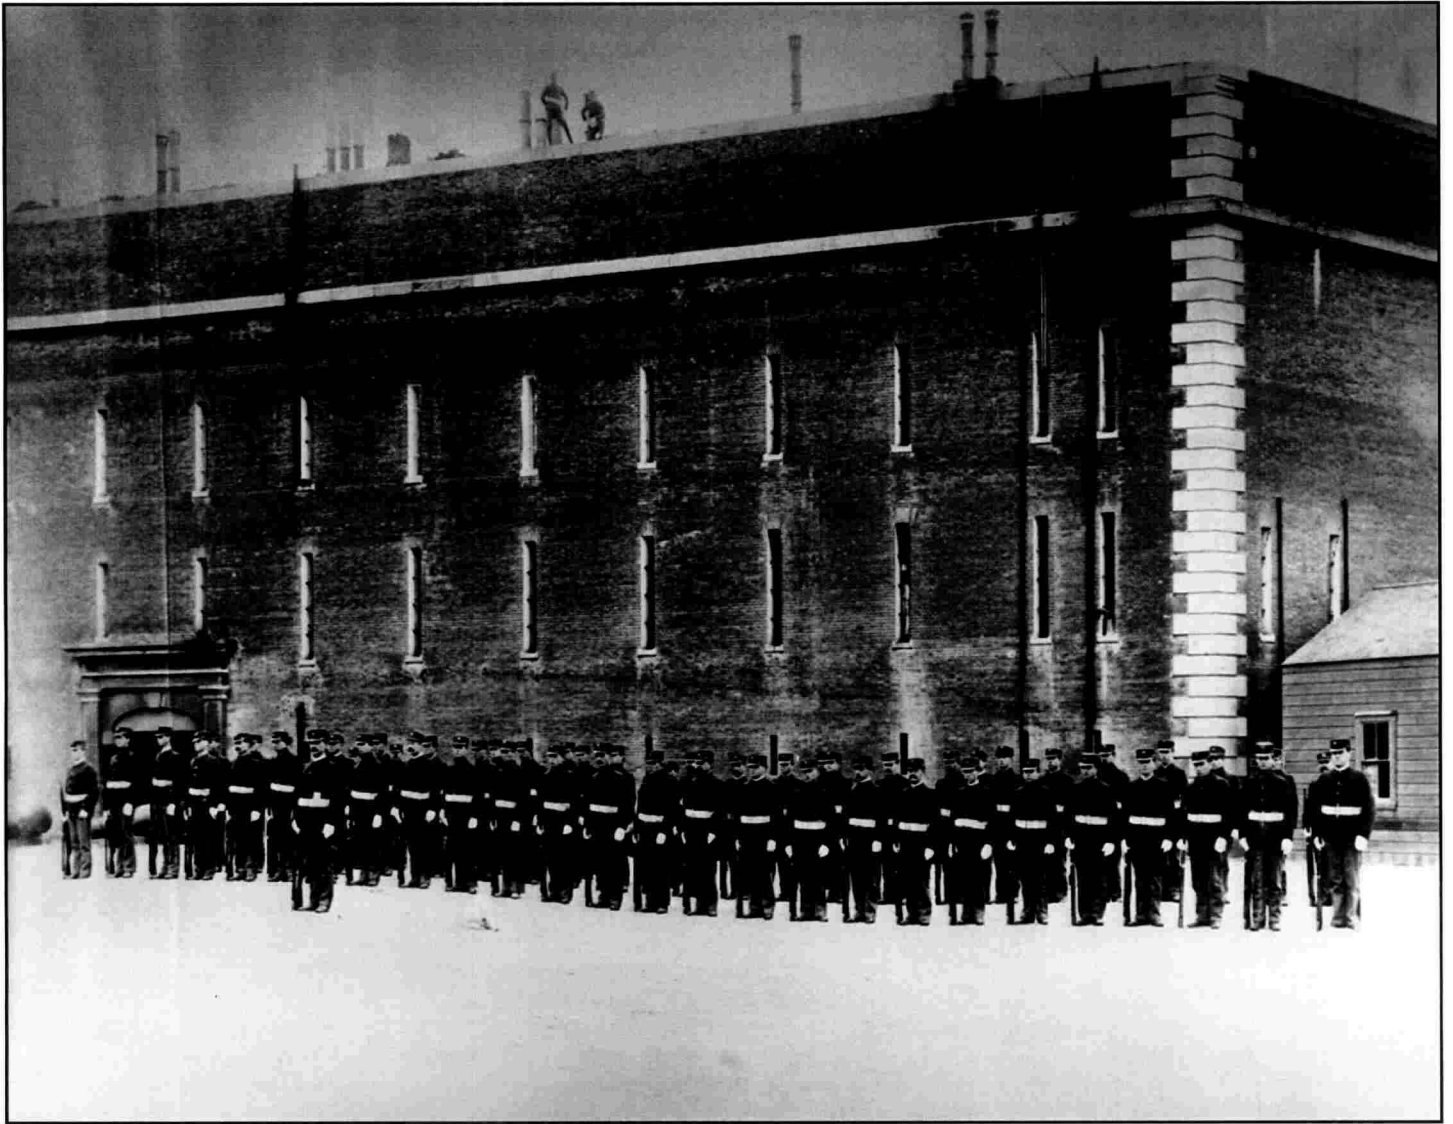
Figure 9. Photograph: Garrison in front of the Fort, circa 1900. Credit: Fort Point NHS Collection, Golden Gate National Recreation Area.

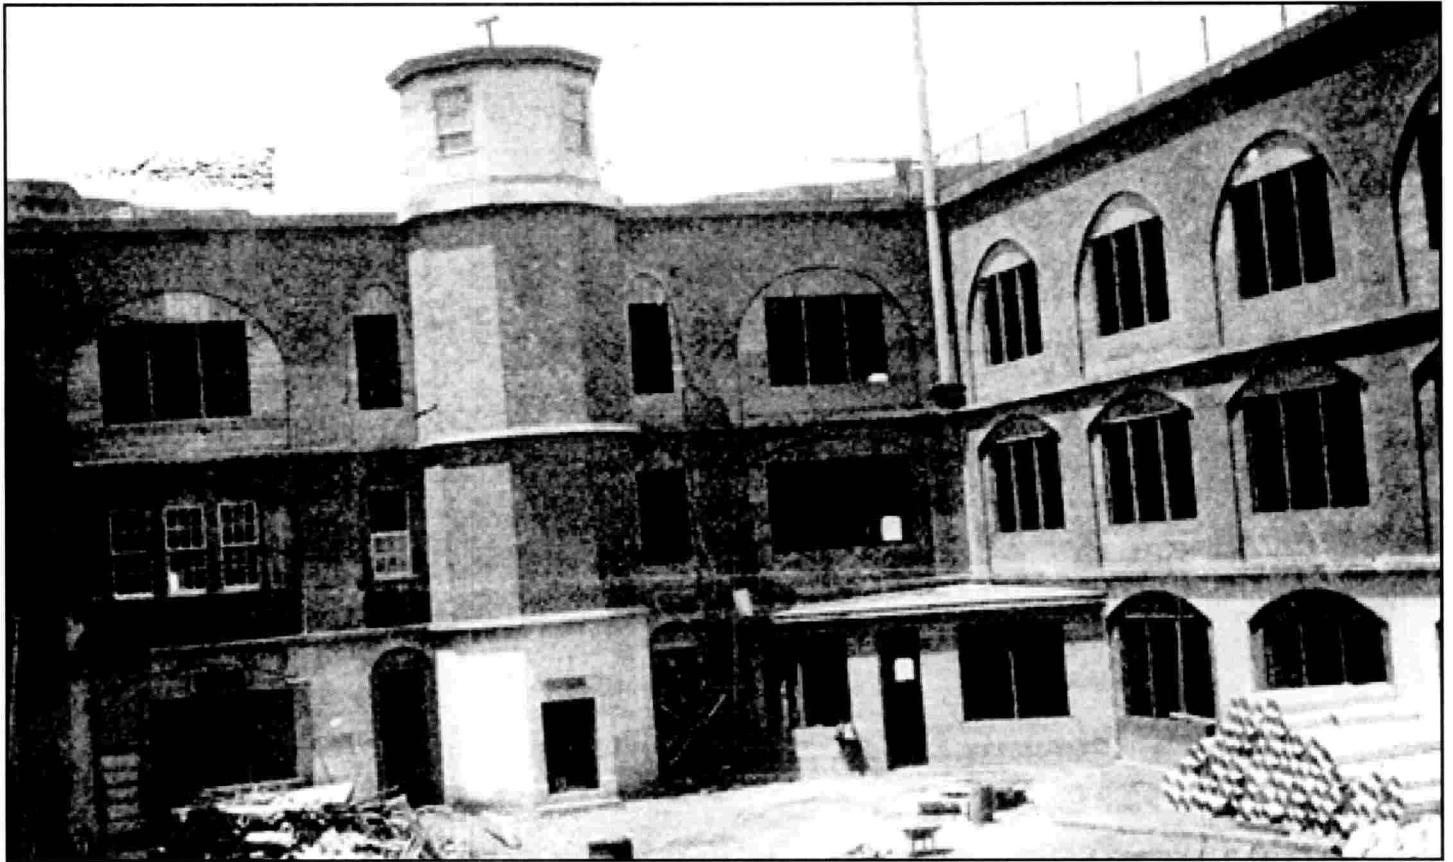
Figure 11. Photograph: Detention Barracks conversion in progress, viewed from the parade, circa 1914. Credit: Fort Point NHS Collection, Golden Gate National Recreation Area.

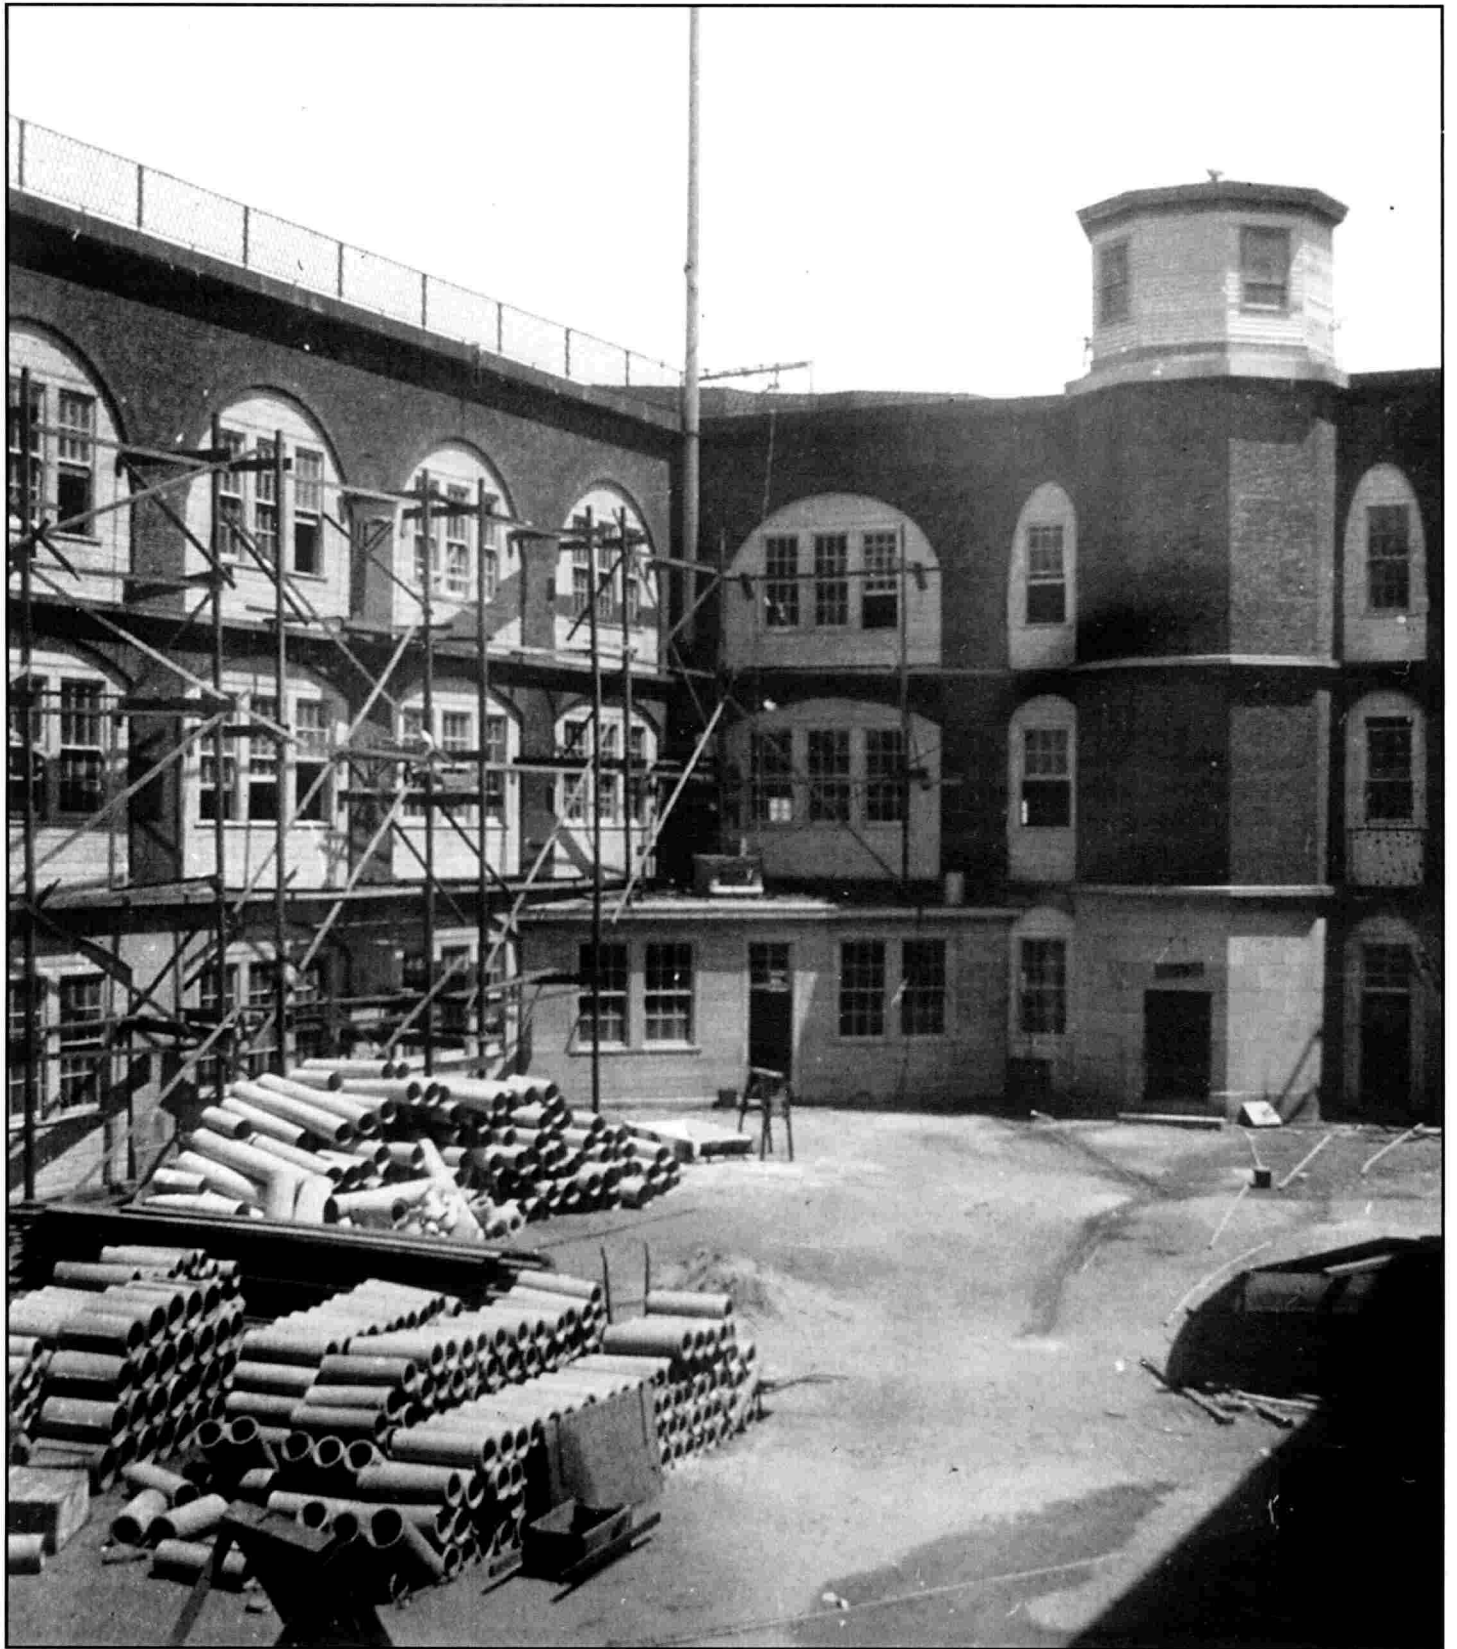
Figure 12. Photograph: Detention Barracks conversion in progress, viewed from the parade, circa 1914. Credit: Fort Point NHS Collection, Golden Gate National Recreation Area.

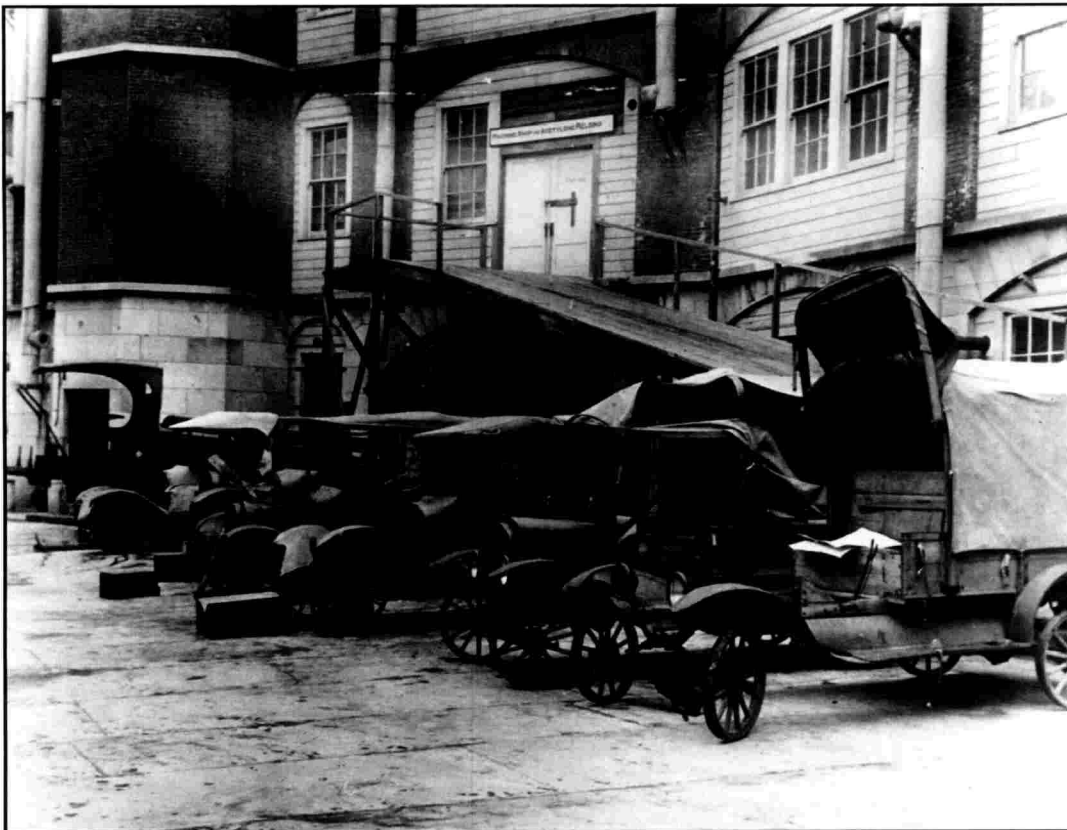
Figure 14. Photograph: Vocational School, viewed from the parade, circa 1924-1925. Credit: Fort Point NHS Collection, Golden Gate National Recreation Area.

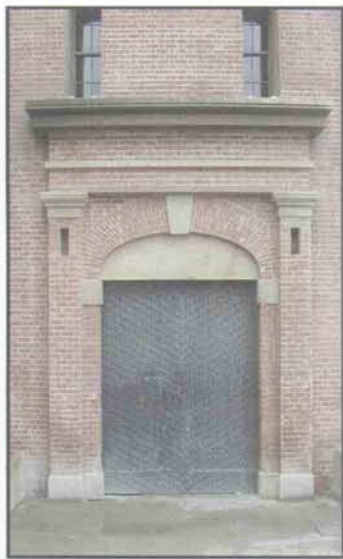
Above: The only entry into the fort is through this pair of large doors. (Jane Lehman, 2005)

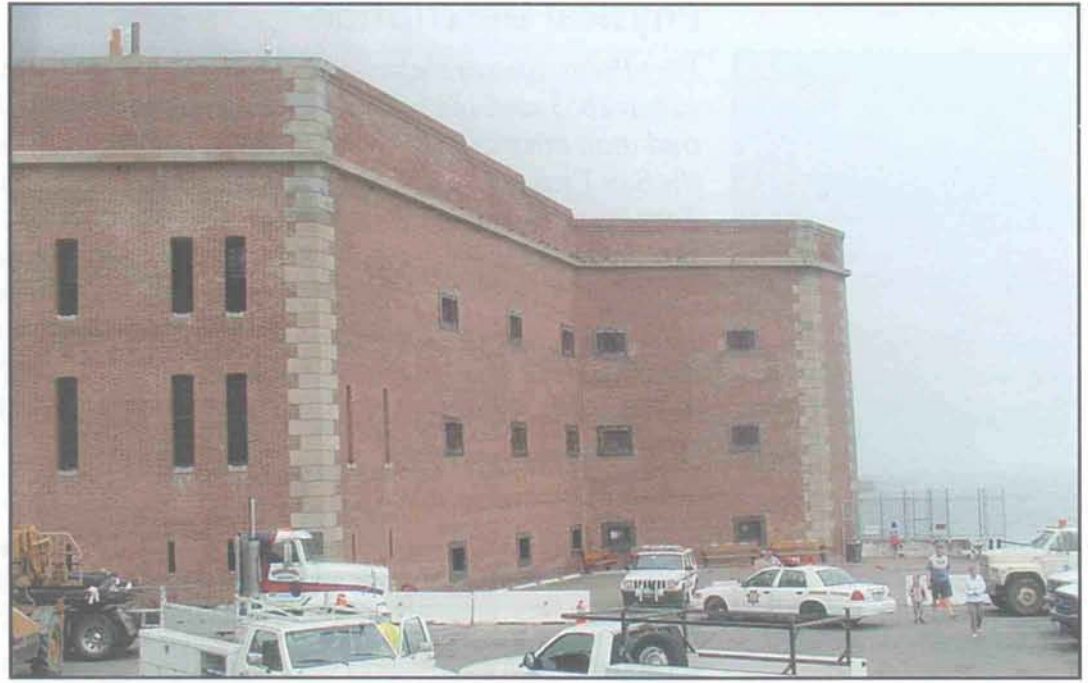
inside the fort near casemate 28. There is a wheel mechanism inside a small recess at the top of each of the brick pilasters that would have originally been part of the drawbridge system; however the drawbridge was never installed so this piece of equipment was never actually used.

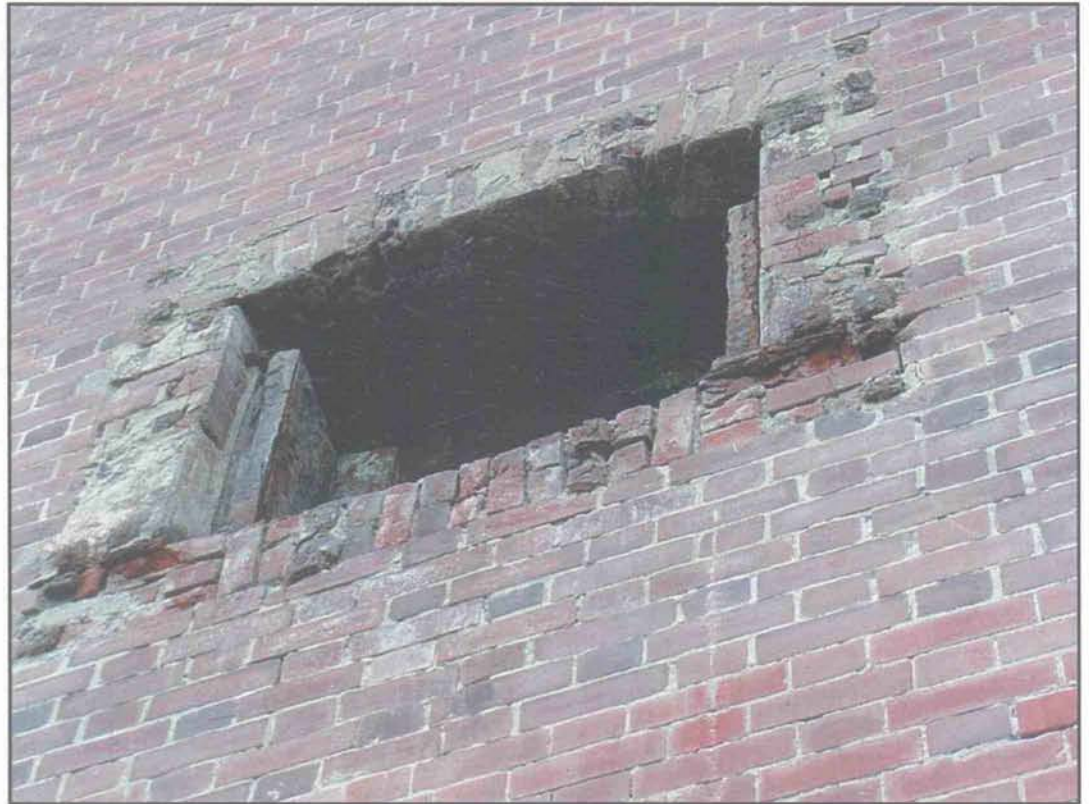
The quoins in the path of the wind and saltwater spray have lost their smooth quarried finish. (Jane Lehman, 2005)

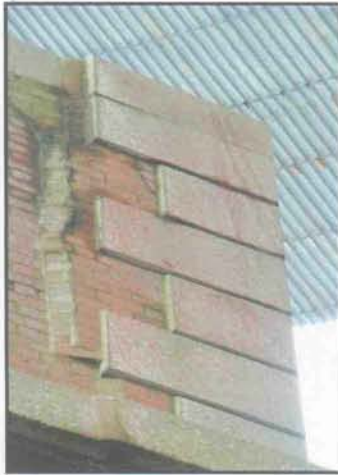
Lateral displacement is evident in the south flank parapet. (Jane Lehman, 2005)

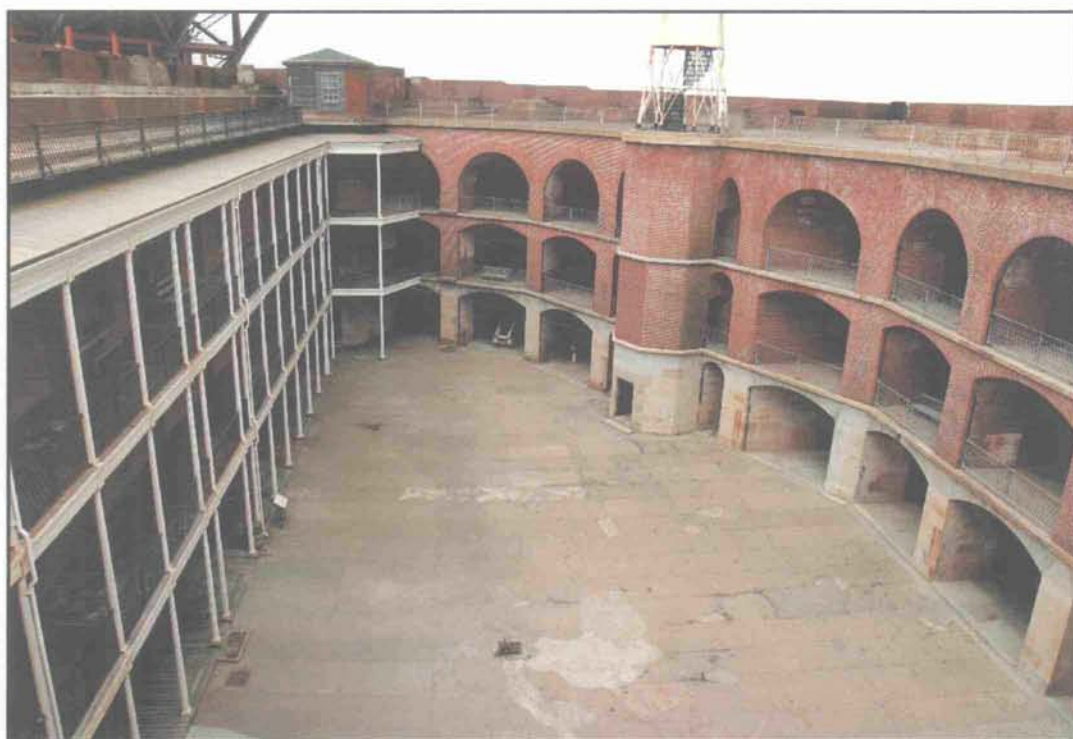
Interior courtyard elevation looking west. The southeast courtyard face is on the left and the lighthouse is partially visible on top of stair #2. (John Martini, 2005)

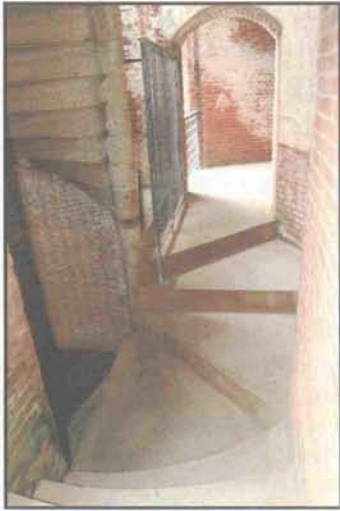
Each landing in the circular staircase is composed of slightly different shaped pieces of granite depending on the floor to floor heights. (John Martini, 2005)
