400 + 641 / D-515

National Park Service
U.S. Department of the Interior

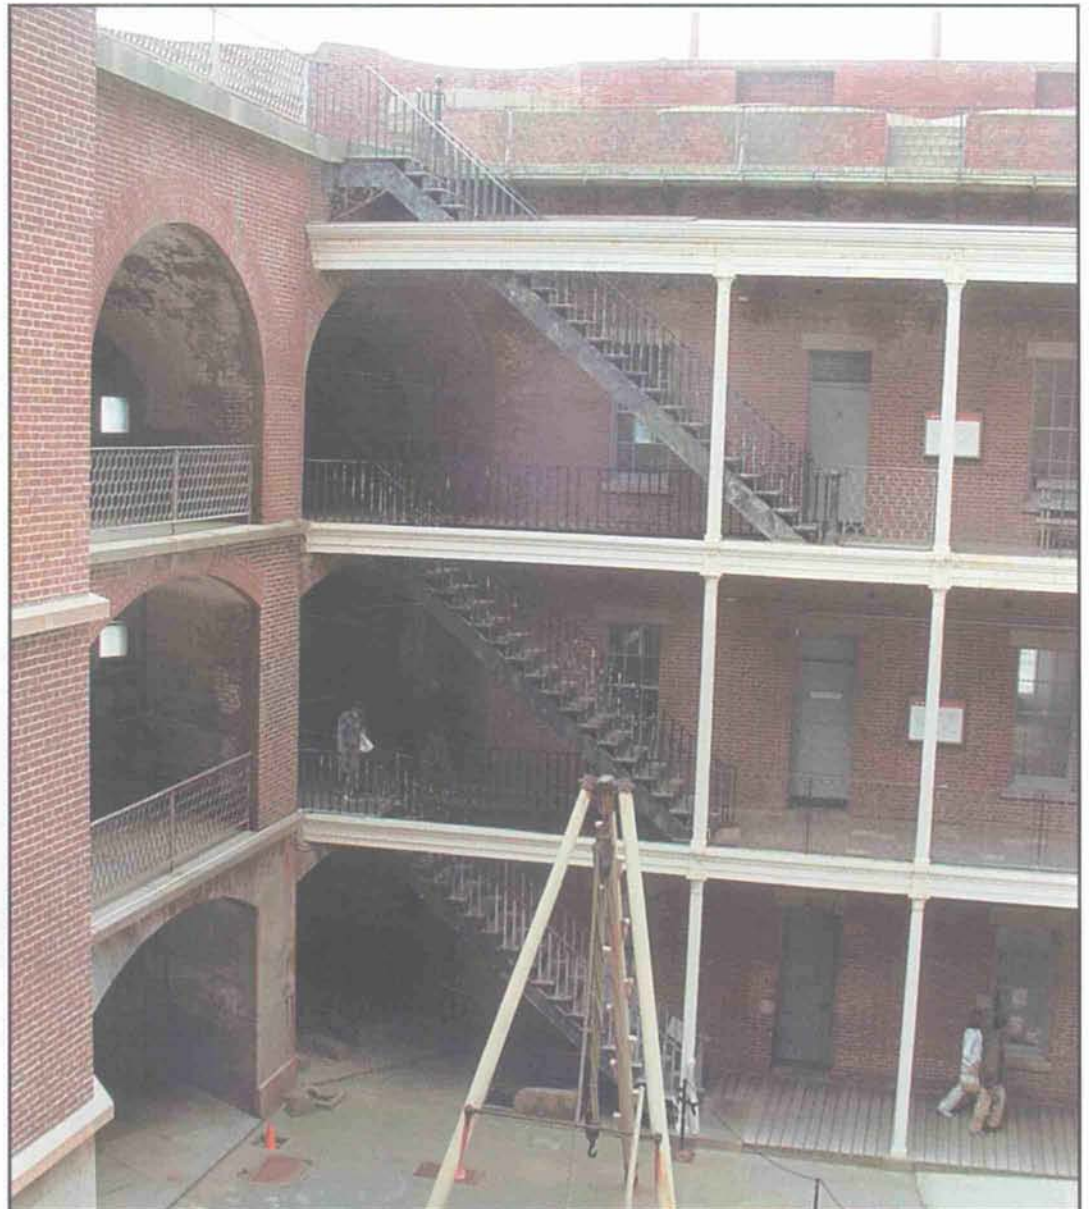
The cast iron staircase at the east end of the gallery is the only straight-run staircase in the fort. (Jane Lehman, 2005)

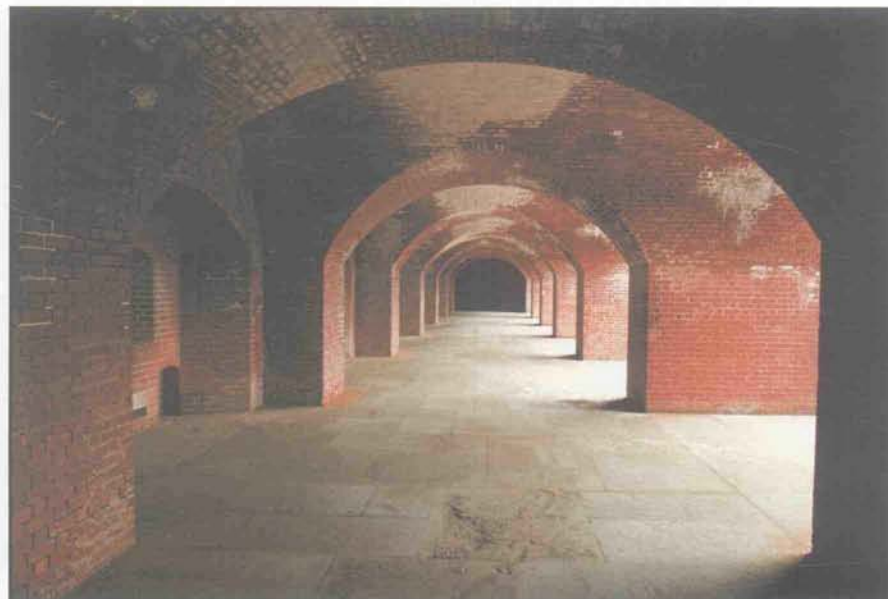
The cannon embrasure openings are 5'-4" wide x 3'-4" high that taper down to 1'-7" wide x 2'-2" high. The embrasures start at 3 ft. above the floor. Below this main opening is a horizontal slit 6" high x 4'-3" wide that held the iron bar on which the cannon pivoted. To either side of this horizontal slit is a rectangular recess with an arched top. This recess, most likely clearance for part of the equipment, is 1'-5" wide x 2' high x 8" deep.

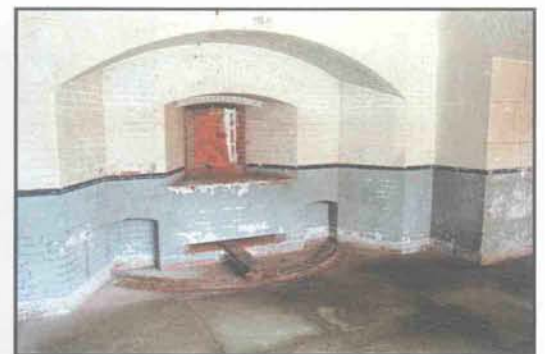
Typical cannon embrasure. This embrasure in casemate 2 still retains part of its original front pintle carriages. (John Martini, 2005)

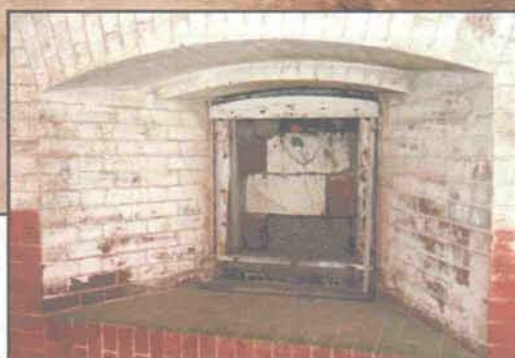
Most of the iron embrasures have deteriorated over the years and the openings have been infilled with brick and block for security purposes. (John Martini, 2005)

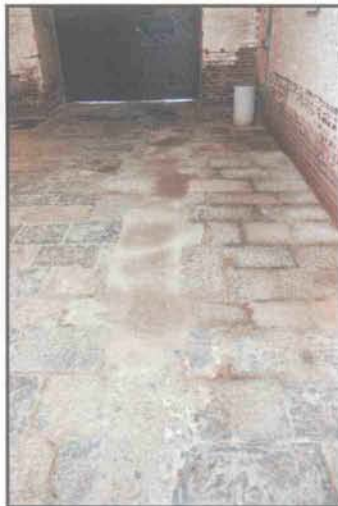
The original granite floors remain in good condition although a large concrete patch exists where a previous water line was installed. (John Martini, 2005)

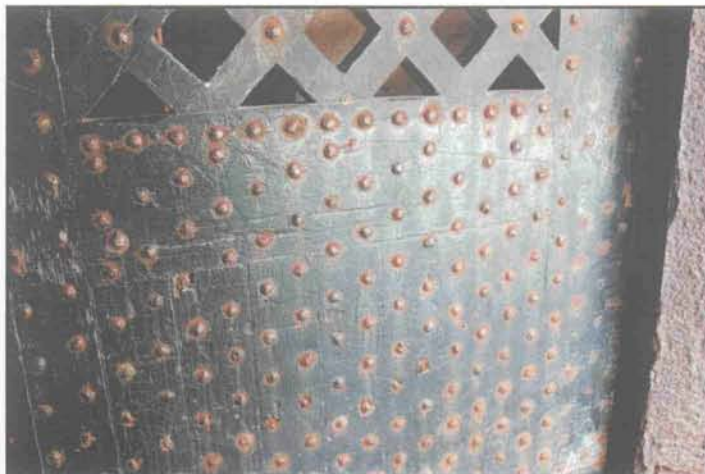
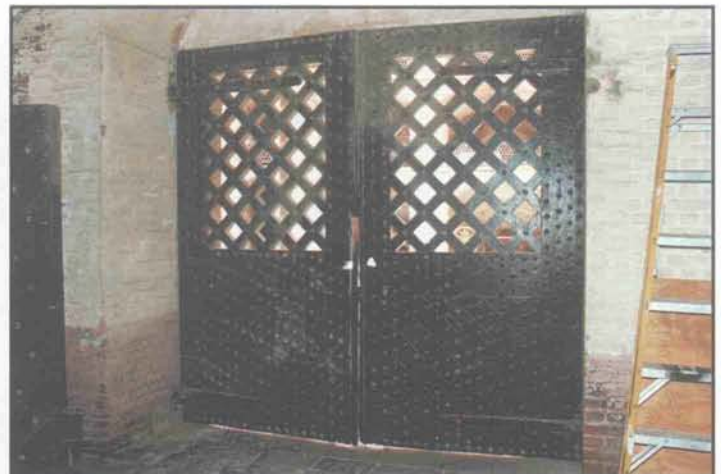
The gorge is the entrance side of an enclosed fort where the living quarters, storerooms, magazines, and shops are located.

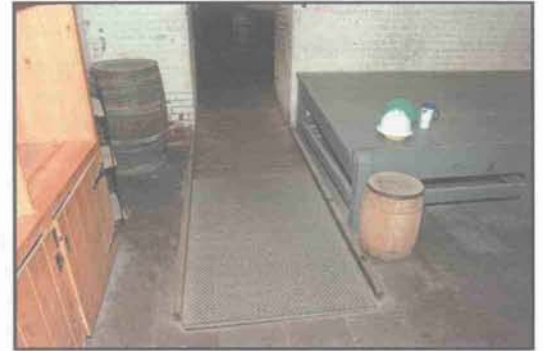
The reconstructed banquette on the right would have doubled as a platform to fire into the sallyport and a sleeping area for the guards. (John Martini, 2005)

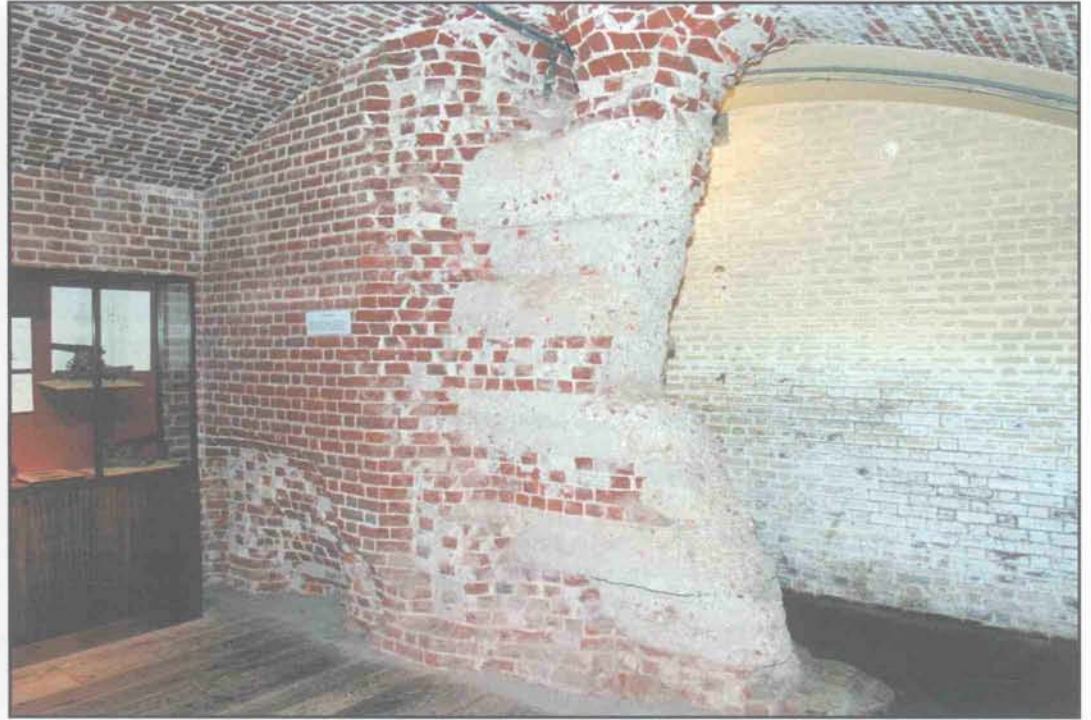
the corridor was removed. This wall shows the four wythes of brick on each side, the concrete infill, and the granite foundation.

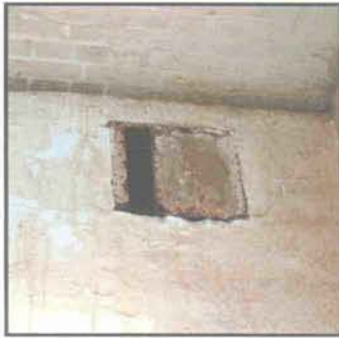
This 12" X 12" metal vent provide the only air circulation into the jail cells when the door was closed. (John Martini, 2005)

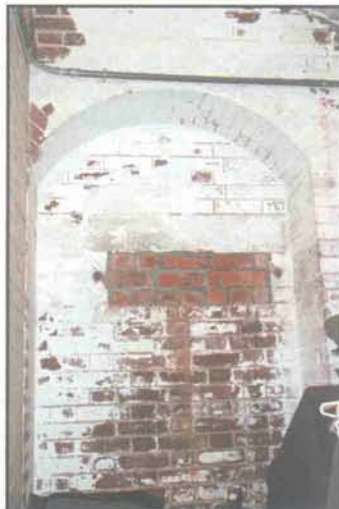
The rifle slit in the corridor of the jail area has been infilled with brick. (John Martini, 2005)

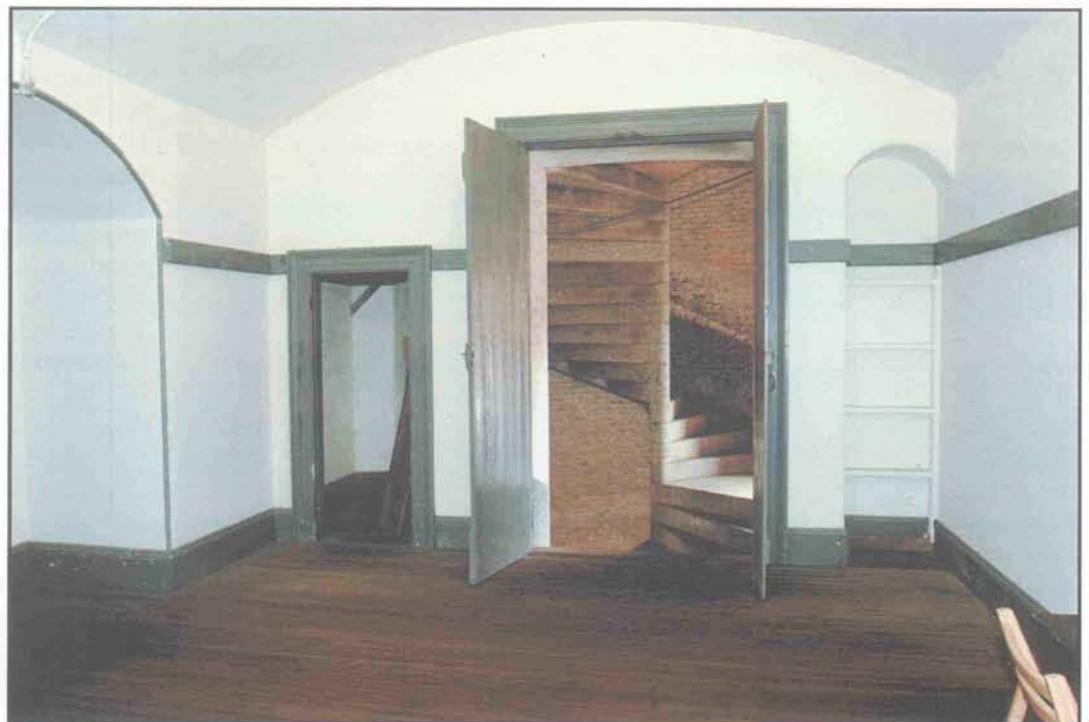
The surgeon's room is accessed directly from stair #1. An irregularly-shaped closet is left of the door and an alcove is on the right. (John Martini, 2005)

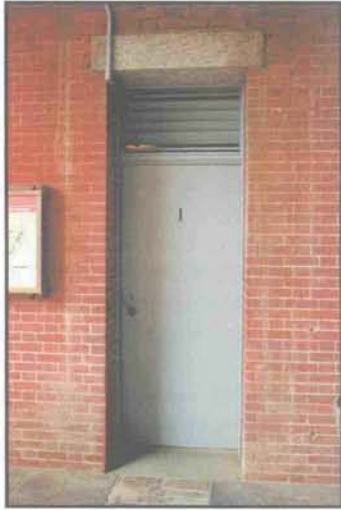
The transom windows above the 3rd tier gallery doors were replaced with wood louvers. These louvers need to be replaced because they are all installed backwards. (John Martini, 2005)

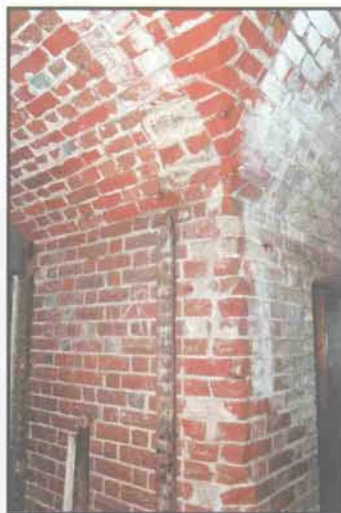
The outline of a previous, original brick wall is visible in the communication arch between enlisted men's quarters 2 & 3. (John Martini, 2005)

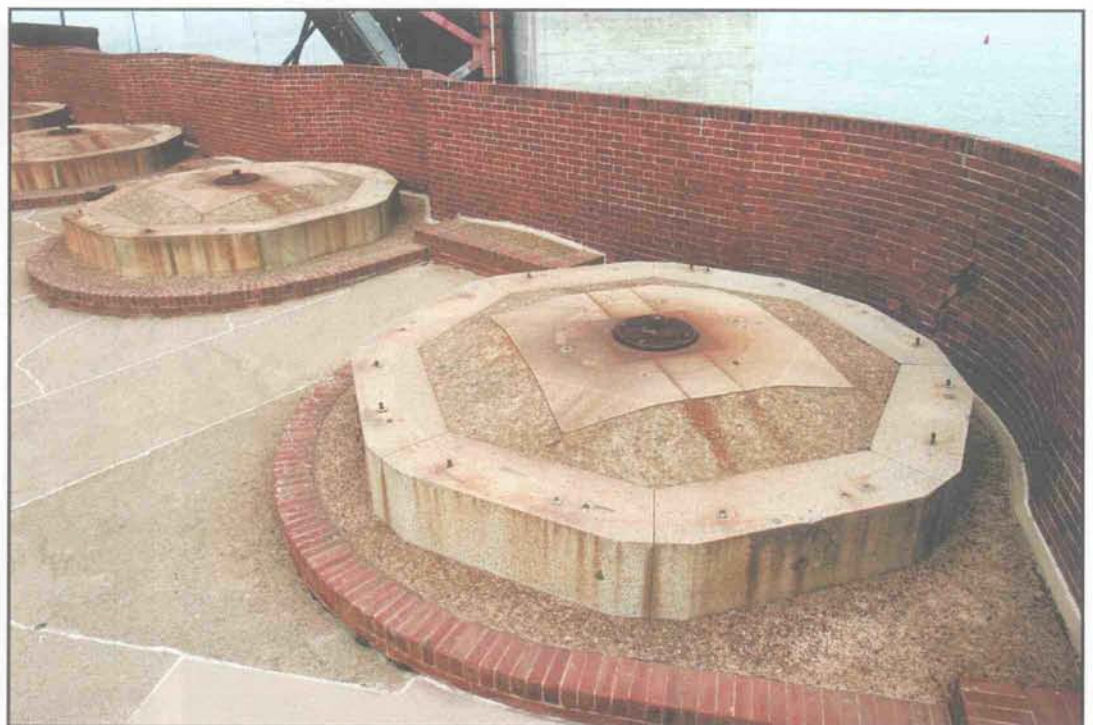
The top of the parapet wall in this area is concrete, but was originally grass. There are several dozen clay flue pipes projecting up through this concrete. There are 3 different styles of pipes, most likely related to the different time periods when they were installed. There are 1" diameter weep holes every 8 ft. in this wall. Although the top is concrete, moisture still appears to be coming from the weep holes, indicating that the concrete is leaking.

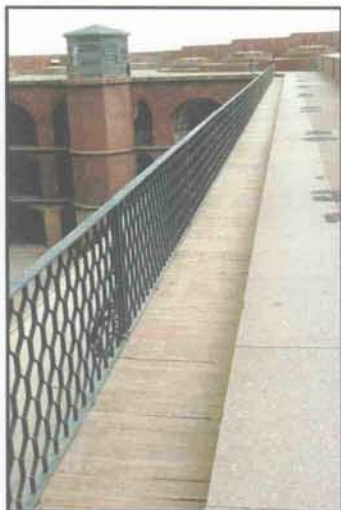
This 3-foot wide walkway and railing above the gallery on the southwest gorge elevation was replaced in a 1973 project. Beyond is the penthouse over stair #3. (John Martini, 2005)

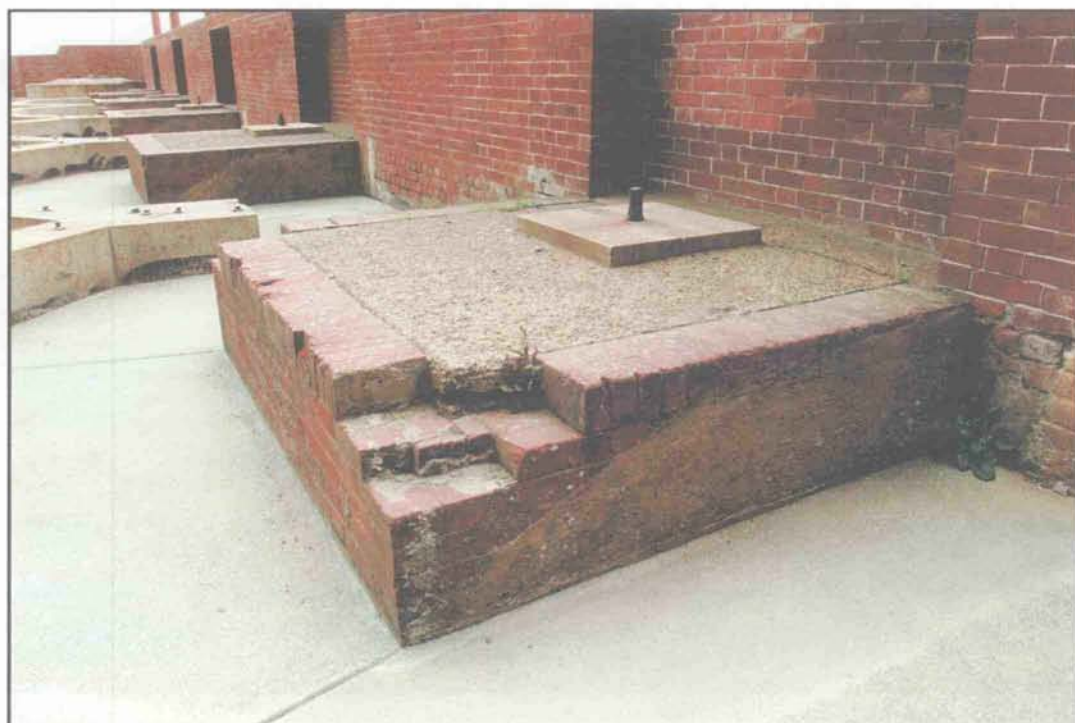
¹ Interpretation Panel, Fort Point Powder Magazine.

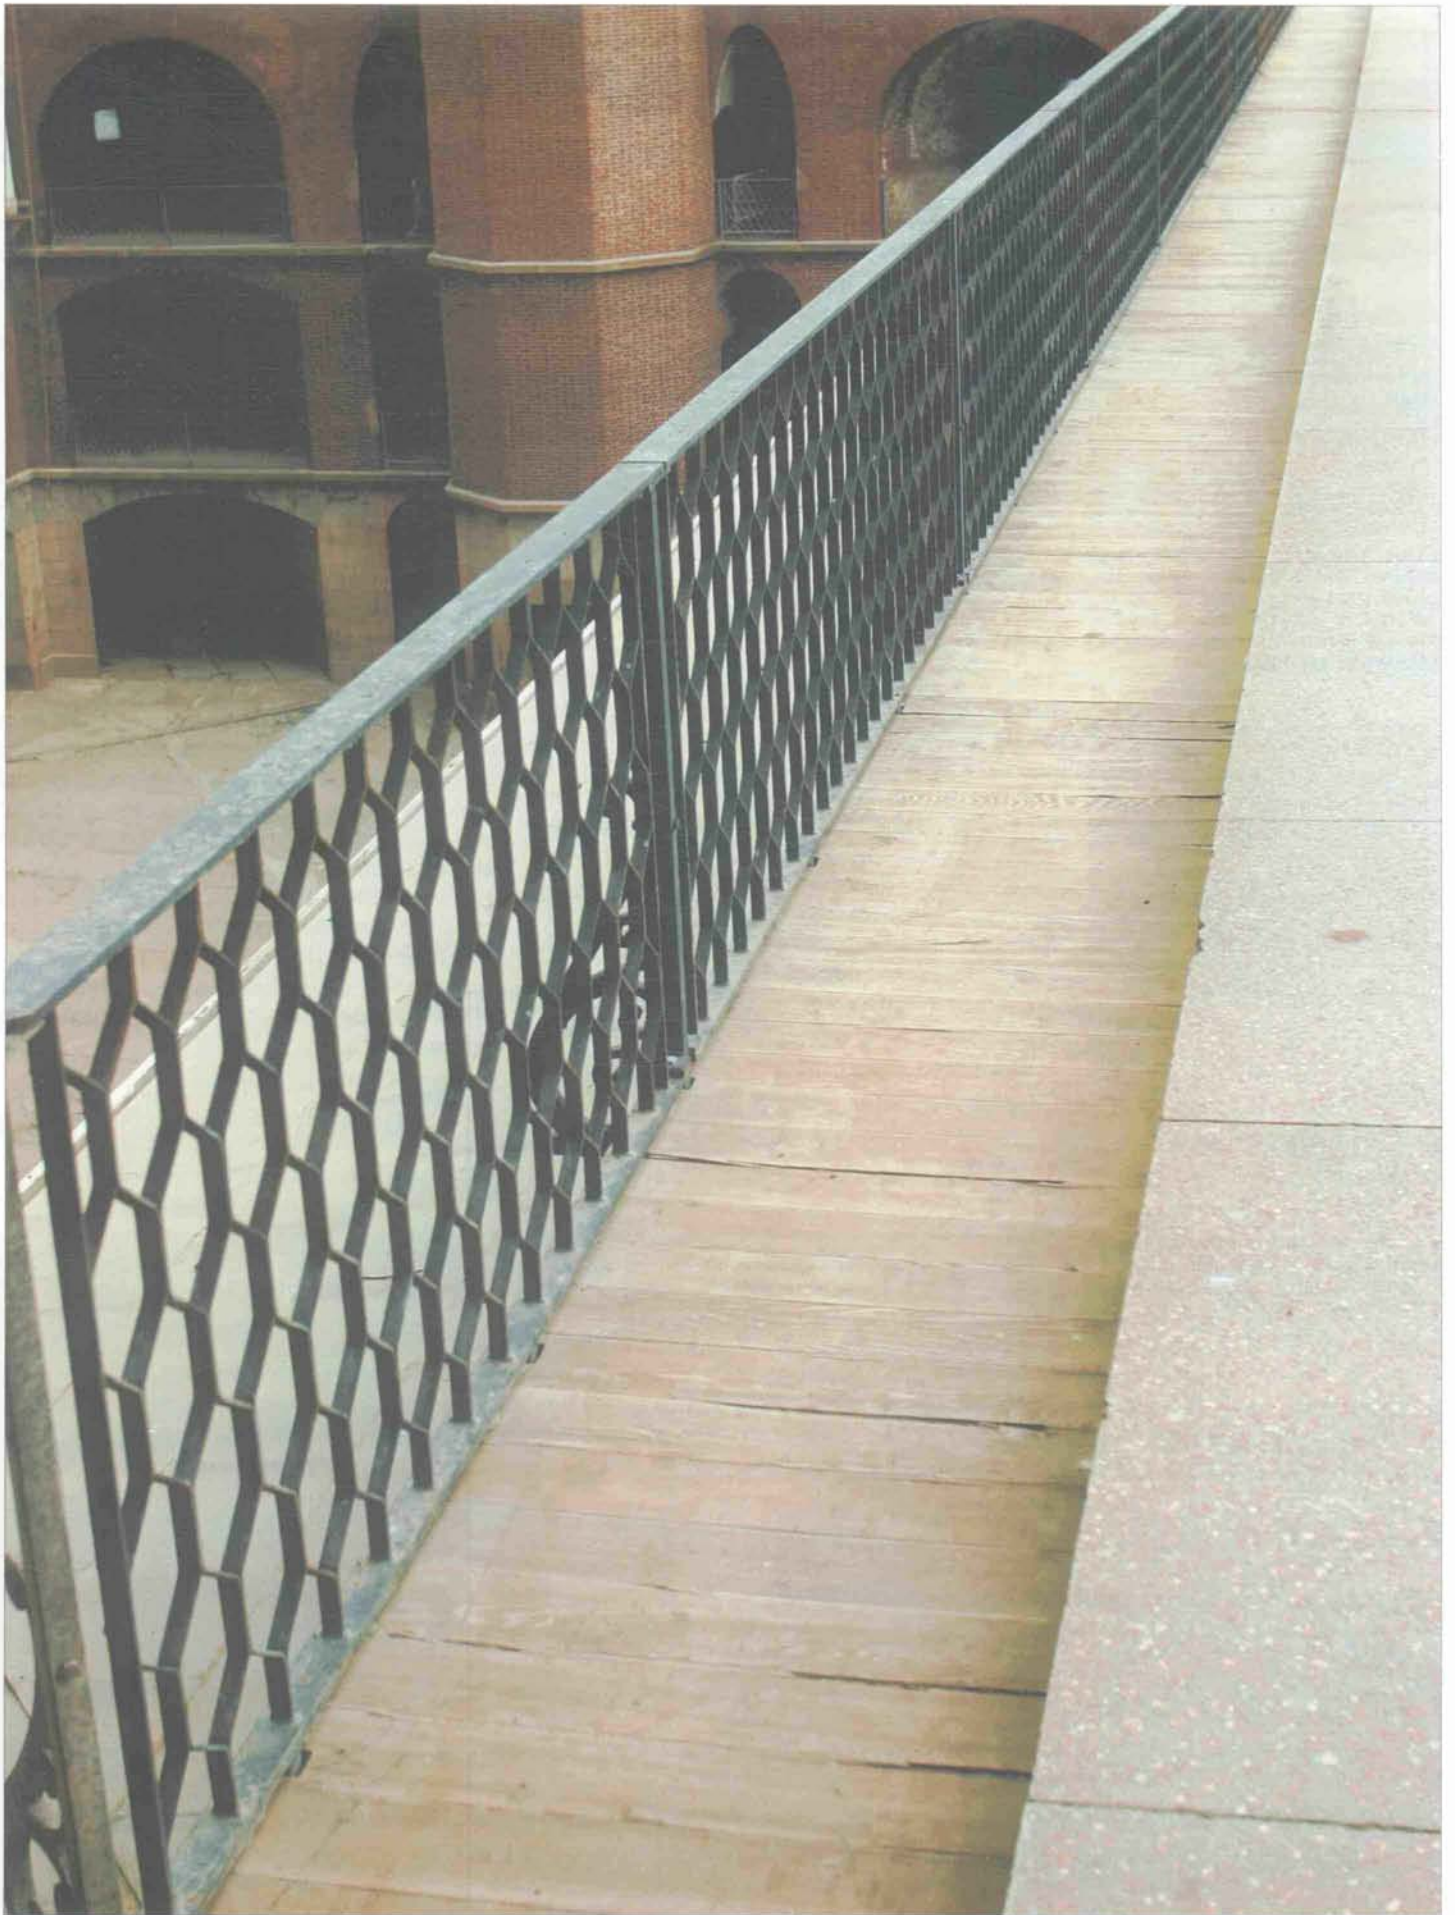
Conditions Assessment and Material Investigations

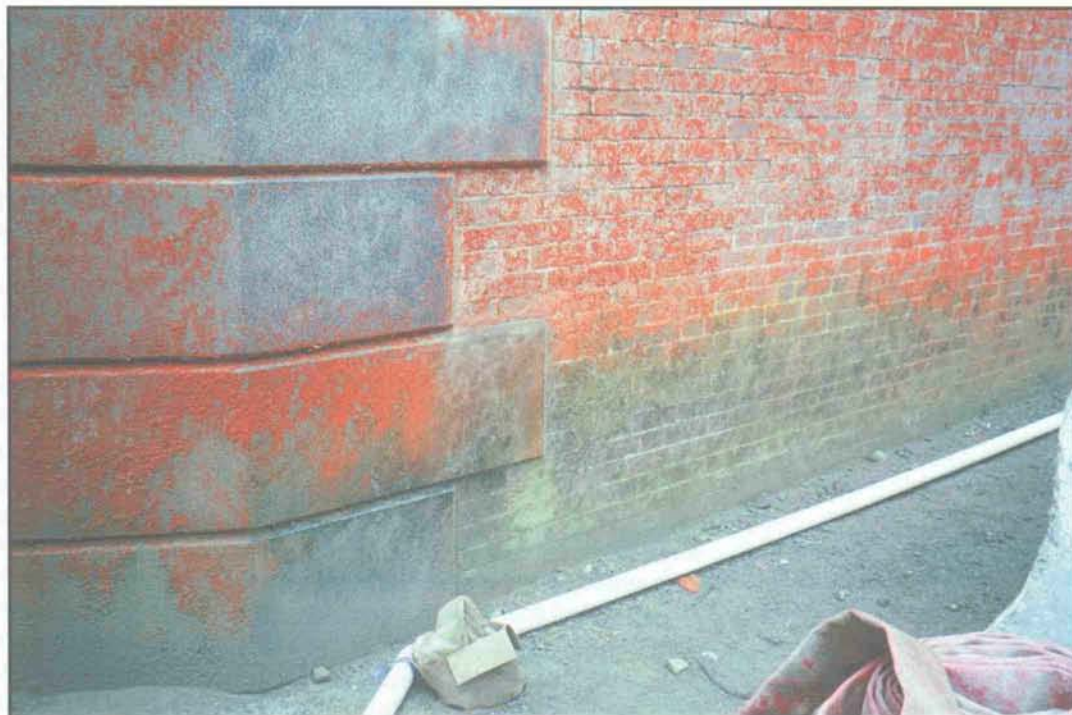
Condition Photo 2:
Intersecting Arch of Casements
98 and 99; Biological growth and
efflorescence settle on masonry
surfaces. (Courtesy of ARG, 2003)

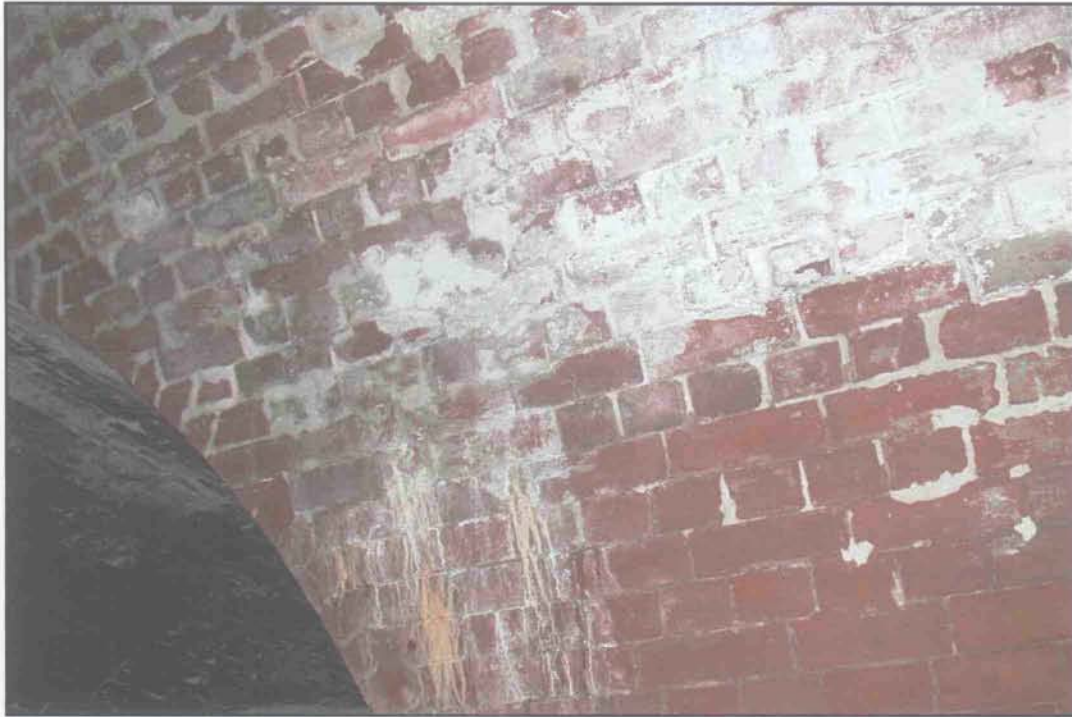
Condition Photo 3:
Casemate 101; Calcium deposits
are draining from open joints
and coasting is no longer extant.
(Courtesy of ARG, 2003)

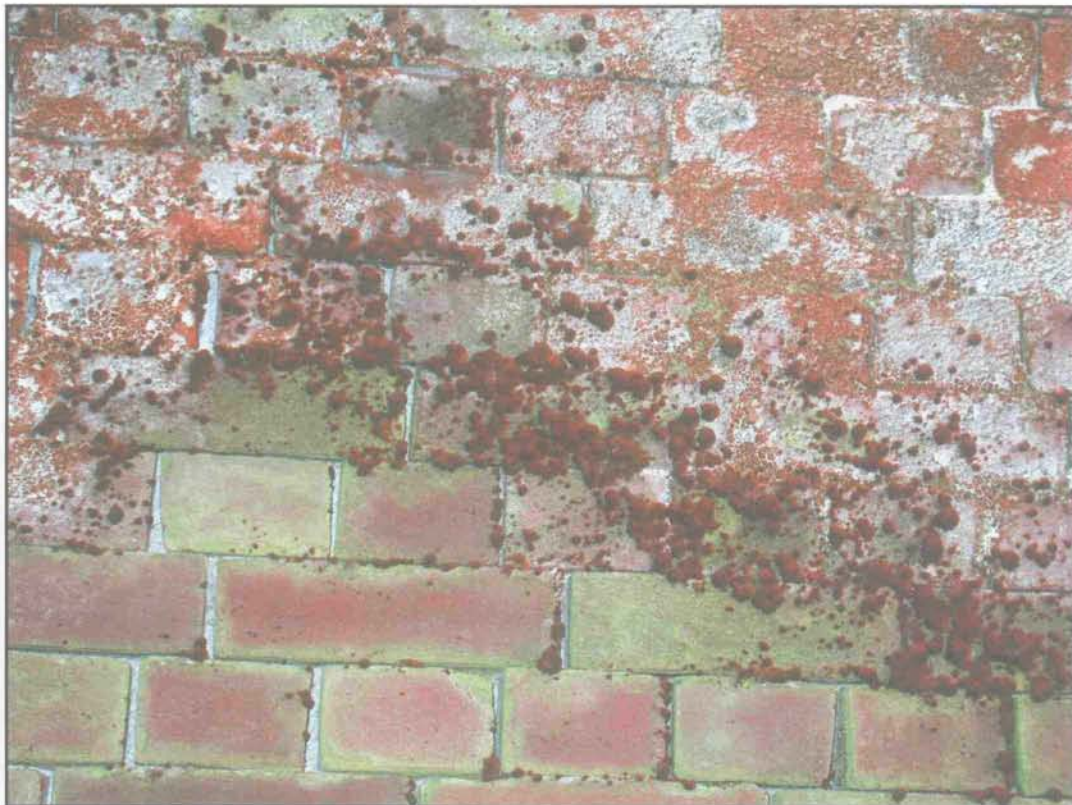
Condition Photo 4:
Casemate 100; Biological growth and
salts on masonry surface.
(Courtesy of ARG, 2003)

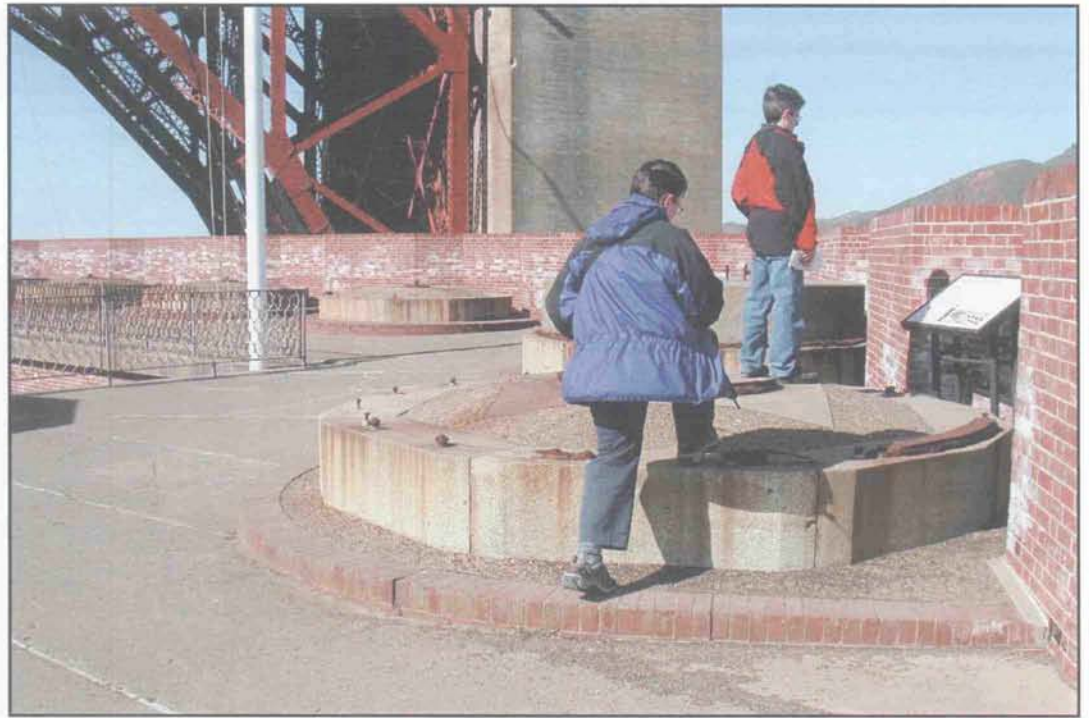
Condition Photo 6:
Top Landing at Barbette Tier; Crack
in granite. (Courtesy of ARG, 2003)

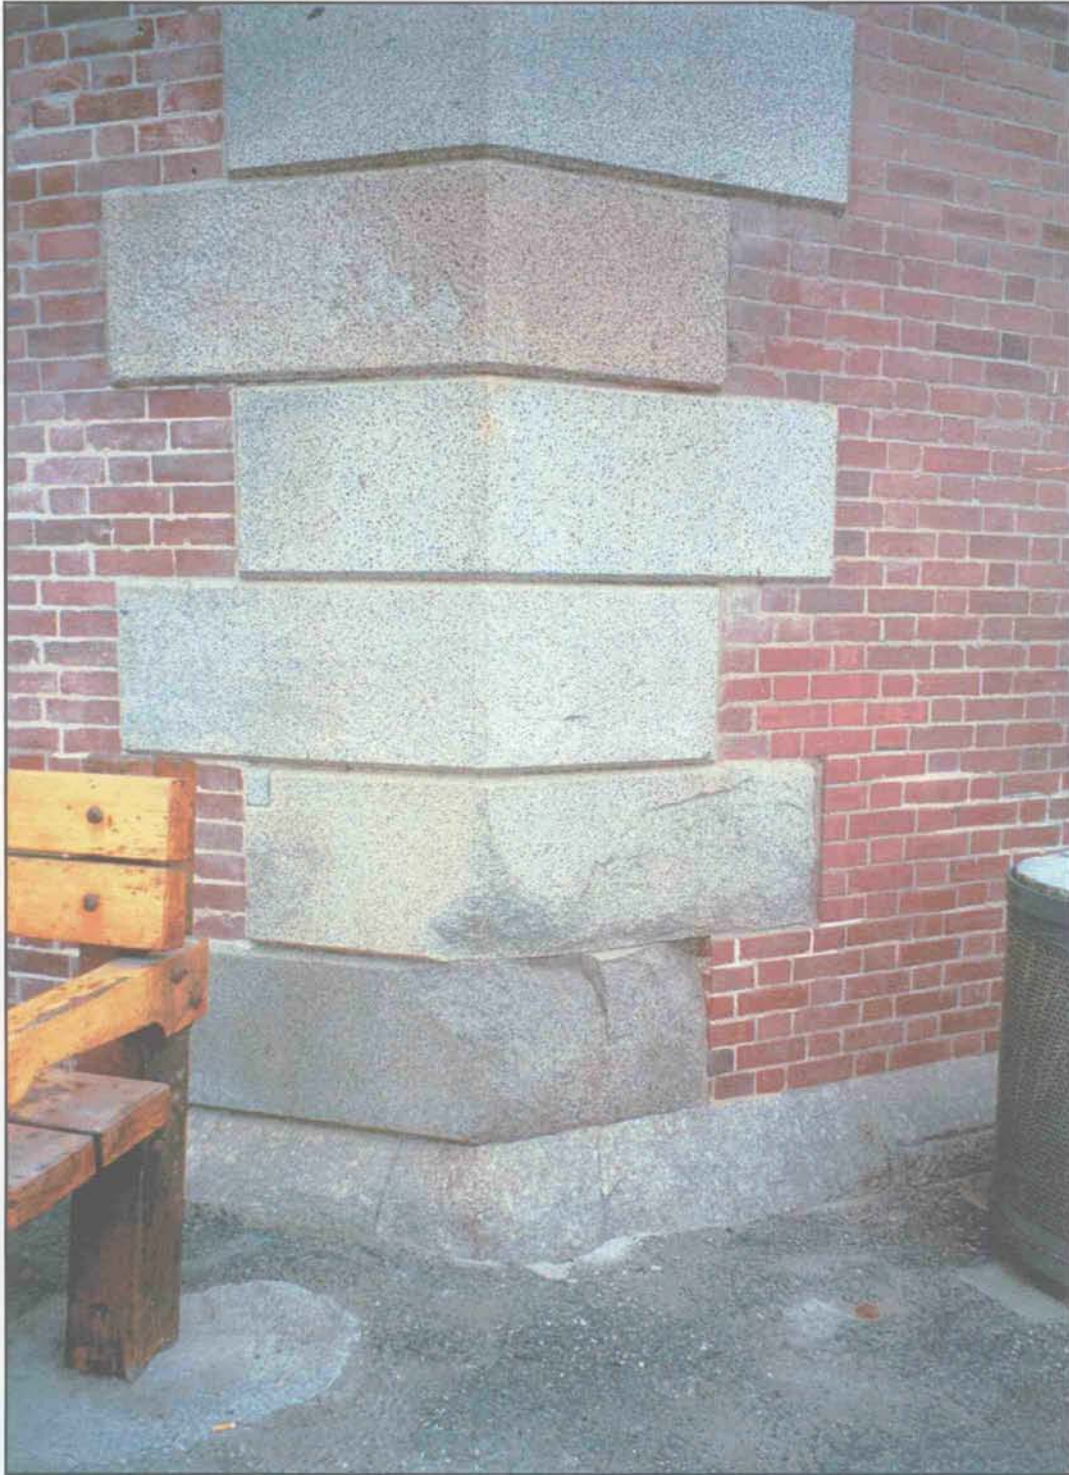
Condition Photo 7:
East Bastion—East Flank; Impact
damage at granite quoins and base.
(Courtesy of ARG, 2003)

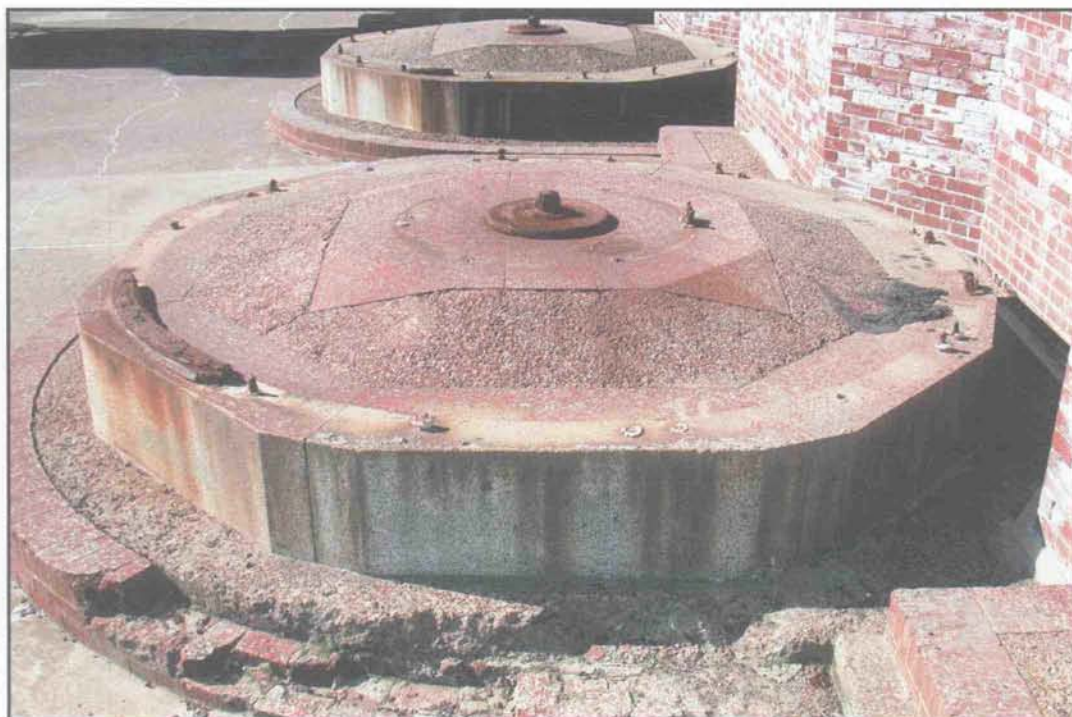
Condition Photo 9:
Southeast Courtyard—Underside
of Walkway at Tier One; Metal
corrosion and staining of the granite
walls. The brick facing is spalling.
Efflorescence occurs on the brick and
granite masonry.
(Courtesy of ARG, 2003)

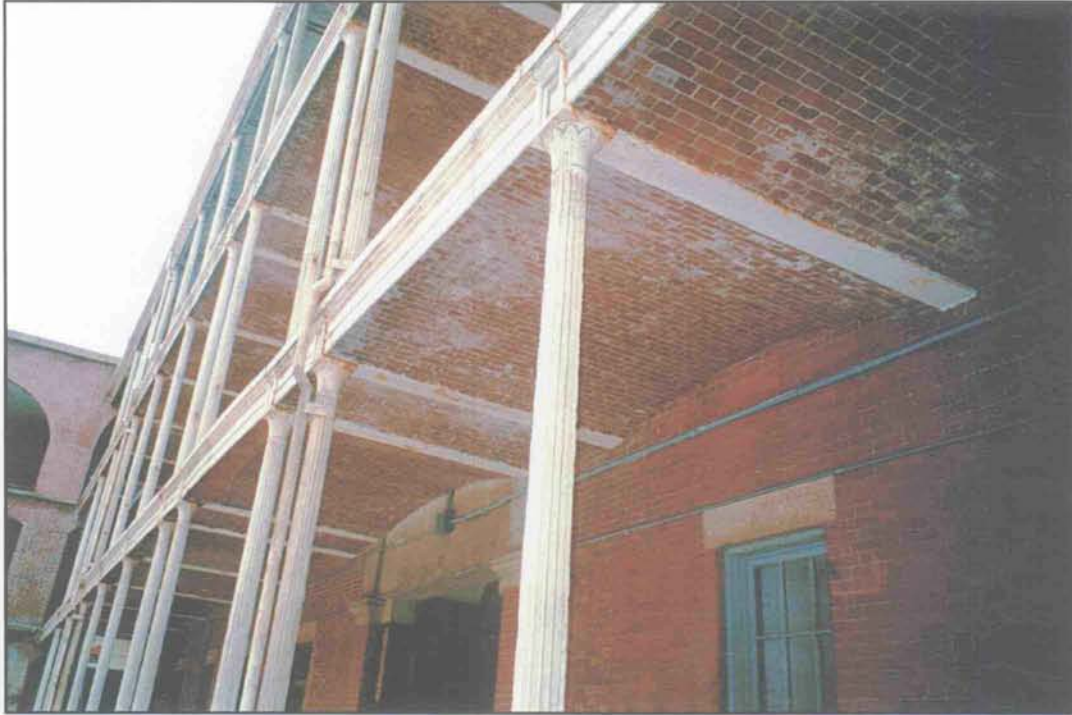
Condition Photo 10:
Southeast Face Courtyard; Corroding
metal columns and walkway
supports. Missing metal railings in
this photo have been reinstalled.
(Courtesy of ARG, 2003)

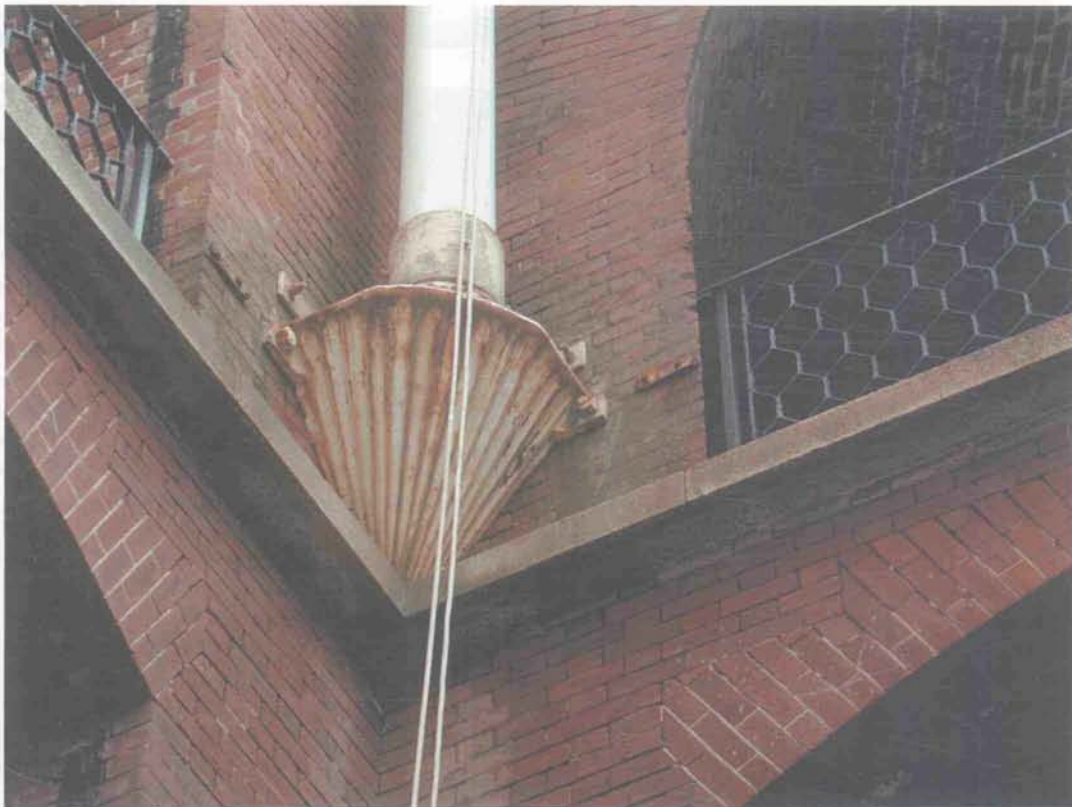
Condition Photo 11:
Biological growth on flagpole.
(Courtesy of ARG, 2003)

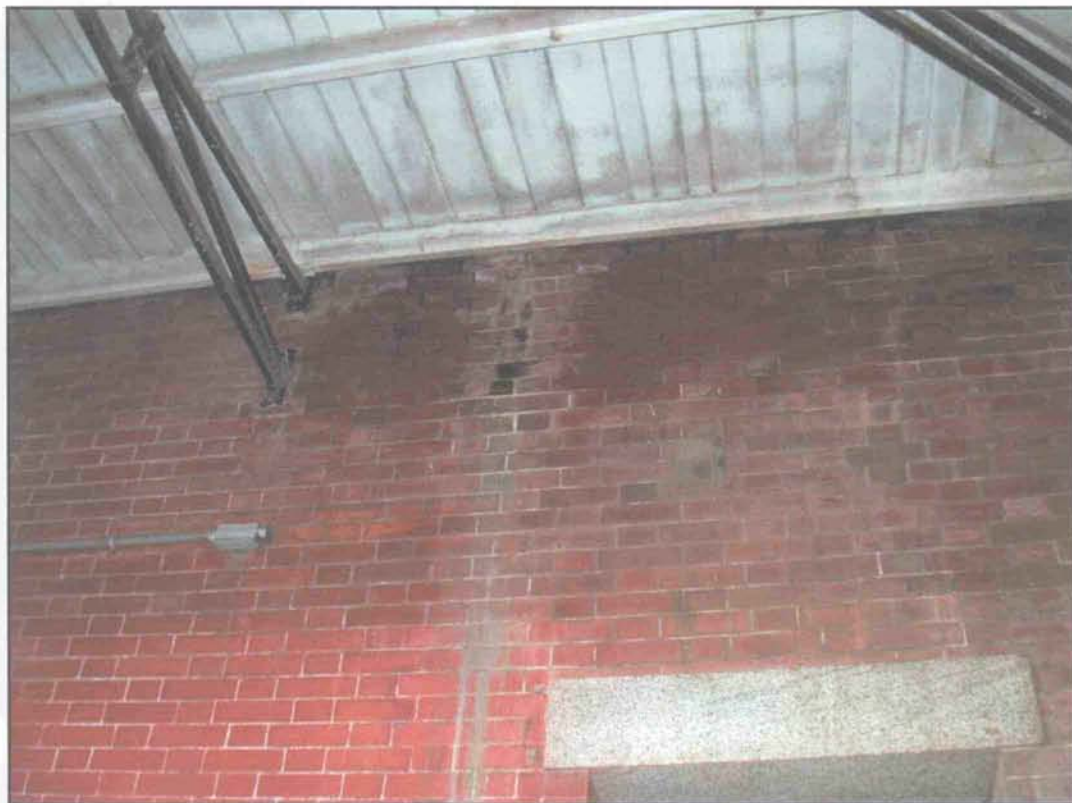
Condition Photo 13:
Stair 3; Missing siding exposes the
structural framing. (Courtesy of ARG,
2003)

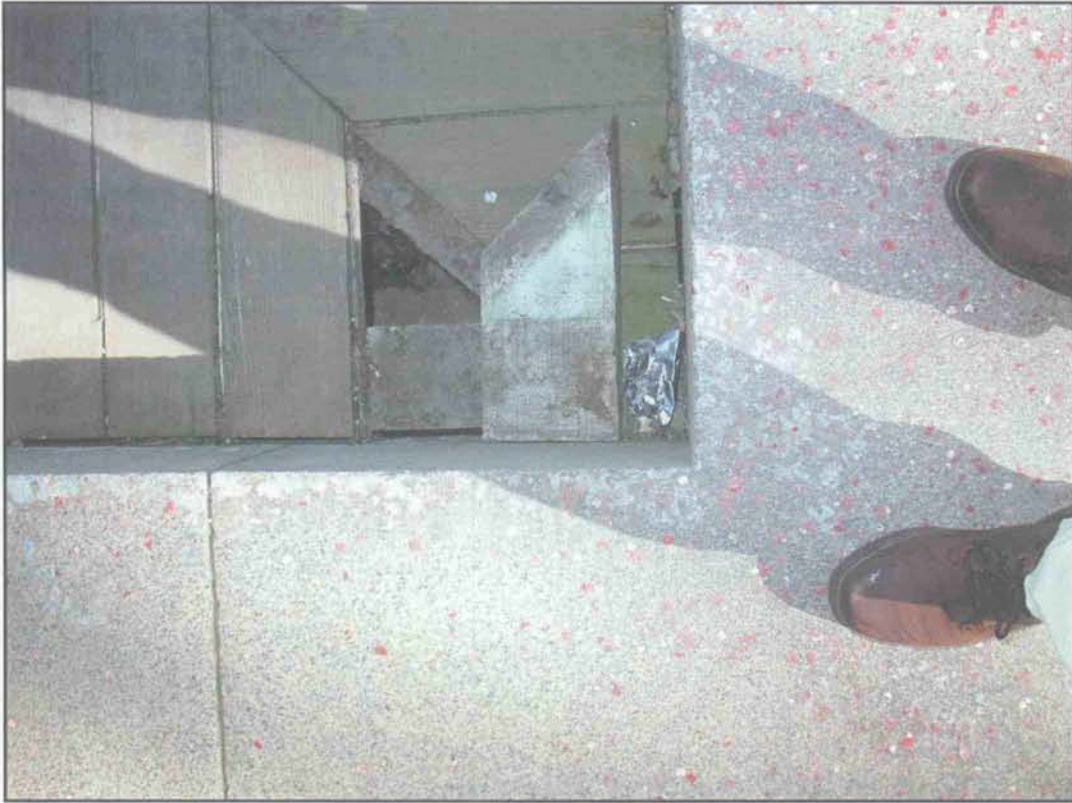
Condition Photo 14:
Wood Walkway – Barbette Tier
by Stair 1; Components are not
properly fastened at wood walkway.
(Courtesy of ARG, 2003)

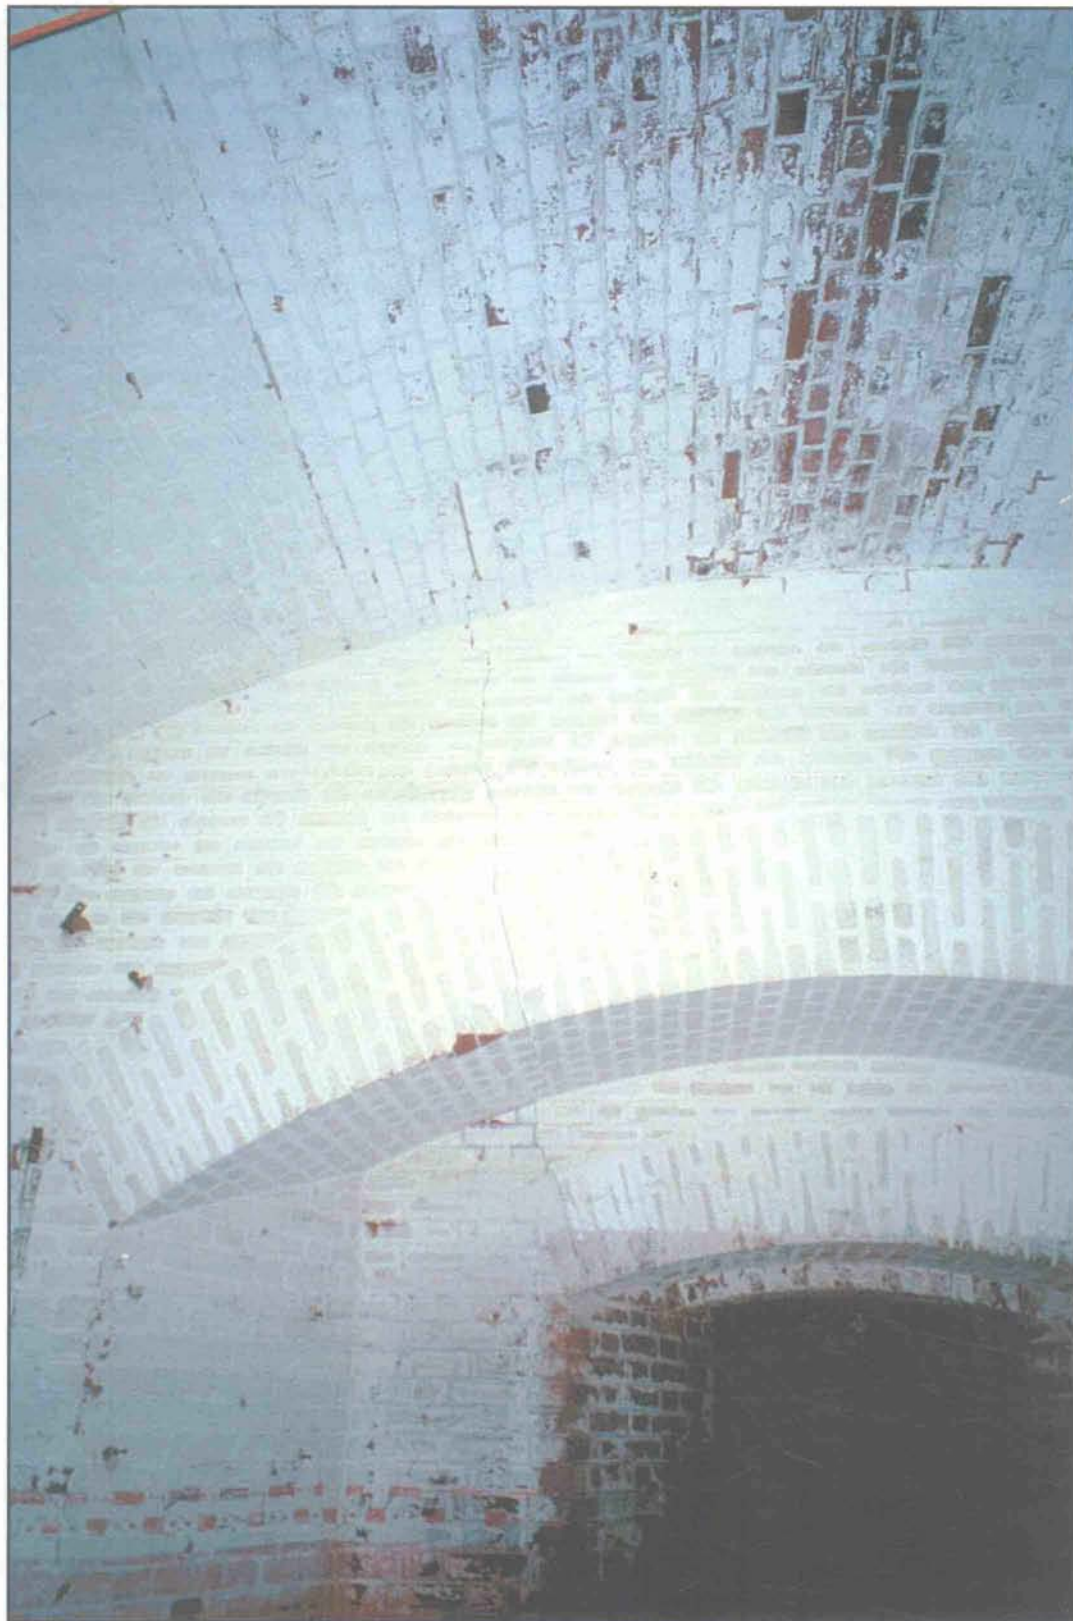
Condition Photo 15:
Casemate 19; Cracks in brick masonry
and joints have failed. The heavily
flaking paint is typical in casements.
(Courtesy of ARG, 2003)
