400 + 641 / D-515

National Park Service
U.S. Department of the Interior

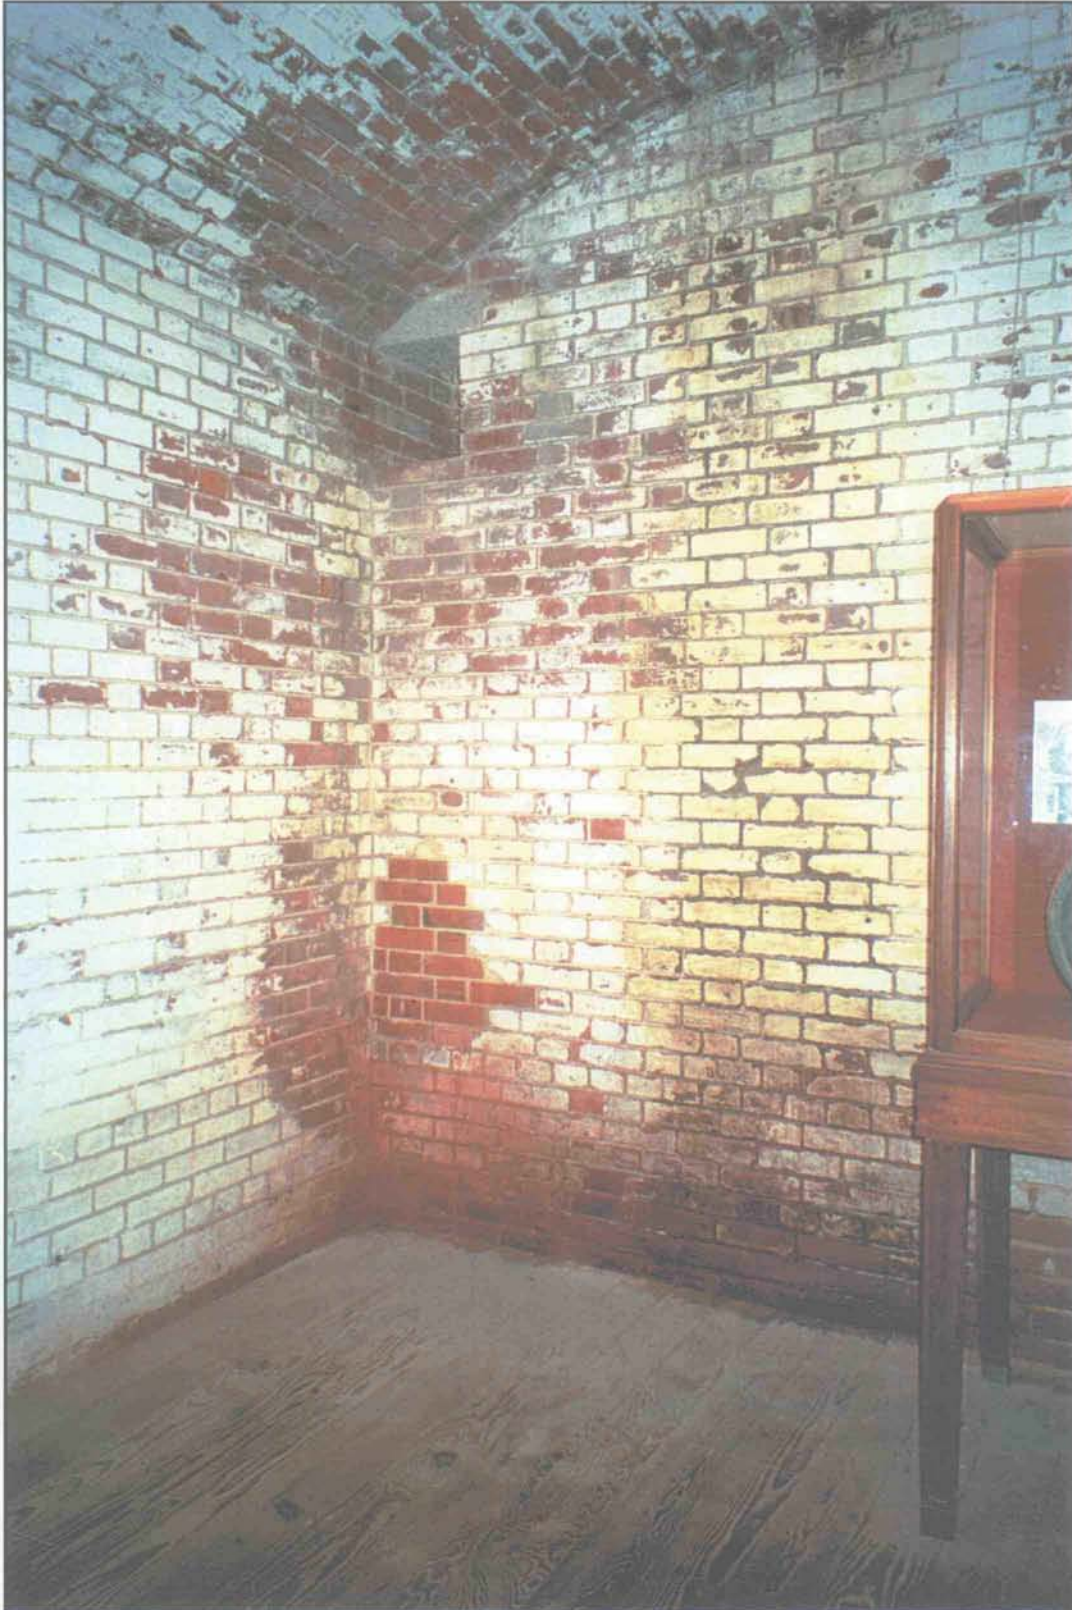
Condition Photo 16:
Casemate 11; Open joints at the
brick masonry and heavy water
infiltration. Biological growth on
the interior brick. (Courtesy of ARG,
2003).

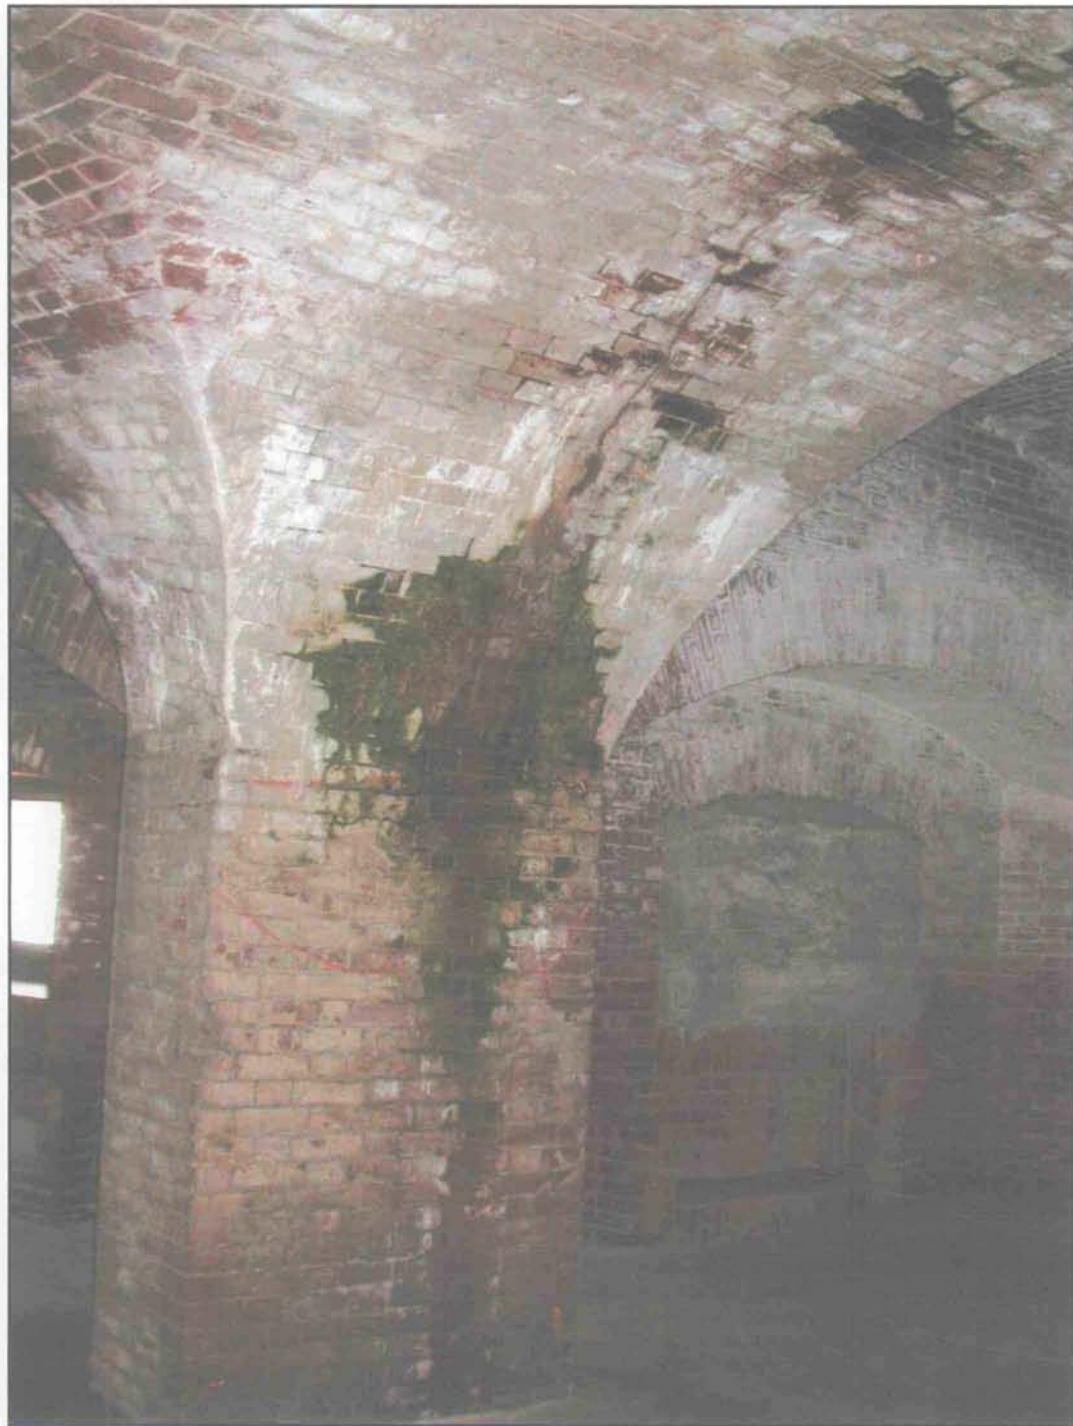
Condition Photo 17:
Casemate 68A- Third Tier; Crack
spanning the arch of a casemate,
typical at the intersection of the east
bastion and arch of the adjacent
walkway. Extensive water damage,
biological growth and efflorescence
of masonry. (Courtesy of ARG, 2003)

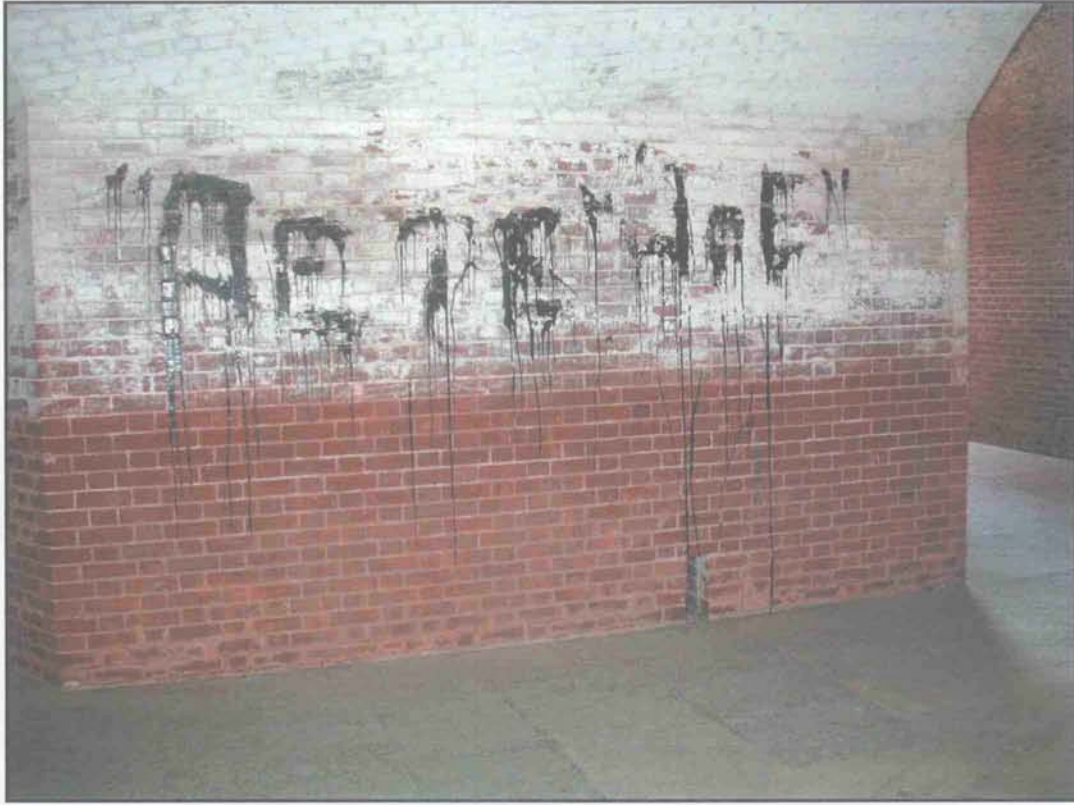
Condition Photo 18:
Casemate 68A—Second Tier; Graffiti
noted on masonry wall.
(Courtesy of ARG, 2003)

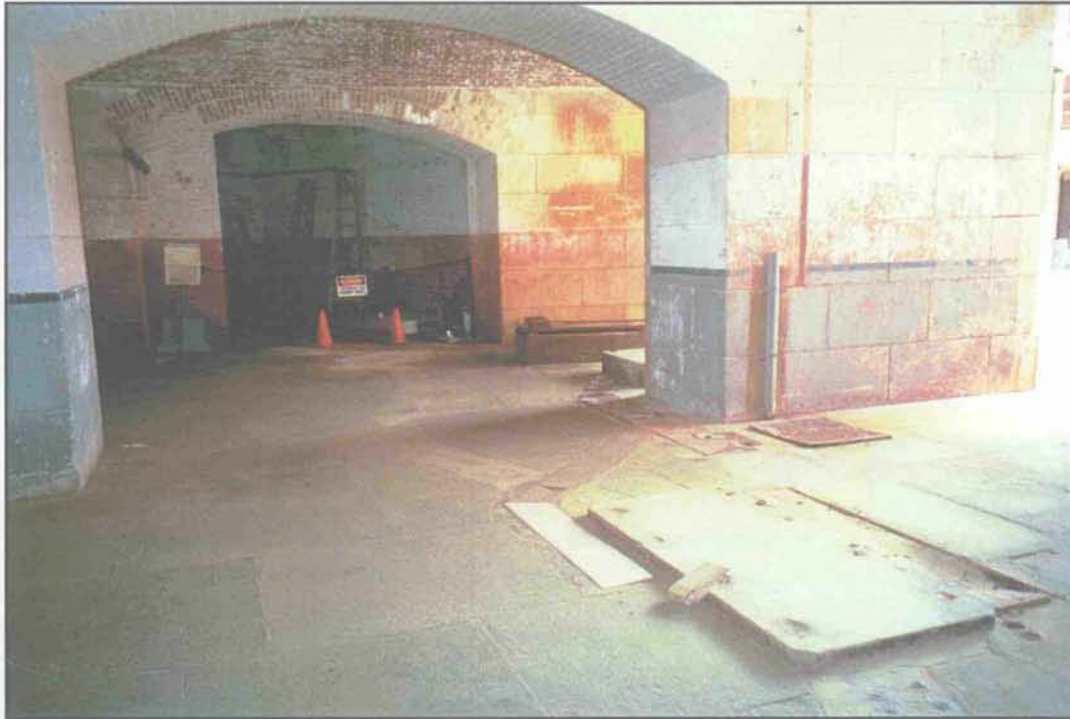
Condiiton Photo 19:
Casemate 34; Uneven surfaces, open
holes and potential tripping hazards.
(Courtesy of ARG, 2003)

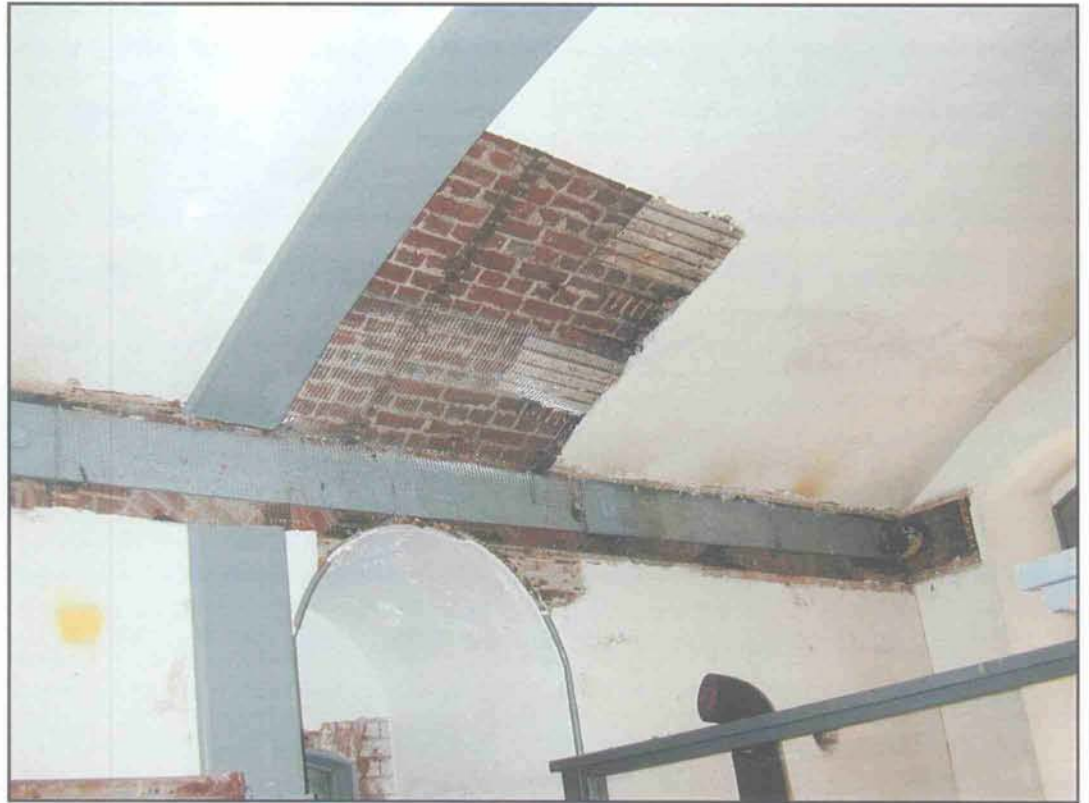
Condition Photo 21:
Detail of brick lath, wire mesh, and
plaster layers. (Courtesy of ARG,
2003)

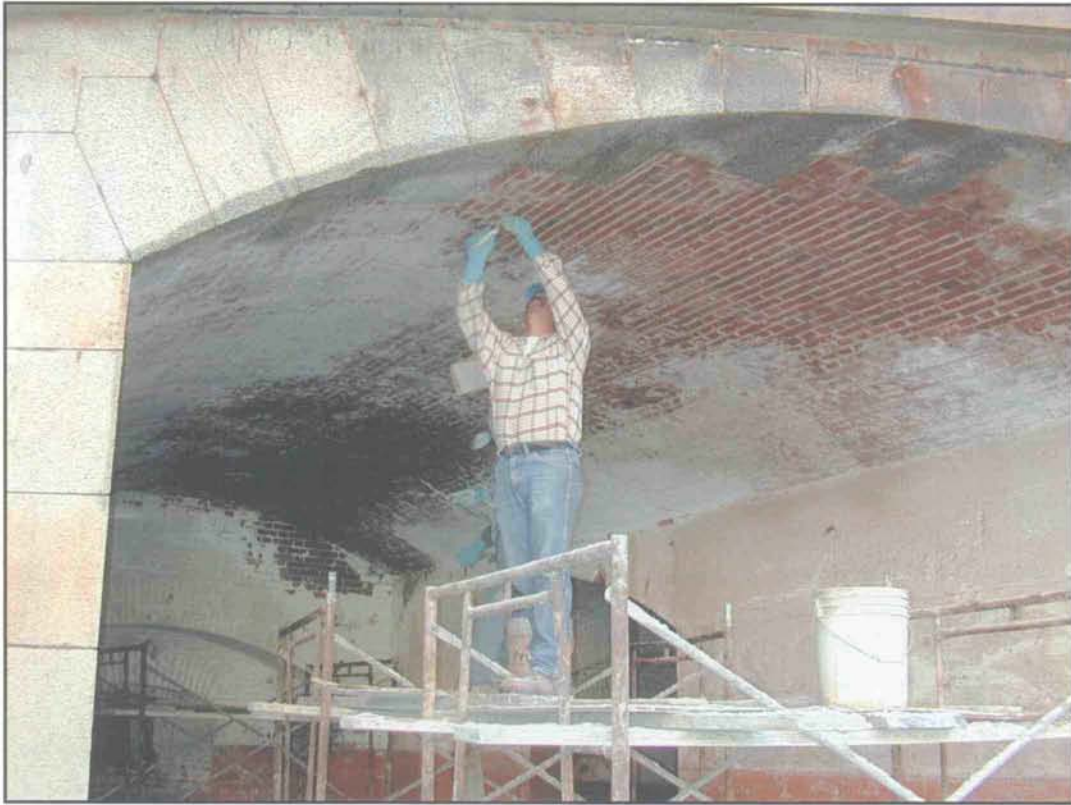
Condition Photo 22:
Masonry repointing project at 1st
tier. (Courtesy of ARG, 2003)

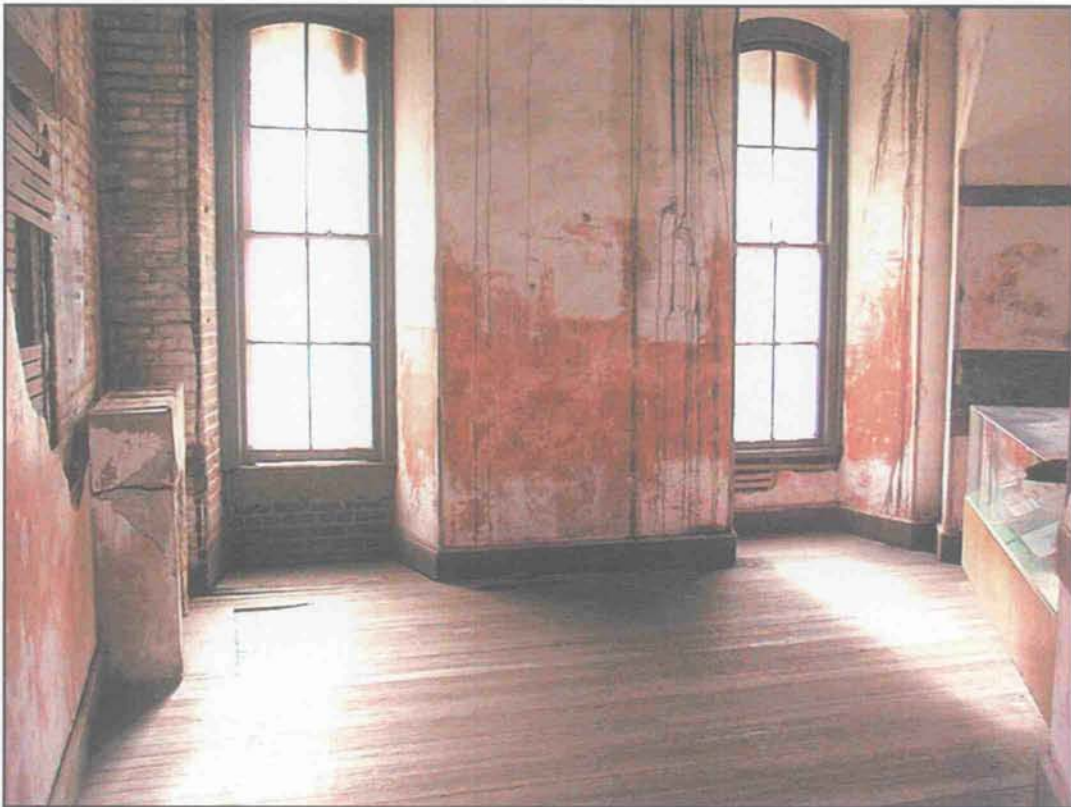
Condition Photo 23:
Stained plaster at Casemate 81.
(Courtesy of ARG, 2003)

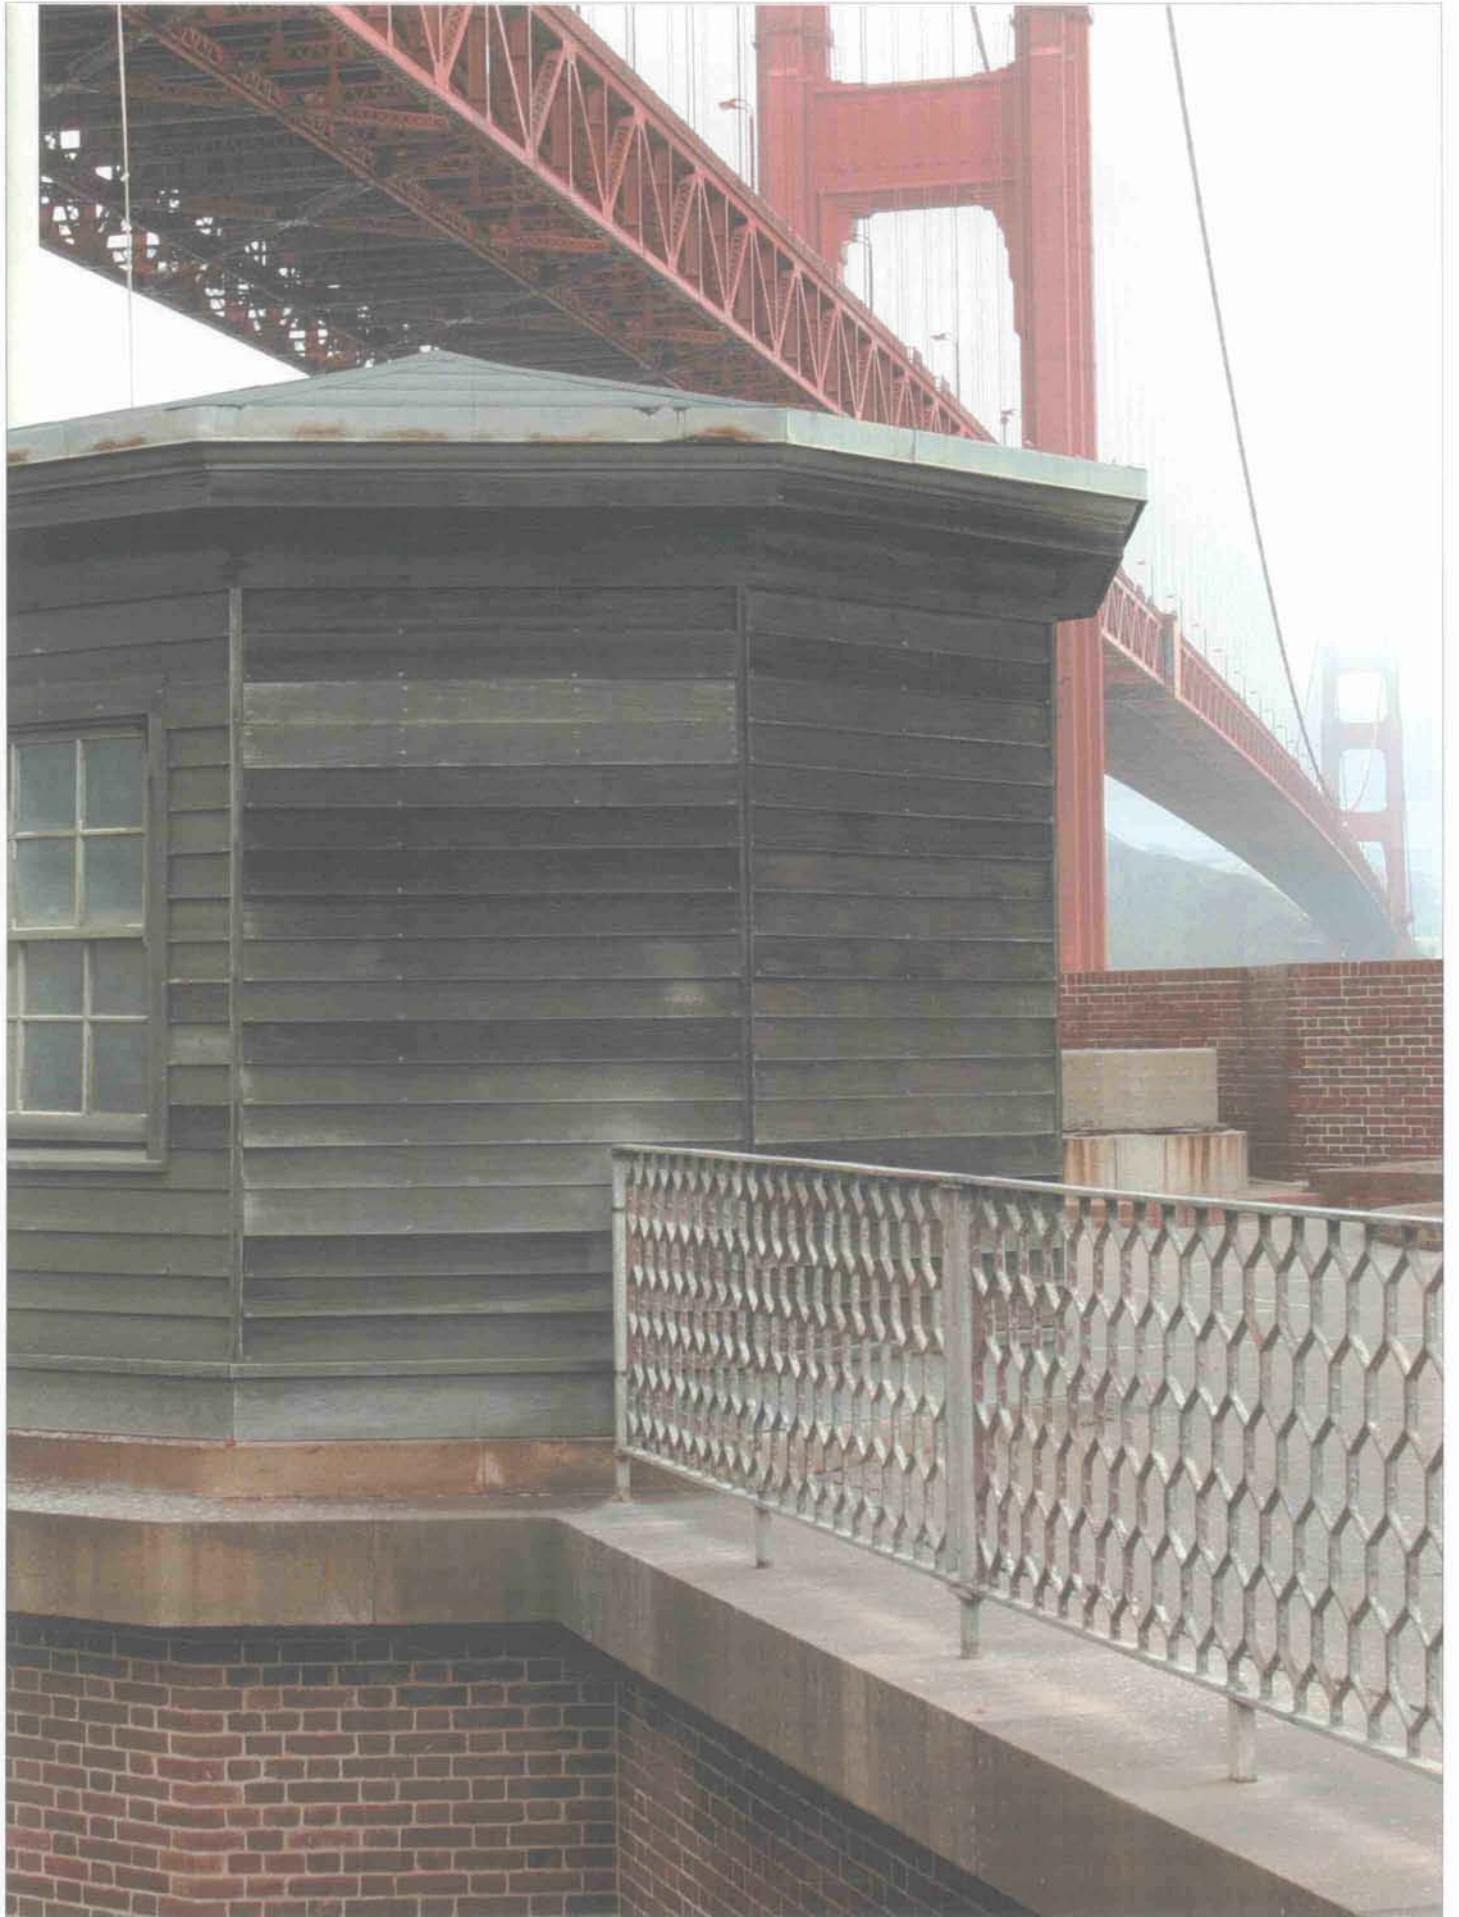
Treatment & Work Recommendations

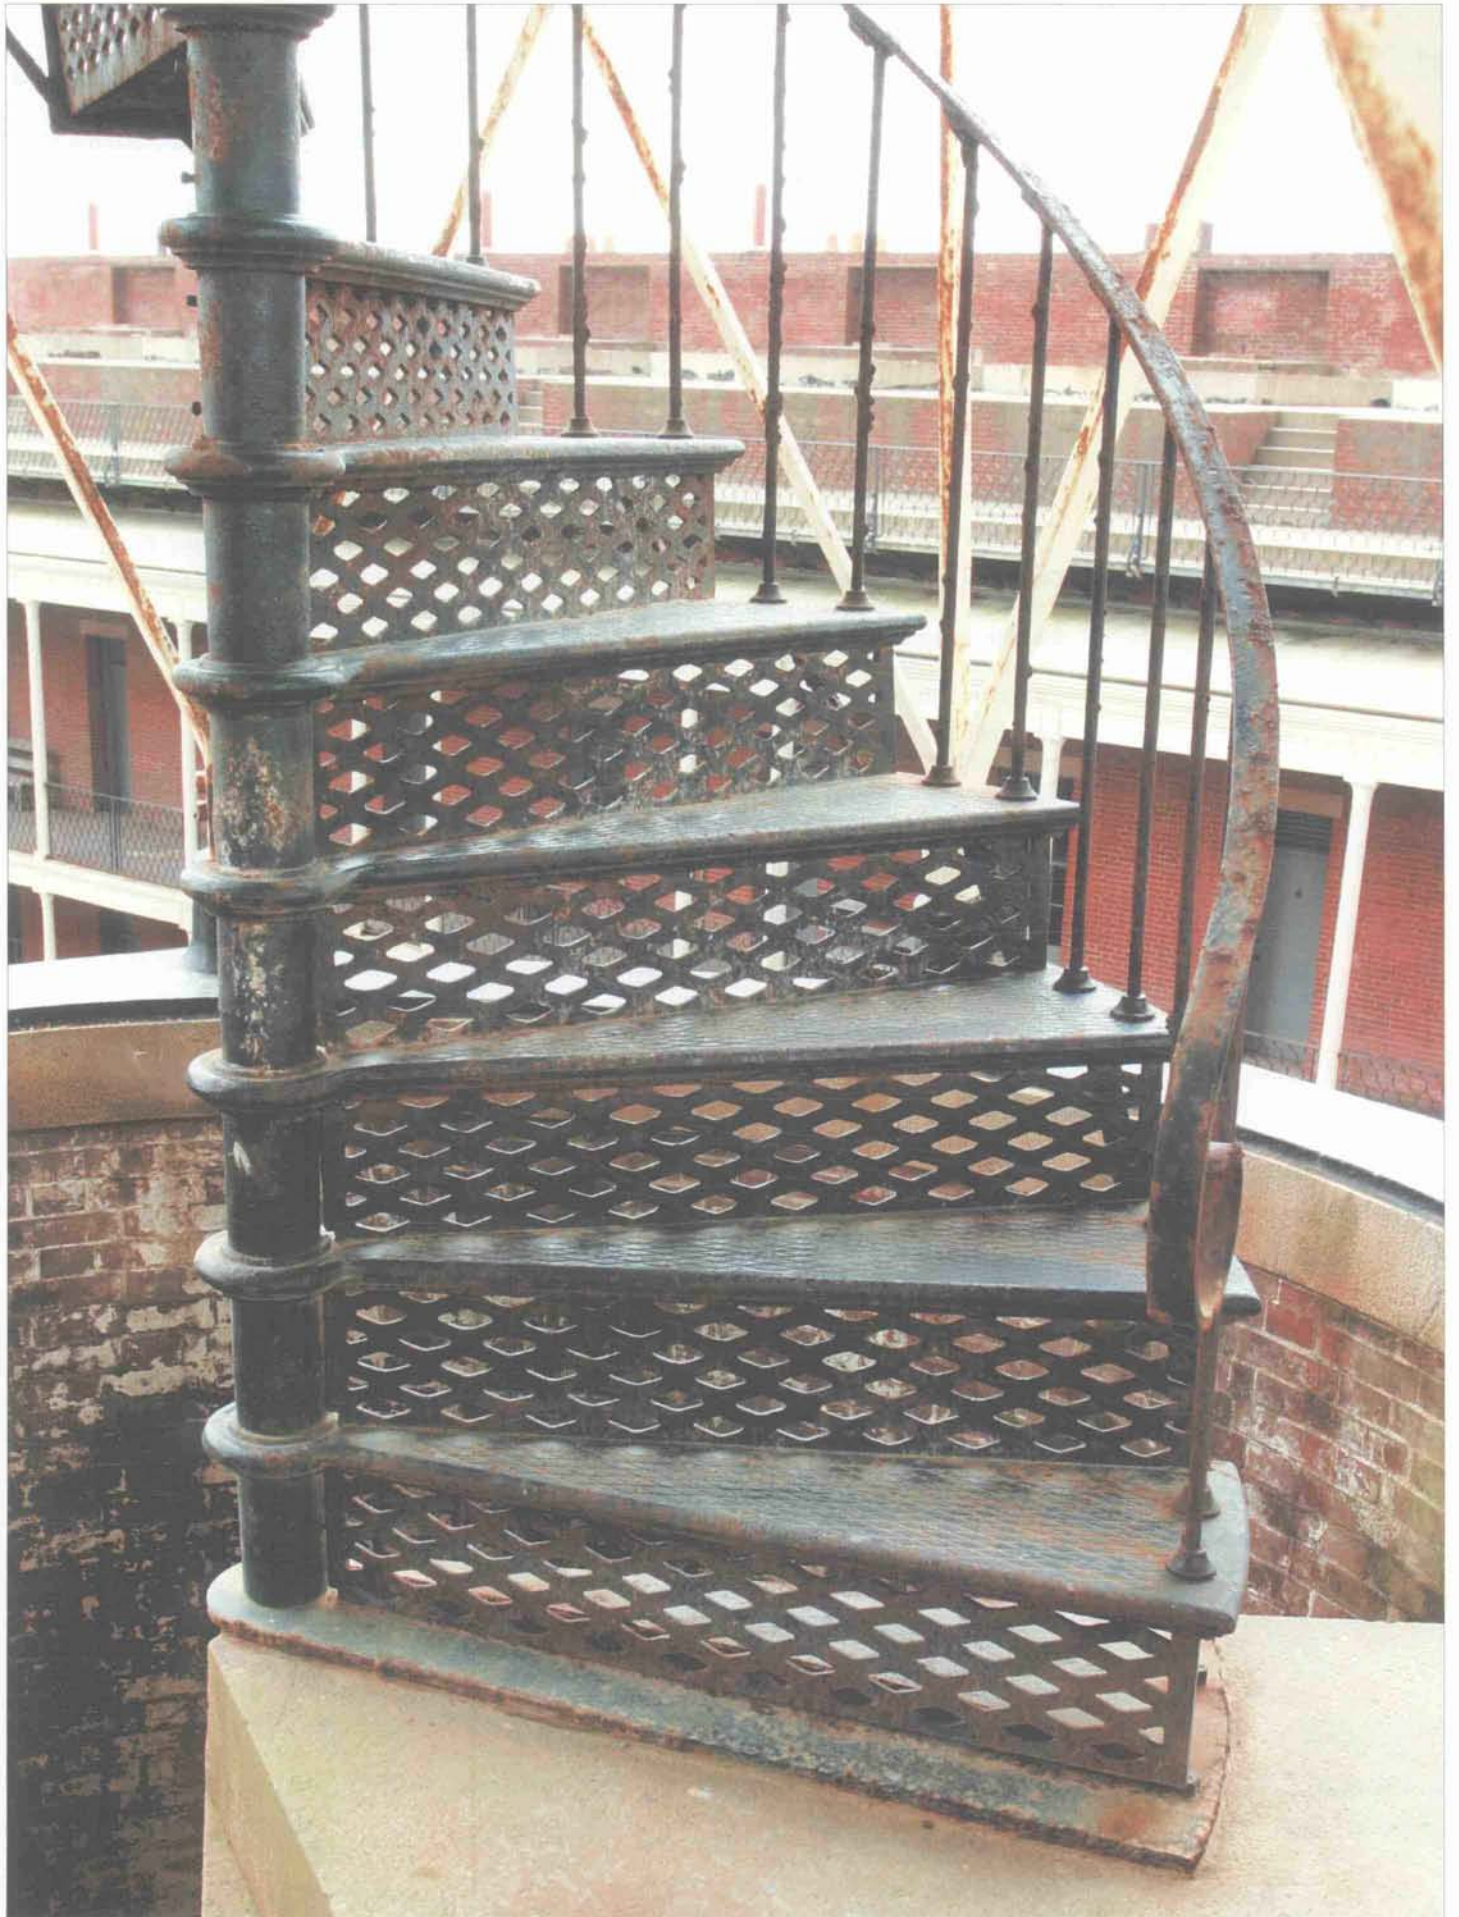
United States Department of the Interior Requisition; July 30, 1985; R.B. McNair Sons.

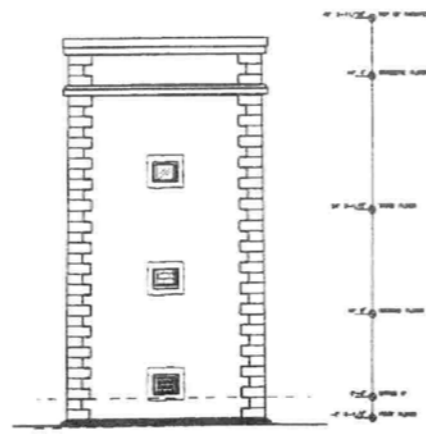
⑤ EAST BASTION- NORTHEAST FACE ELEVATION

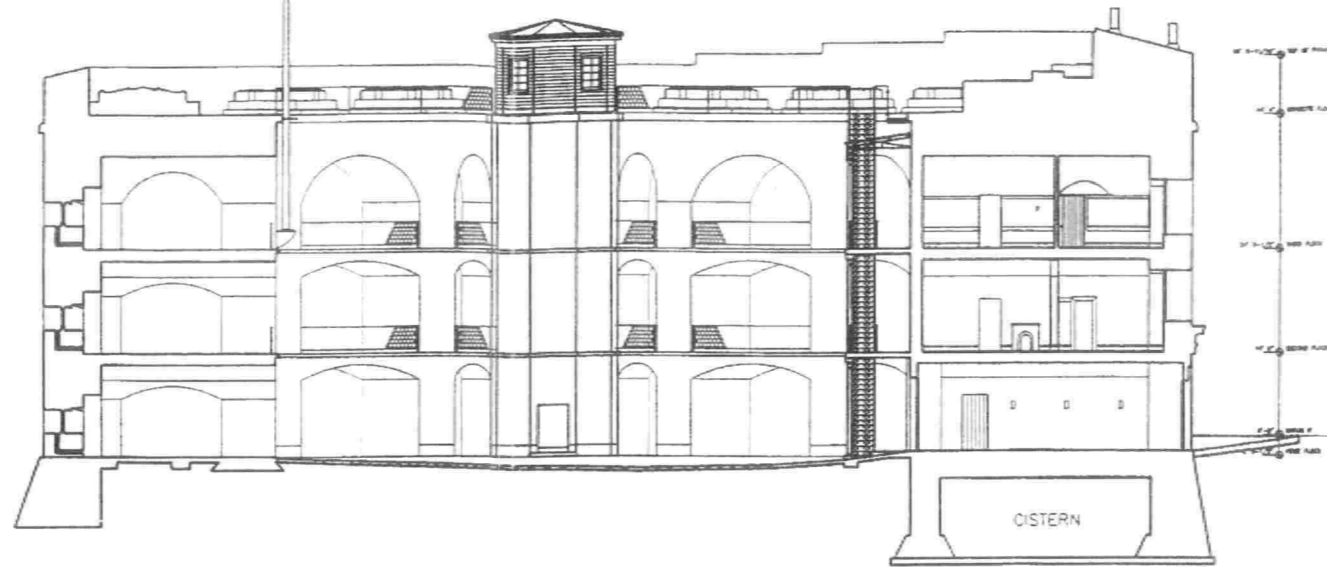
Figure 31. Drawing: Exterior Elevations, 1998. Credit: Carey & Co. Inc.

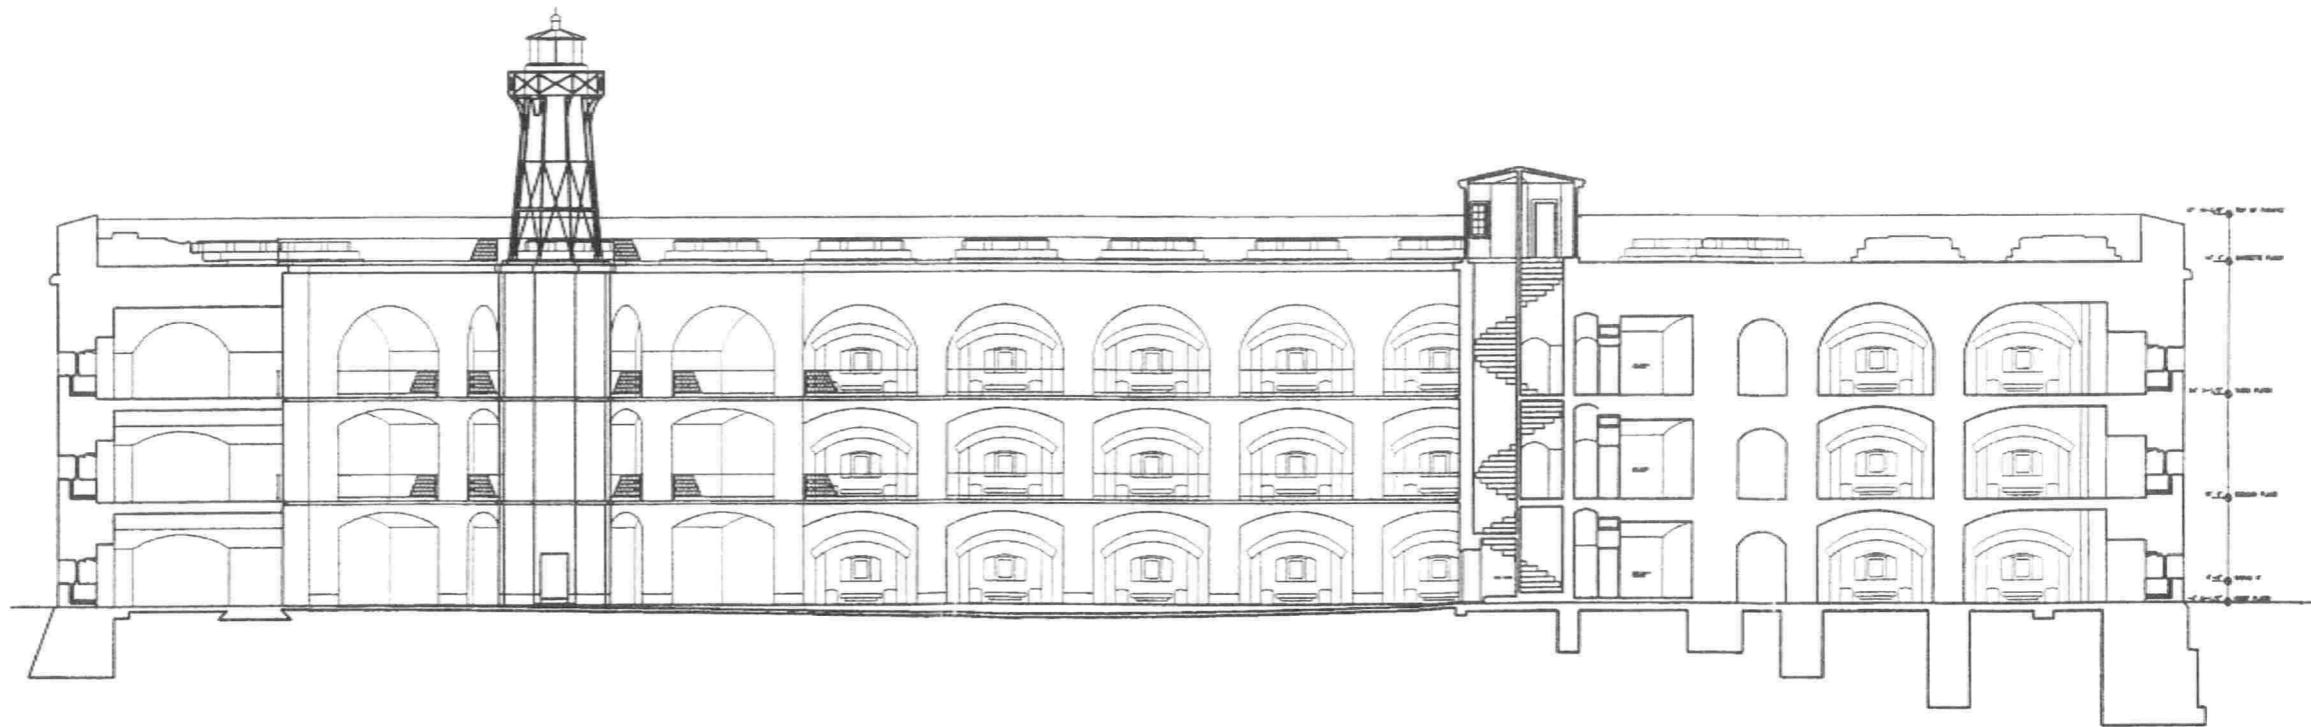
LIGHTHOUSE AND FOUNDATION NOT SURVEYED

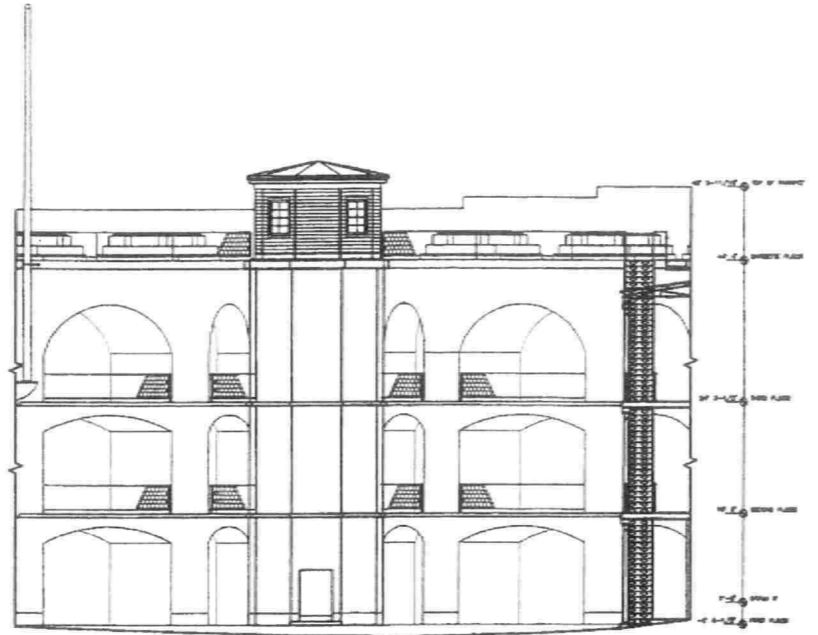
19 NORTHEAST COURTYARD ELEVATION
