113/D-SS3  
Grand Canyon

# Yavapai Observation Station

Historic Structure Report

*prepared by*  
Architectural Resources Group  
Architects, Planners & Conservators, Inc.  
San Francisco

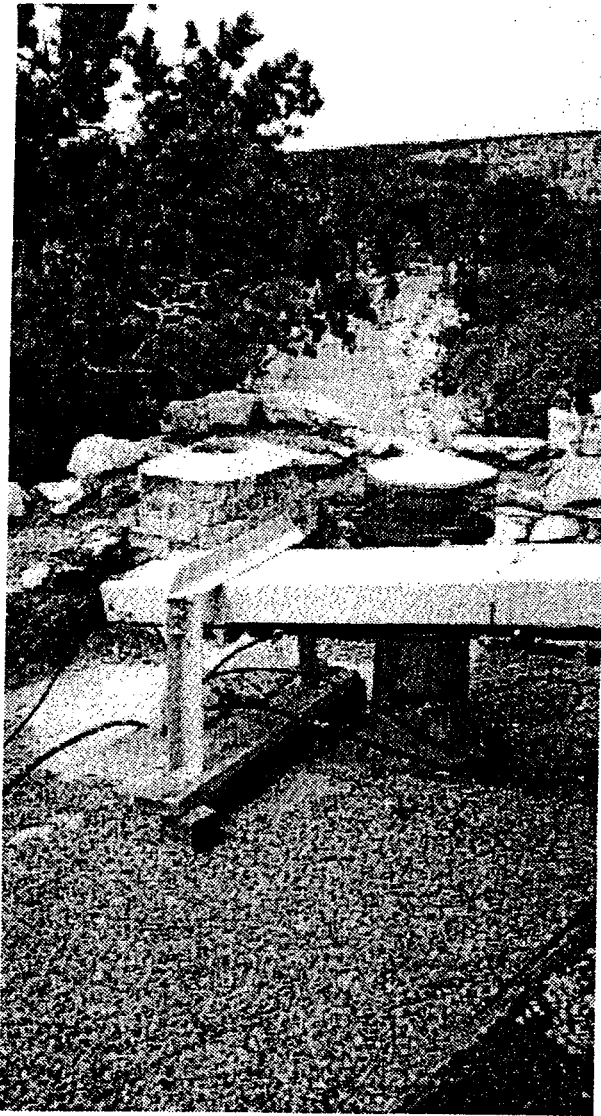
*Figure 9. This image illustrates typical conditions on the flat tar and gravel roof. In the foreground is the brick chimney below the parapet. View is looking to the southwest corner. Long view is looking southwest. Note paved rim trail and boulders along the walk. Photo dated May, 2000.*

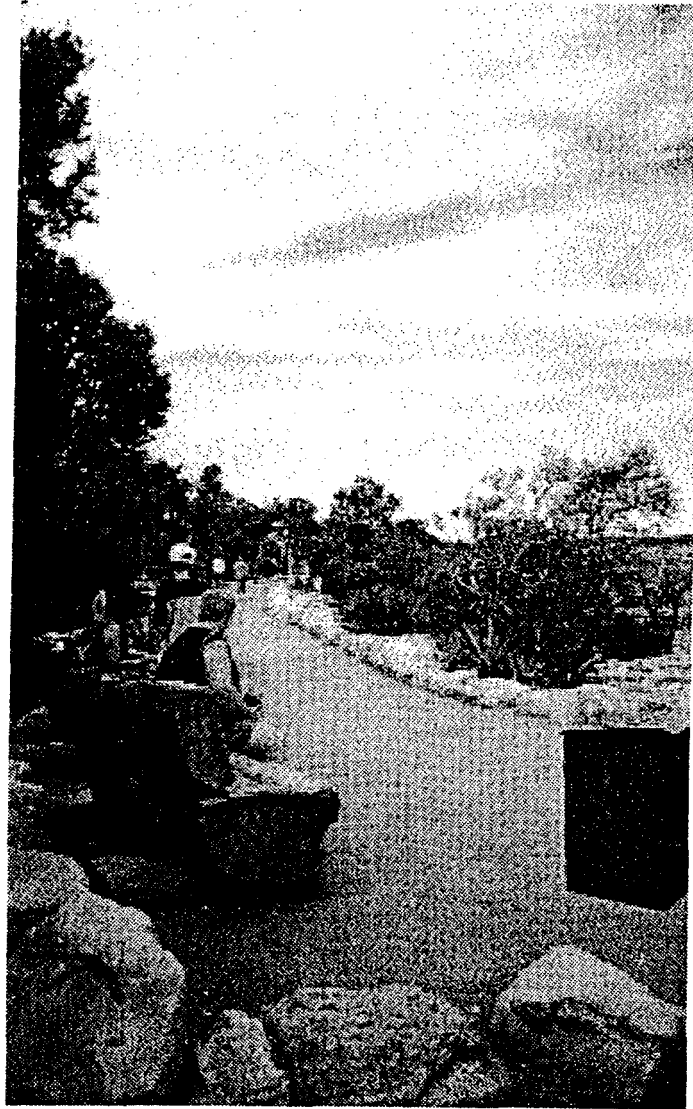
*Figure 13. This image illustrates the landscaping and paving leading to the west side of the building. Benches are in poor condition. Photo dated May, 2000.*

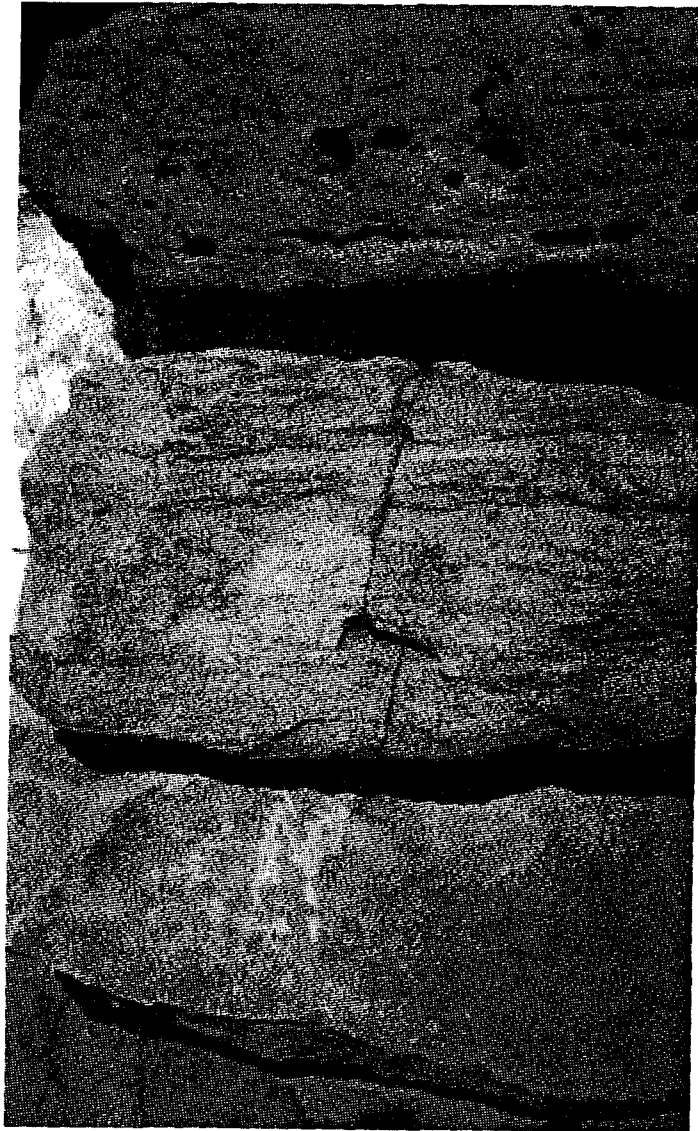
*Figure 15. This detail image illustrates a fracture that runs the length of a boulder near a small window opening on the east elevation. The fracture may be the result of a natural cleft in the stone or it may be due to stresses on the rock. View is looking toward the north. Photo dated May, 2000.*

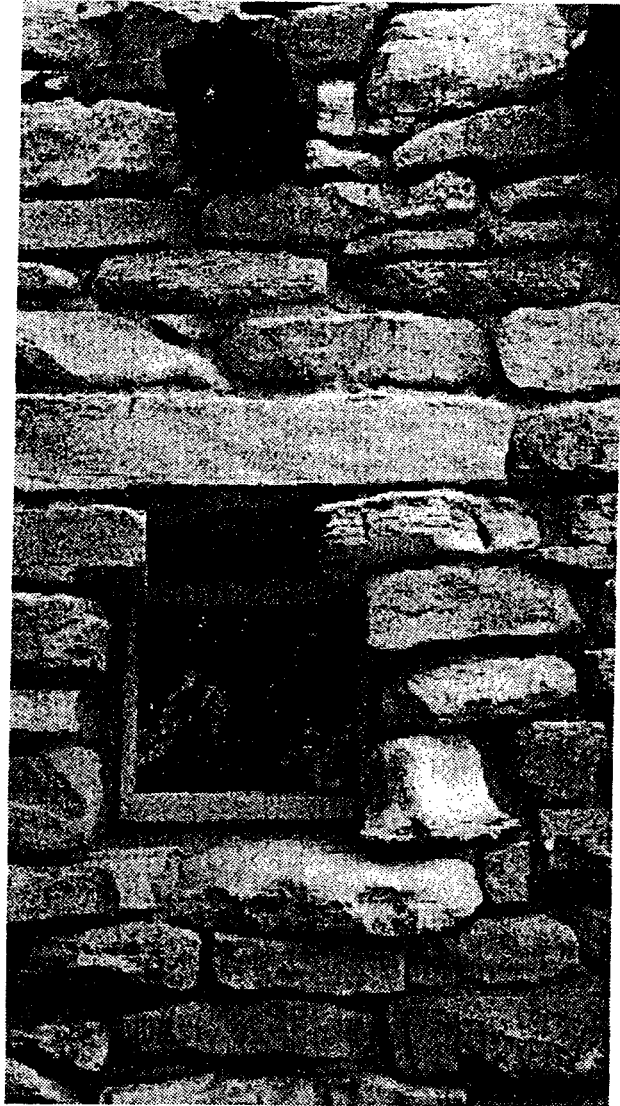
*Figure 17. Detail shows window on the west elevation of the Yavapai exterior. Wood log end exhibits deterioration. Photo dated May, 2000.*

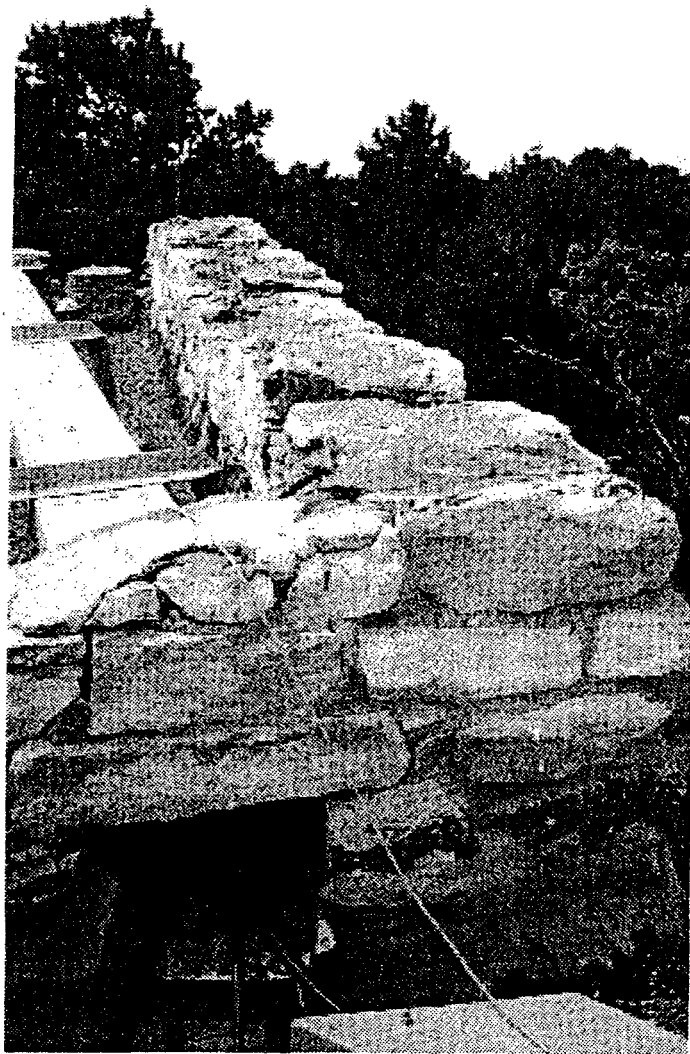
*Figure 19. This image illustrates the parapet above the flat roof. Evidence of mastic repairs. View is looking south. Photo dated May, 2000.*

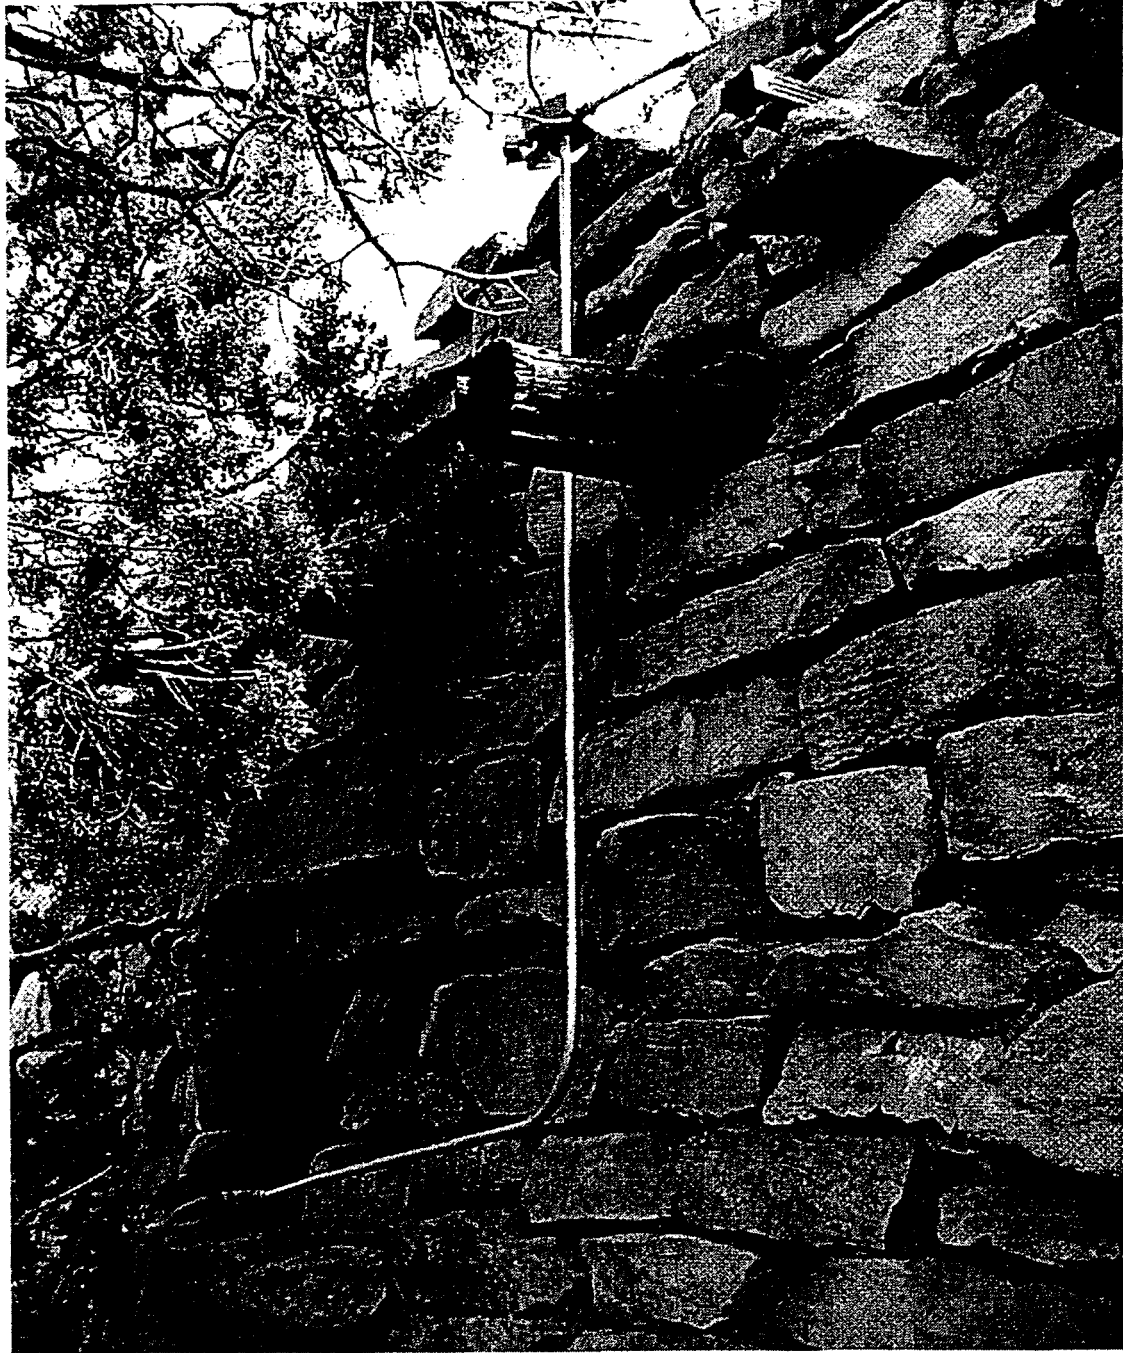
1: Conduit on Exterior Wall and Scupper

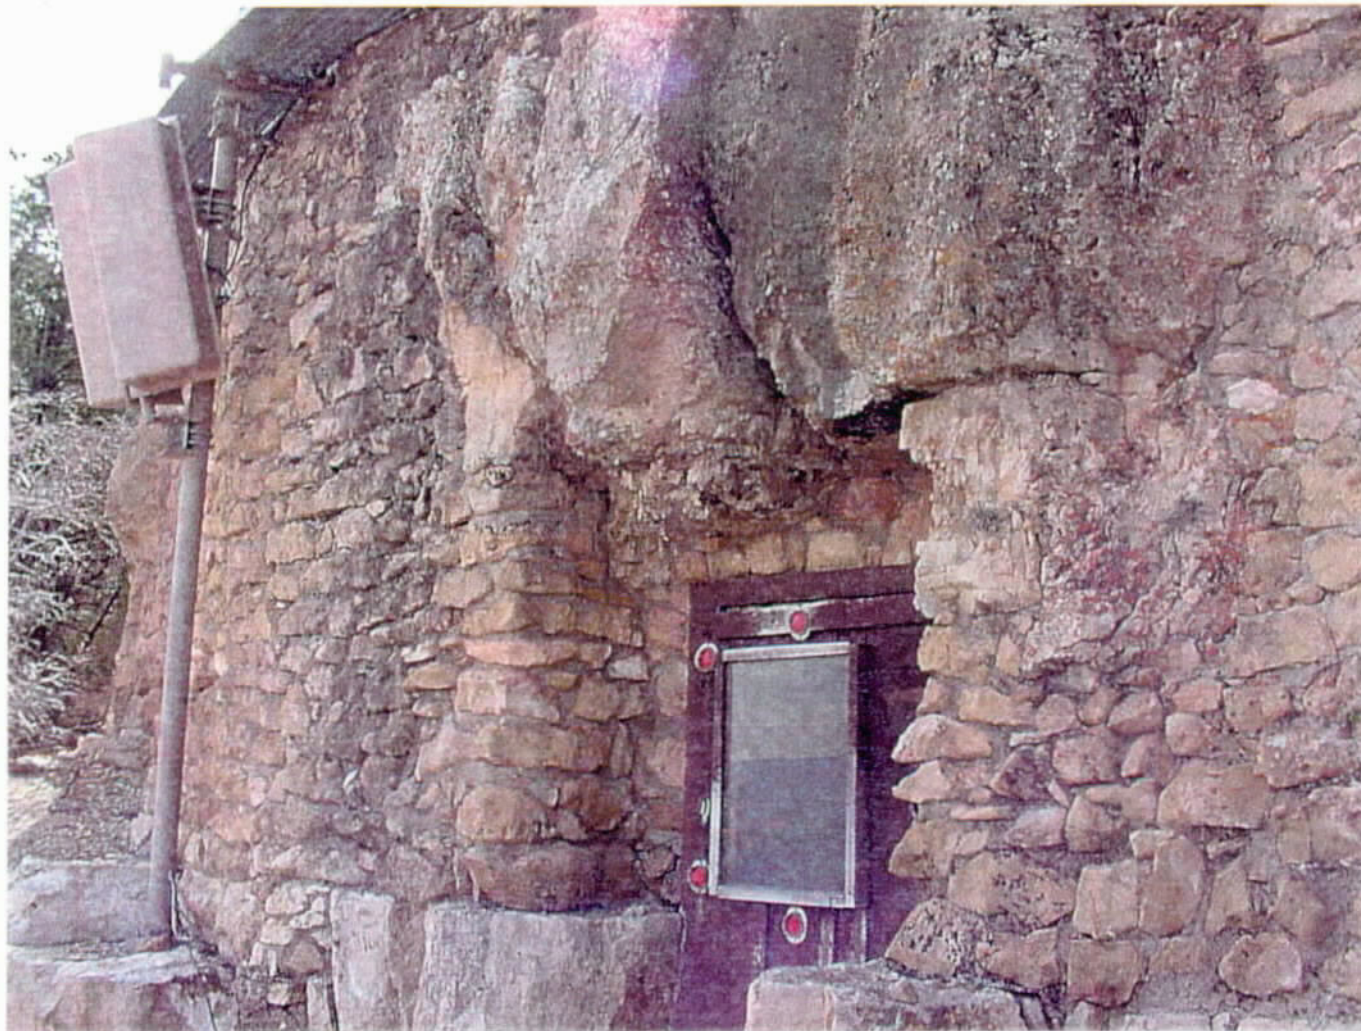
BASEMENT, SHOWING CRACK AND MASONRY REPAIRS TO CANYON WALL

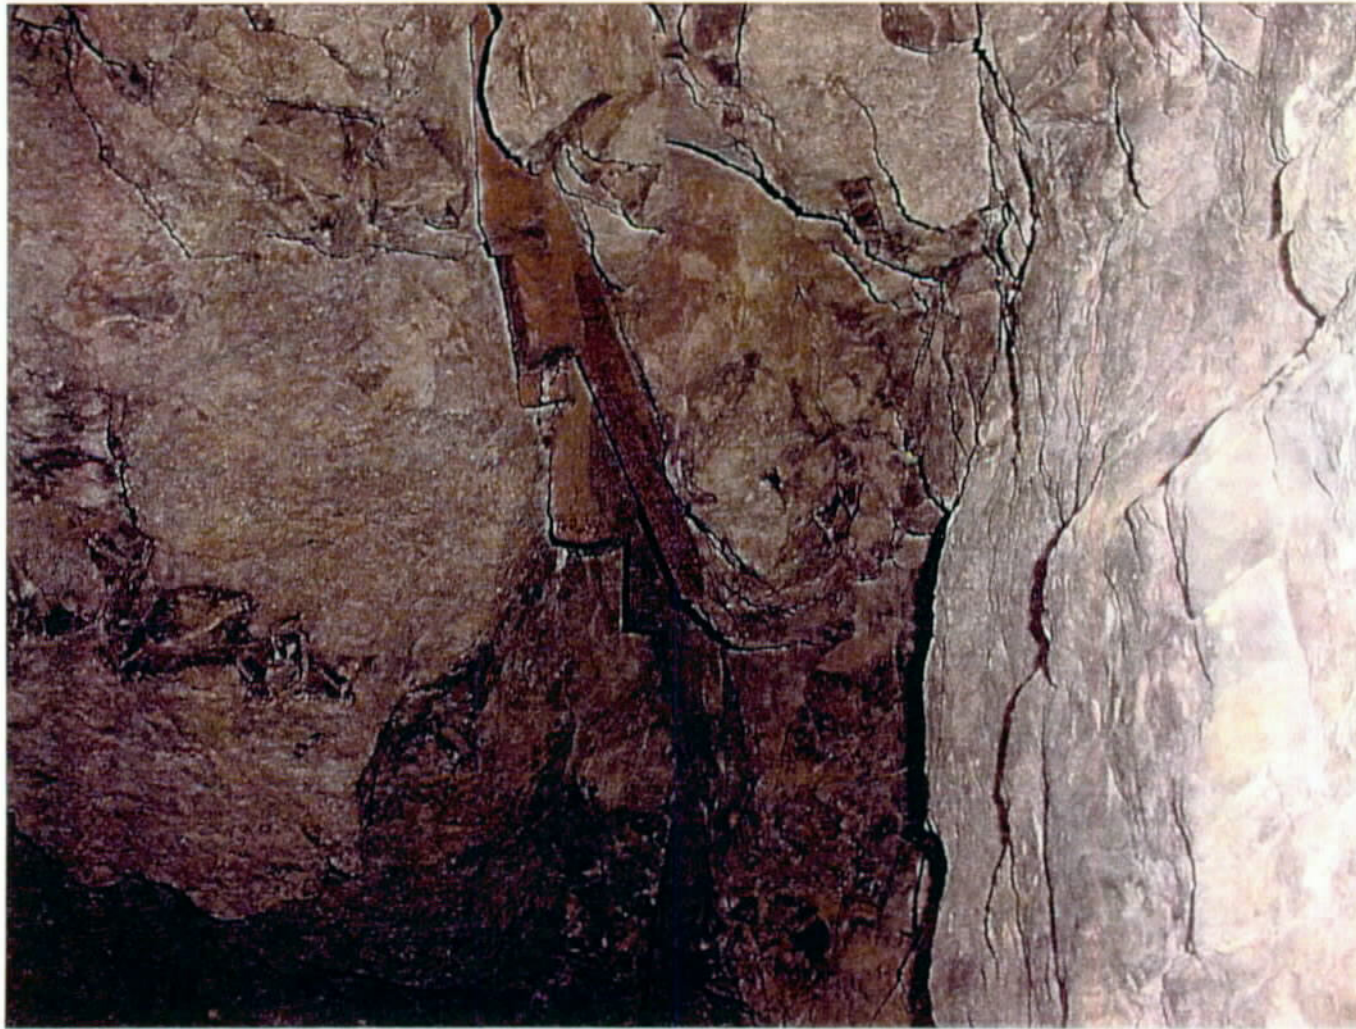
BASEMENT, SHOWING CONTINUING CRACK AND WOODEN WEDGES

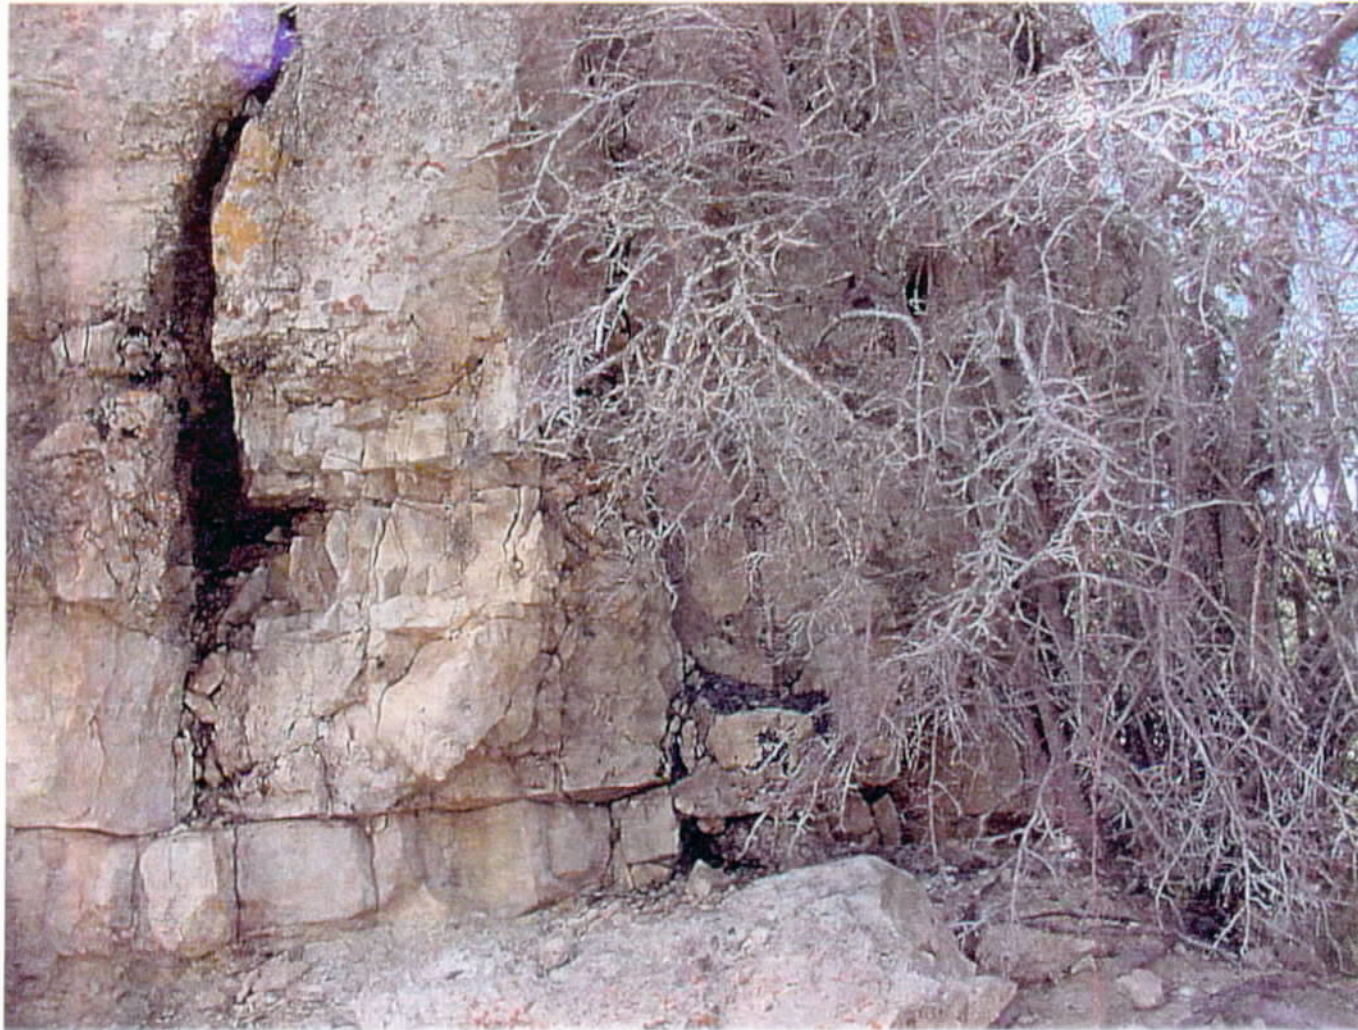
LARGE CRACK IN STRATA BELOW STRUCTURE

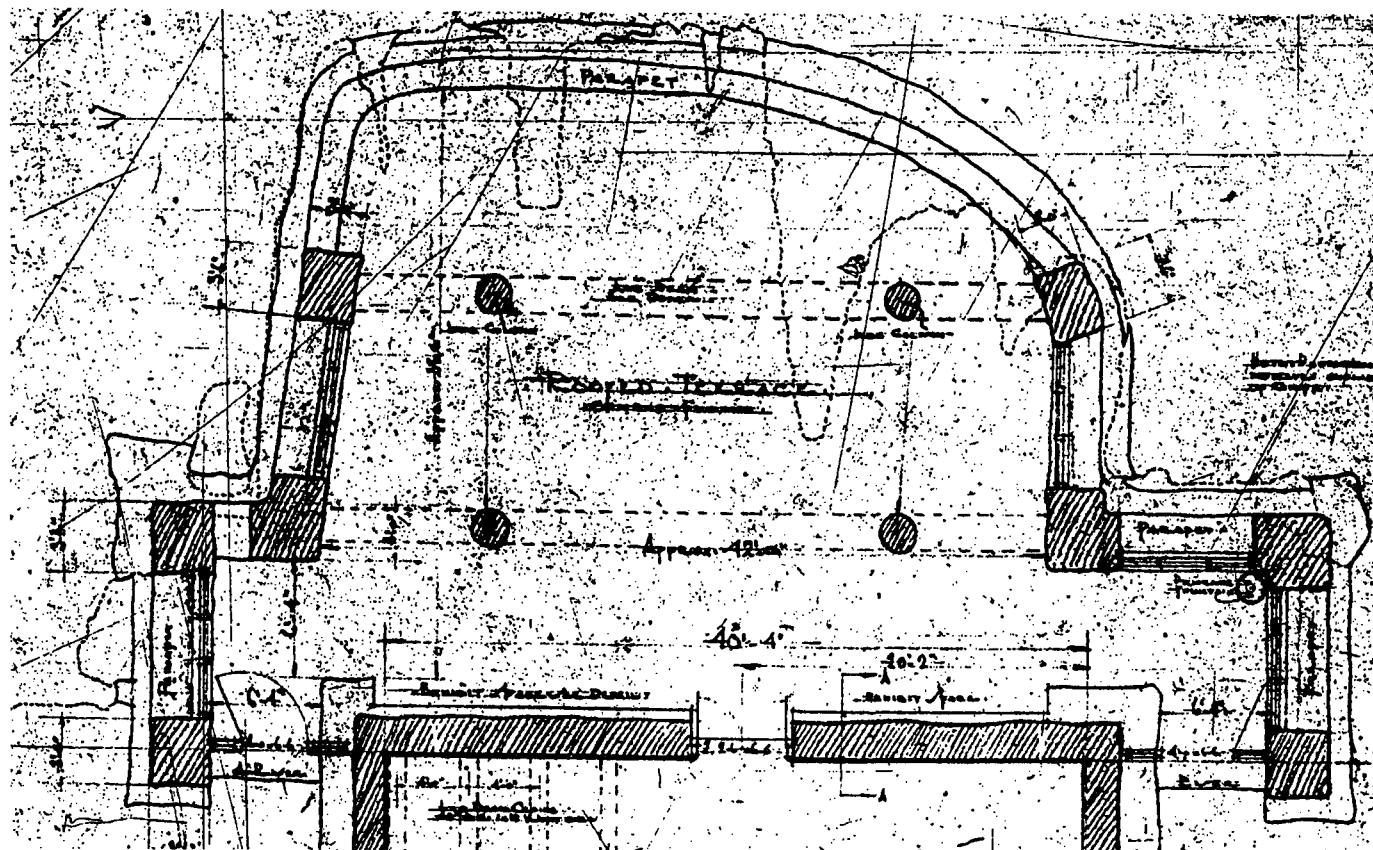
PORTION OF ORIGINAL FLOORPLAN SHOWING VOIDS BELOW STRUCTURE
