Comet

Submerged Cultural Resources Site Report

Channel Islands National Park

Submerged Resources Center
Professional Reports
Number 17

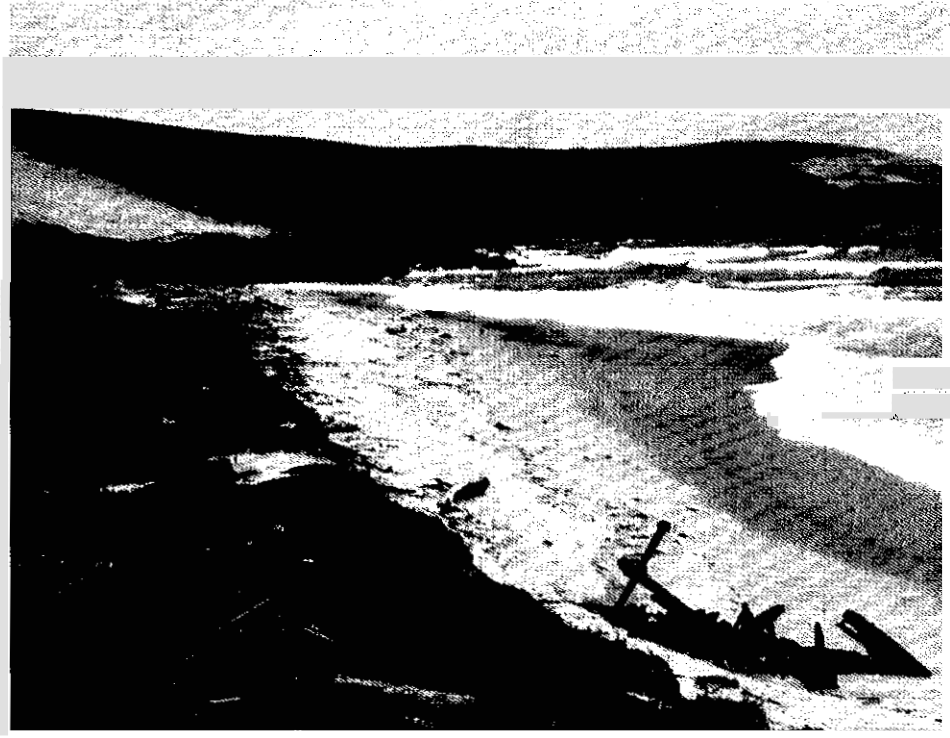
Figure 1.1. The *Comet* site exposed in Simonton Cove in 1984. NPS photo by Reed McClusky.

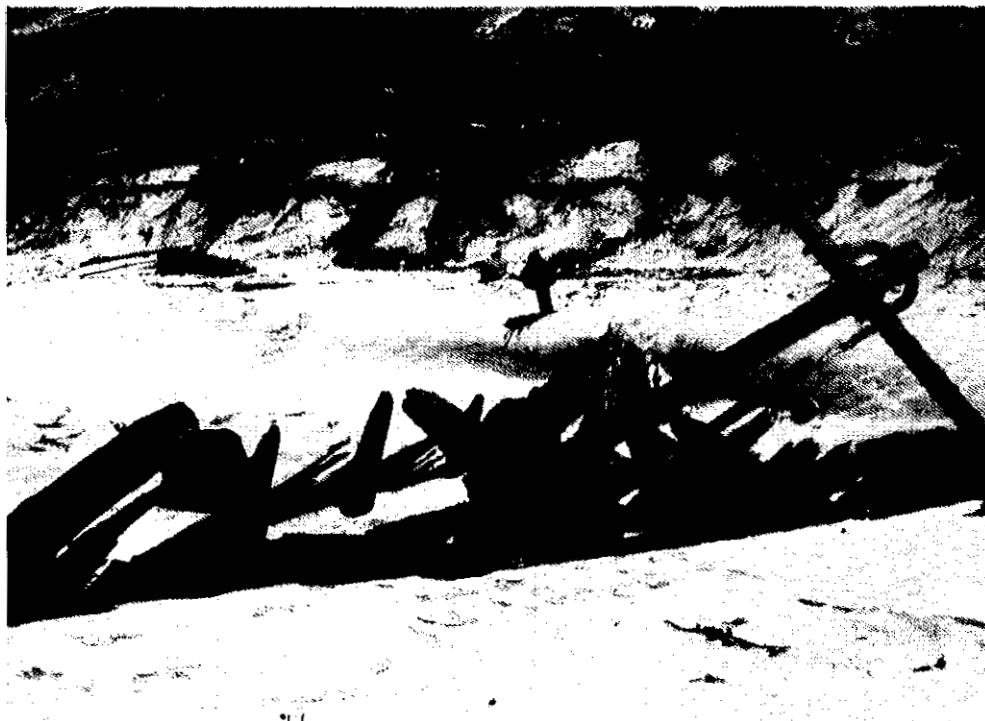
Figure 1.2. *Comet* timbers and anchor exposed in 1984. NPS photo by Reed McClusky.

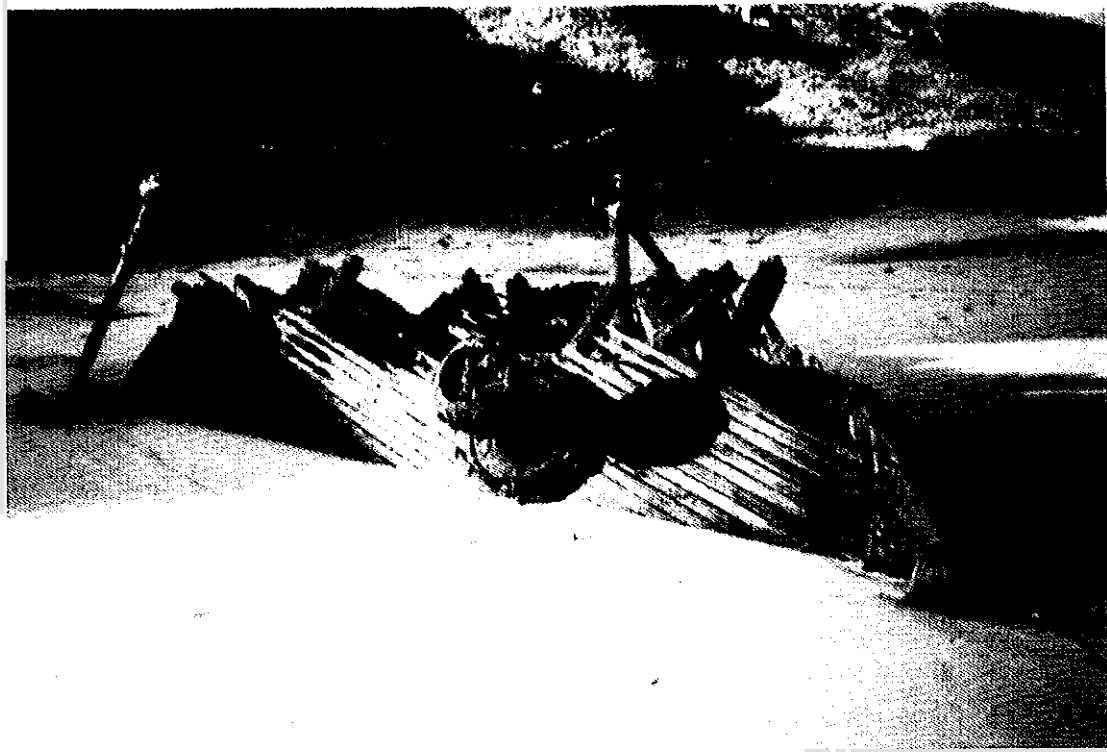
Figure 4.3. *Comet* site in April 1999, looking down on the forecastle deck with the capstan mounted to it. The bow is to the right. NPS photo by Matt Russell.

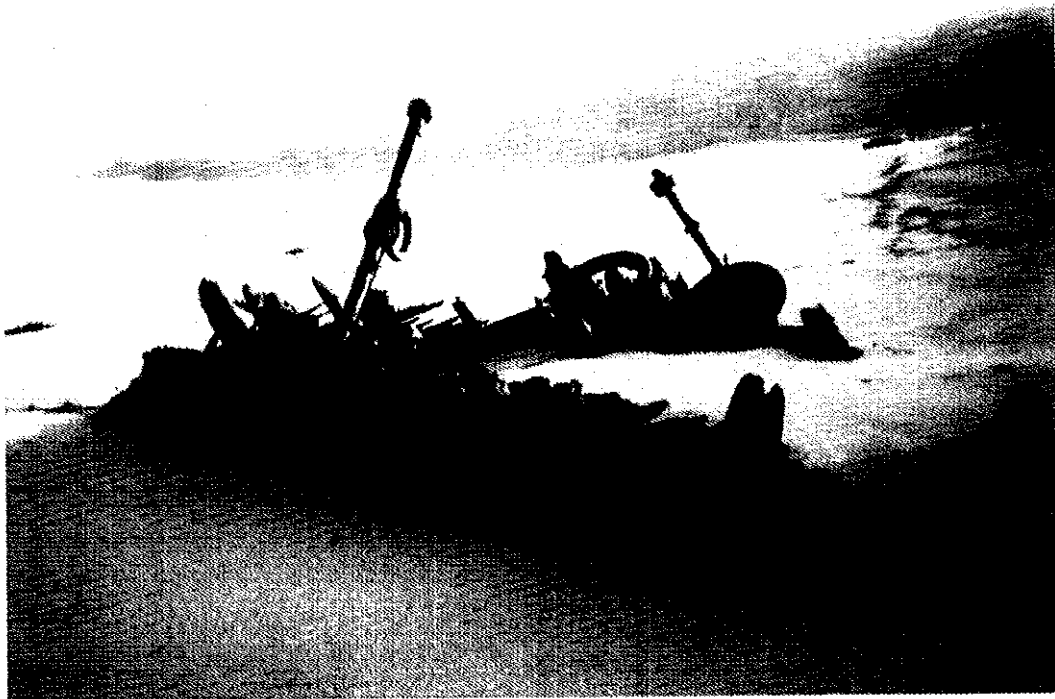
Figure 4.4. *Comet* site in April 1999, looking at the port side outer hull timbers. NPS photo by Don Morris.

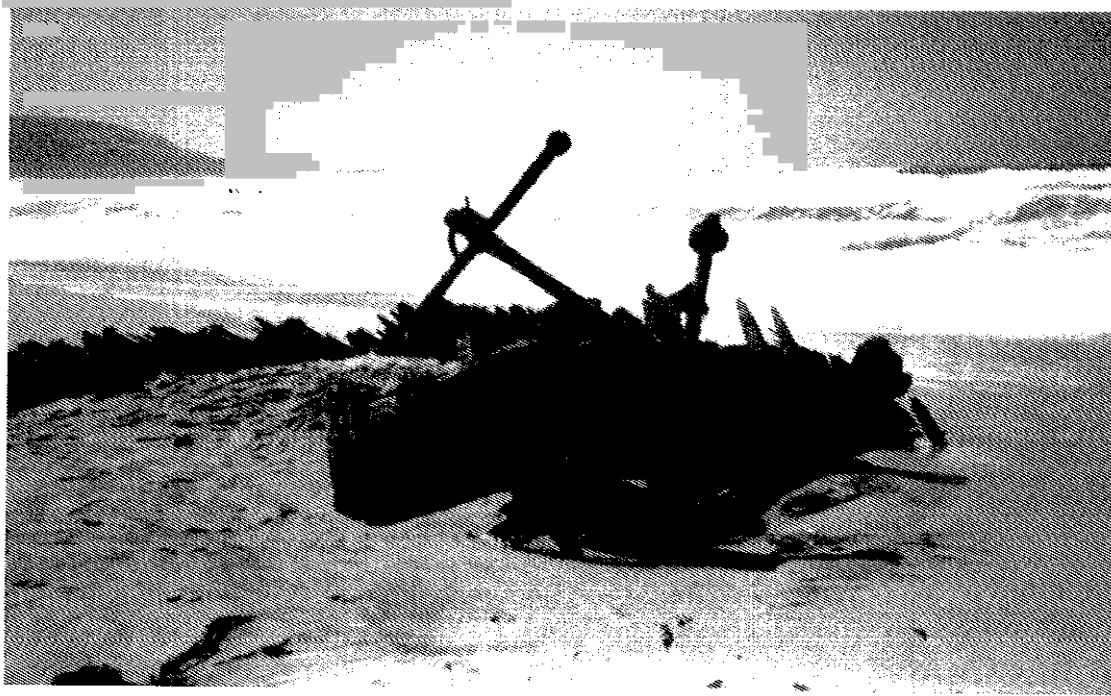
Figure 4.5. *Comet* site in 1999, looking towards the windlass (mounted on the main deck) in the center of the photo, with the capstan (mounted on the forecastle deck) to the right. NPS photo by Don Moms.

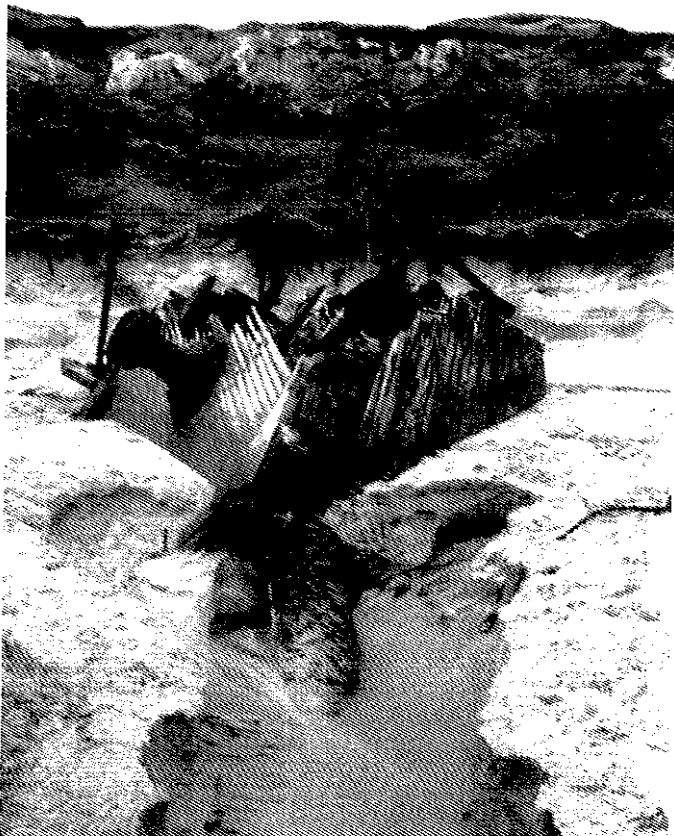
Figure 4.6. *Comet* site in April 1999, looking straight towards the bow, which is canted to the left in this photo. The forecastle deck is to the left, port side outer hull planking to the right, and the bowsprit is in the bottom of the photo. NPS photo by Matt Russell.

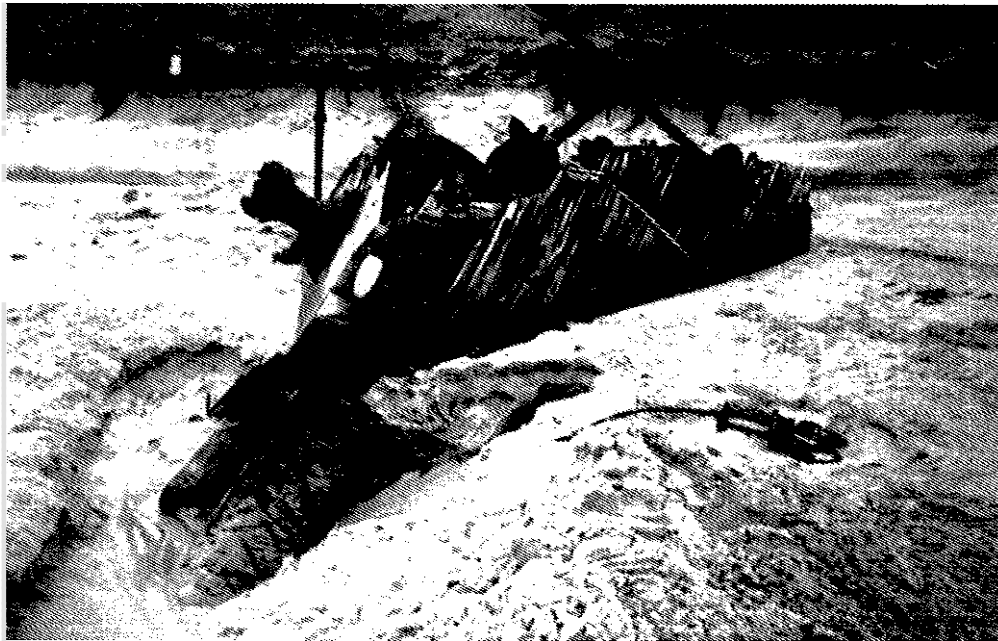
Figure 4.12. *Comet's* bow. The hawse timbers are in the center with the white float on them. The hawse pipe is visible at the sand-line, to the right of the hawse timbers. In the right foreground is an unattached rigging element. NPS photo by Matt Russell.

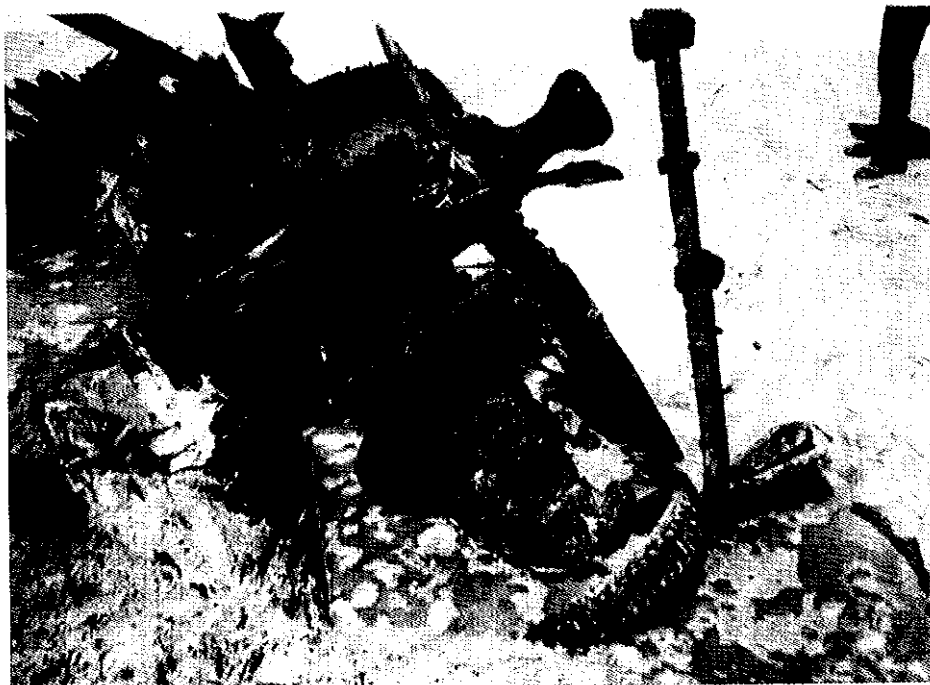
Figure 4.40. *Comet's* windlass and the iron shaft sticking out of the sand on the right side of the photograph. NPS photo by Matt Russell.

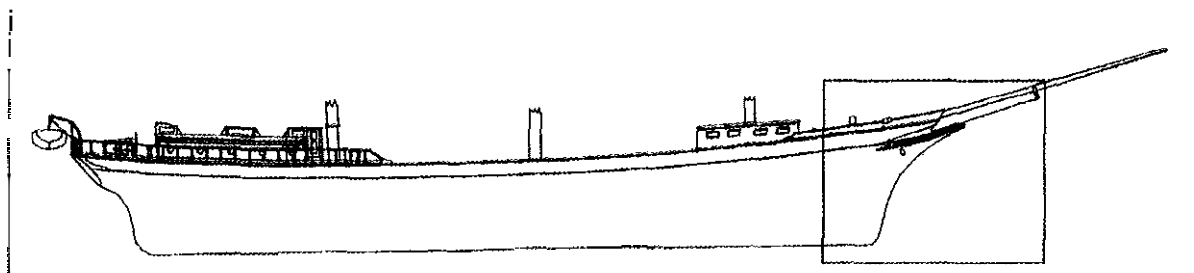
Figure 4.46. Area of *Comet's* preserved hull.
