**WILLIAM JOHNSON HOUSE
NATCHEZ NATIONAL HISTORICAL PARK
NATCHEZ, MISSISSIPPI**

HISTORIC STRUCTURE REPORT

ANN BEHA ASSOCIATES

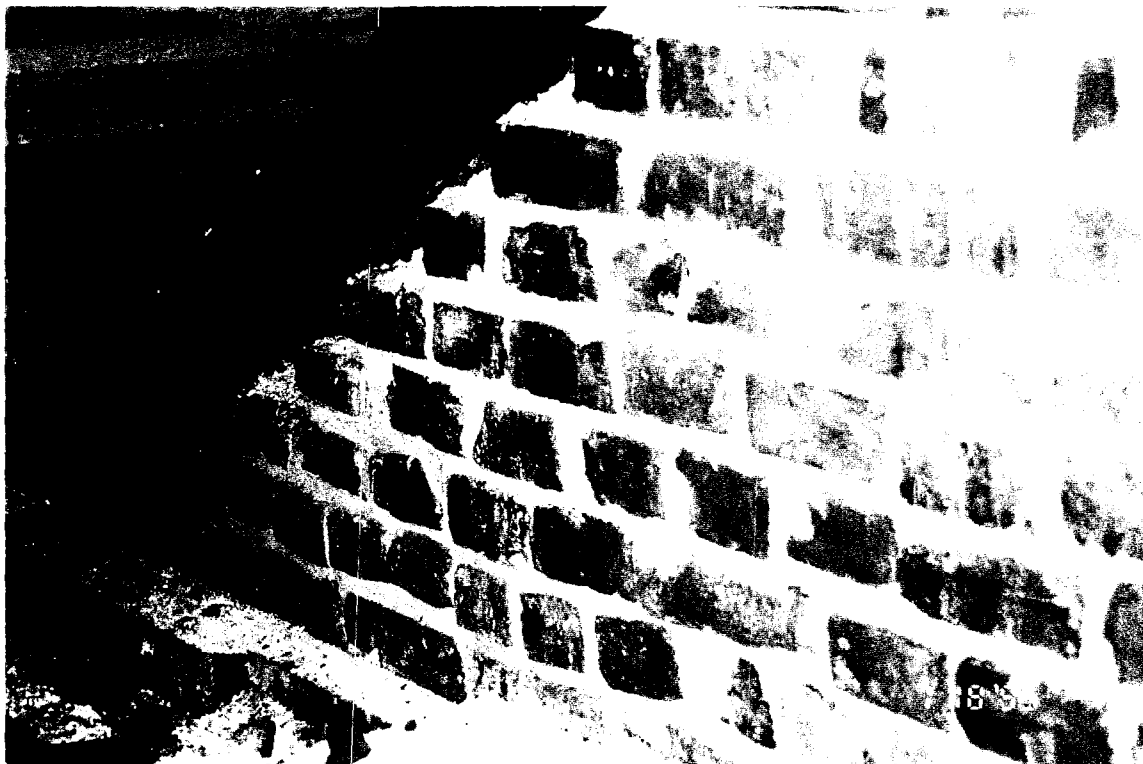
23-A Main House - Deteriorated mortar on east wall in attic.

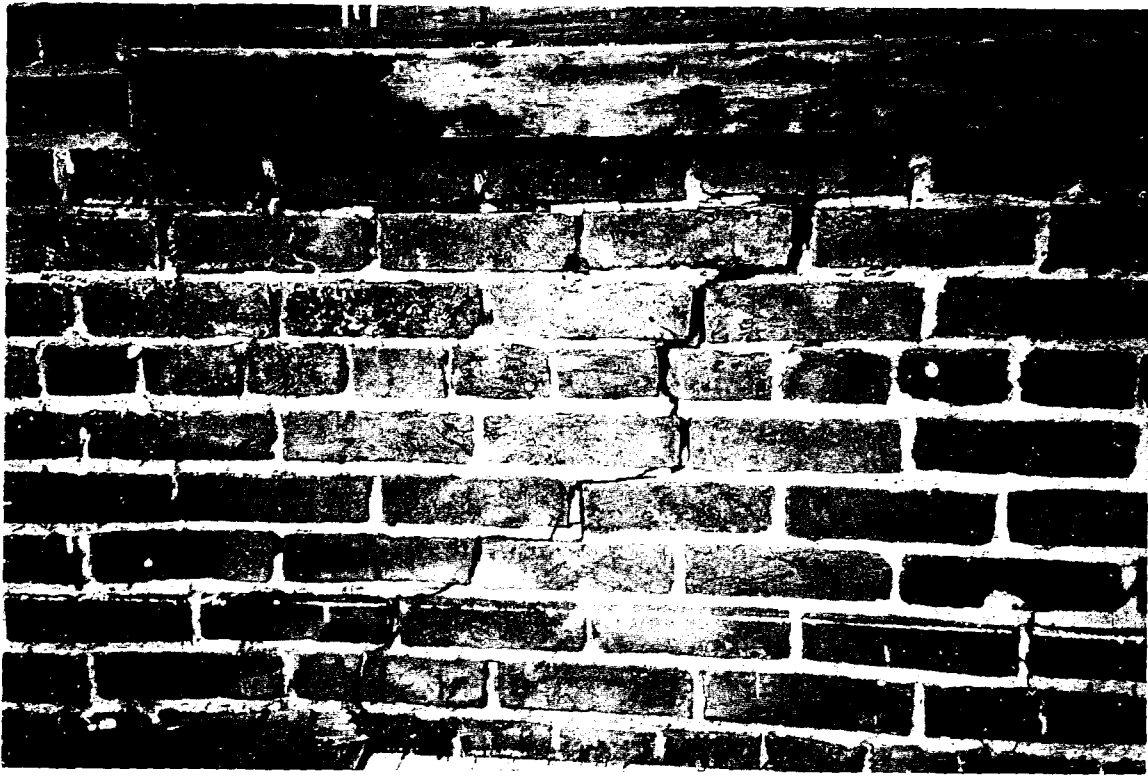
24-A Main House - Mortar cracks on south elevation.

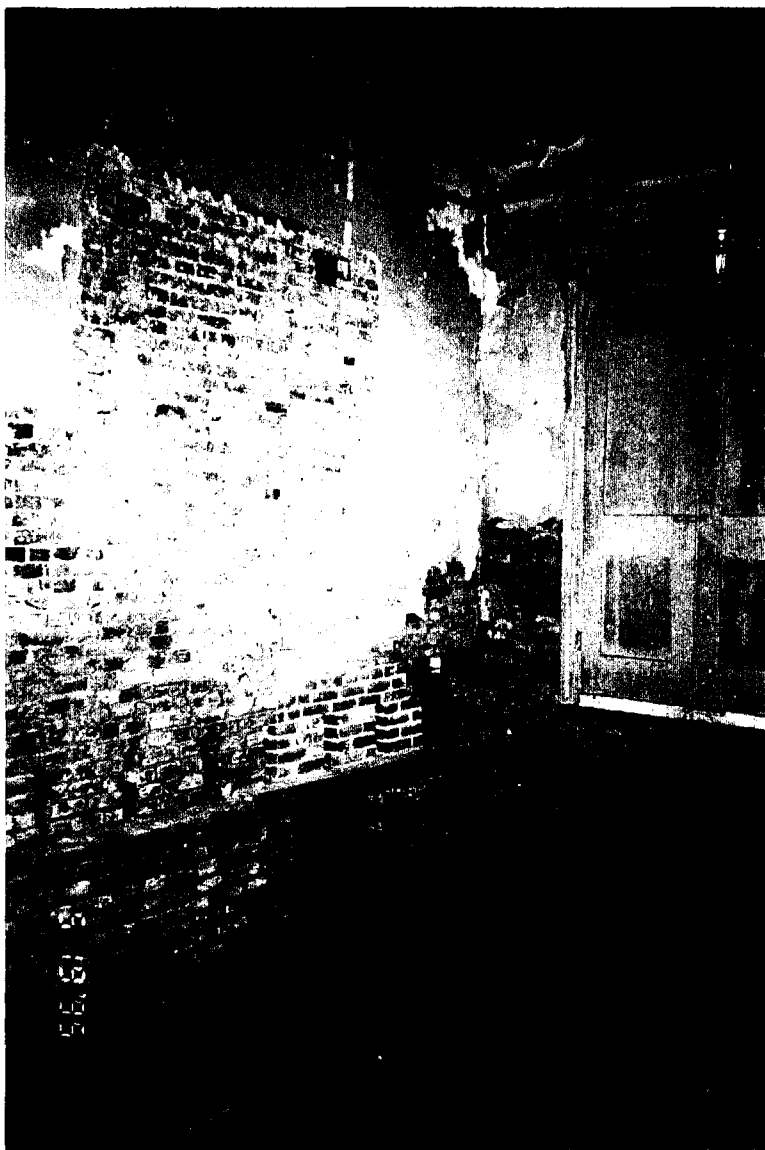
32-A Main House - Missing floor joists and floor from first floor. Missing plaster from walls.

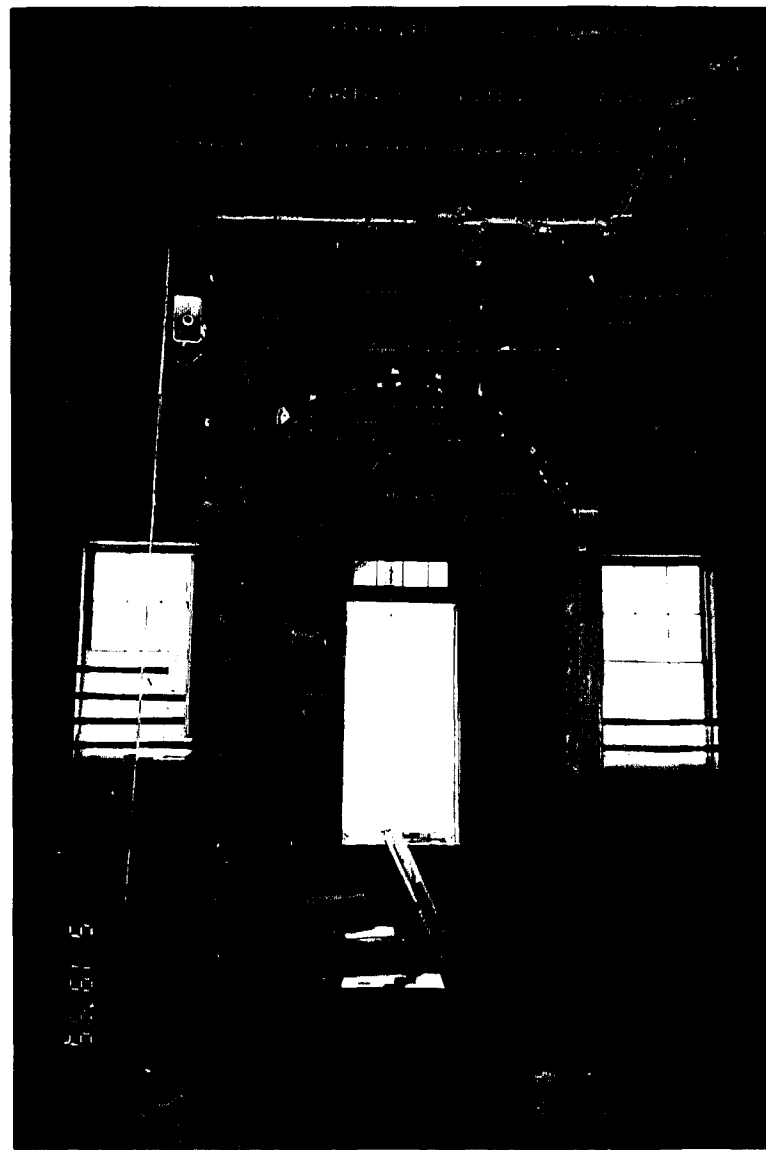
33-A Main House - Missing lath and plaster from ceiling of first floor. View of underside of second-floor framing and the top of the columns supporting the second-floor partition wall (above).

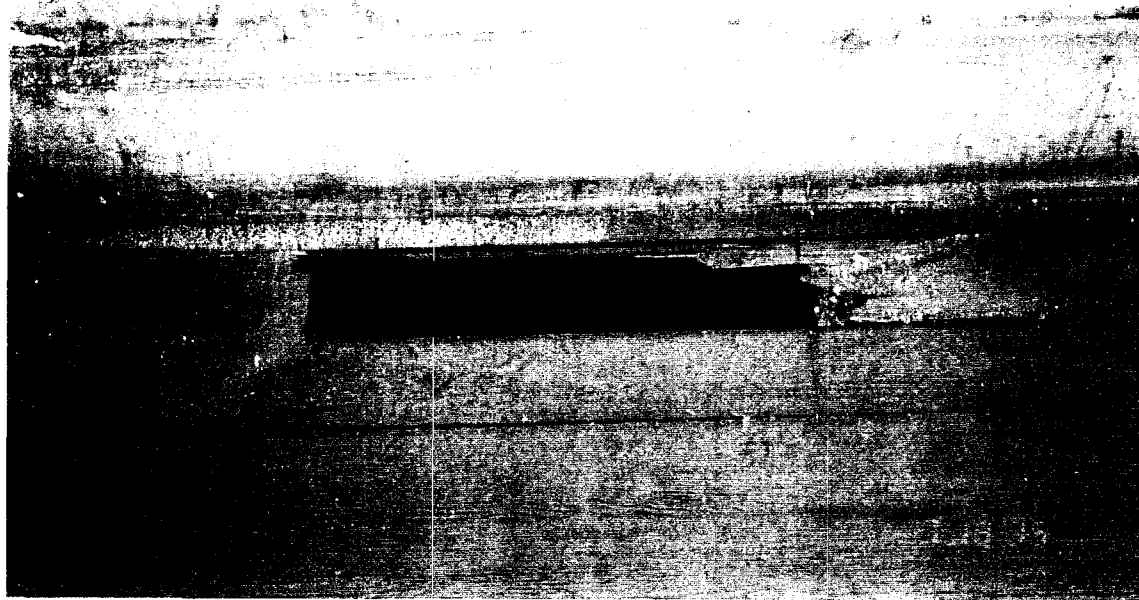
34-A Main House - Holes in second-floor flooring.

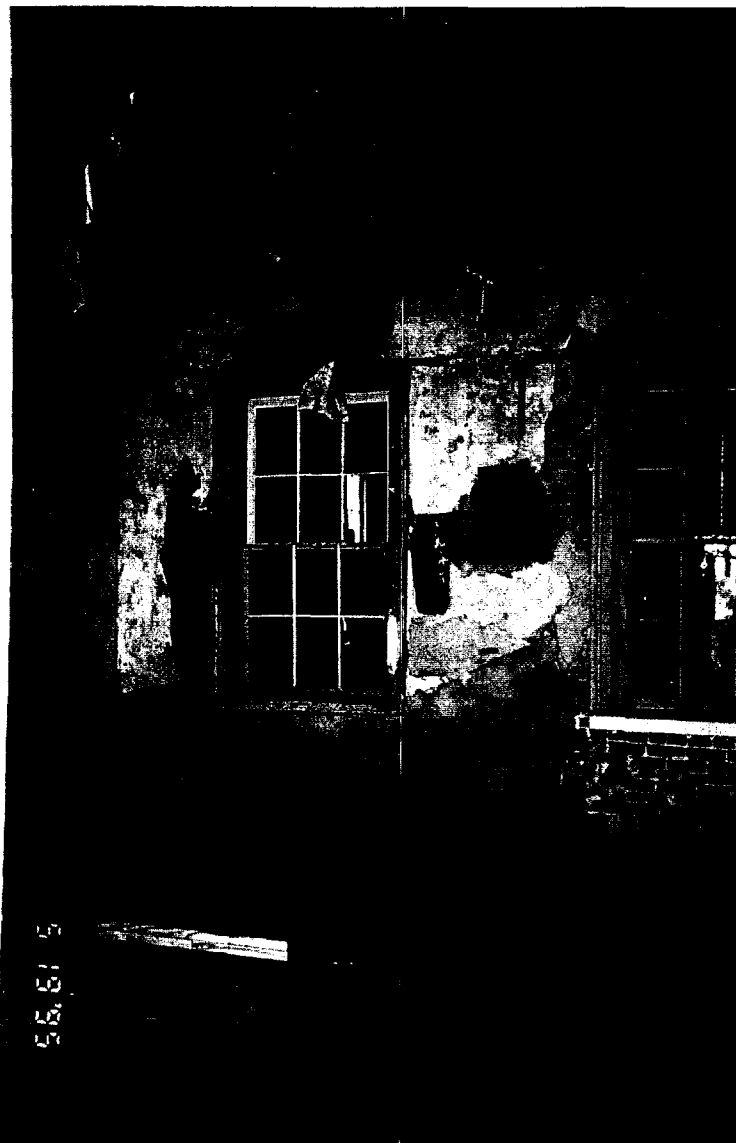
35-A Main House - Missing plaster from second-floor walls and ceiling.

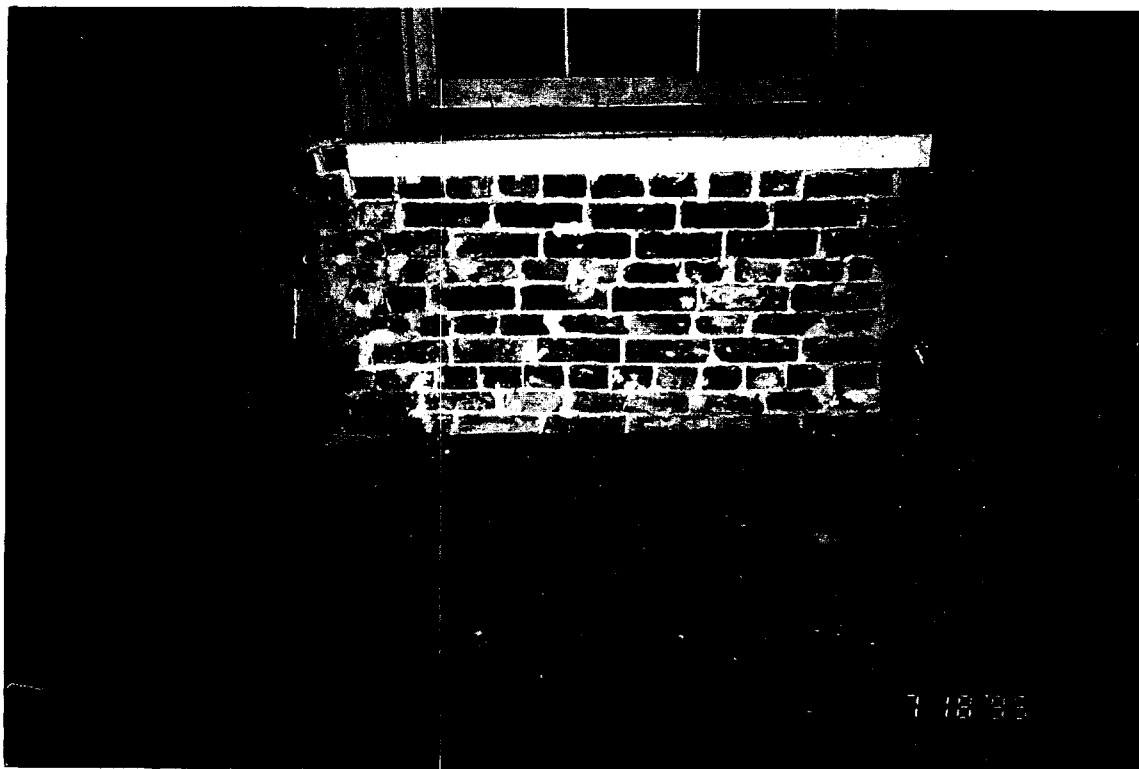
38-A Main House - Missing baseboard in northeast room of second floor.

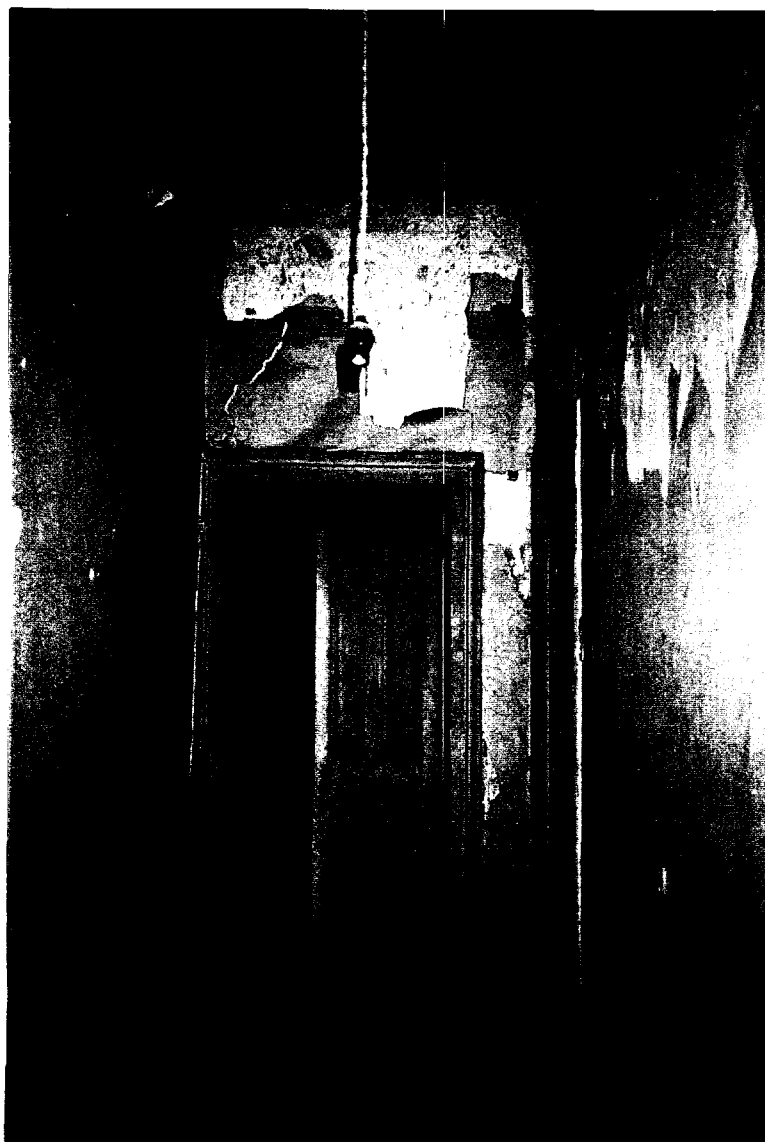
39-A Main House - Typical second-floor door with missing hardware. (ABA)

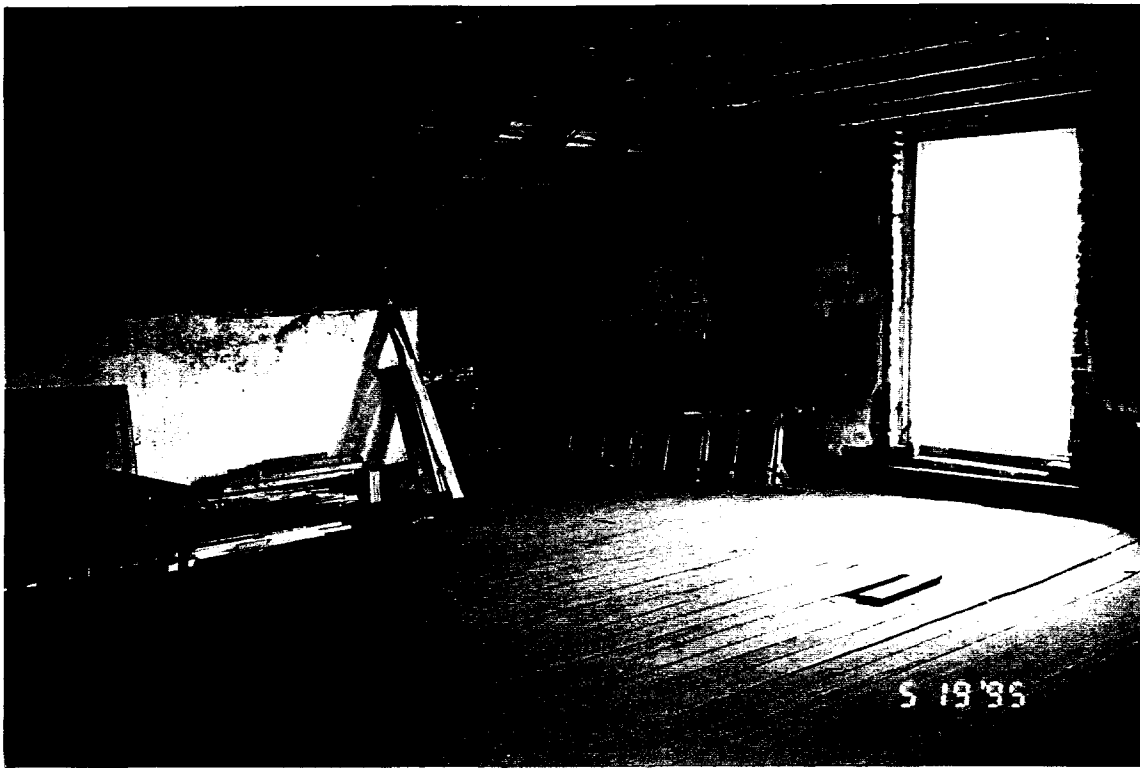
40-A Main House - Missing third-floor plaster.

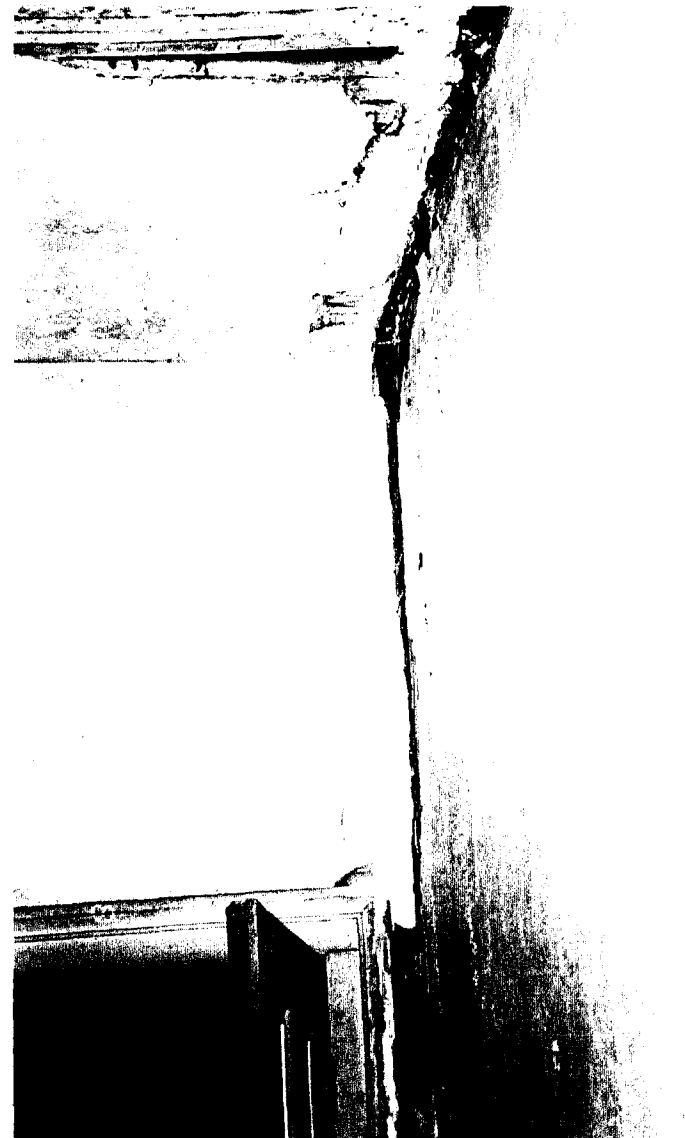
45-S Main House - Crack between second-floor east/west partitions and the "party" wall.

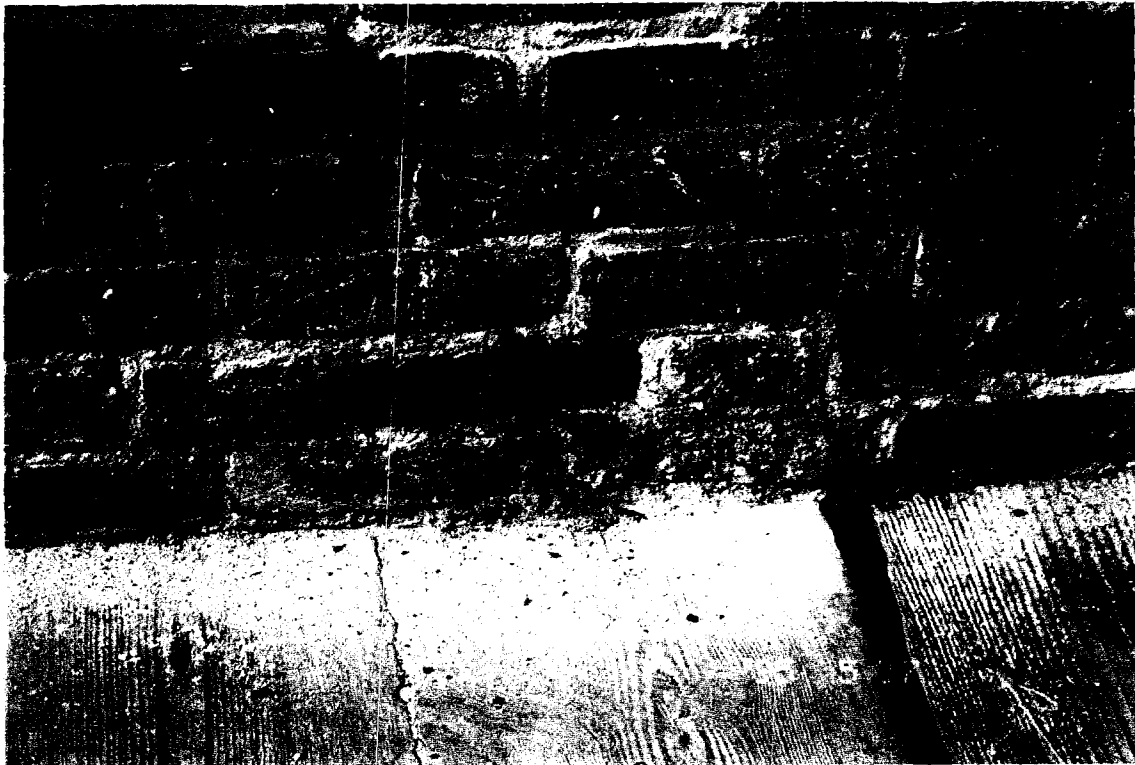
50-S Main House - Detail view of south wall showing spalled brick.

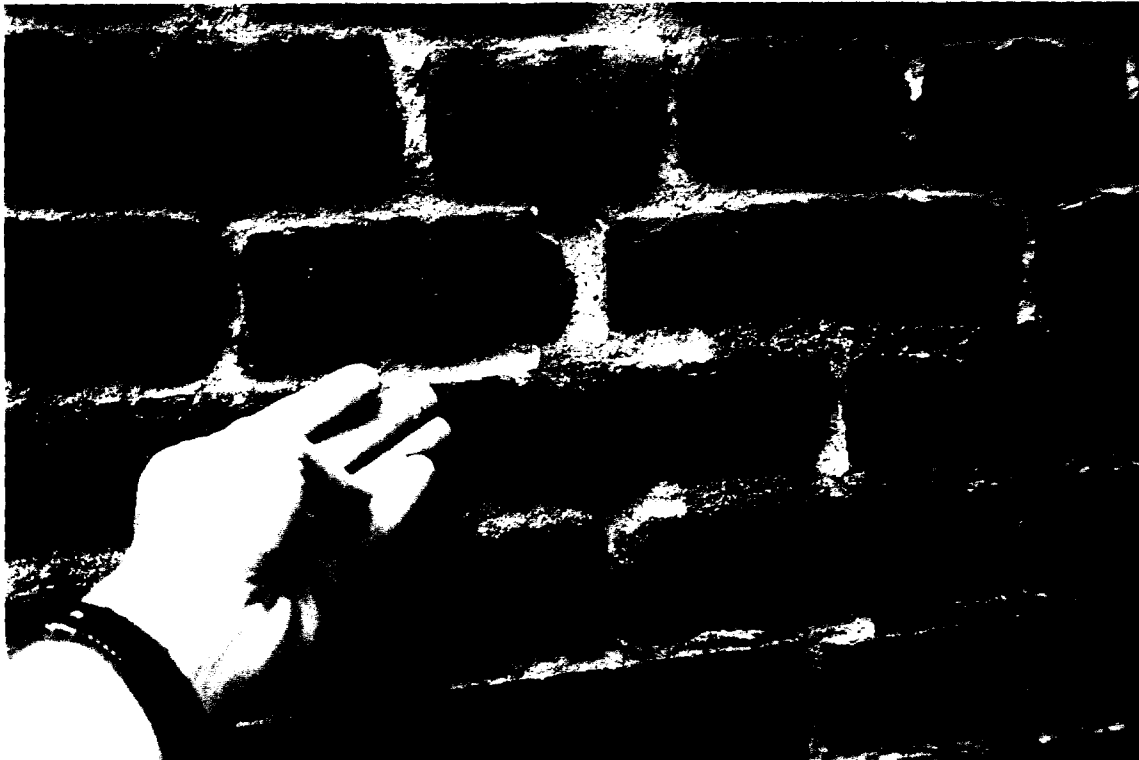
53-S Dependency - Area of spalling mortar on south elevation.

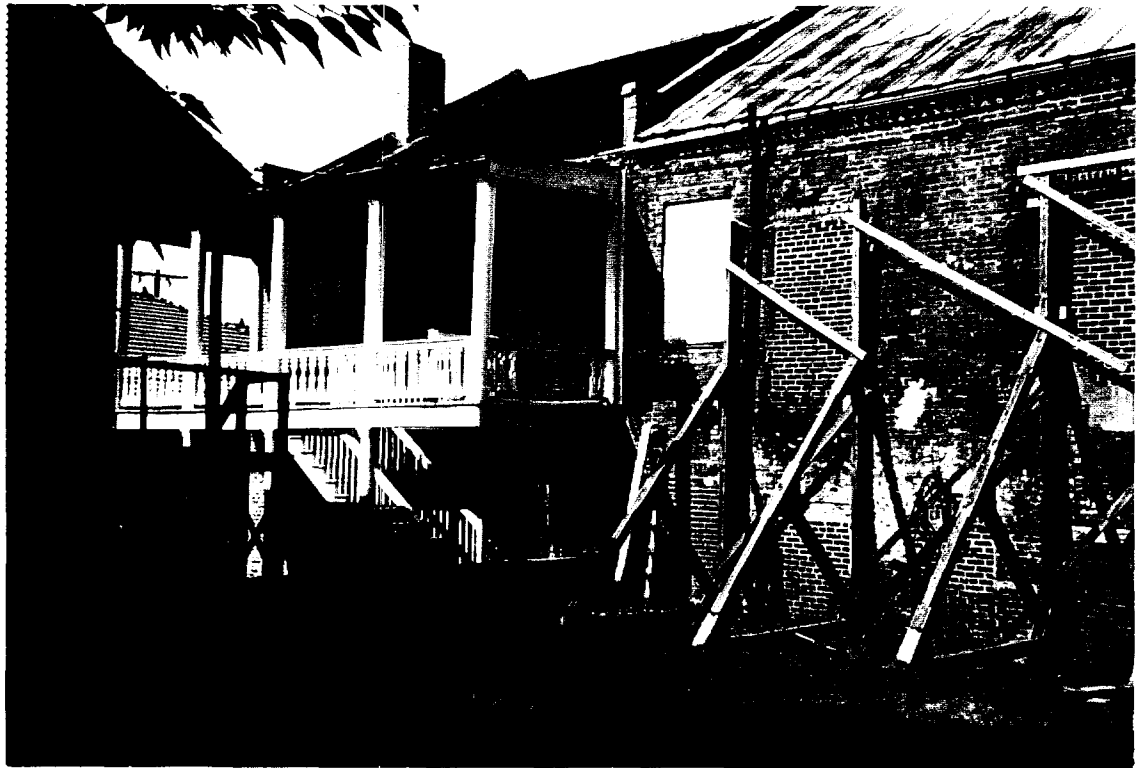
54-S Main House - South elevation of the William Johnson House and McCallum House. Note missing wood column on right side of porch.

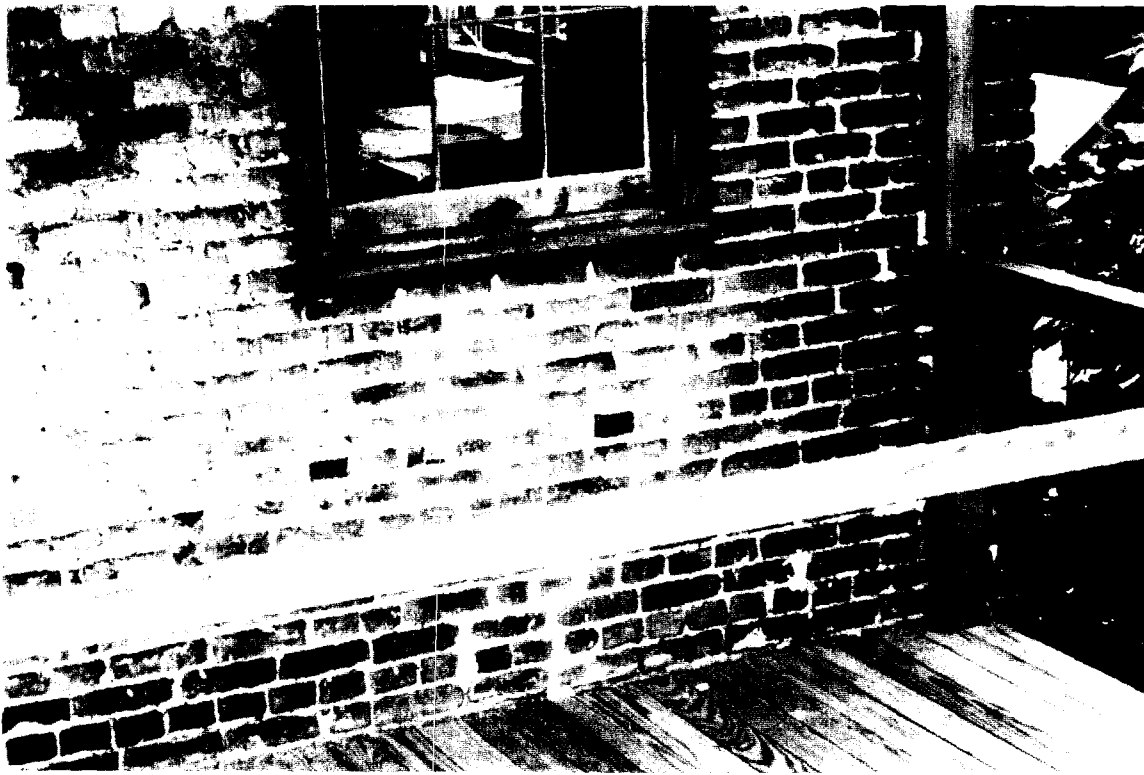
64-A Dependency - Poor match of mortar on north facade.

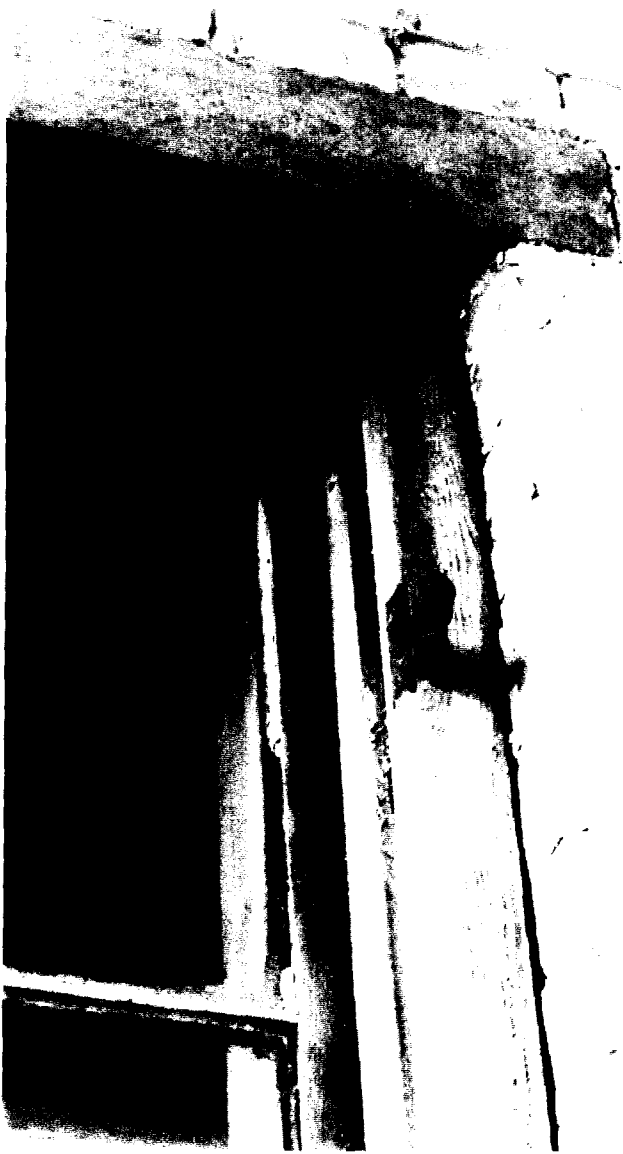
66-A Dependency - Caulk gaps at window frames on north facade.

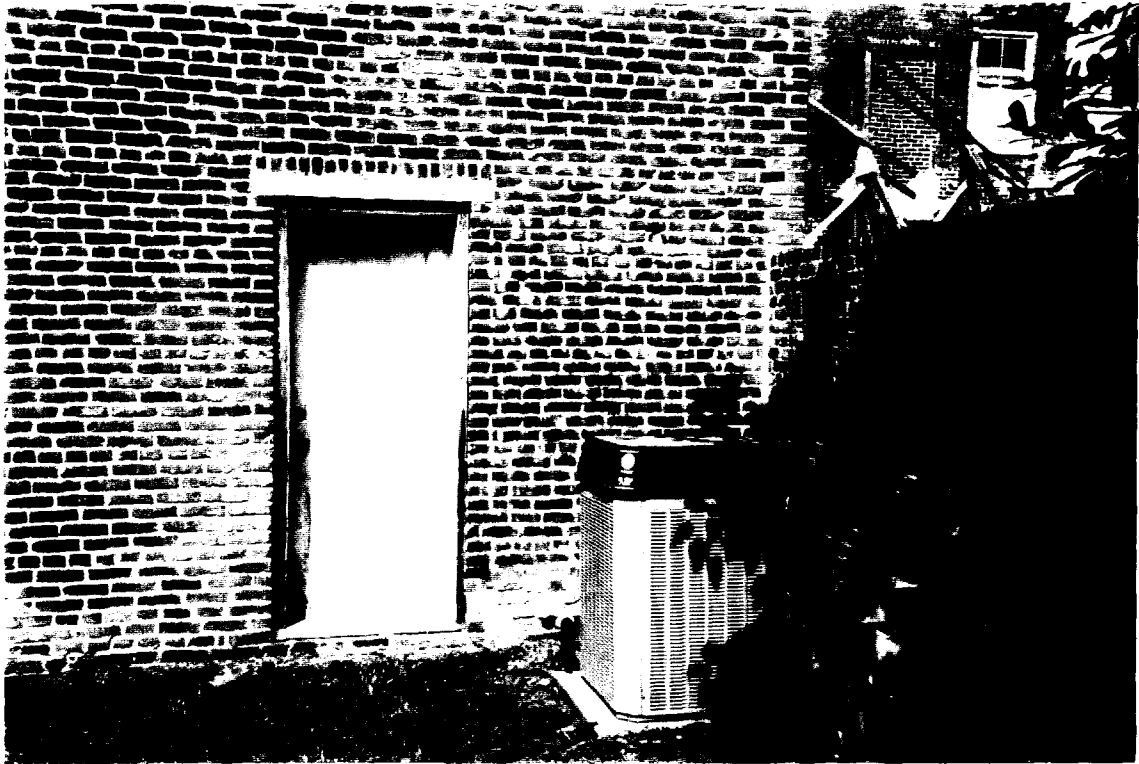
70-S Dependency - Deterioration of brick and mortar on south elevation.

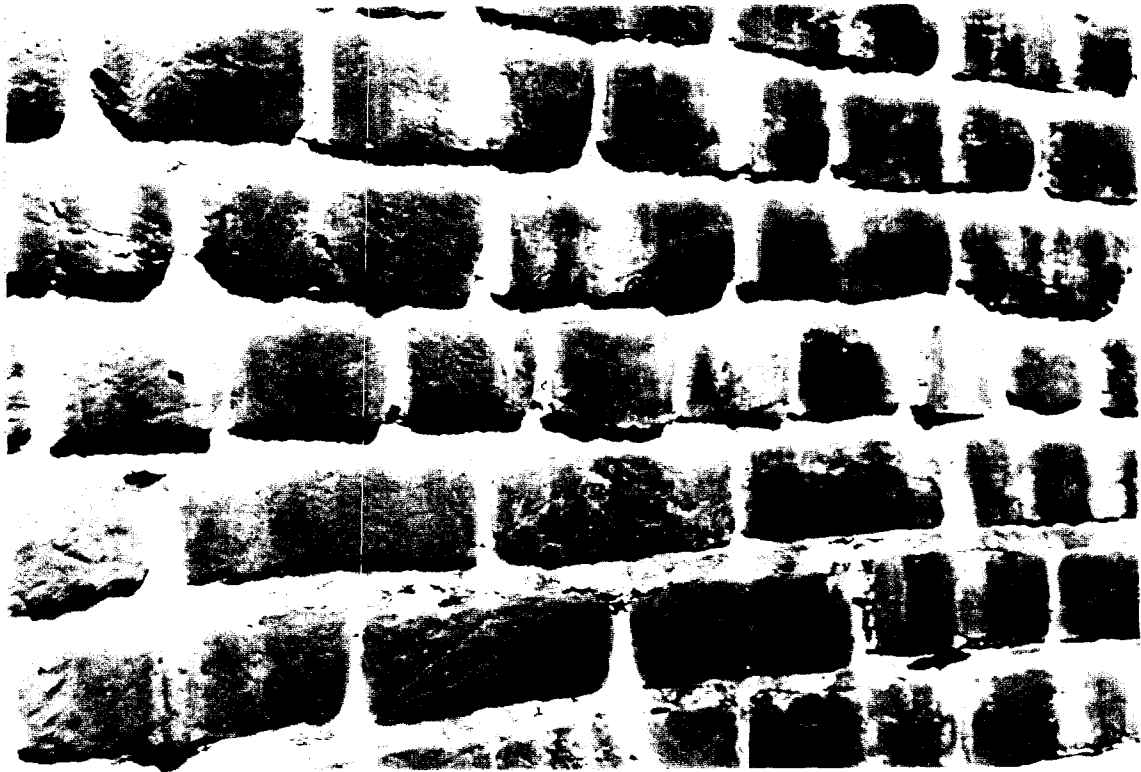
71-S Dependency - Close-up of deterioration of brick on the south elevation.

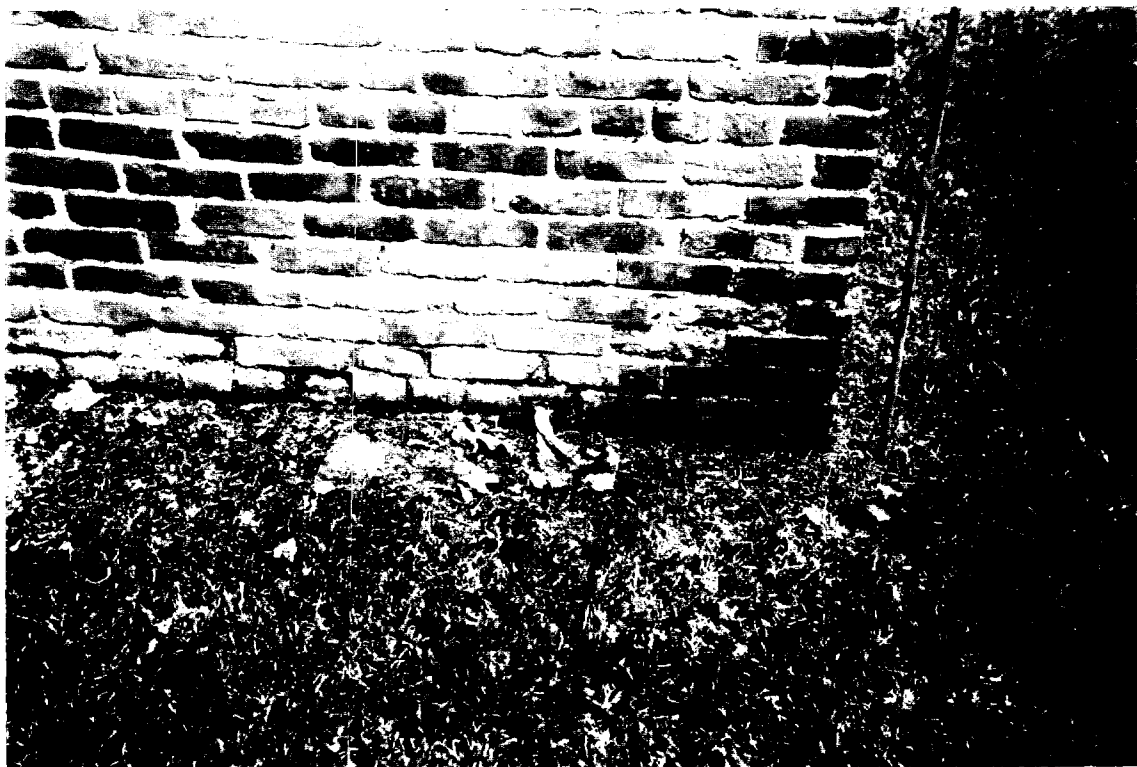
72-S Dependency - View of the rising damp damage to the brick and mortar at the southwest corner.

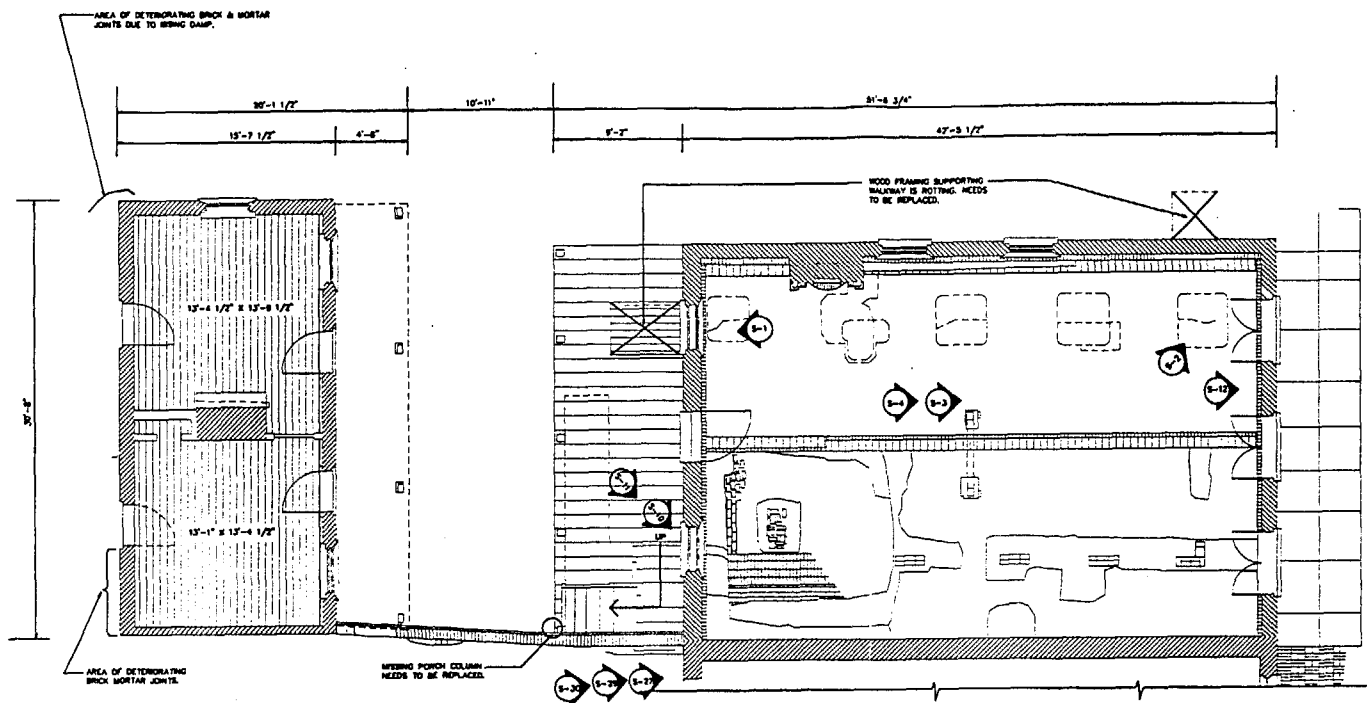
AREA OF DETERIORATING BRICK & MORTAR JOINTS DUE TO BEING DAMP.

WOOD FRAMING SUPPORTING WALKWAY IS ROTTING. NEEDS TO BE REPLACED.
