MELROSE ESTATE
NATCHEZ NATIONAL HISTORICAL PARK

NATCHEZ, MISSISSIPPI

HISTORIC STRUCTURES REPORT
VOLUME II
PAINT AND CONCRETE ANALYSIS

ANN BEHA ASSOCIATES

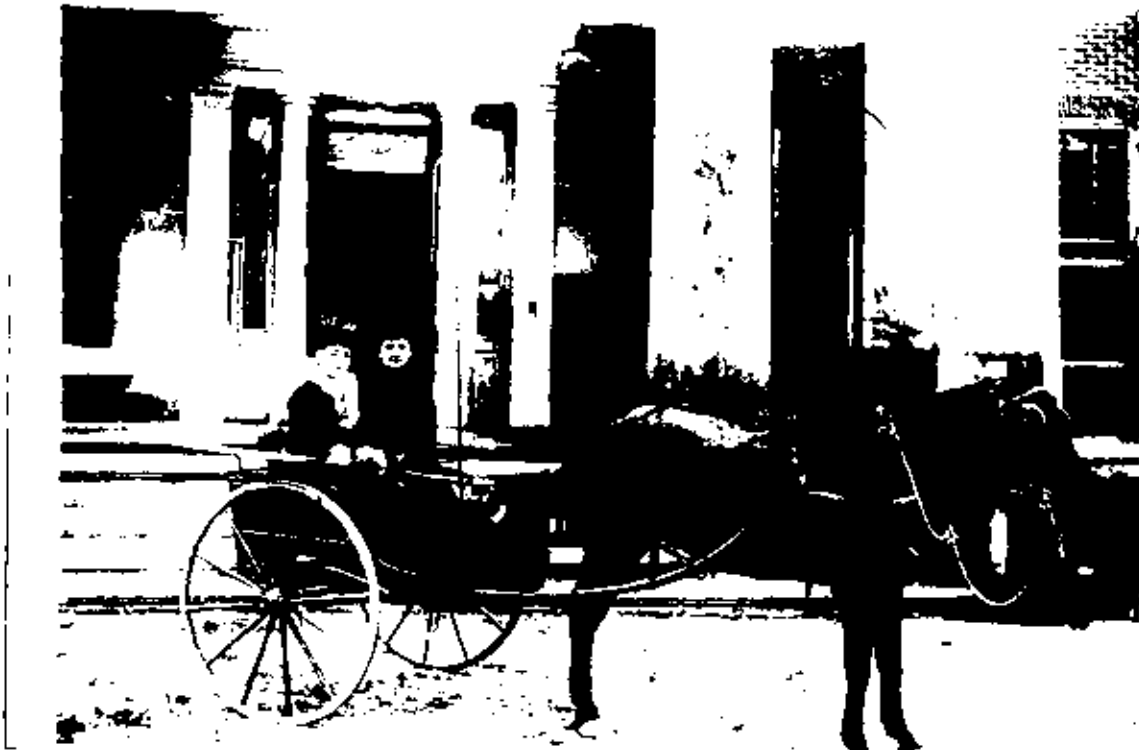
The window sills of the house were painted in a series of dark red colors to imitate the appearance of red sandstone, as can be seen in the late nineteenth-century photographs of Photographs P3 and P5. The first dark red color corresponded to the 5YR 3/4 glossy notation. The second red color matched the 7.5YR 2/4 notation. The third painting of the window sills matched the 2.5YR 3/4 notation. The small, cast-iron foundation vents on the north, south and west elevations were also painted in the same series of red colors as found on the window sills. The first two times the basement windows were painted was with a light-tan color to blend with the surrounding marbleized treatment. All elements of the windows were painted with a 10YR 9/1 tan color from the Munsell glossy collection. The third painting of the basement windows was with the same white, N9.5 color as was used in the third painting of the principal windows.

Photograph P3. This detail of a late nineteenth-century photograph of the west elevation shows the pattern of marbling on the wall, column, and pilaster stucco. Also recorded is the dark color of the wall plinth. (NATC Gandy II.A.3)

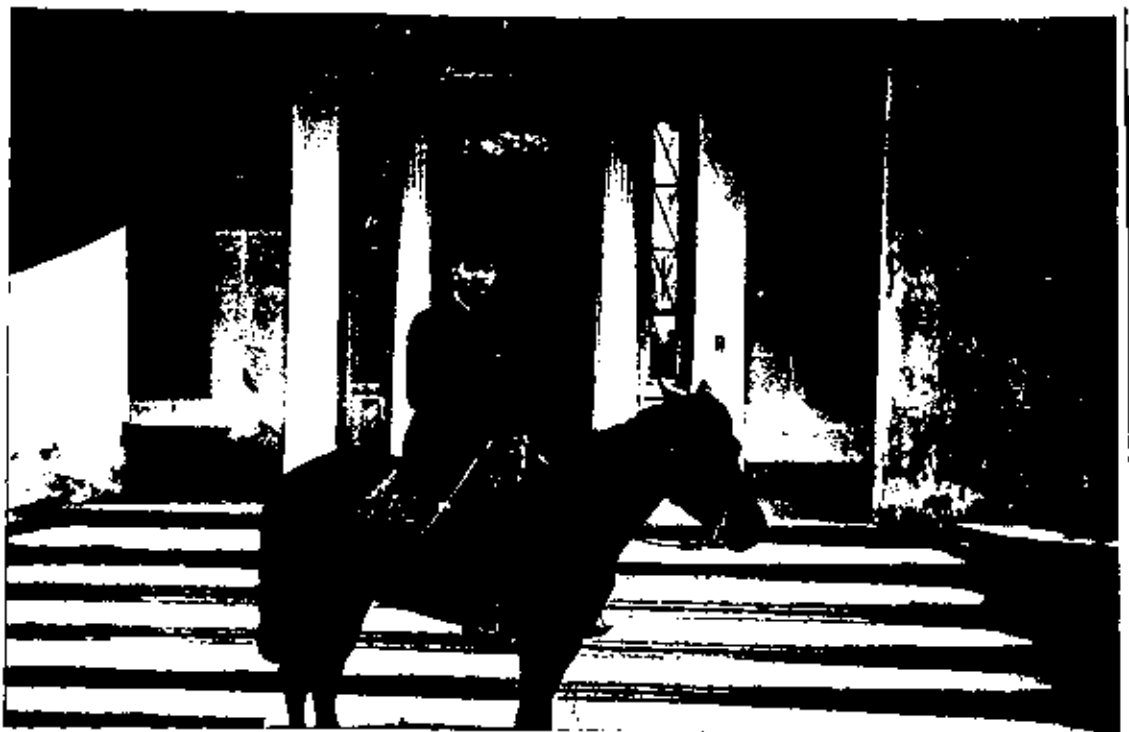
Photograph P4. This detail of a late nineteenth-century photograph of the west elevation shows variations in the colors of the scored stucco blocks. (NATC Gandy II.A.1)

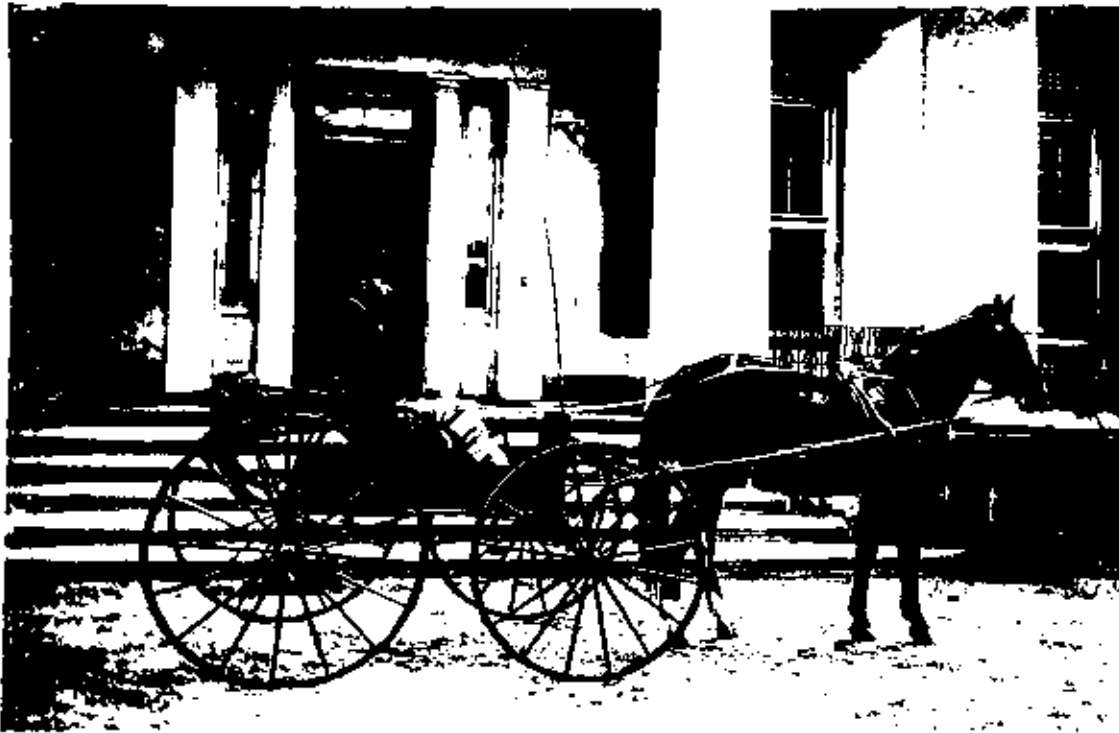
Photograph P5. This detail of a late nineteenth-century photograph of the west elevation shows marbleizing veins above the window to Room 110 and on the water table at the basement level. (NATC Gandy II.A.2)

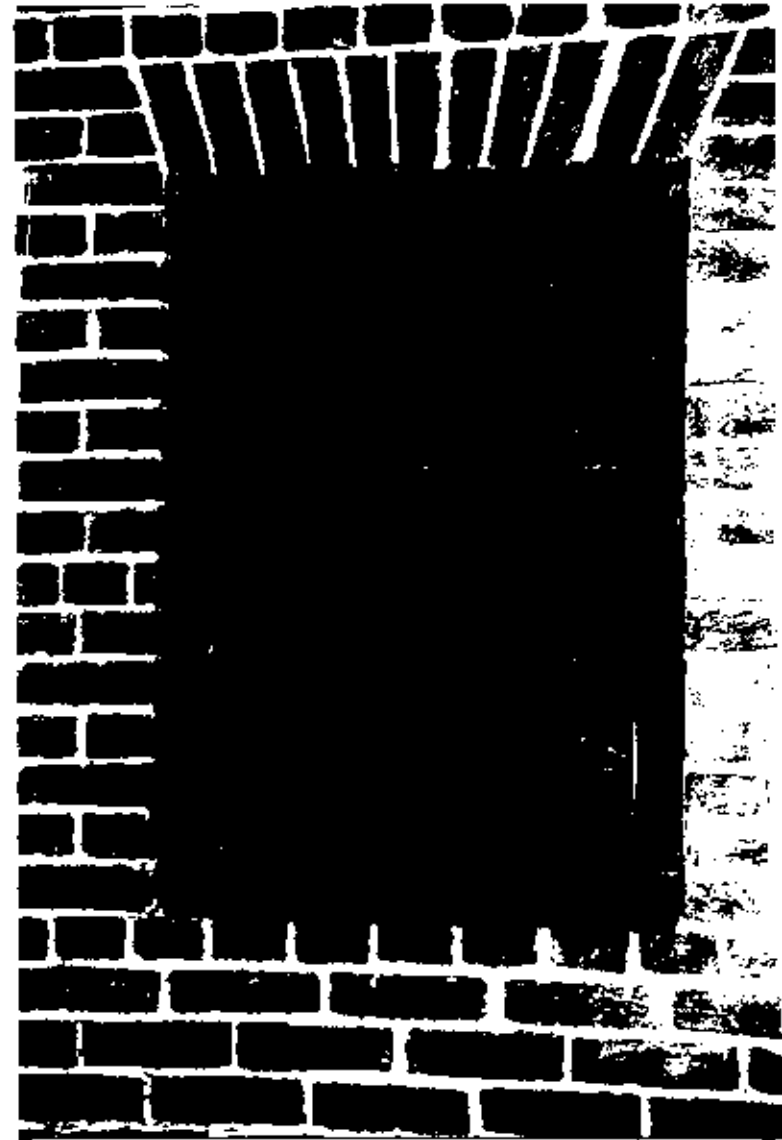
Photograph P29. The louvered window on the smoke house was originally painted in a three-color scheme. The narrow, outer band was painted off-white. The bead, the jamb, and the louvers were painted a medium green. The window sill was painted a dark red. These colors were the same as those used on the exterior of the house.

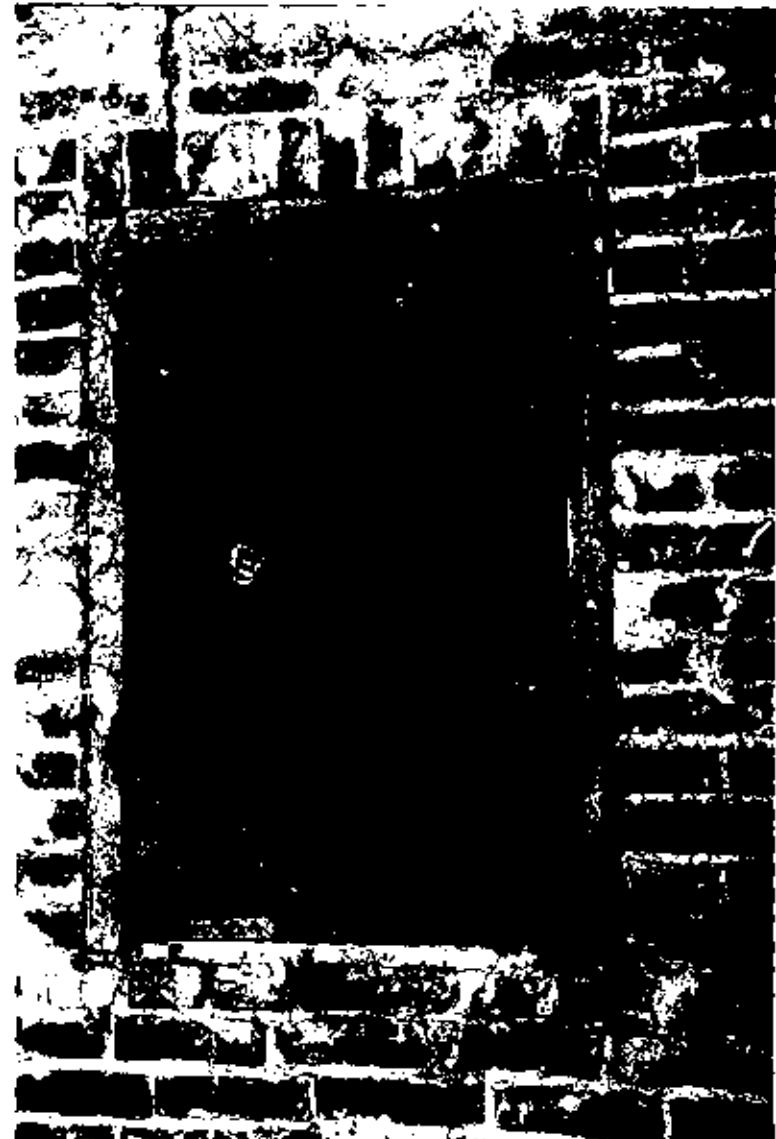
Photograph P31. The paint on the interior face of the smoke house window shutter appears as it did when it was applied in the mid-nineteenth century.

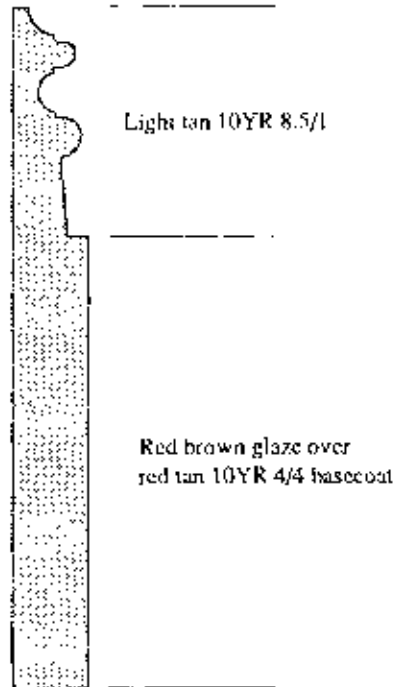
Observations and Conclusions: Treatment of baseboard cap mold and fascia is typical for all baseboards throughout the house, excepting for Rooms 109 and 110. There is also a change in the pattern of application in the four service rooms on the second floor.
