# Ocmulgee National Monument The Earth Lodge Historic Structure Report

August 2005

2004 Historic Structure Report The Earth Lodge Ocmulgee National Monument Macon, Georgia LCS#: 001186

#### **Historic Structure Report**

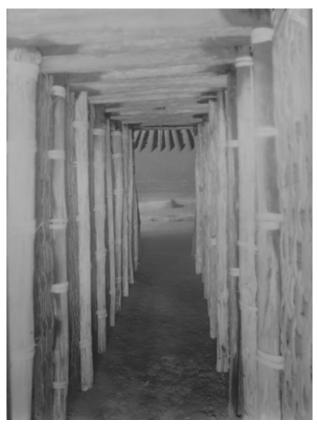
FIGURE 49. View of interior of Earth Lodge through passage, summer 1937. (Swanson, OCMU Coll.)

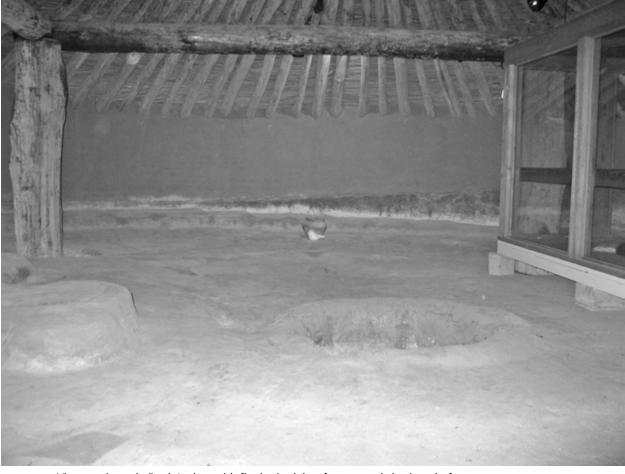
**FIGURE 94.** View northeast in Earth Lodge, with fire basin right of center and viewing platform at upper right. Reddish material around fire basin is clay that has fallen from the reconstructed roof. Dark trapezoidal shape at lower left marks location of one of the supports for the metal walkway installed in 1952 and removed in 1975. (NPS-SERO-CR, 2004)

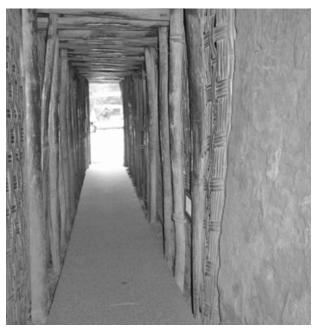
FIGURE 105. View of passageway, looking toward entrance. Note where visitors' hands (or heads) have worn the ceiling logs. (NPS-SERO-CR, 2004)

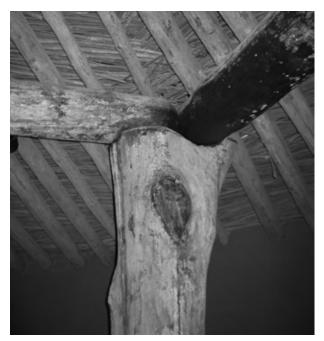
The wood and cane appear to be in fair condition, but inspection was only visual and did not include probes that might reveal hidden damage. All of thecane is heavily soiled and some mildew may be

FIGURE 107. View of junction of post, beams and rafters. (NPS-SERO-CR, 2004)
