historic structure report
architectural data section

PISCATAWAY PARK
MARSHALL HALL

HISTORIC STRUCTURE REPORT
ARCHITECTURAL DATA SECTION
FOR
MARSHALL HALL
PISCATAWAY PARK

January 1983

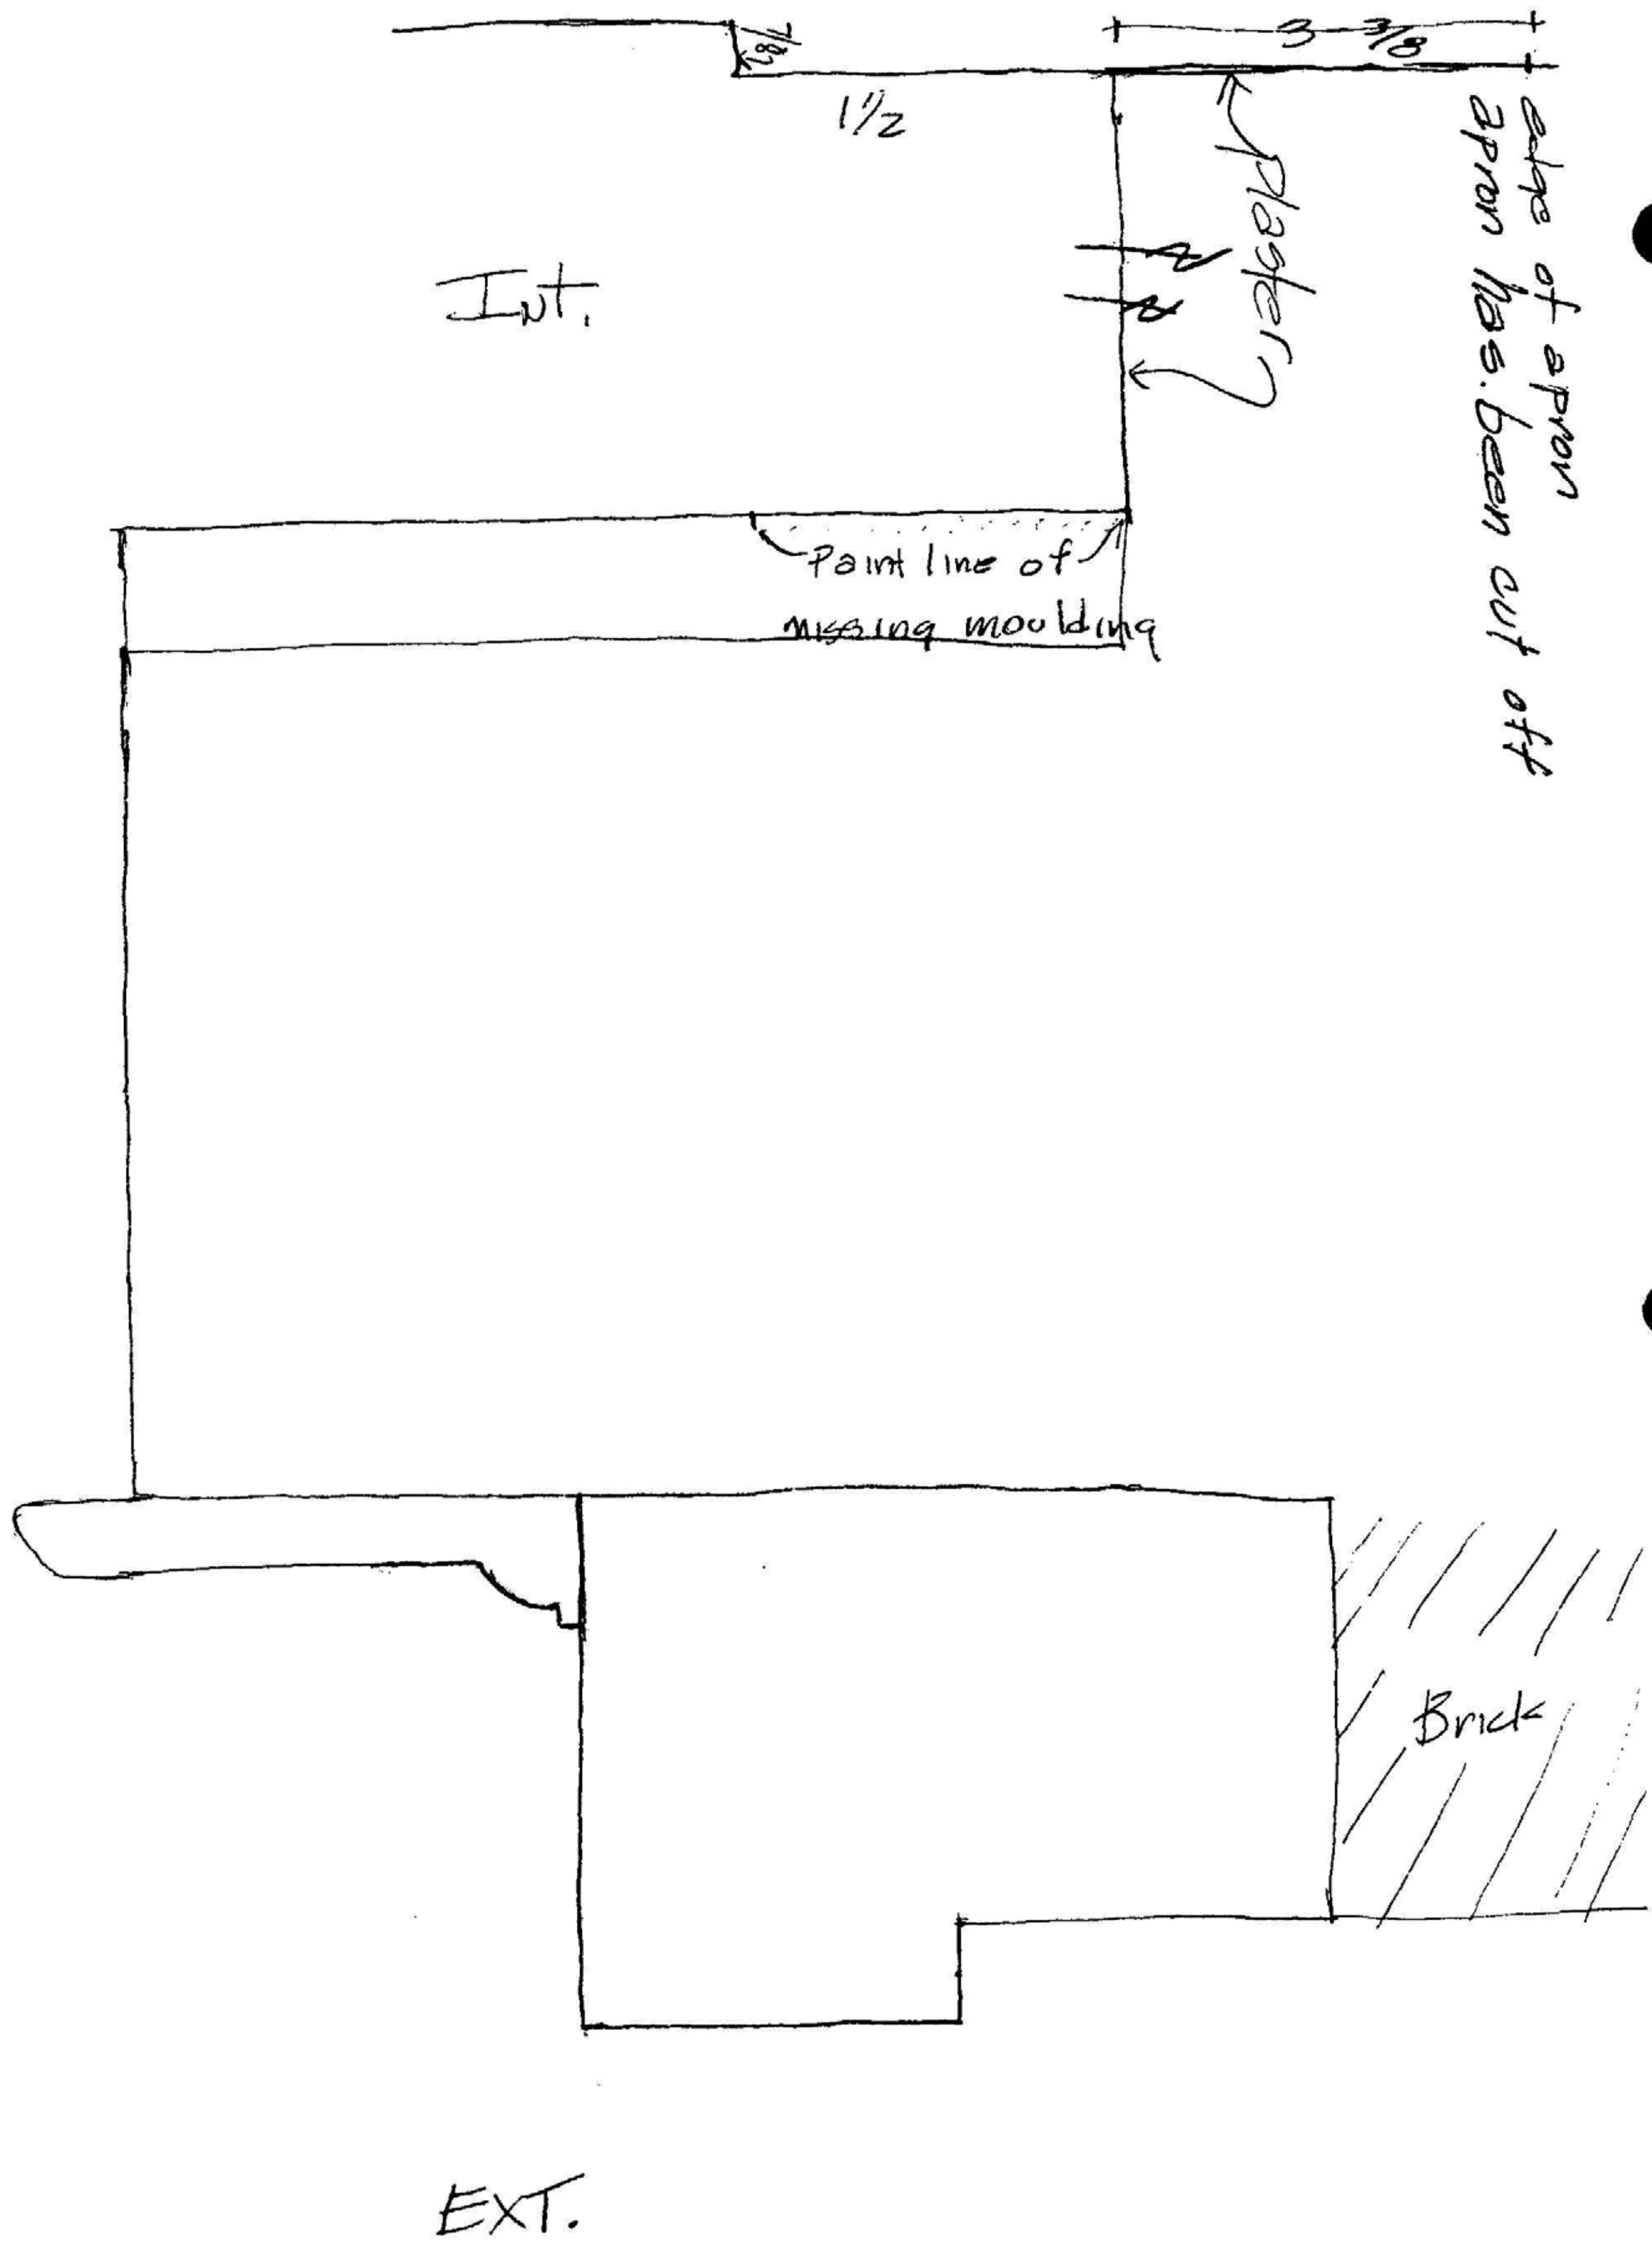
31
E
F.S.
WINDOW 202 (W201, W213, W214 SIM)

Note: sill has been replaced with modern material

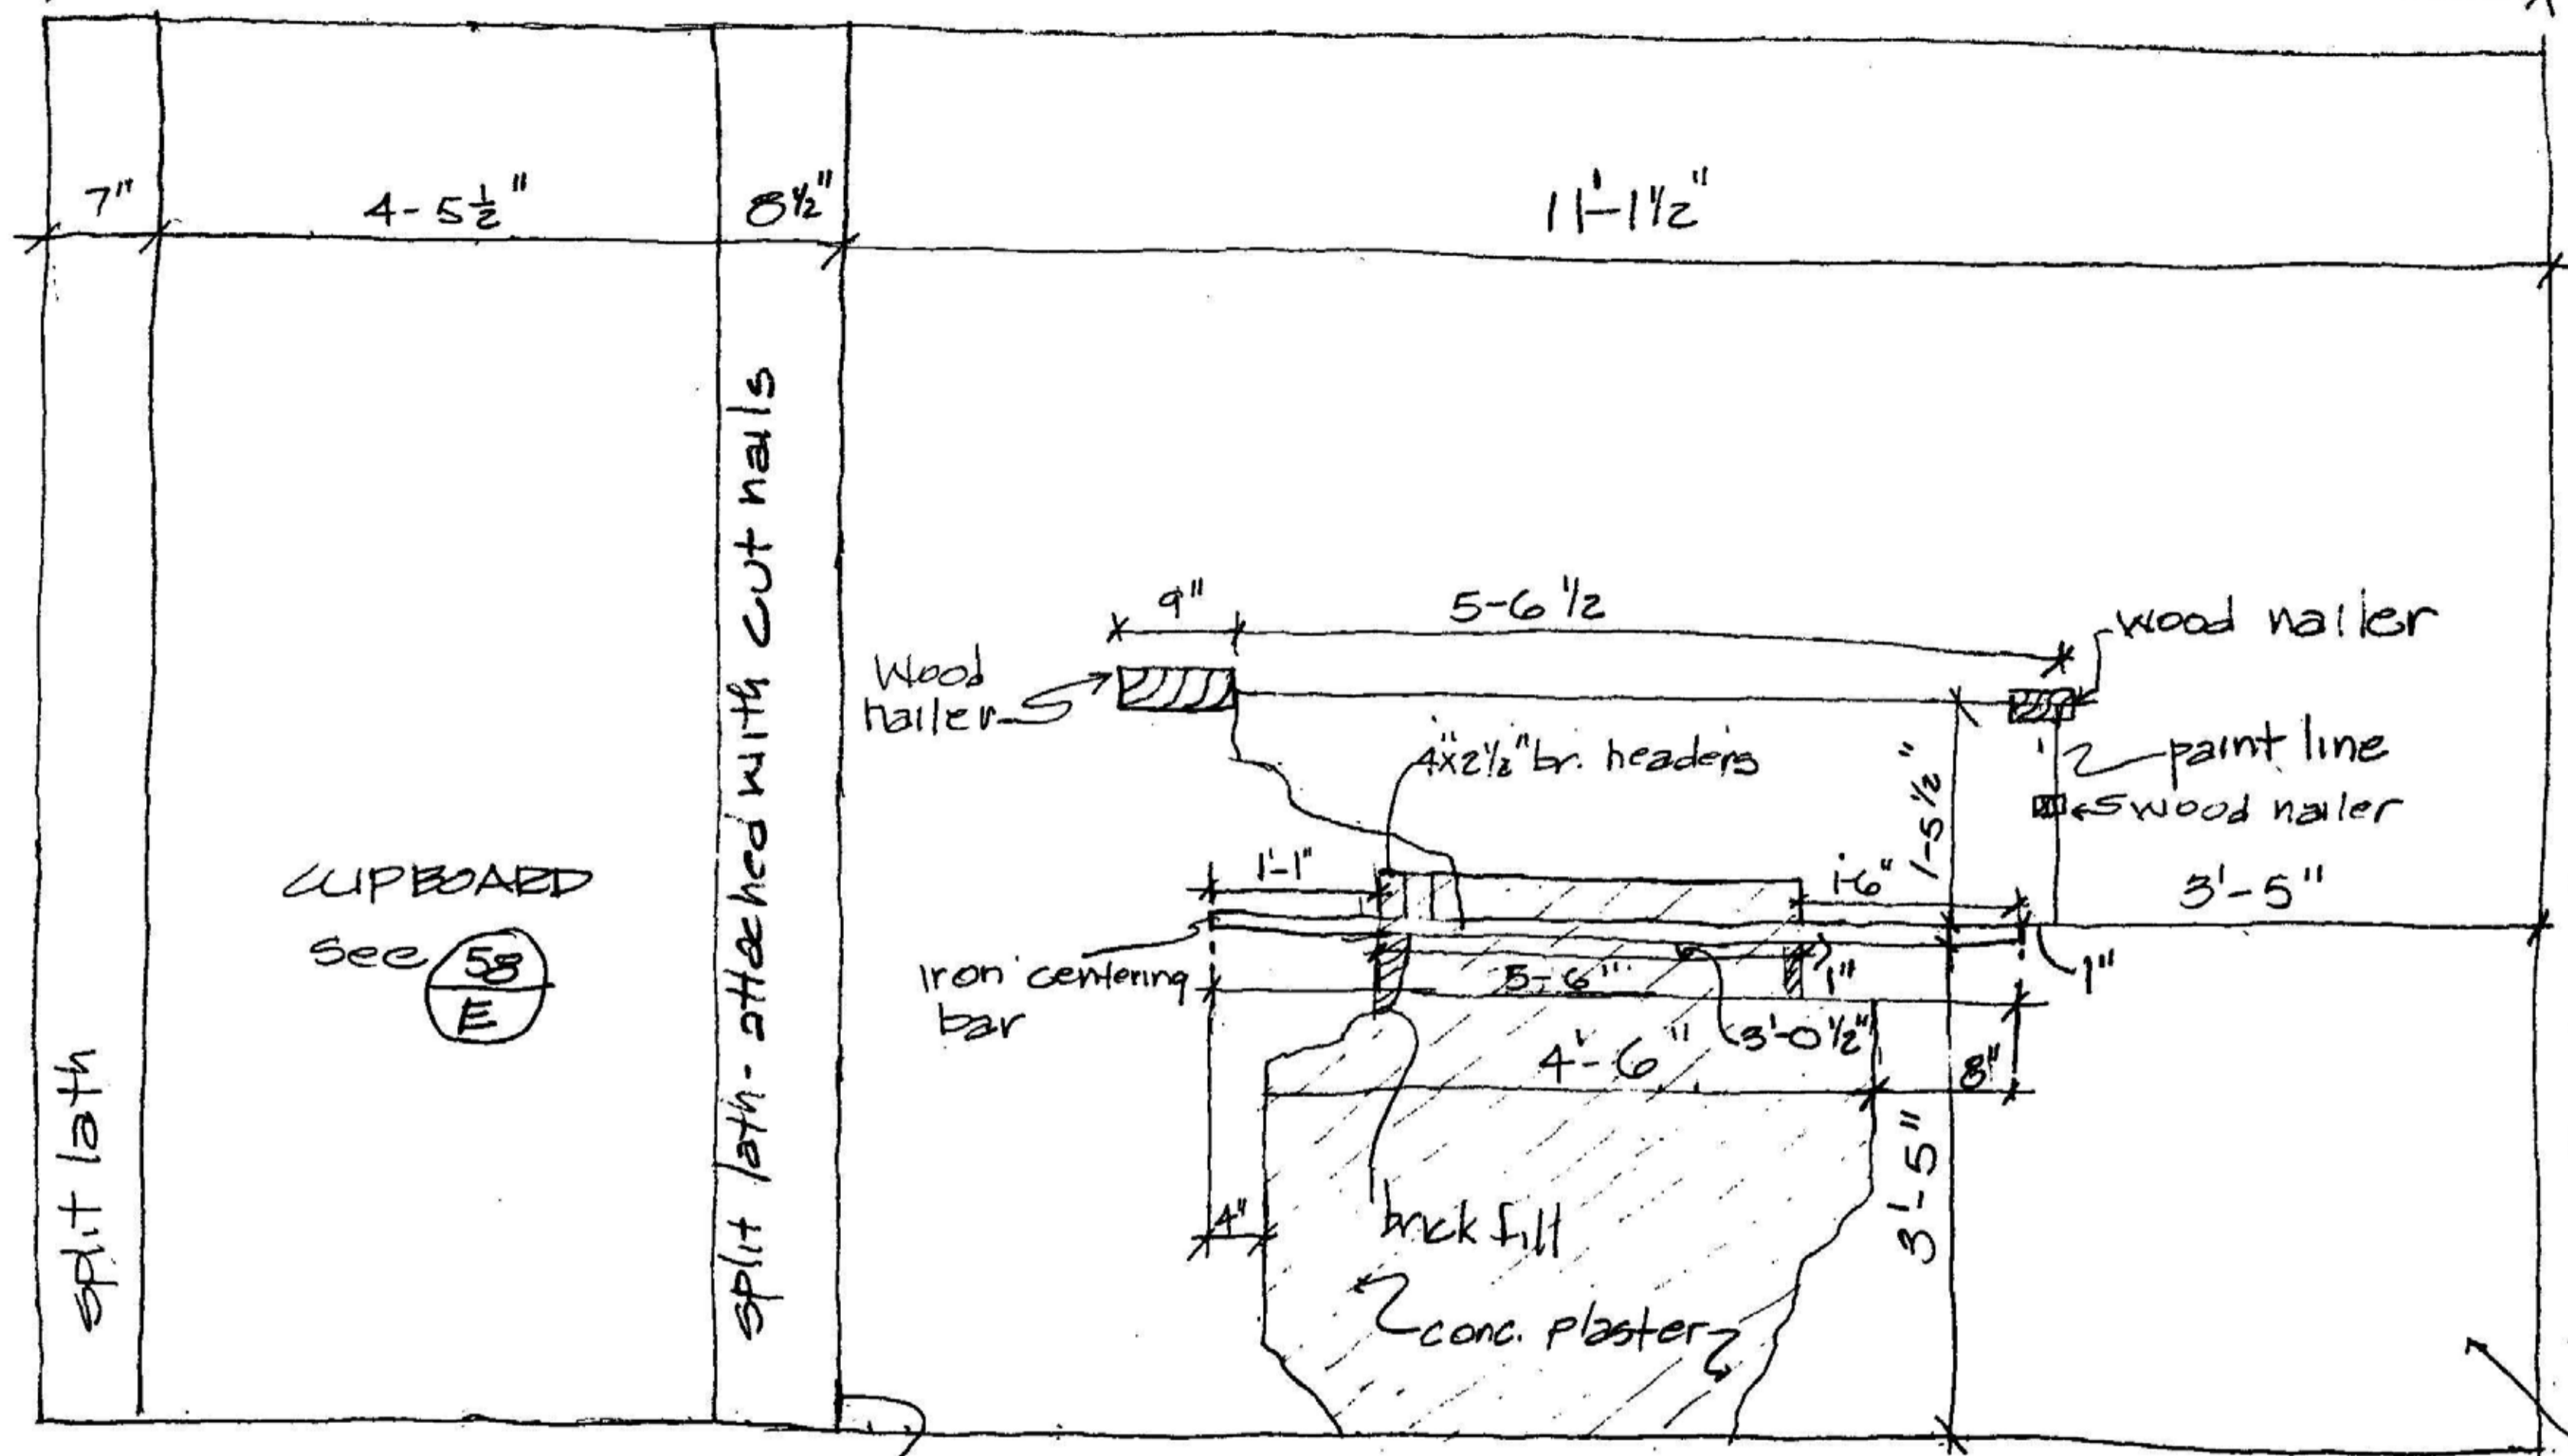
49
E RM. 103 - NORTH ELEVATION

BRICK wall stretcher courses - same as used brick - butt - brick no gap in wall - the two walls are not tied together
