historic structure report

architectural data section

SPRINGFIELD ARMORY

NATIONAL HISTORIC SITE/MASSACHUSETTS

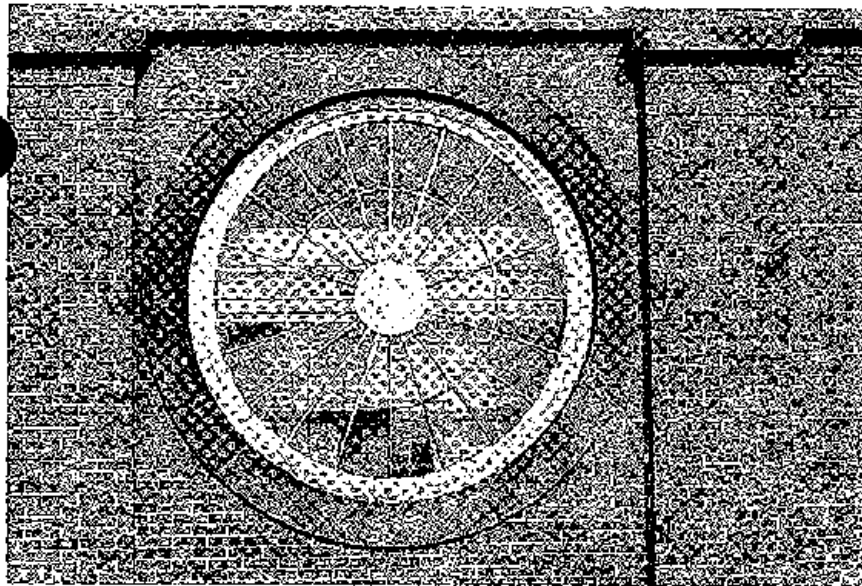
Illustration 21
Arsenal
Circular Tower Window
Note Wood Deterioration

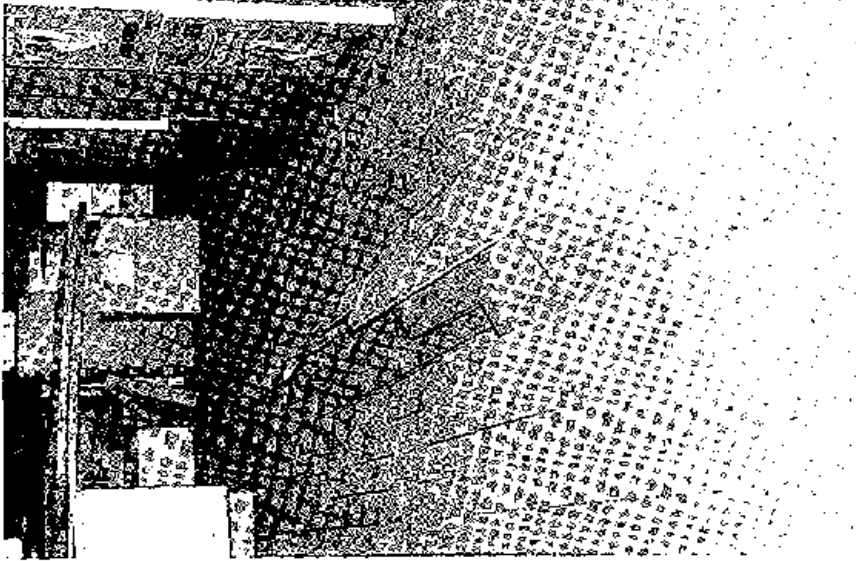
Illustration 30
Arsenal
Second Floor
Buckled Floor Due to
Water Leakage

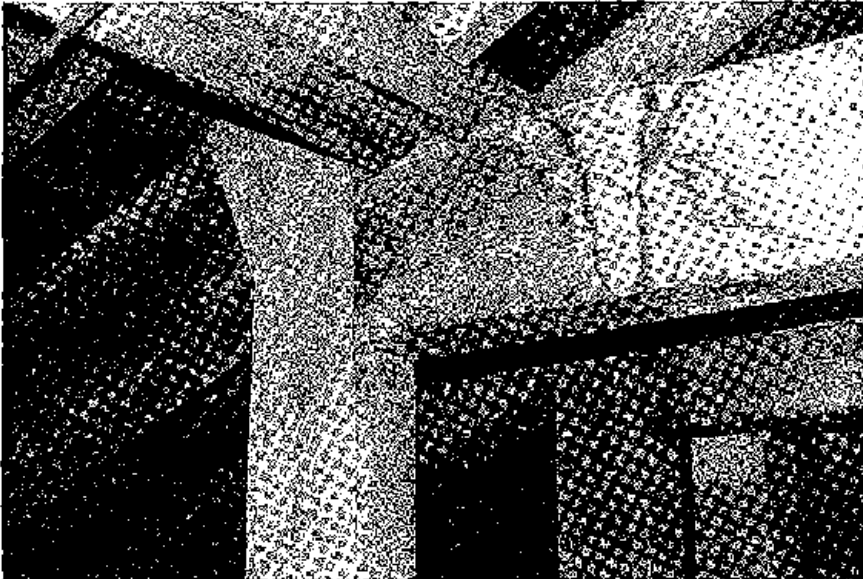
Illustration 37
Arsenal
Attic Framing
Note Water Stains

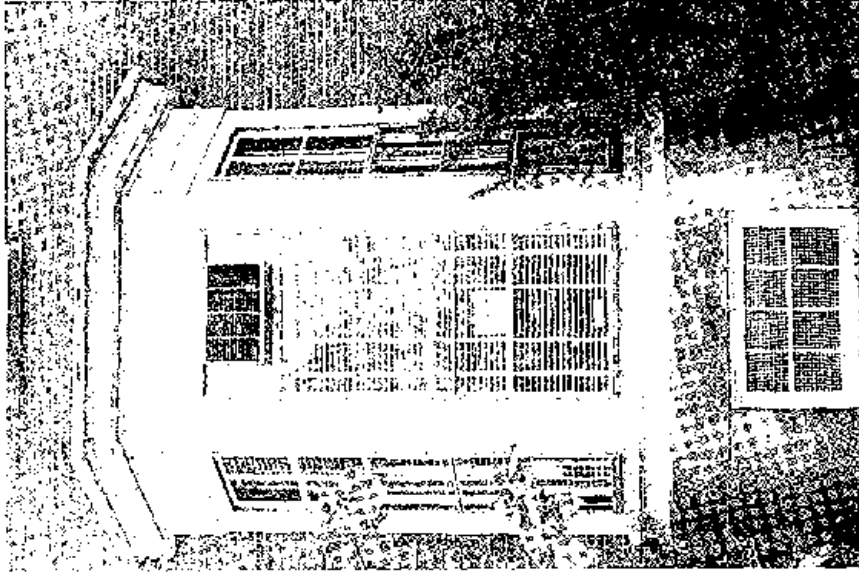
Illustration 73
C. O.'s House
Wing Roof from Main House
Note: Light-colored slates
indicate repairs

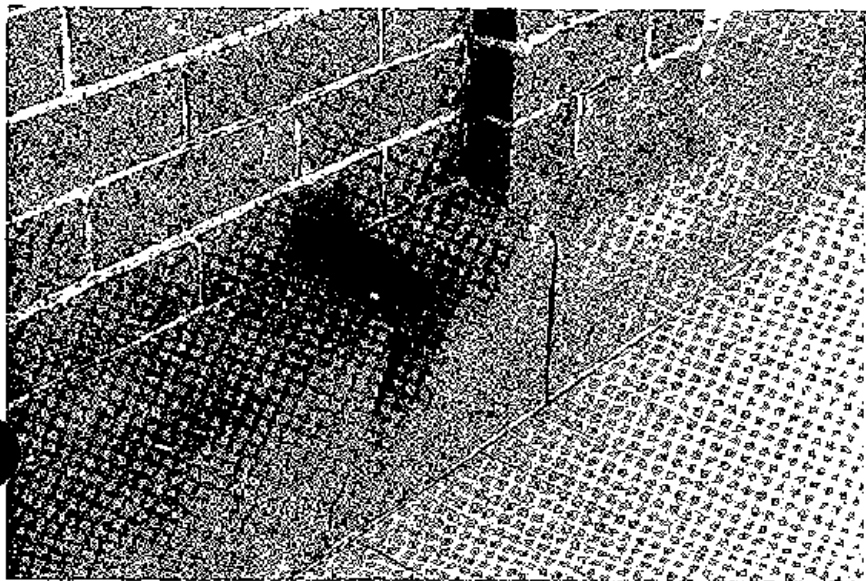
Illustration 80
C. O.'s House
Shutter Dog
Note: Cracked Stone

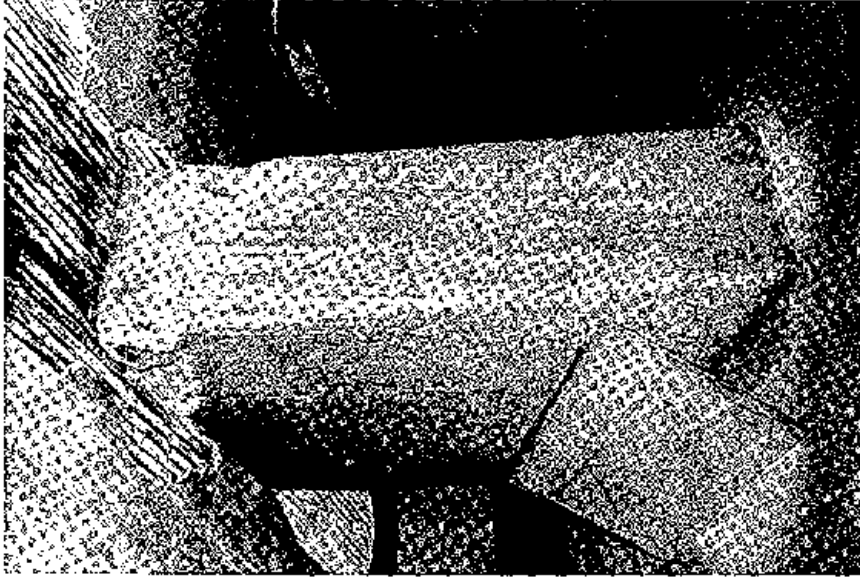
Illustration 94
C. O.'s House, Room 304, Attic
Northwest Chimney
Plaster damaged due to
deteriorated flashing
