historic structure report

TUMACACORI

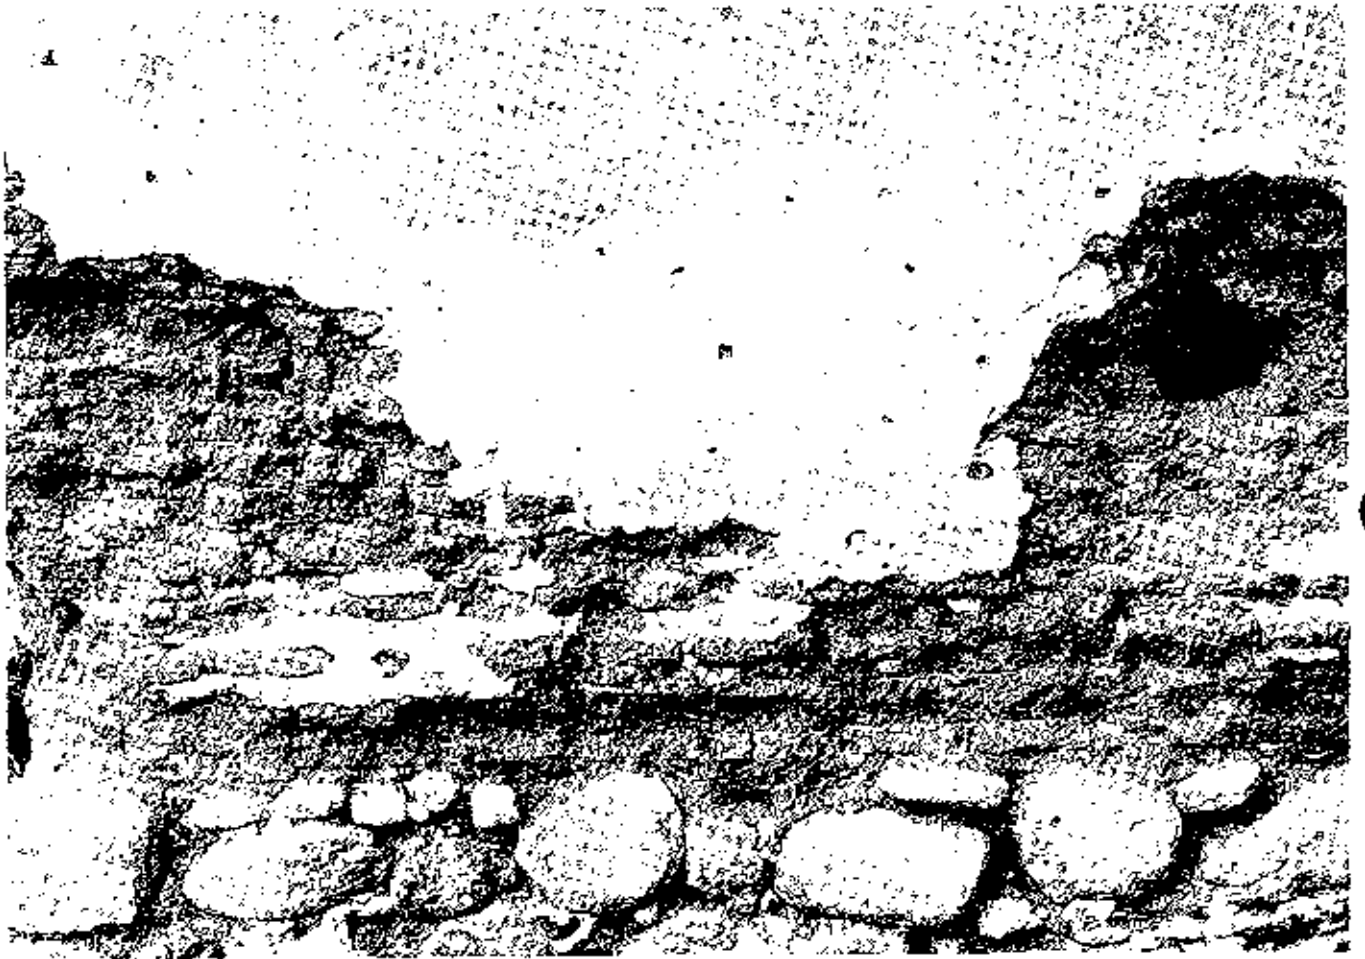
3. The north side of the bell tower after the removal of the hard cement stucco.

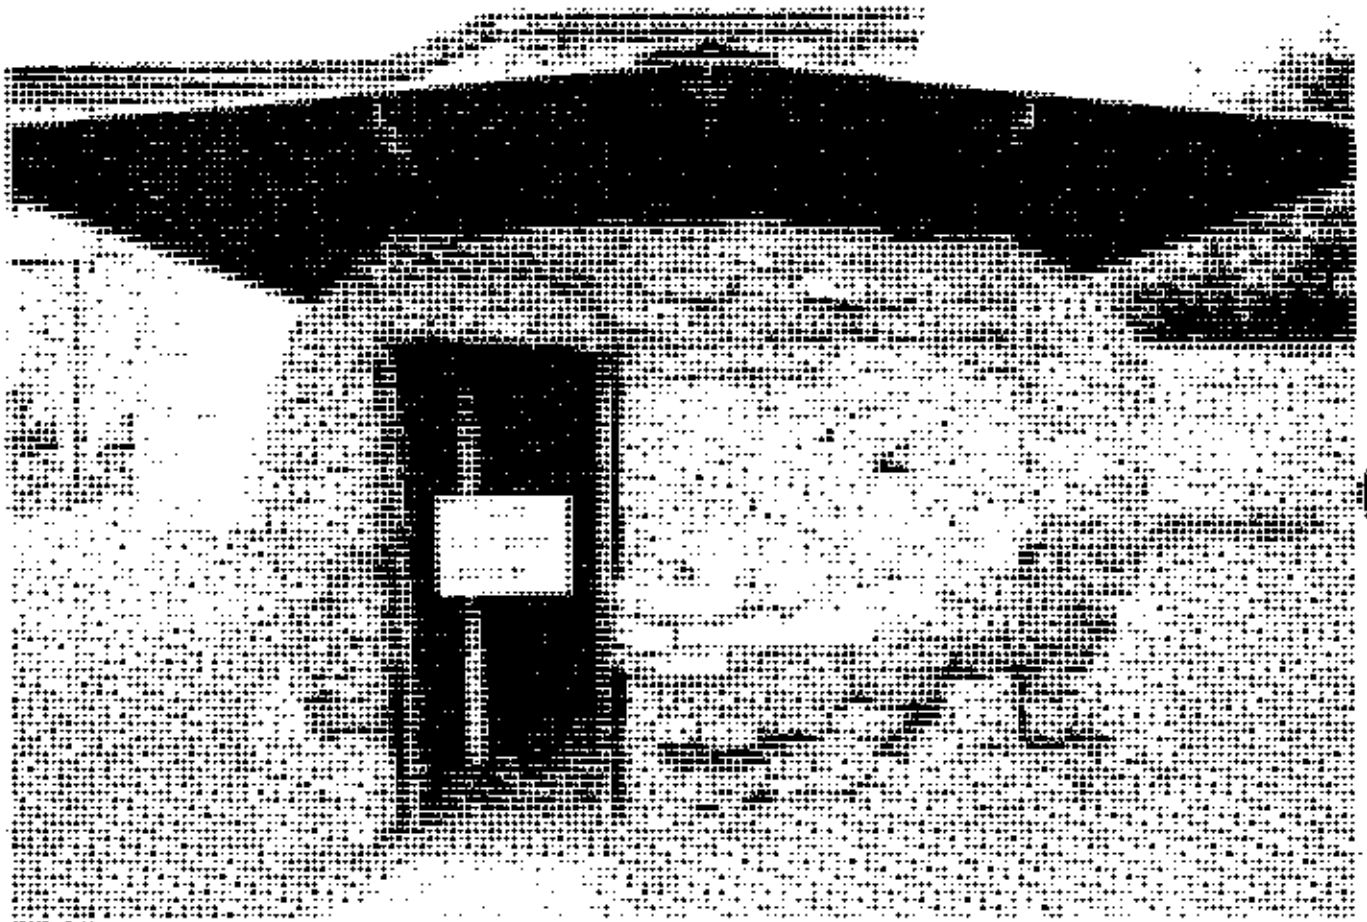
4. A view of the corridor prior to the removal of the protective roof. Photograph taken in August 1979.

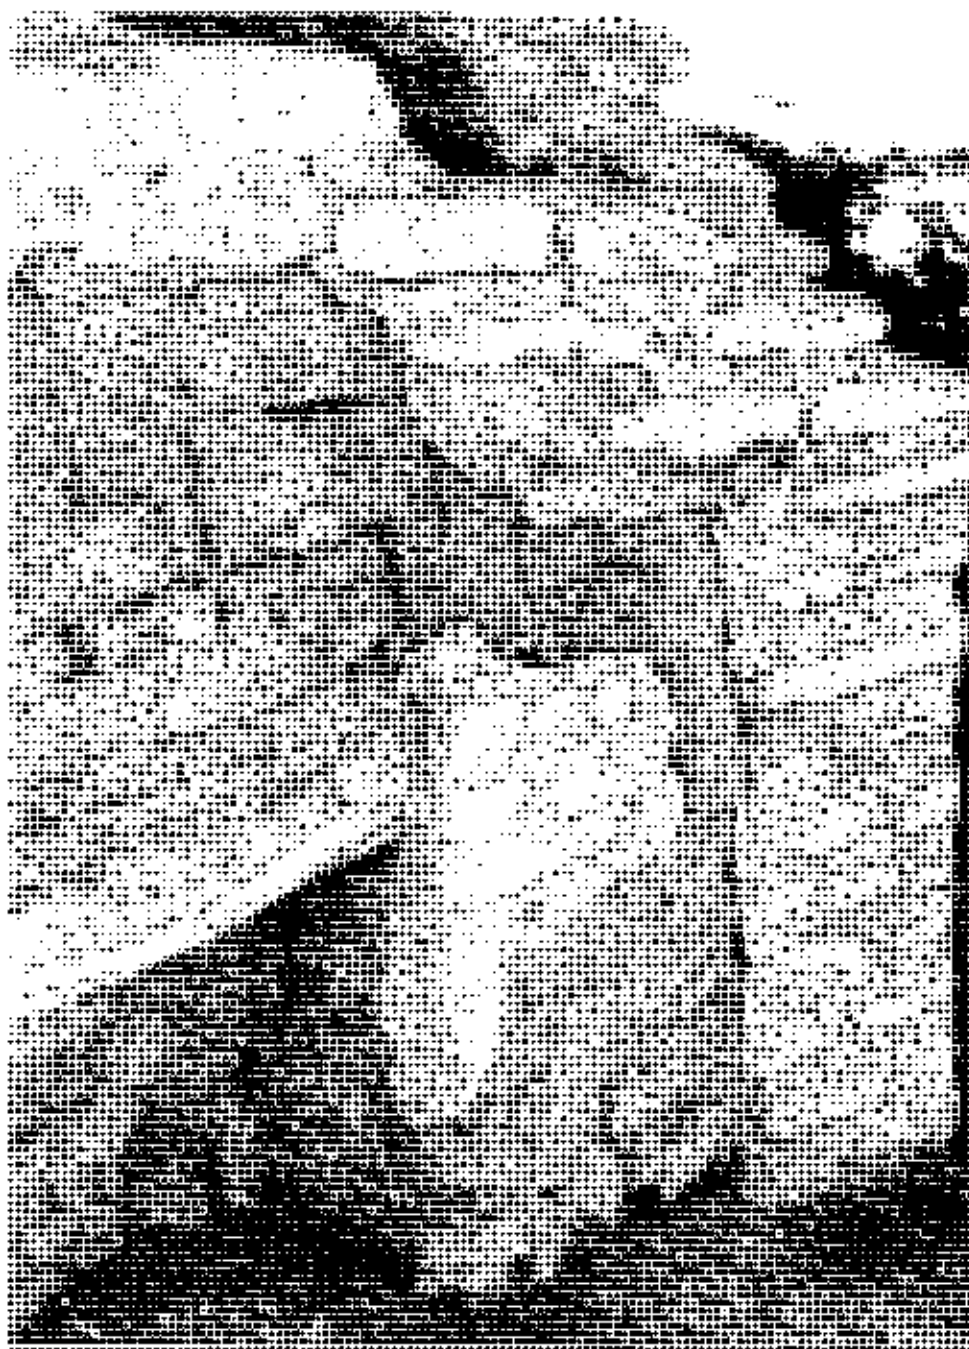
5. Northeast corner of granary showing effects of dissimilar materials.

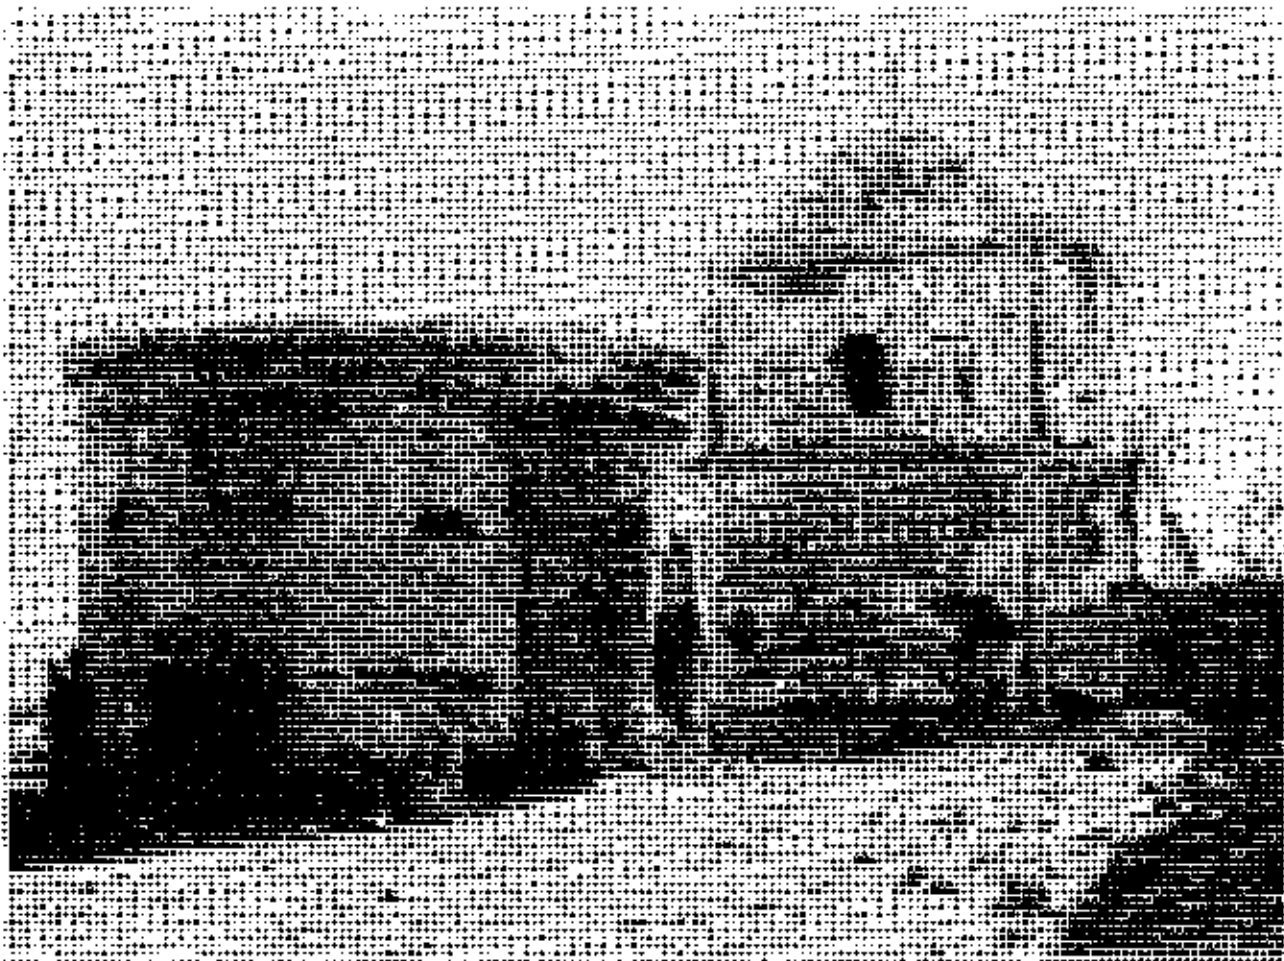
8. A view of the mortuary chapel from the northwest. 1892 International Boundary Resurvey photograph, No. JM-22/3275, Arizona Historic Foundation, Arizona State University Library, Tempe, Arizona.

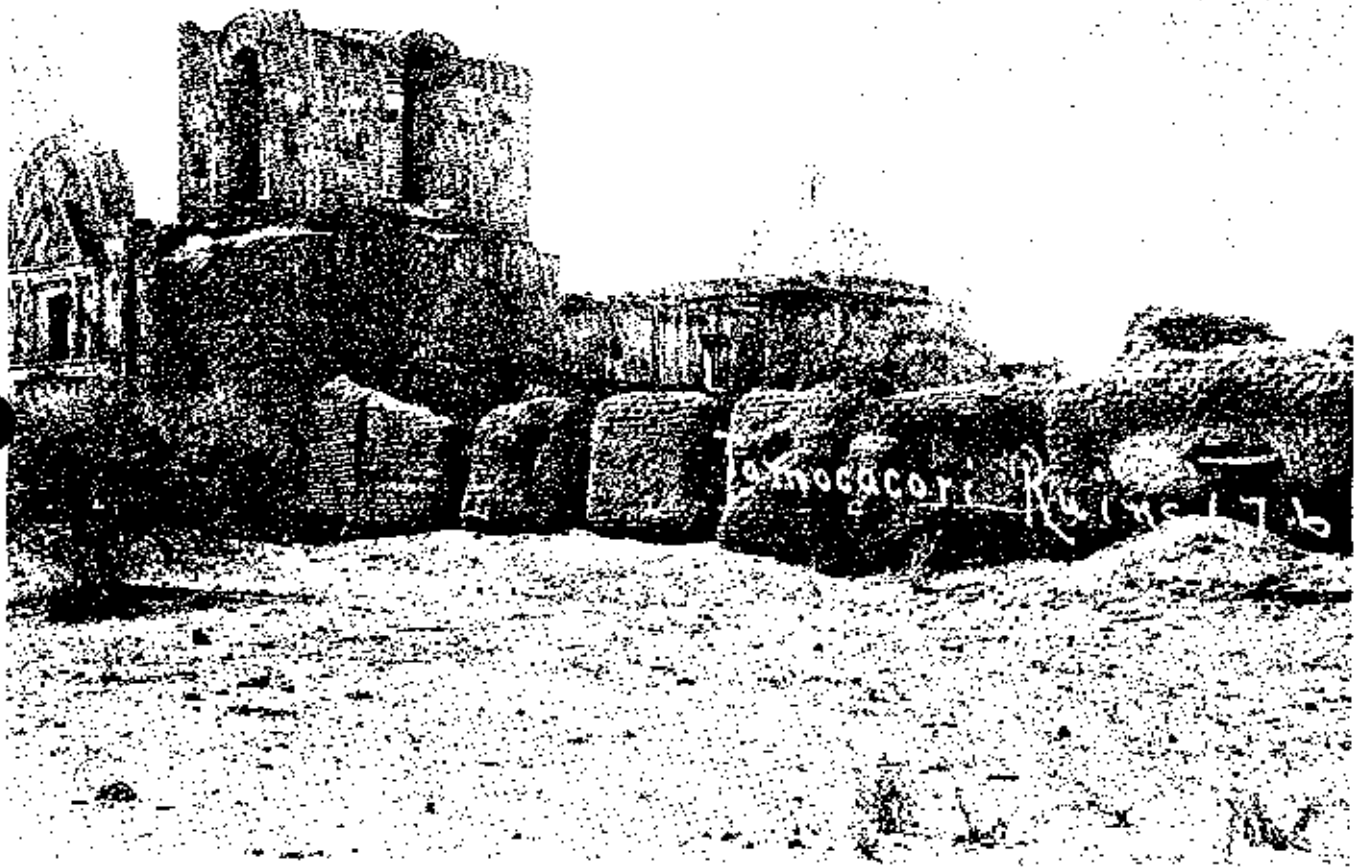
9. View of the church and convento from the southeast.

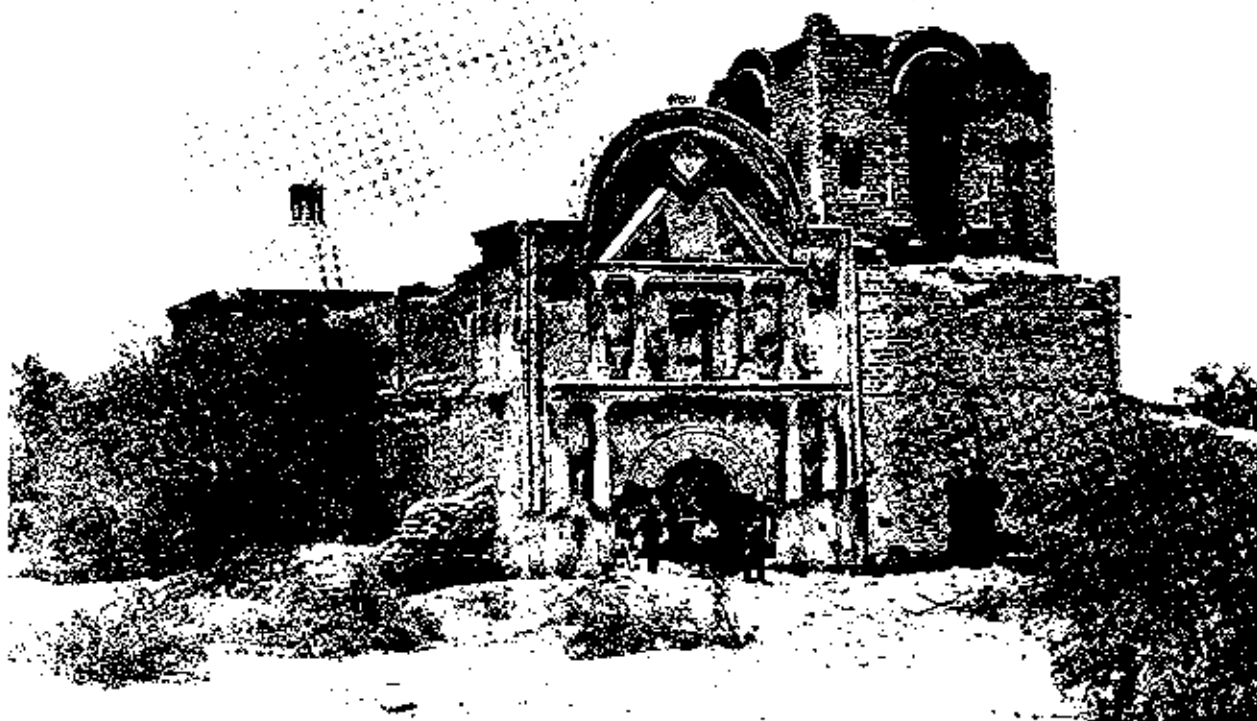
10. An 1889 George Roskrige photograph of the church from the south. Photograph is from the Tumacacori National Monument files.

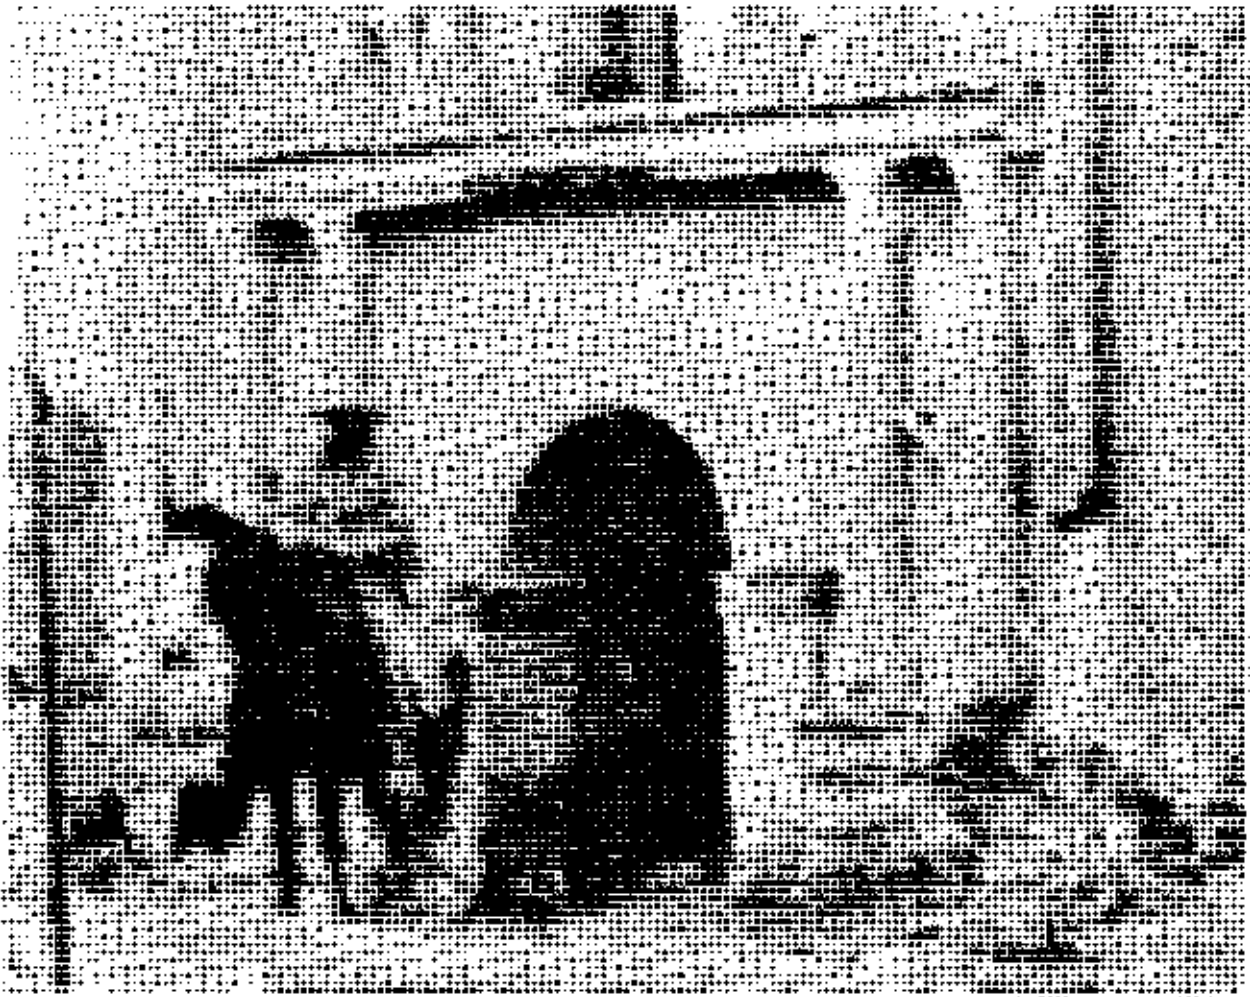
11. Detail of the front of the church ca. 1882.

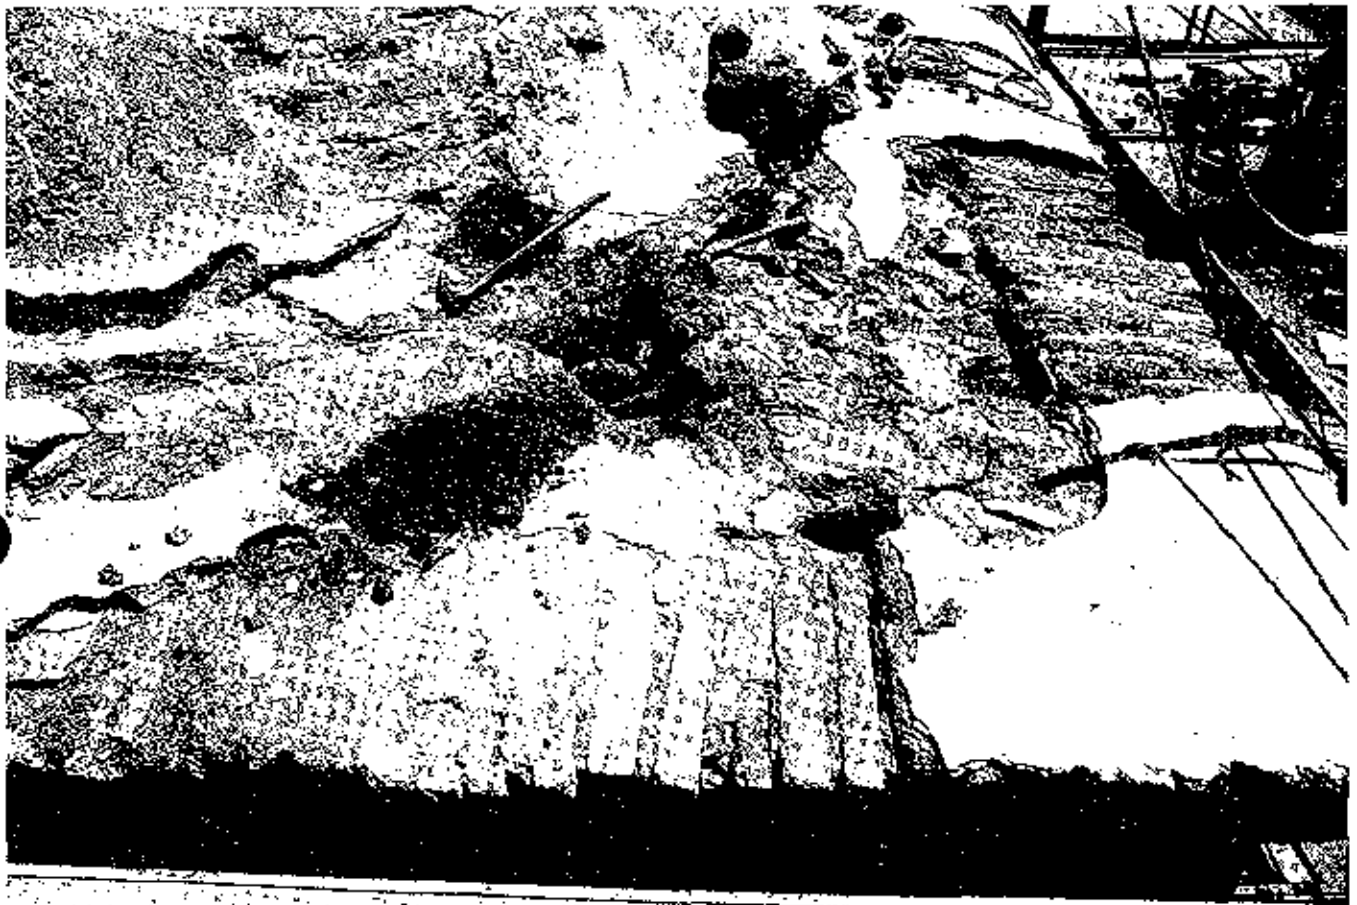
12. A view of the northwest flat portion of the sanctuary adjacent to the dome after removal of the cement stucco. Photograph taken in August 1979.

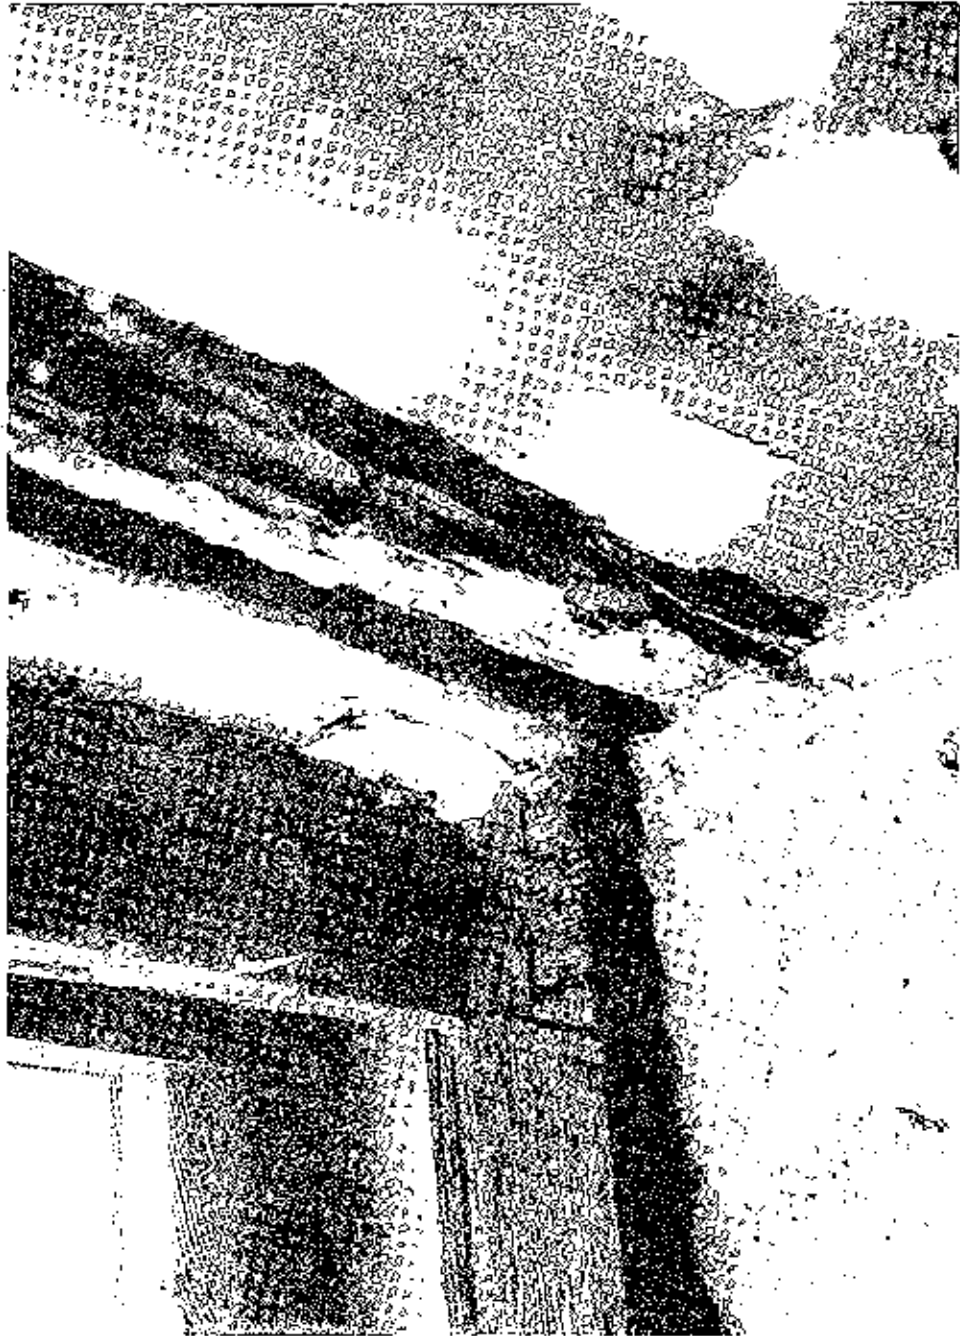
14. Deteriorated lintel in a west nave window.

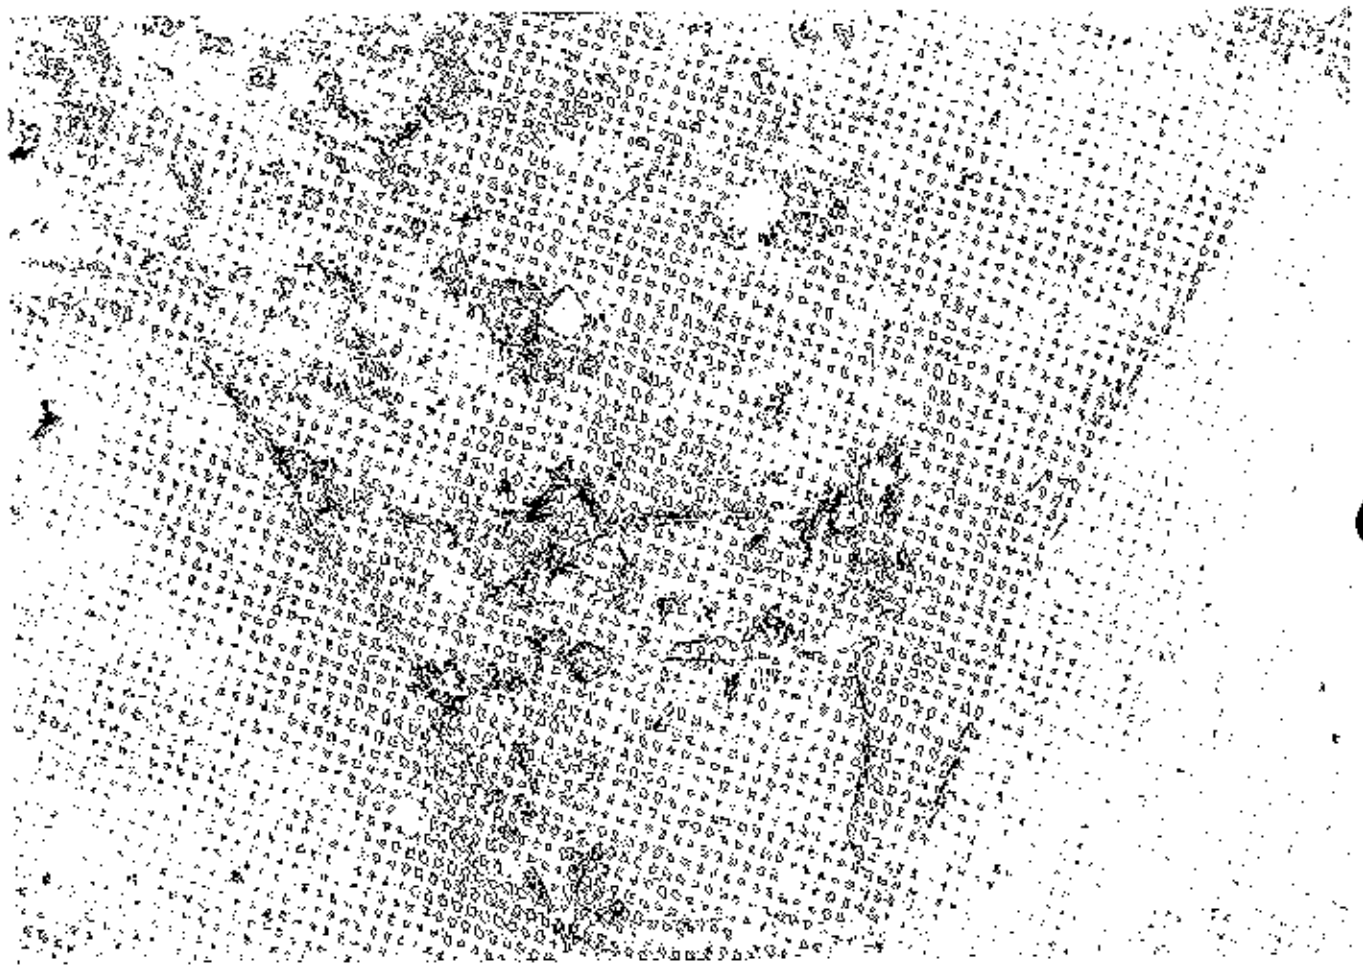
15. View of the northwest pendentive.

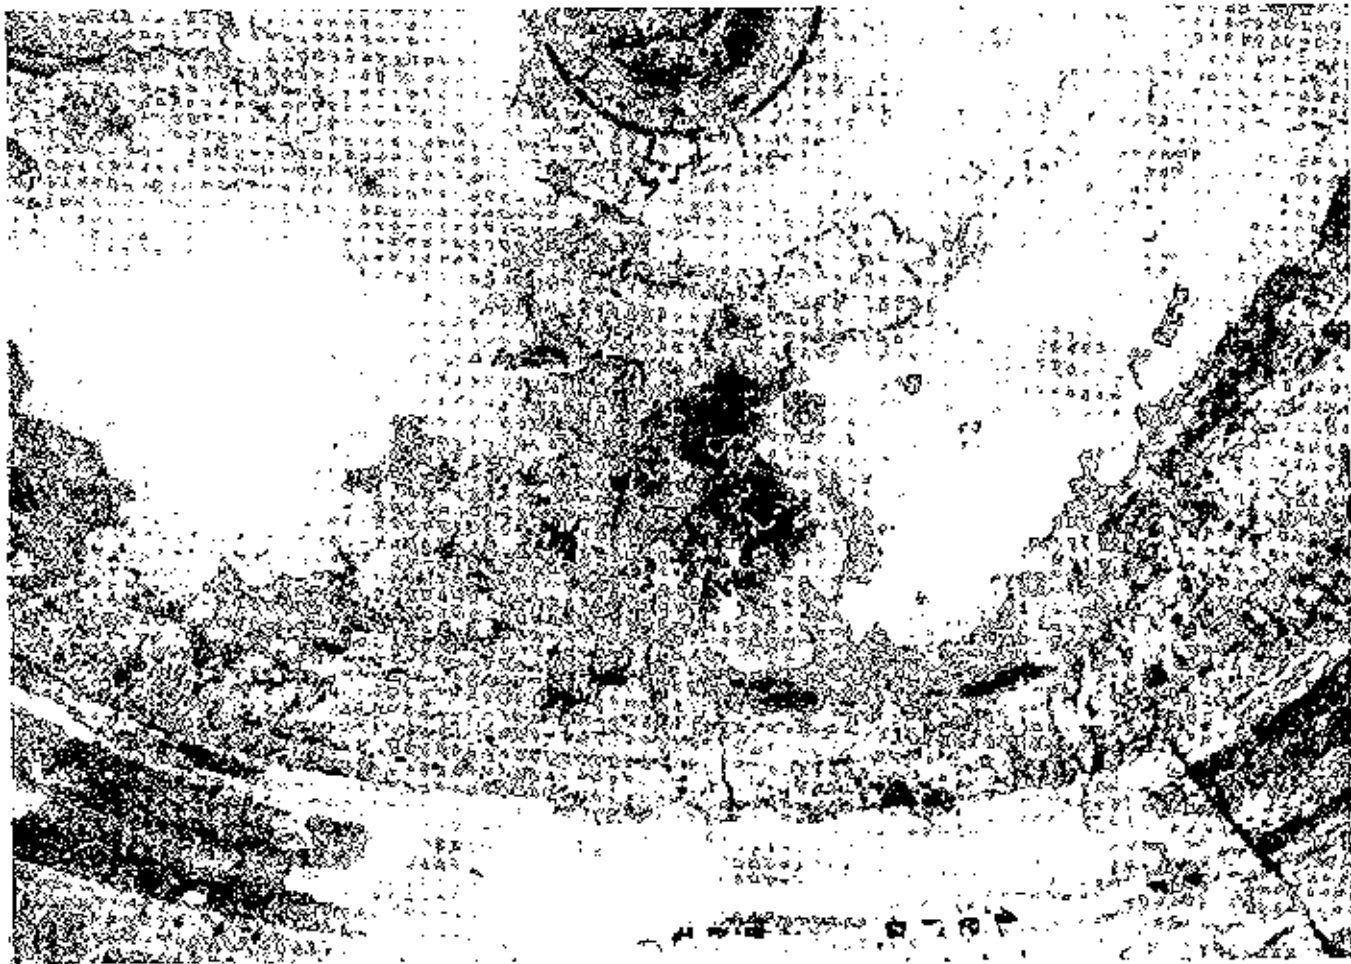
16. South side of the sanctuary dome before treatment, 1981.

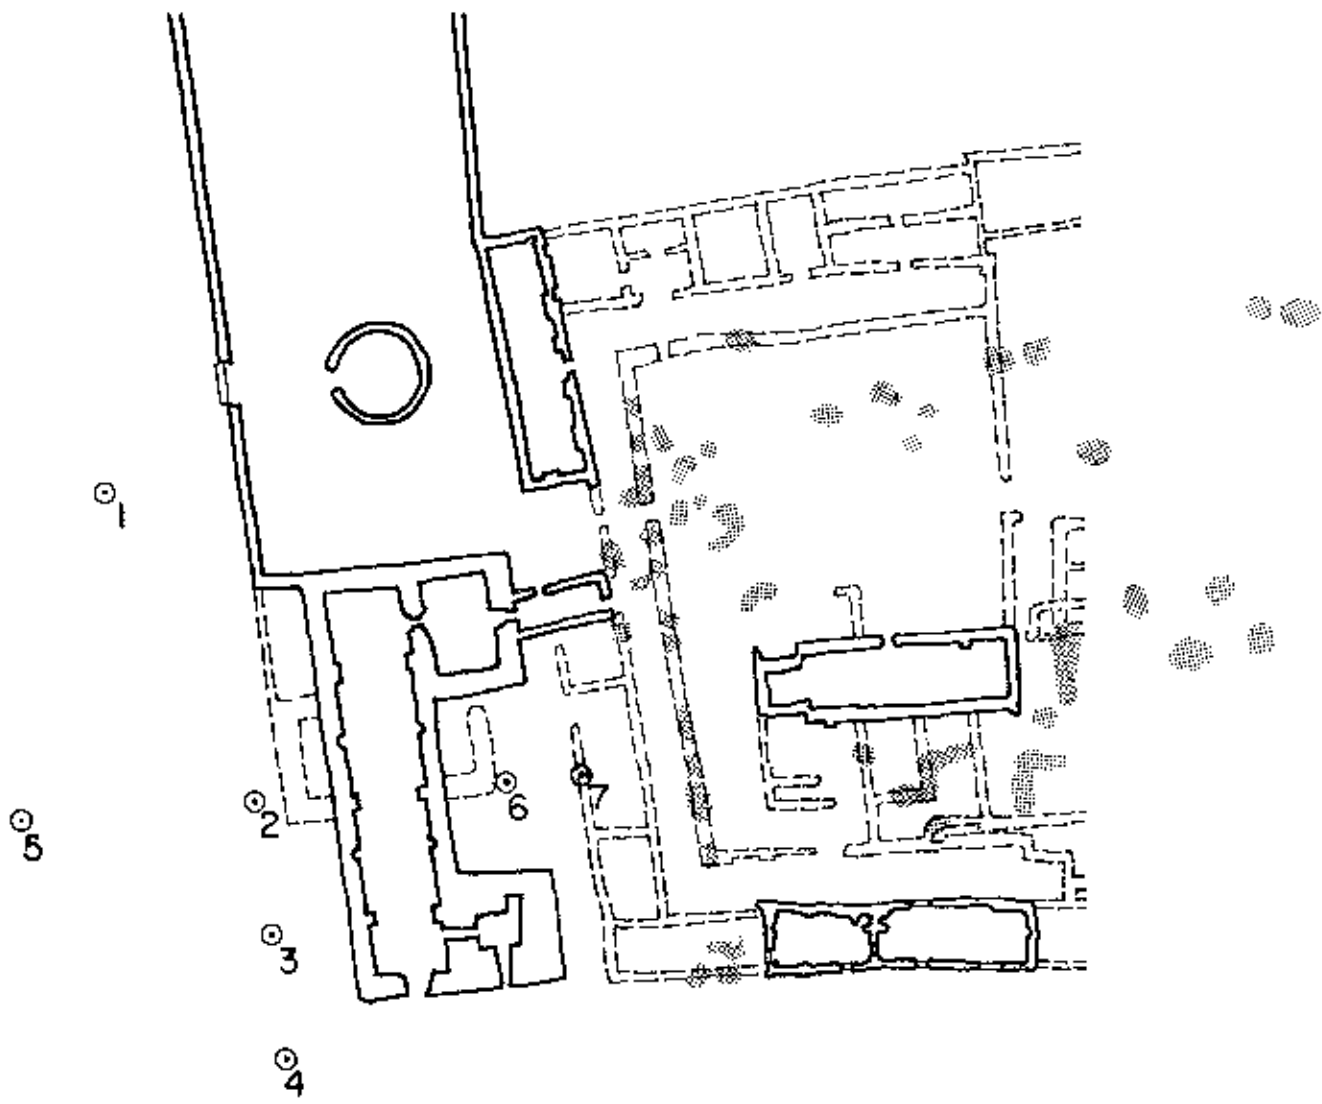
The darkest areas were approximately 40 feet east of the east nave wall of the church, just to the west of the paved walk, southeast of the granary, and just east of the concrete block foundations that mark the apparent foundations of an earlier Jesuit church. The architectonic quality of these stained spots seems to indicate some direct relationship to subsurface architectural remains. The one area that extends parallel to

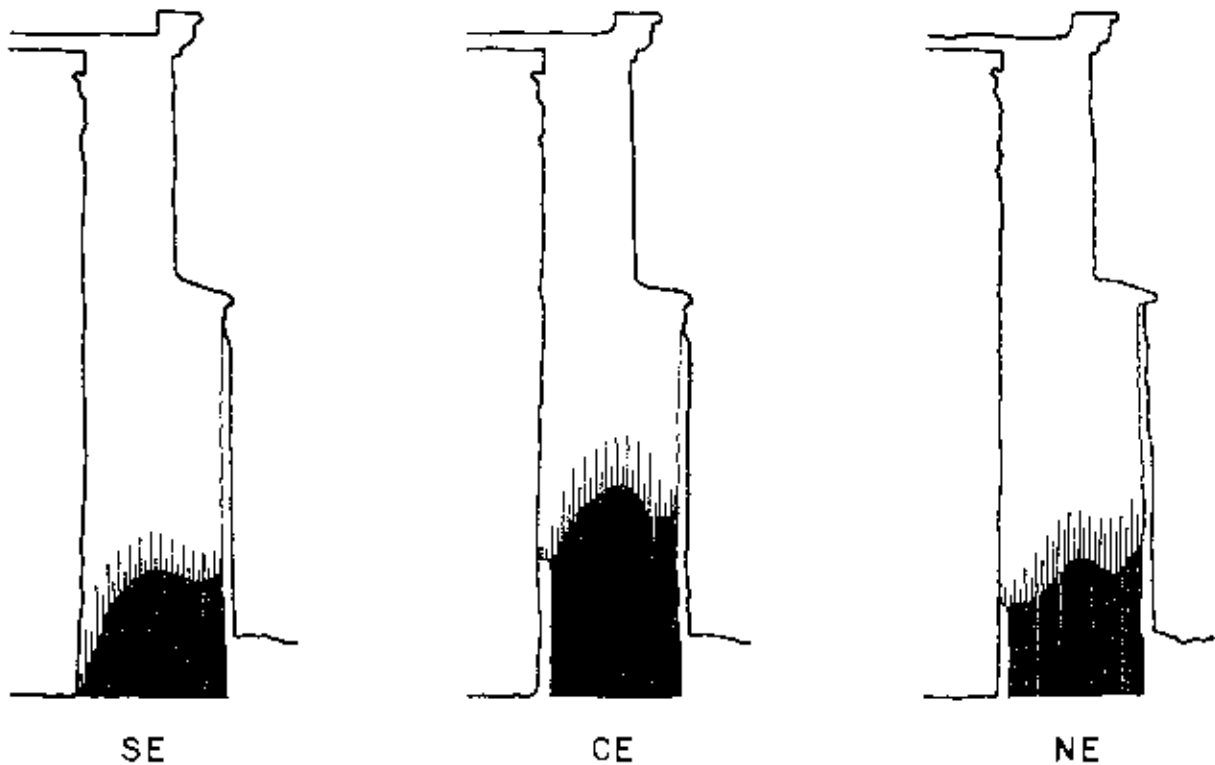
**MOISTURE PROFILES: EAST NAVE WALL**

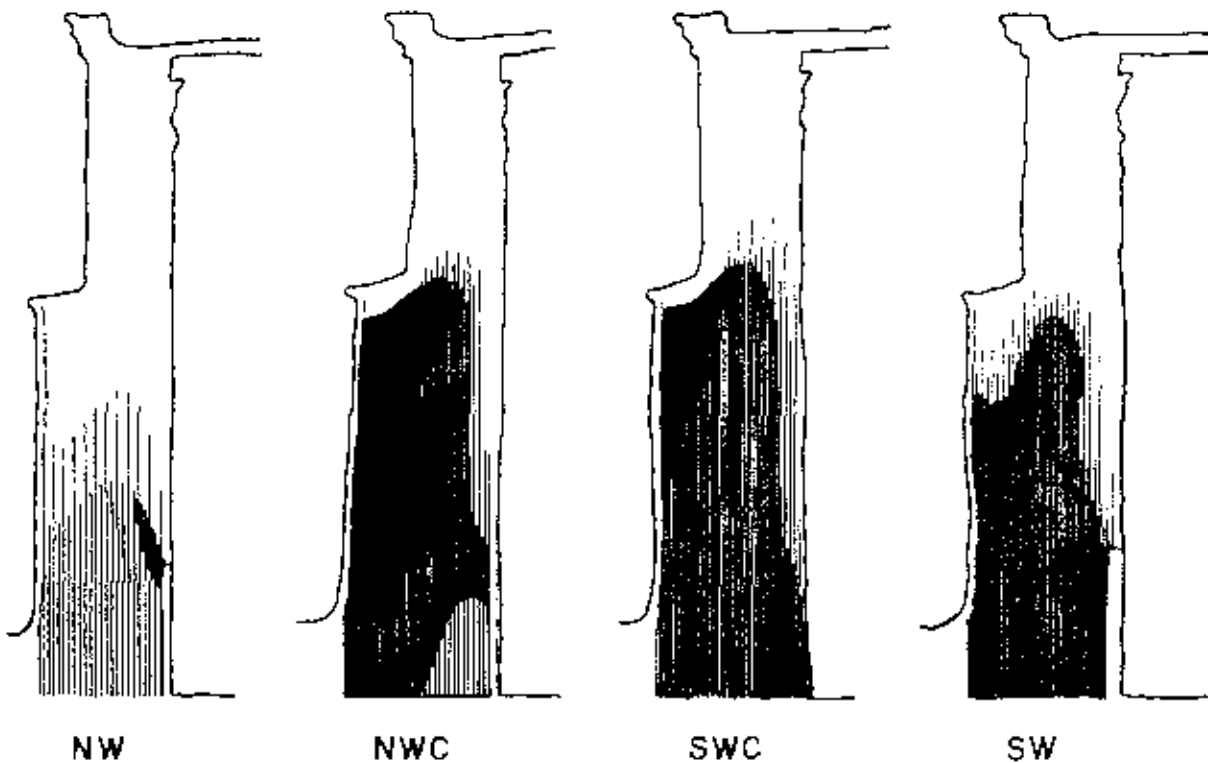
**MOISTURE PROFILES: WEST NAVE WALL**

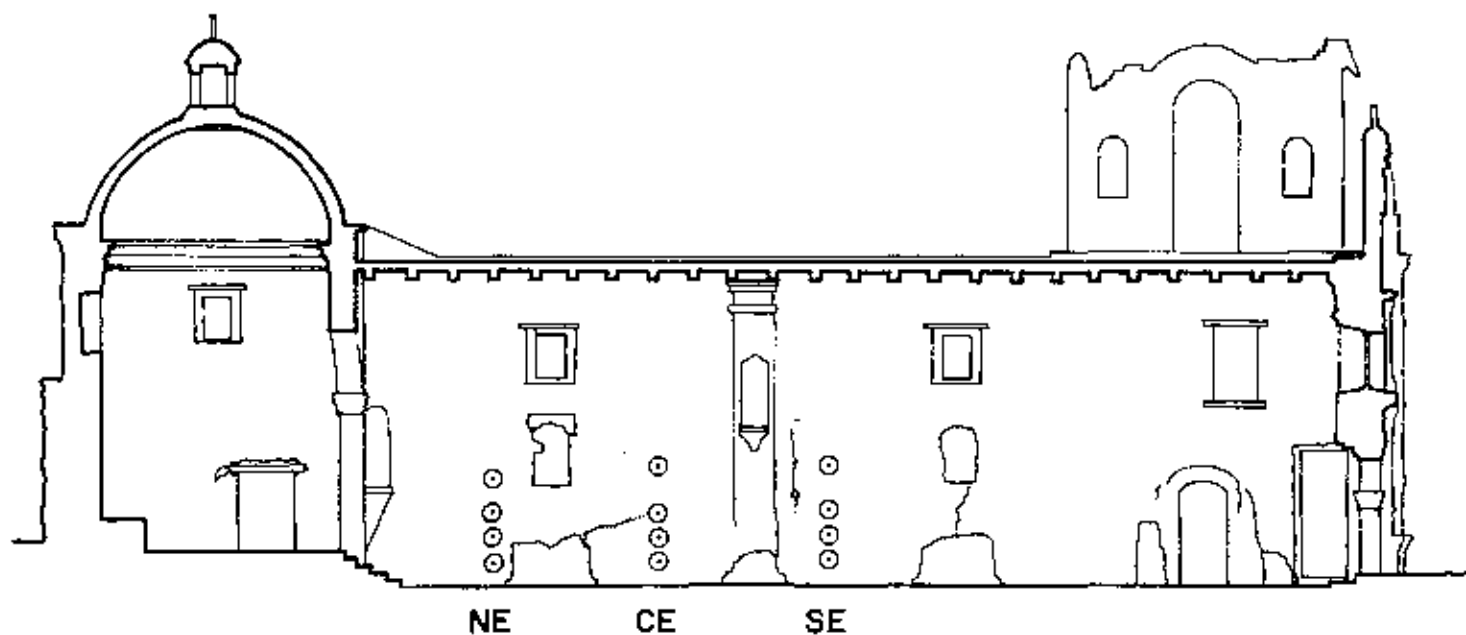
## EAST NAVE WALL SAMPLING LOCATIONS

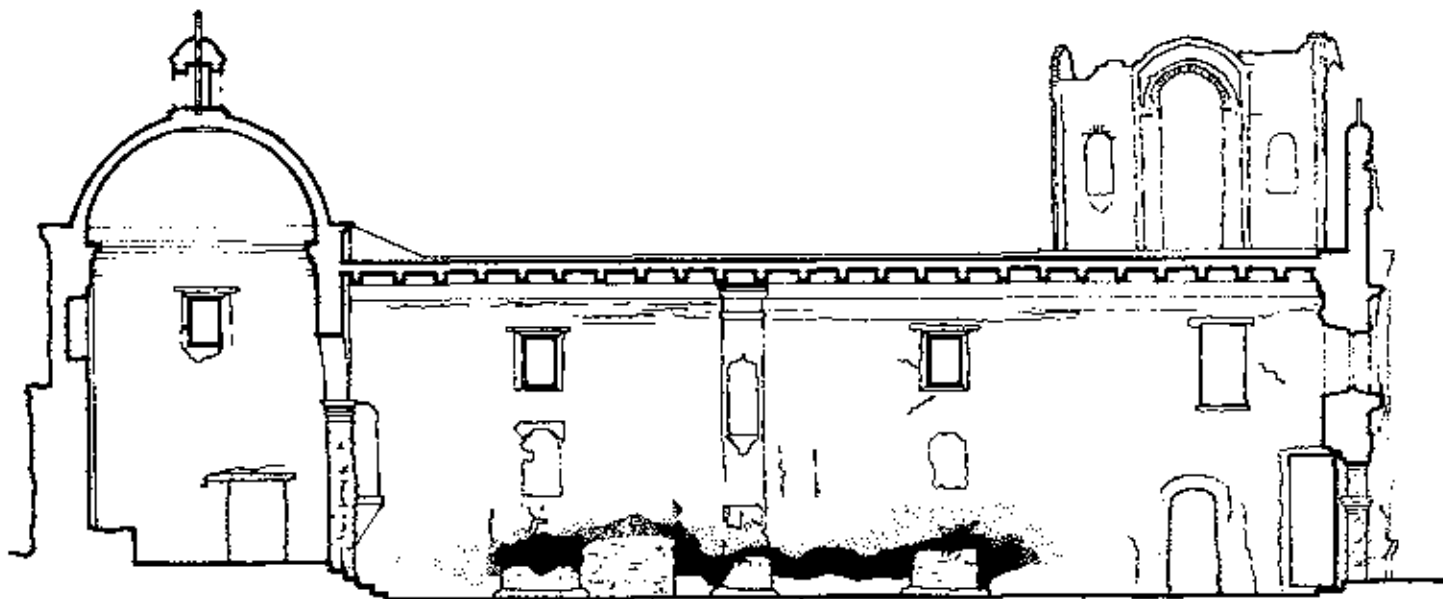
**SURFACE MOISTURE SURVEY: EAST NAVE WALL**  
Dec. 1, 1976 reading    □ 0-30    ◻ 30-60    ◼ 60-85    ◼ 85-100  
Readings taken with Protimeter Mini.

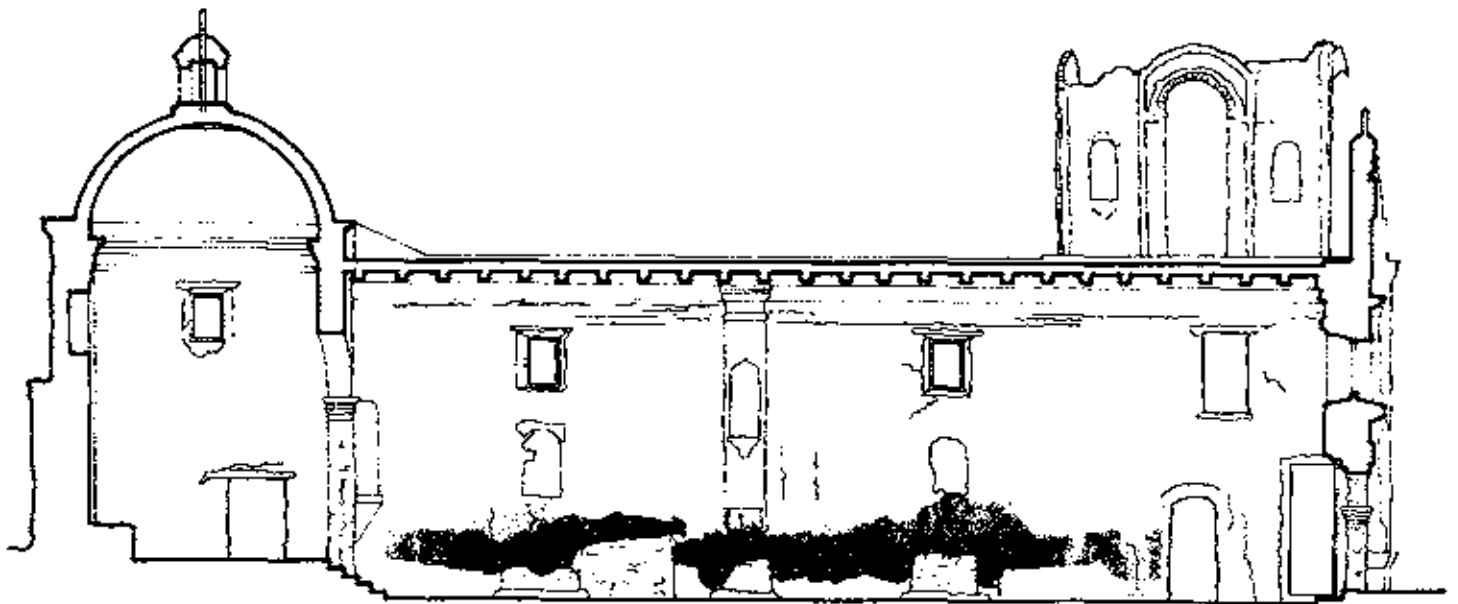
**SURFACE MOISTURE SURVEY: EAST NAVE WALL**

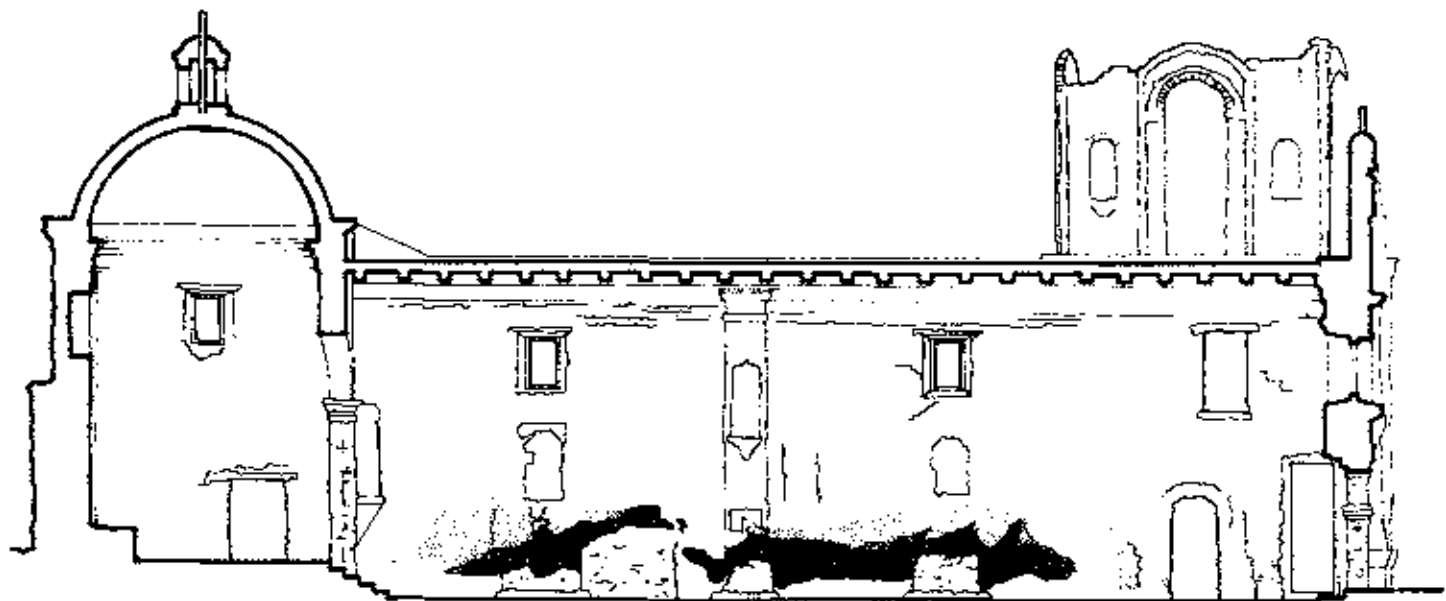
**SURFACE MOISTURE SURVEY: EAST NAVE WALL**

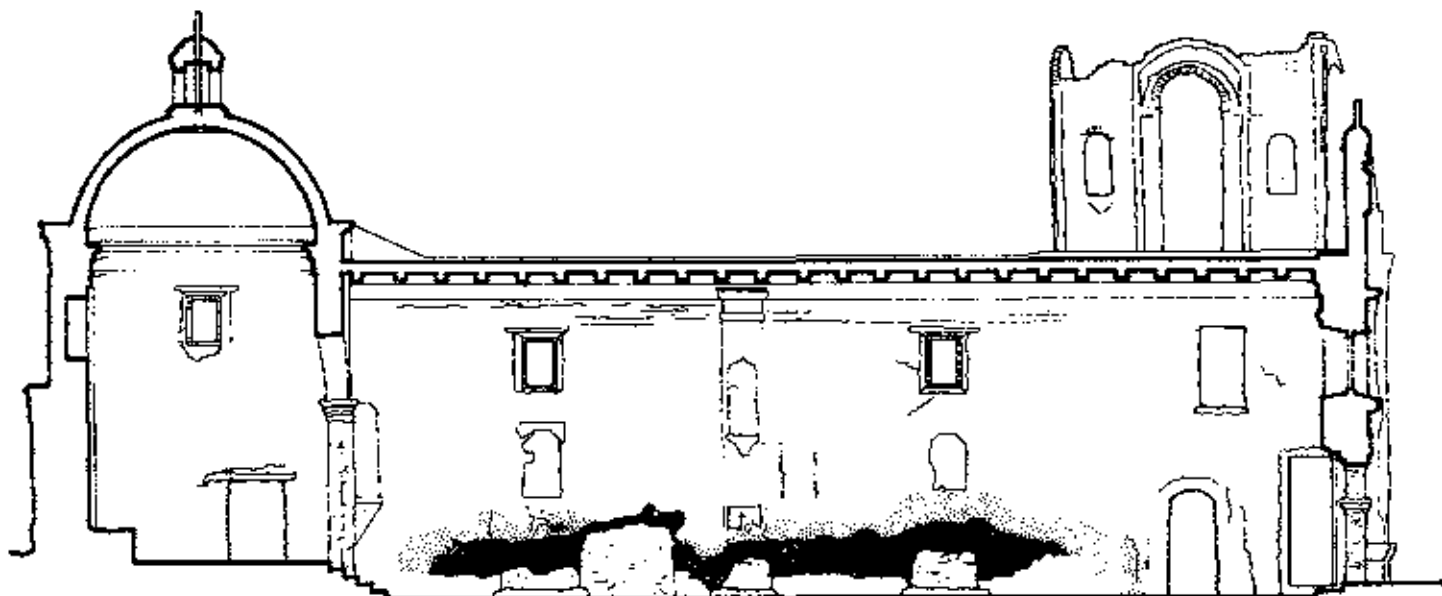
**SURFACE MOISTURE SURVEY: EAST NAVE WALL**  
**May 14, 1977 reading** □ 0-30 ▨ 30-60 ▩ 60-85 ■ 85-100  
Readings taken with Protimeter Mini.

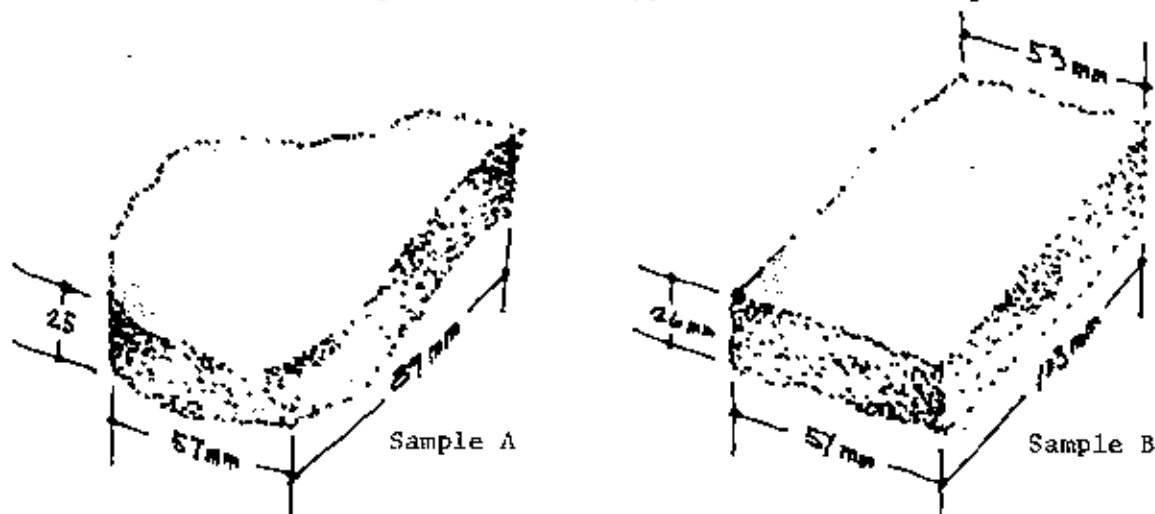
All the tests were conducted at a room temperature that varied between 65° and 75° fahrenheit and a relative humidity that varied between 38% and 50%. At the beginning of each test the samples were weighed and

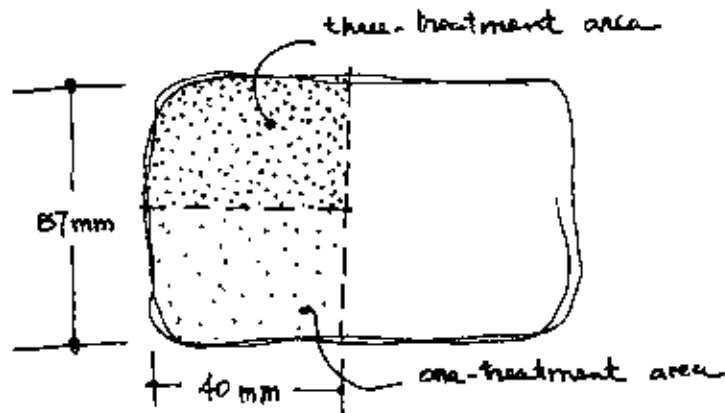
The resin was brushed on both areas on the finished surface, the back or unfinished raw plaster, and the two corresponding raw plaster edges. The application was repeated three times in the three-treatment area. Following the third application some of the resin remained on the finished surface for several minutes. The plaster was then set aside for one week before additional experiments were undertaken.

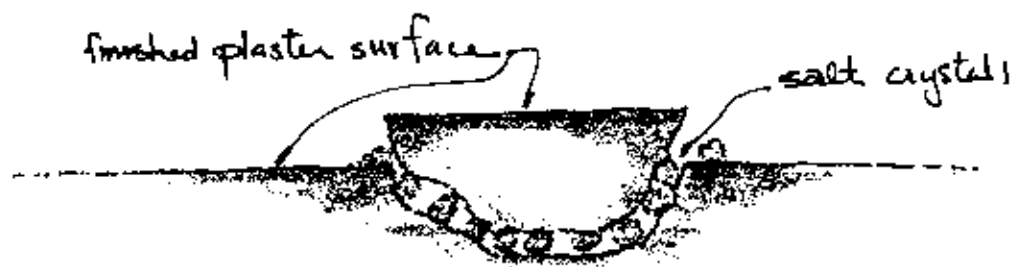
In this latter case, the salt crystals, lifted the surface material, then recemented it in place. However, when the salts went back into solution as the material was rewetted, the separated area would come off under minimal pressure.
