historic structure report

TUMACACORI

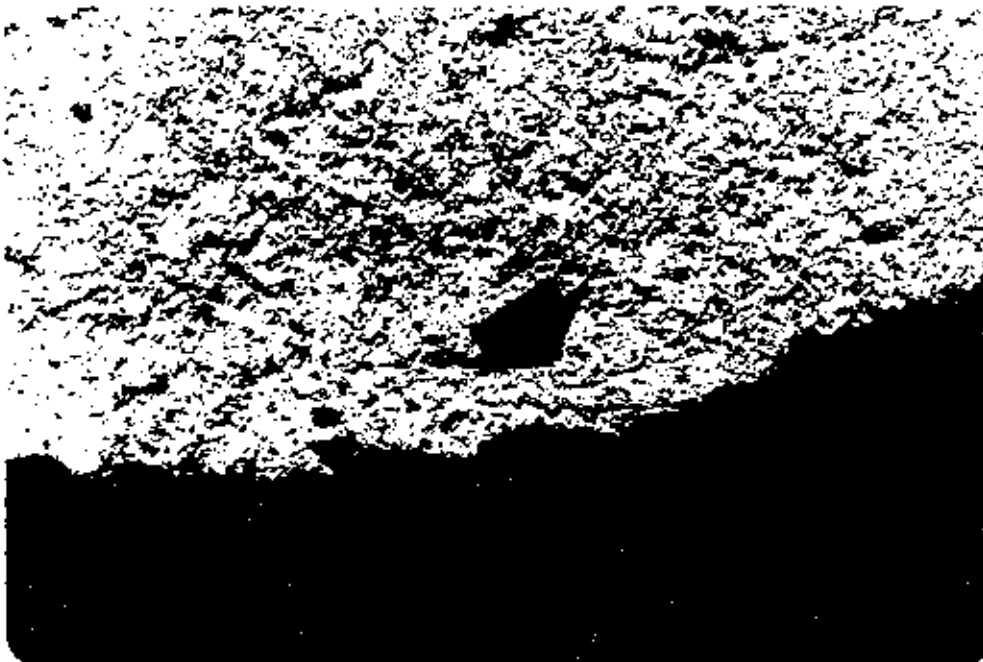
Figure 3: Detail of plaster Sample B showing edge fractures. Scale: approximately five times actual size.

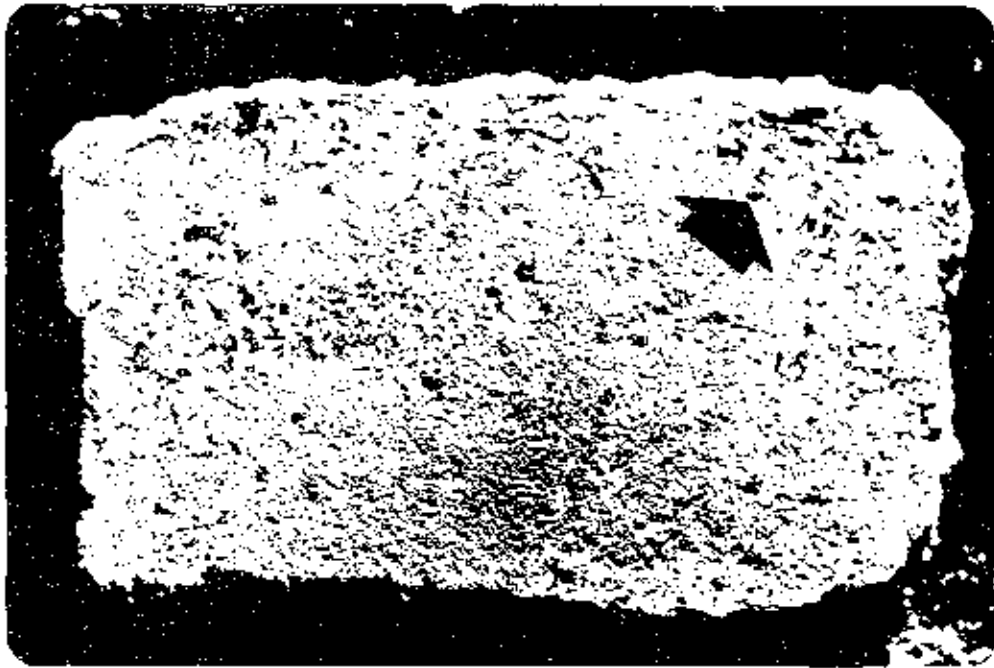
Figure 4a: Surface deterioration of plaster Sample B.  
Scale: actual size.

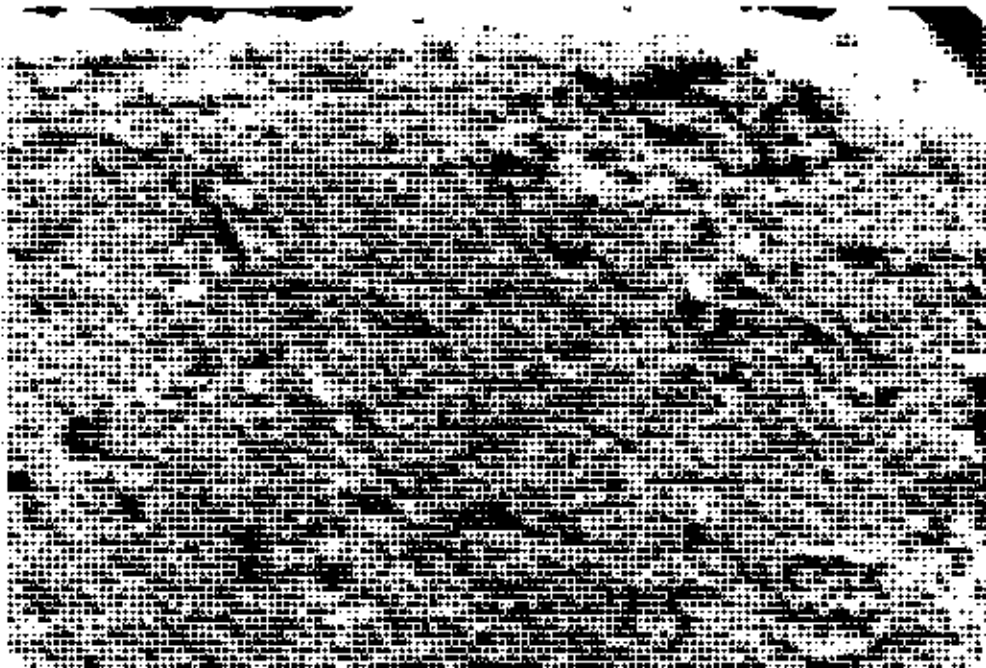
Figure 4b: Detail of Figure 4a. Scale: approximately two  
times actual size.

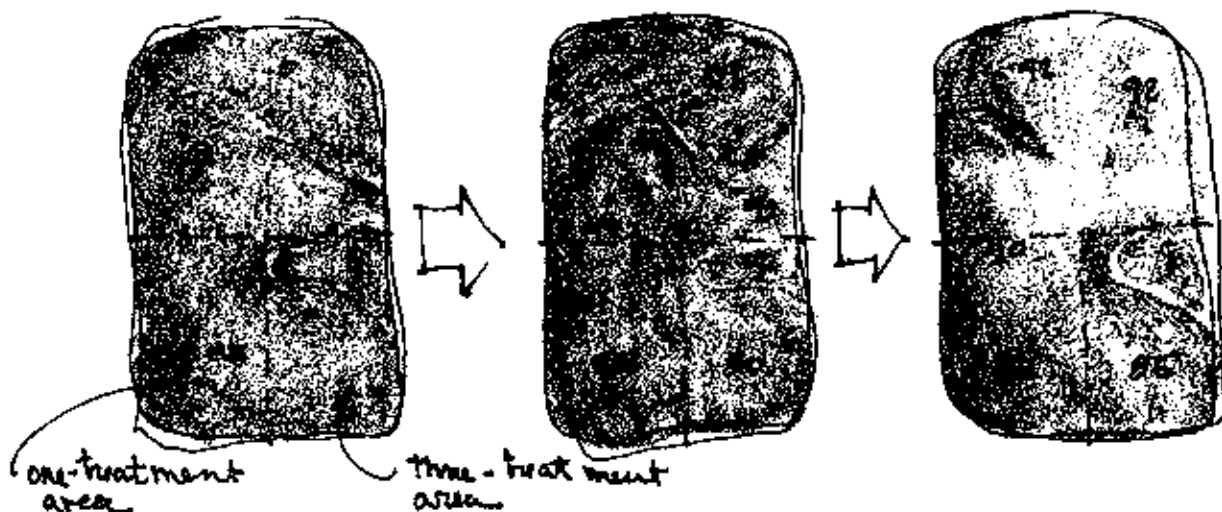
Figure 7: Back side of plaster Sample B showing visible capillary rise and relative surface moisture readings after 1 1/2, 2 1/2, and 4 hours, respectively. The blue areas are those which appear to be wet.

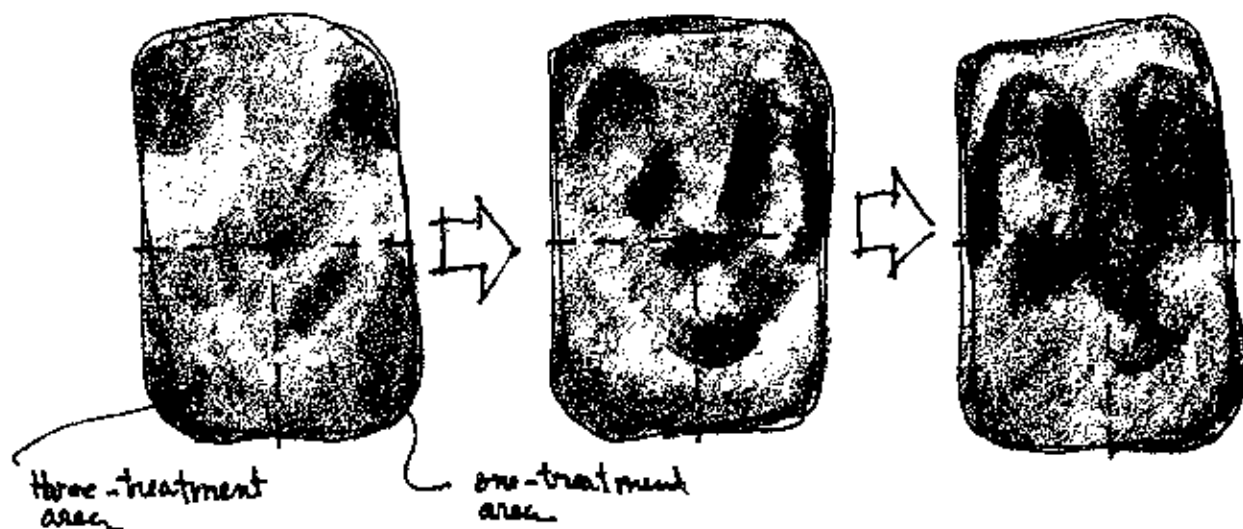
Figure 8: Front side, or finished surface of plaster Sample B showing the formation of efflorescence after 2, 3, and 18 hours respectively. The intensity of the gray areas represents the amount of efflorescence.

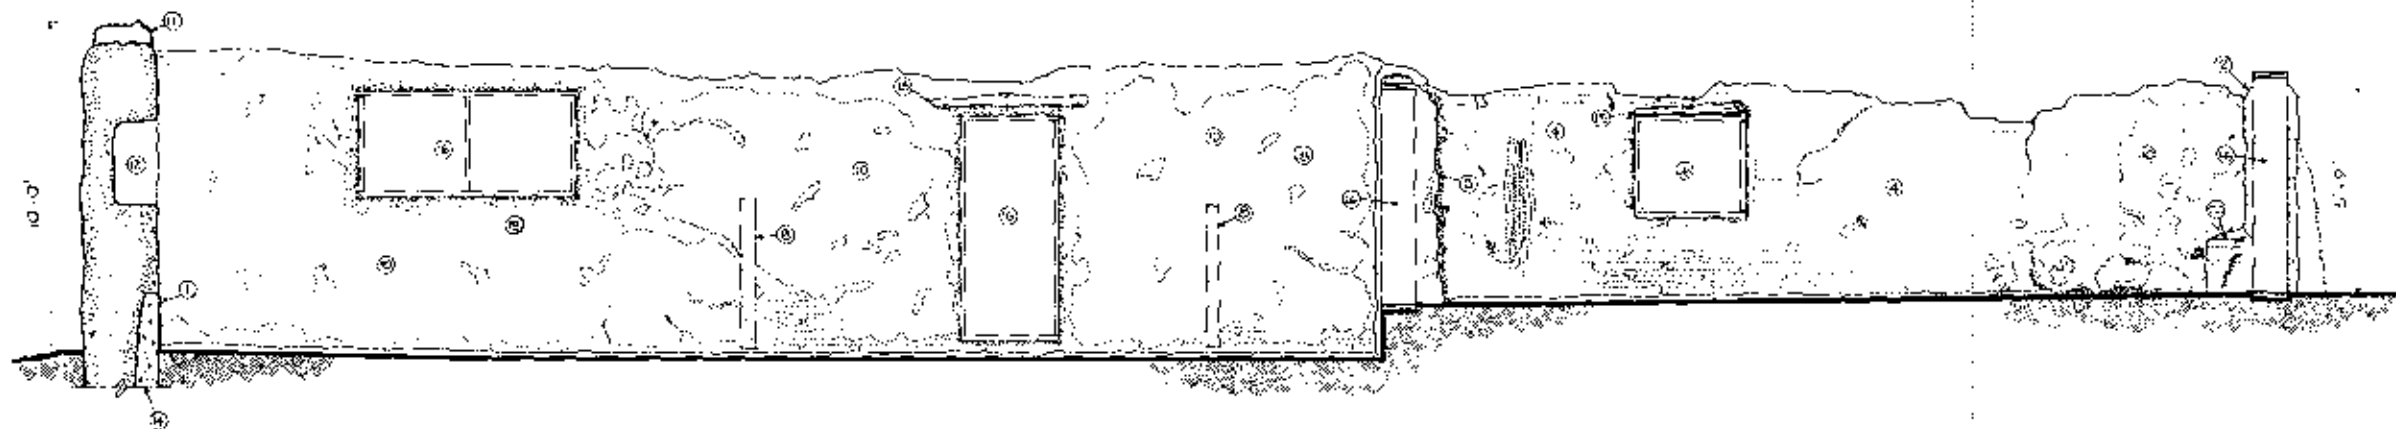
| <ul style="list-style-type: none"> <li>① CONCRETE</li> <li>② NEW HISTORICAL WALL</li> <li>③ FULL OF HISTORICAL BRICK</li> <li>④ ADDED BRICK WALL</li> <li>⑤ CRACK IN WALL</li> <li>⑥ FIREBRICKS</li> <li>⑦ NON-HISTORICAL FIREPLACE</li> <li>⑧ '84 REINFORCEMENT</li> <li>⑨ REINFORCEMENT ROD</li> <li>⑩ ORIGINAL LIME PLASTER</li> <li>⑪ LIME CEMENT MORTAR WITH FIREBRICKS</li> <li>⑫ STATUE NICHE</li> <li>⑬ DISCREPANCY HOSTURE</li> </ul> | <ul style="list-style-type: none"> <li>⑭ ACTUAL DEPTH OF FOUNDATION UNKNOWN</li> <li>⑮ CLOSER COTTONWOOD LINE</li> <li>⑯ ALL OF THE PRESENT OPENINGS ARE APPARENTLY MOST SPANISH COLONIAL OR MESTIZO MEXICAN</li> <li>⑰ AREA OF SOIL SAMPLE</li> <li>⑱ LEANING UPPER WALL</li> <li>⑲ ARCADE COVERED PASSAGE WAY</li> <li>⑳ DRENCH FOOTING</li> <li>㉑ CONCRETE REMOVED IN 1919</li> </ul> |
