VICKSBURG NATIONAL MILITARY PARK
SHIRLEY HOUSE

HISTORIC STRUCTURE REPORT

2004
Historic Structure Report
SHIRLEY HOUSE
Vicksburg National Military Park
Vicksburg, Mississippi
LCS#: 001362

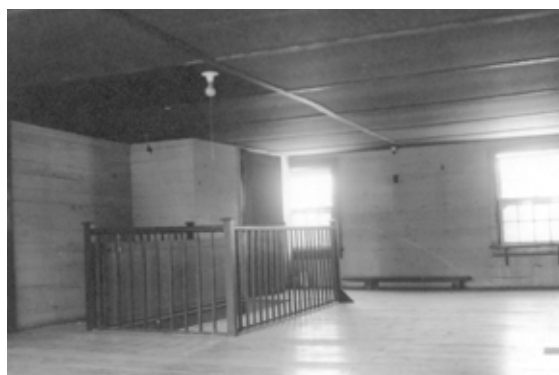
Figure 18 View north in Room 200, May 1965, showing fiber board ceiling installed by Major Holt in 1931. VICK Coll.

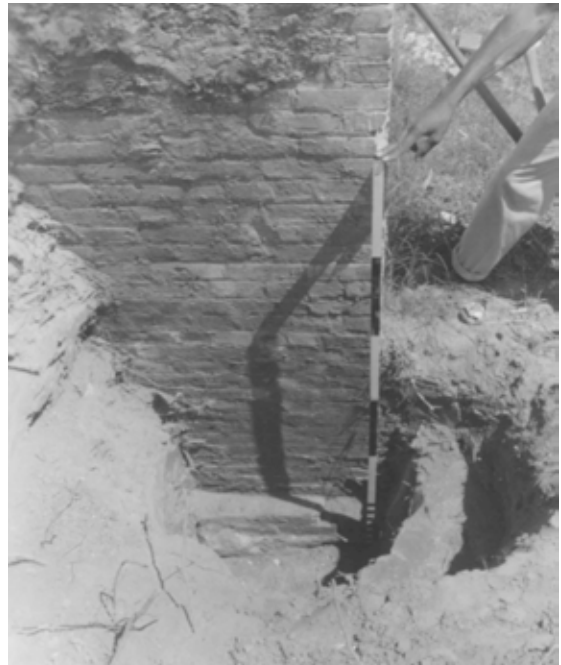
Figure 27 Excavated foundation at southeast corner of house, 1965. VICK Coll.

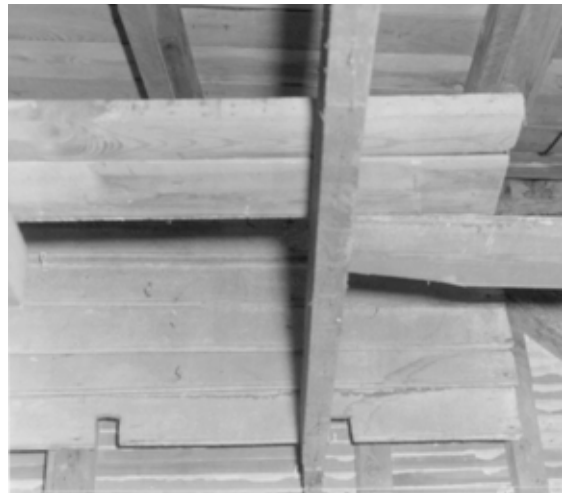
Figure 28 View of original beaded siding found above ceiling of Room 103, November 1965. VICK Coll.

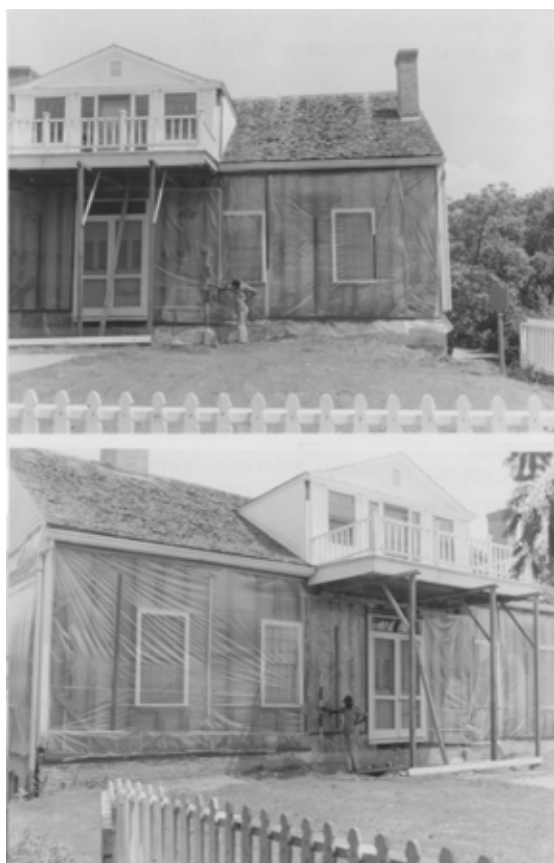
Figure 29 Views of front of house after removal of exterior siding to investigate structural condition, July 1965. VICK Coll.

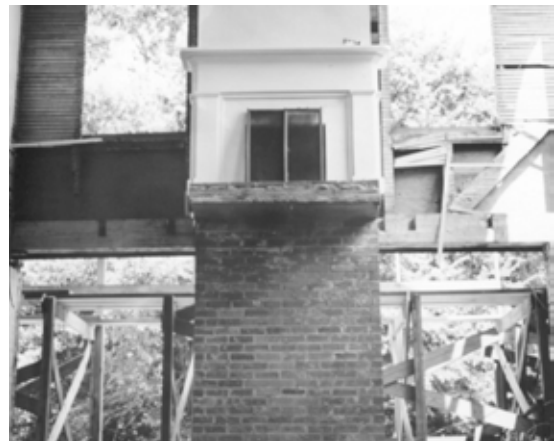
Figure 31 View east after removal of floor in Room 105, May 1966. VICK Coll.

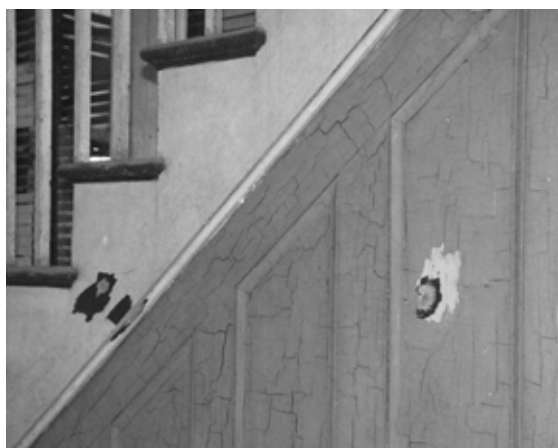
Figure 46 View of original woodwork on staircase, with scraped areas exposing the brown paint used in 1902. NPS SERO 2001.
