CAPE LOOKOUT NATIONAL SEASHORE
GUTHRIE- OGILVIE HOUSE

HISTORIC STRUCTURE REPORT

**Historical Architecture, Cultural Resources Division
Southeast Regional Office
National Park Service**

2004

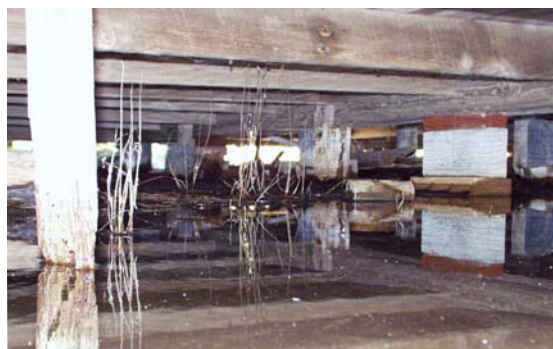
Figure 16 View to south from rear of house, showing standing water several days after rain. (NPS-SERO-CR, 2003)

with around 110 feet of frontage on the main road. The site is flat and very poorly drained. A slight depression has formed beneath the rear of the house, allowing large amounts of stand-

- Replace foundation piers.
- Raise finish floor level to accommodate changes in grade that are recommended for improved drainage.

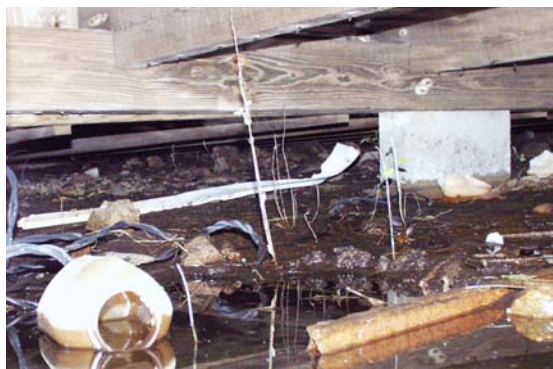
The house is set on wooden piles sunk to an indeterminate depth. The piles are very low, elevating the house less than a foot from the ground. Some have rotted away from the sills, leaving the building's sill and frame unsup-

ported at several locations. All are in poor condition.

Figure 19 View south under Room 101, showing front sill of house. (NPS-SERO-CR, 2003)

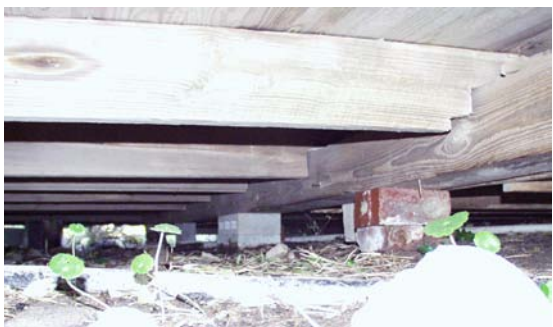
Figure 20 View west under Room 101. (NPS-SERO-CR, 2003)

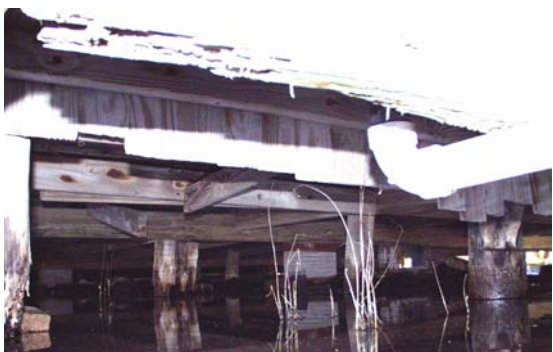
Figure 21 View south under old porch, now a bathroom. Note original siding. (NPS-SERO-CR, 2003)

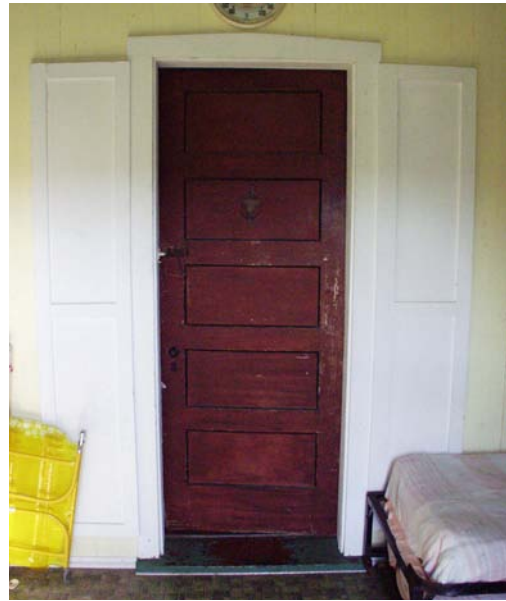
Figure 22 View of front door. Shutters and possibly the shaped header are modern additions. (NPS-SERO-CR, 2003)

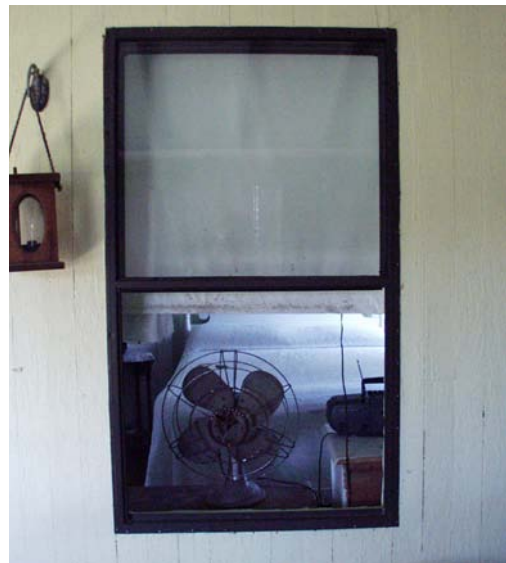
Figure 23 View of typical modern storm window that replaced all of the historic wooden sash. (NPS-SERO-CR, 2003)

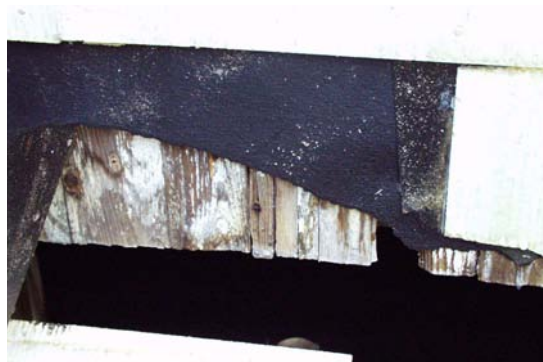
Figure 24 View of typical wood siding and asbestos-cement siding. (NPS-SERO-CR, 2003)

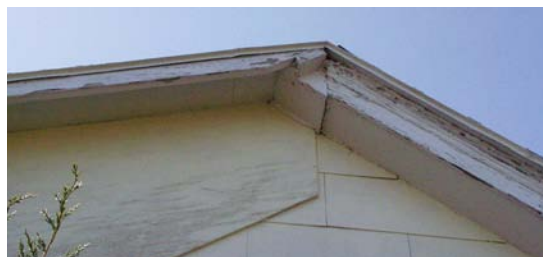
Figure 25 View of typical boxed cornice at right and modern alteration to front shed of roof at left. (NPS-SERO-CR, 2003)

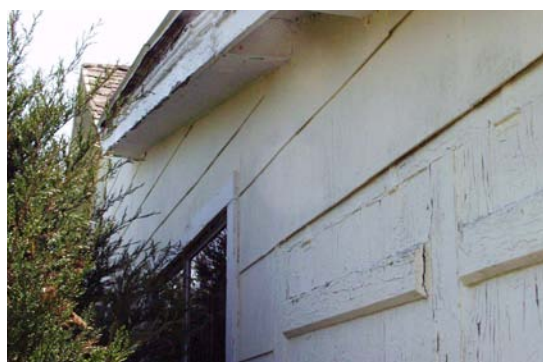
Figure 26 View of typical exterior finishes including top-hinged shutters from original back porch. (NPS-SERO-CR, 2003)

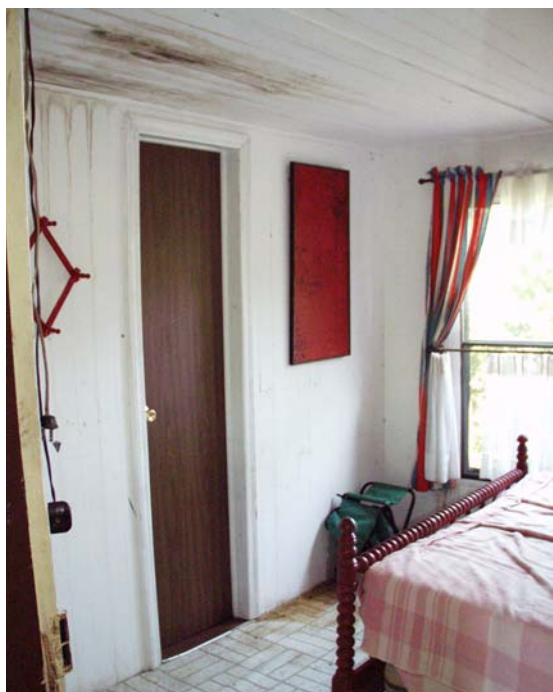
Figure 34 View north of Room 102, showing door added for bathroom. Note water damage to ceiling. (NPS-SERO-CR, 2003)

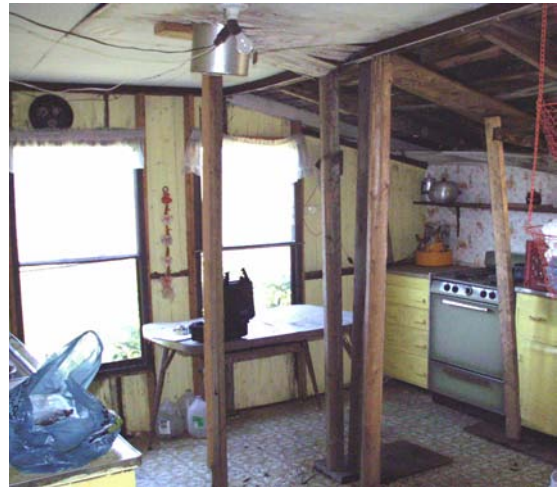
Framing is in generally fair condition in most of the house, but there has been major water dam- age to roof, floor, and wall framing on the northwest (rear) side of Room 103. In addition, parts of the rear of the house were originally framed for porches, which were later enclosed. With later repairs and alterations, the framing in these areas is very irregular and in generally poor condition.

Figure 35 View west in Room 103, showing deteriorated shed-roofed addition that was combined with this room after World War II. (NPS-SERO-CR, 2003)

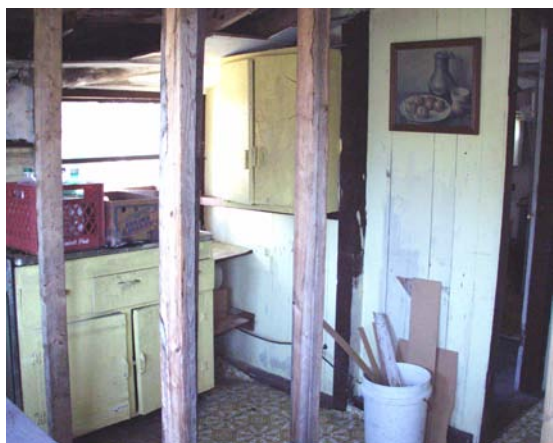
Figure 38 View to north in Room 103. Posts in foreground have been added to stabilize roof structure where wall was removed. (NPS-SERO-CR, 2003)
