Cape Lookout National Seashore
LEWIS - DAVIS HOUSE

HISTORIC STRUCTURE REPORT

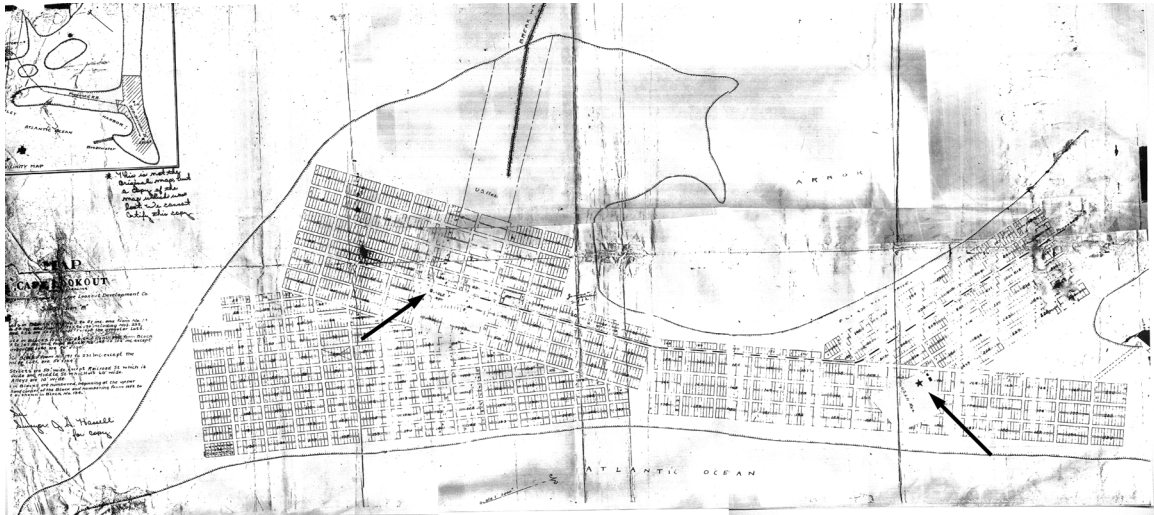
Figure 7 Plat of proposed development of Cape Lookout in 1915. Arrows have been added to indicate Coast Guard Station, at left, and Lighthouse at right.

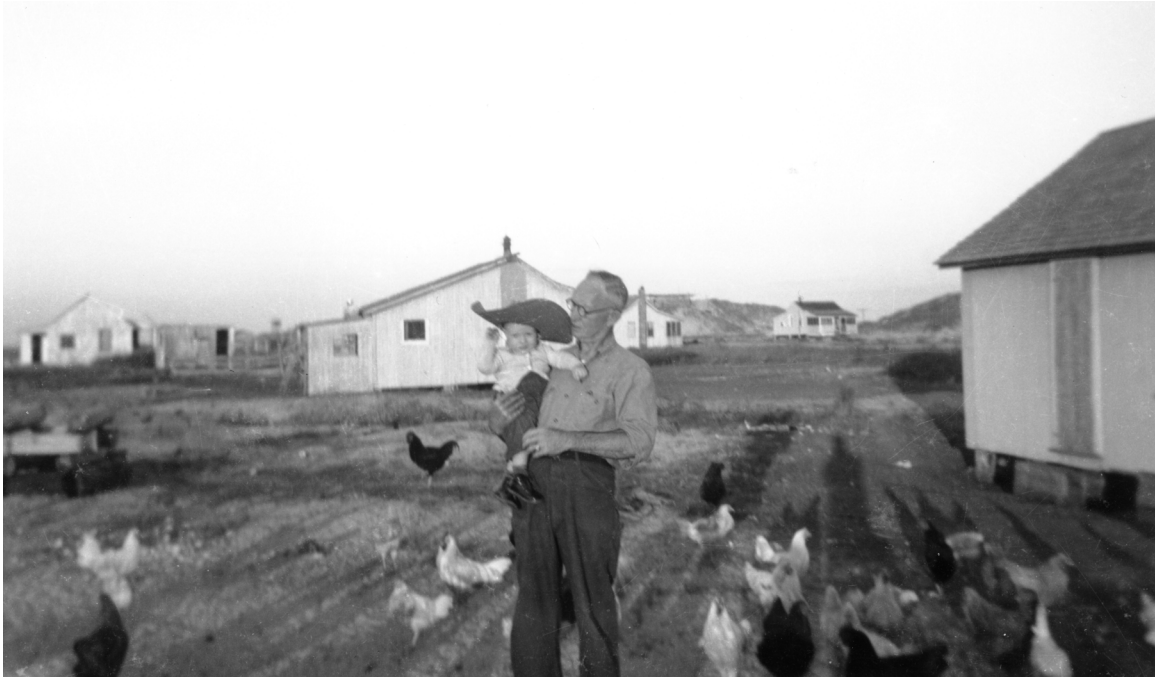
Figure 10 View of Cape Lookout Village, 1942. The Lewis-Davis House is out of view at left. (CALO Coll., Royer #4)

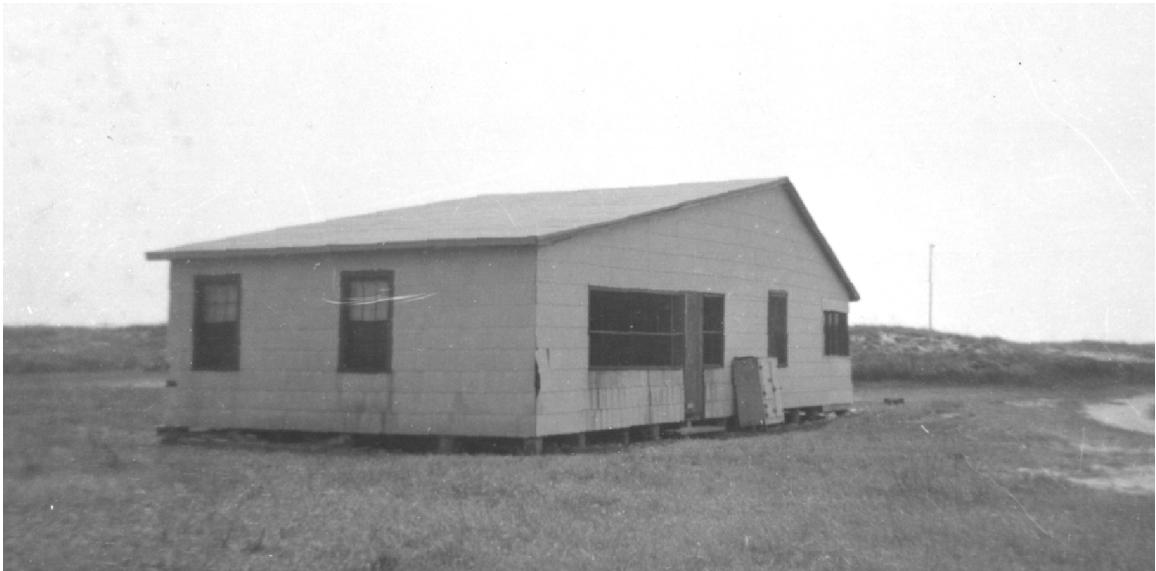
Figure 18 View to east of Lewis-Davis House in August 1958. (CALO Coll.)

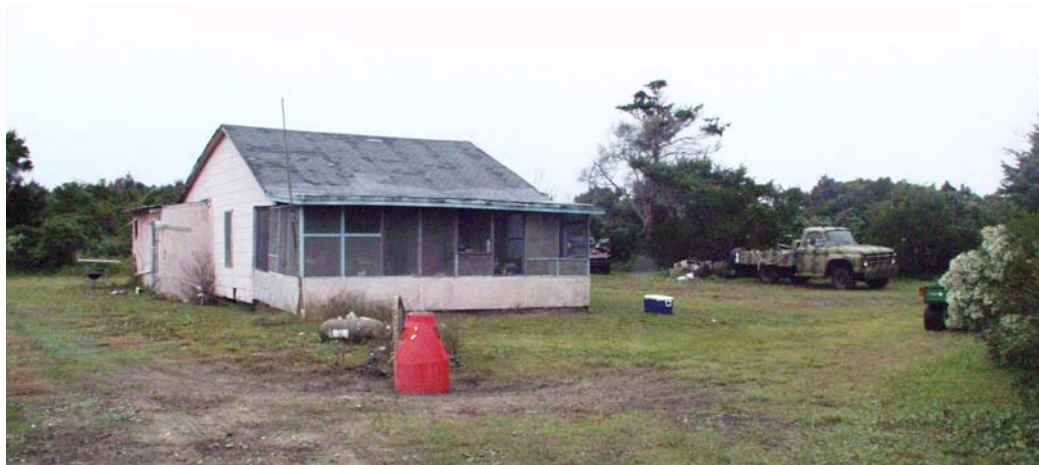
Figure 20 View to north of Carrie Davis House. (NPS-SERO-CR, 2002)

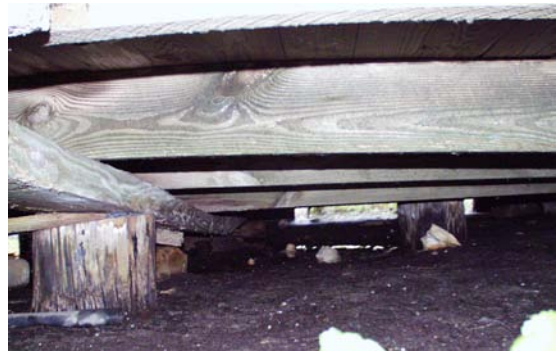
Figure 23 View of crawl space and piers. (NPS-SERO-CR, 2002)

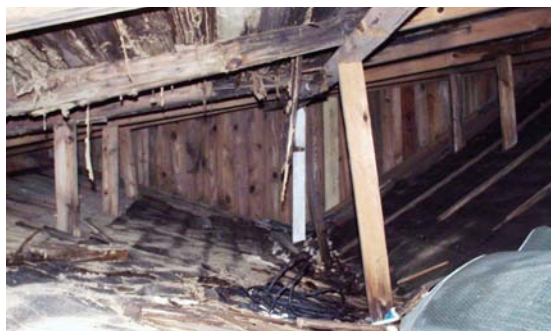
Figure 26 View of junction of roofs of two original structures; note severe termite damage in rafters and decking at left. (NPS-SERO-CR, 2002)

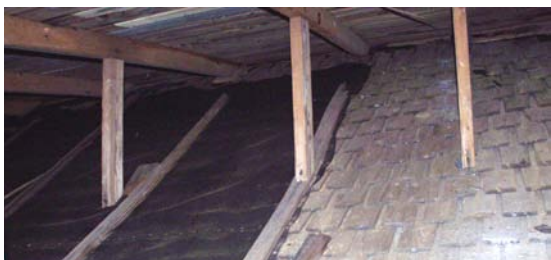
Figure 27 View of wood shingle roof on original structure encompassing Rooms 100 and 101. (NPS-SERO-CR, 2002)

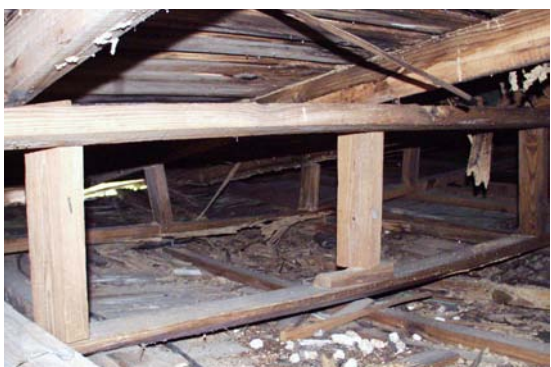
Figure 28 View of heavily-damaged roof and ceiling structure over Room 104. (NPS-SERO-CR, 2002)

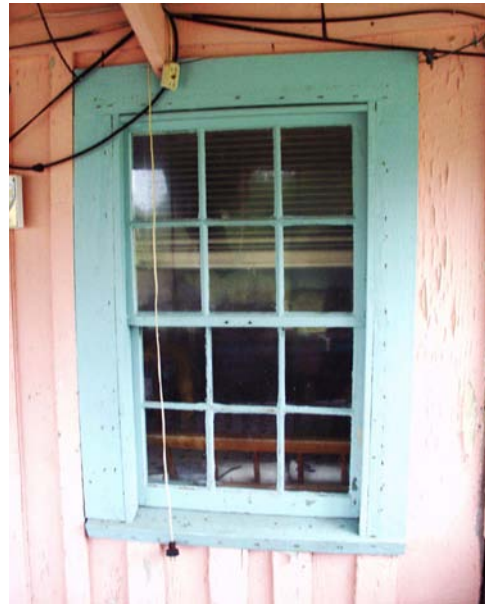
Figure 29 View of window W-2 on southeast (front) side of house, with exterior siding and trim typical of the original building. (NPS-SERO-CR, 2002)

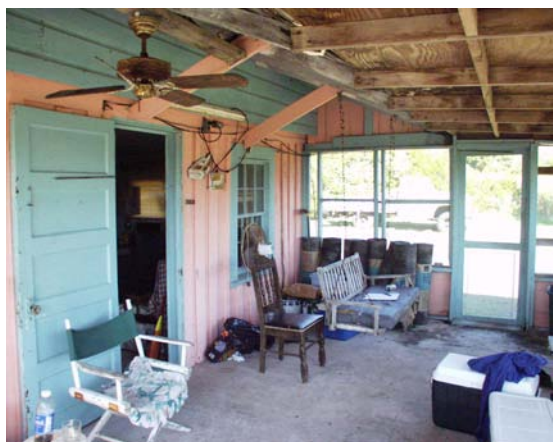
Figure 31 View to north on front porch. (NPS-SERO-CR, 2002)

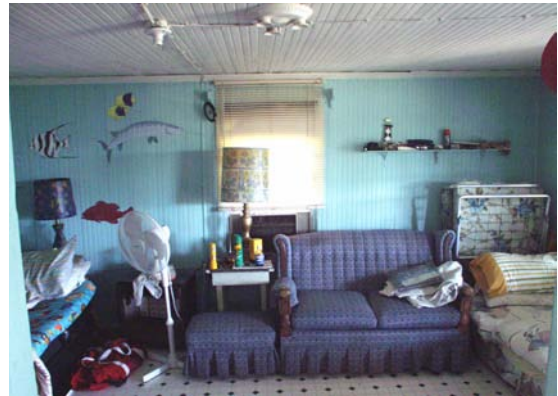
Figure 32 View to northeast in Room 100. (NPS-SERO-CR, 2002)

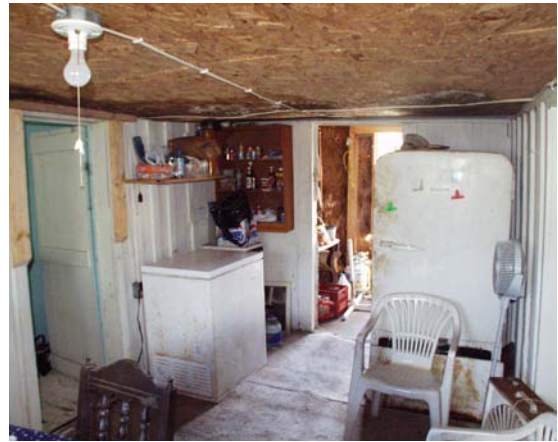
Figure 36 View to south in Room 102. (NPS-SERO-CR, 2002)

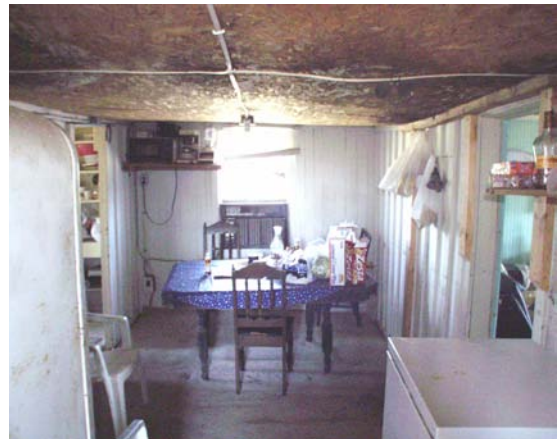
Figure 37 View to northeast in Room 102. (NPS-SERO-CR, 2002)

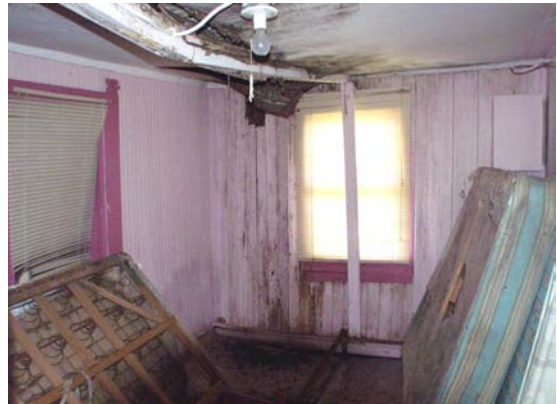
Figure 40 View to west in Room 104. (NPS-SERO-CR, 2002)

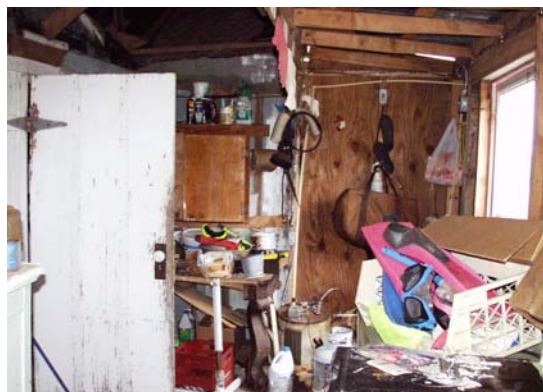
Figure 43 View to southeast in Room 105. (NPS-SERO-CR, 2002)
