Presidio Gate, Broadway Gate and Vicinity

Cultural Landscape Report

Presidio of San Francisco

October 1996

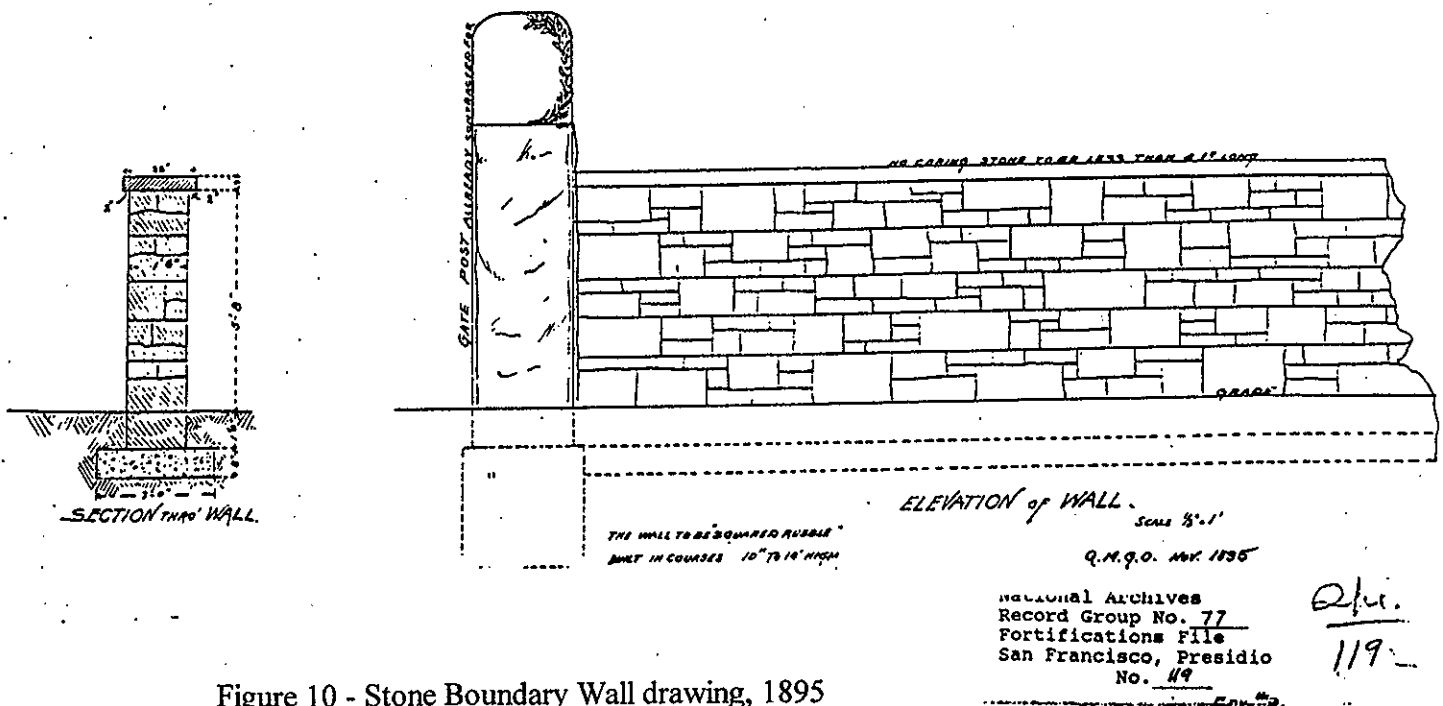
Figure 10 - Stone Boundary Wall drawing, 1895

The boundary wall is typically in good condition, an area on the east wall is missing, the coping and mortar joints need to be repaired in several areas.

The boundary wall is a key element to the historic landscape, for its definition of the Presidio, and for its quality of material and design. The stone boundary wall was constructed to "*prevent trespass by unauthorized persons and the unauthorized departure of soldiers of the post*" Major Wm. W. Harts, 1907. The walls should be repaired following the original design in form and materials.

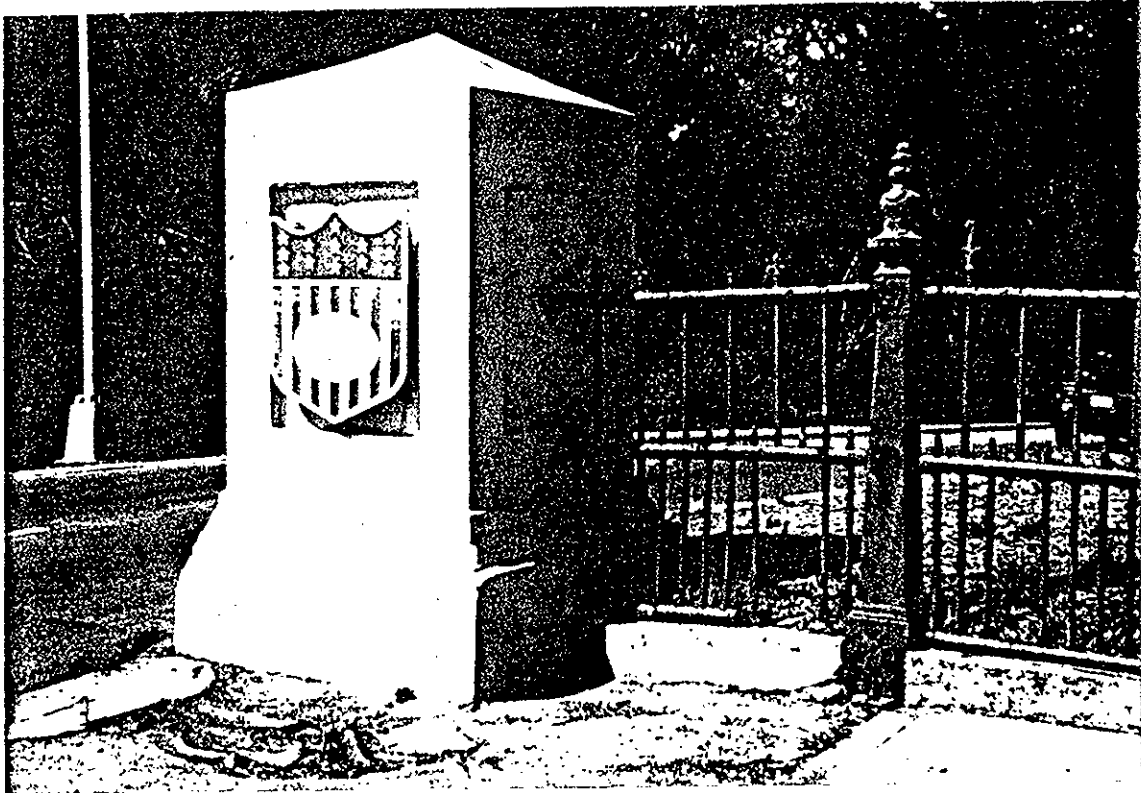
Figure 11 - Presidio Gate Masonry Pedestal

Today, the masonry pedestals have a thick stucco finish, buses are hitting the easternmost pedestal causing moderate damage to the base. The masonry pedestals are 19' apart at the base, extremely narrow for two buses to maneuver. The ornamental iron fence is moderately deteriorated, several pickets are missing, many of the finials are missing, decorative moldings from the iron posts are missing, many of the iron stringers are rusted away from the posts. The pedestrian gate is not the same gate as shown in the 1906 photograph, figure 3, it is unknown when this gate was replaced. The gate is moderately deteriorated, the connection to the masonry pedestal is missing. There is only one pedestrian gate, which is located on the west side of the entrance. Pedestrian and bicycle access from the east side is extremely dangerous, visitors must either cross Presidio boulevard or enter in the vehicular lanes. In either case view is obstructed by the masonry pedestals.

The road through the gate is 19' wide, minimum road width for buses to pass is 20'. The damage buses are causing to the pedestals is moderate at this time. As more vehicular traffic goes through the gate, the damage will become more severe. Design alternatives to reduce damage to the pedestals:

- A. Move the eastern pedestal to widen road to 22', the design standard for Presidio Boulevard. This solution would allow buses to pass and maintain the historic character of the gate. This solution would move the pedestal from its historic location.
- B. Keep the pedestals in existing locations, restore the cannon

bollards and iron vehicular gates, sign the gate as a narrow entrance. This solution would maintain the historic character and location of the gate. The width of the road would be less than 18', only one bus could pass through the gate. At this width, the gate becomes essentially a one lane gate.

C. Keep the pedestals in existing locations, add narrow curbs to both sides of the road, against the pedestals. This would add non-historic curb to the gate structure. The road width would be reduced to 18.5', extremely narrow for urban setting.

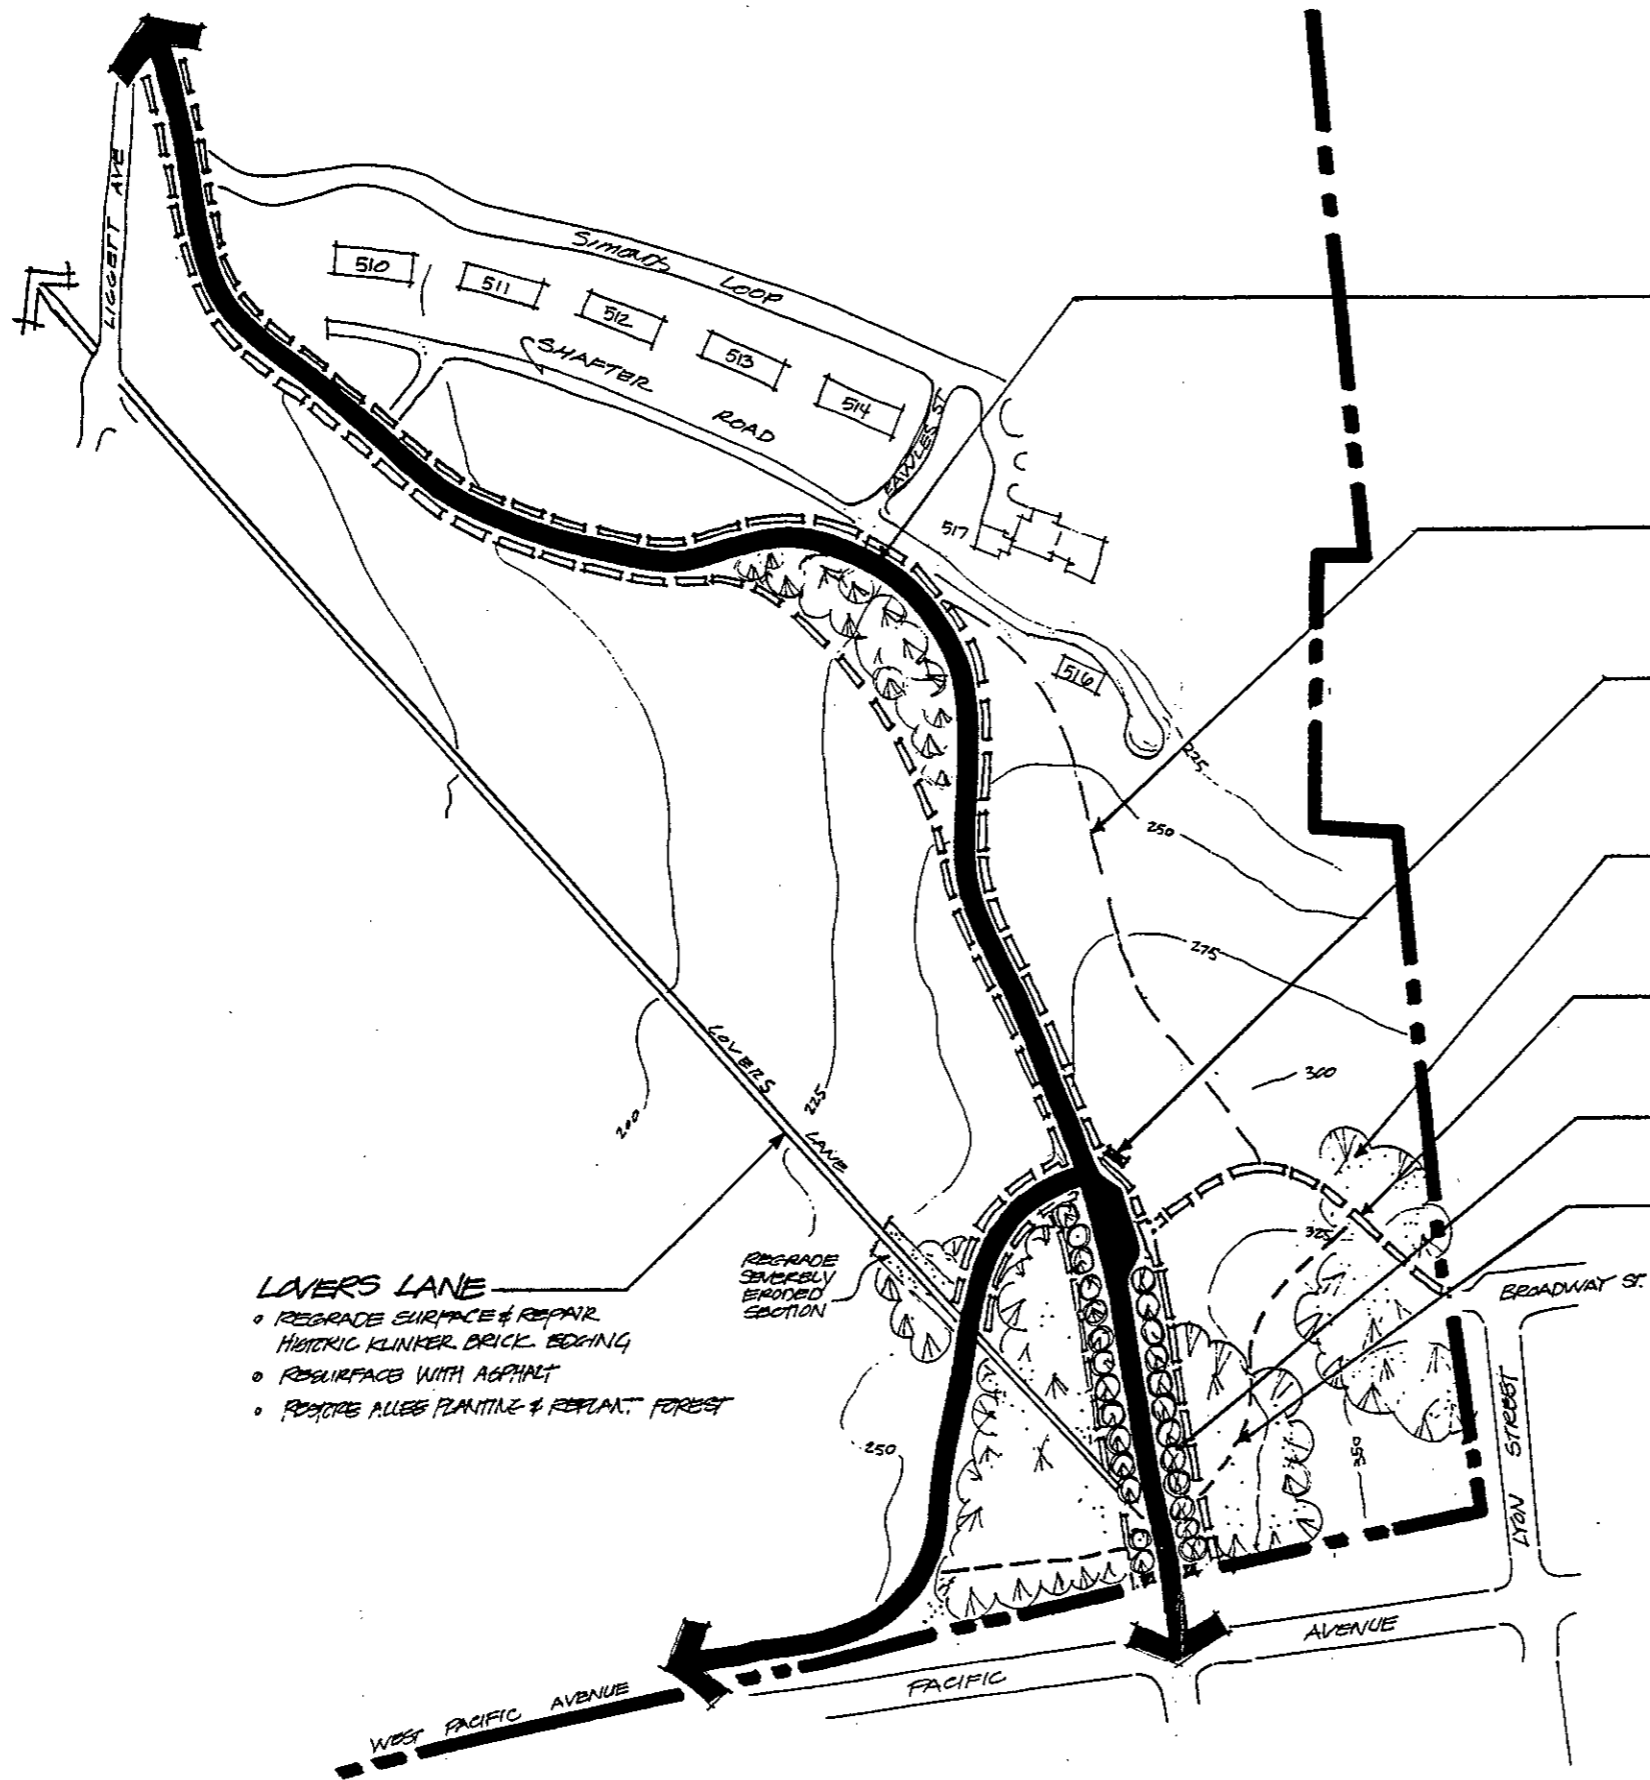
REGRADE SEVERELY ERODED SECTION

- LOVERS LANE**
- REGRADE SURFACE & REPAIR HISTORIC KLINKER BRICK EDGING
 - RESURFACE WITH ASPHALT
 - PROVIDE ALLEE PLANTING & REPLANT FOREST

- REPLACE EXISTING GUARDRAIL WITH NPS WOOD GUARDRAIL
- REDUCE LANE WIDTH TO 11' LANES AND 4' BIKE LANES/SHOULDERS
- REMOVE WOOD FENCE
- MAINTAIN SPLIT WEST SIDE BIKE LANE AT CURVE
