Steam Schooner  
**WAPAMA**  
 HISTORIC STRUCTURE REPORT  
 1986

Steam Schooner  
**WAPAMA**  
HISTORIC STRUCTURE REPORT

1986

**Tri-Coastal Marine, Inc.  
(White Elephant Management)  
2104 Strand, Galveston, Texas, 77550**

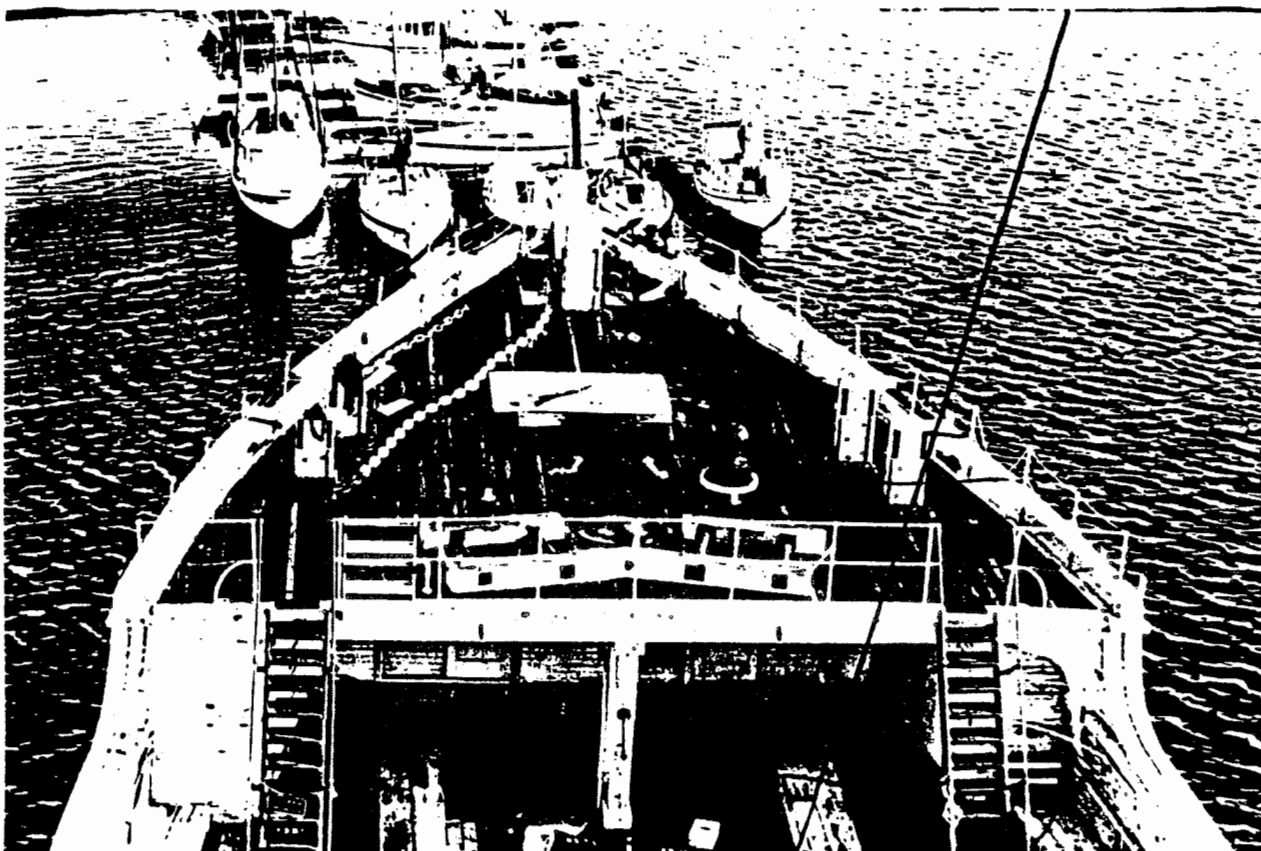
Fig. 10. View of forecastle head deck. Sliding doors to forecastle are visible under overhanging after end of deck. Note winch foundations at after end of deck. This deck is now covered by a roof structure. --Photo, TCM

In order to achieve even the modest goal of public access, the forecastle head deck would have to be rebuilt, including replacement of deck beams, clamps, planking, bulwarks and covering boards. Remounting of the mast and deck gear would require additional work to further support the forebody. Alternately, this deck could be preserved as is by extending weather protection and treating existing rot, though public access would have to be limited.

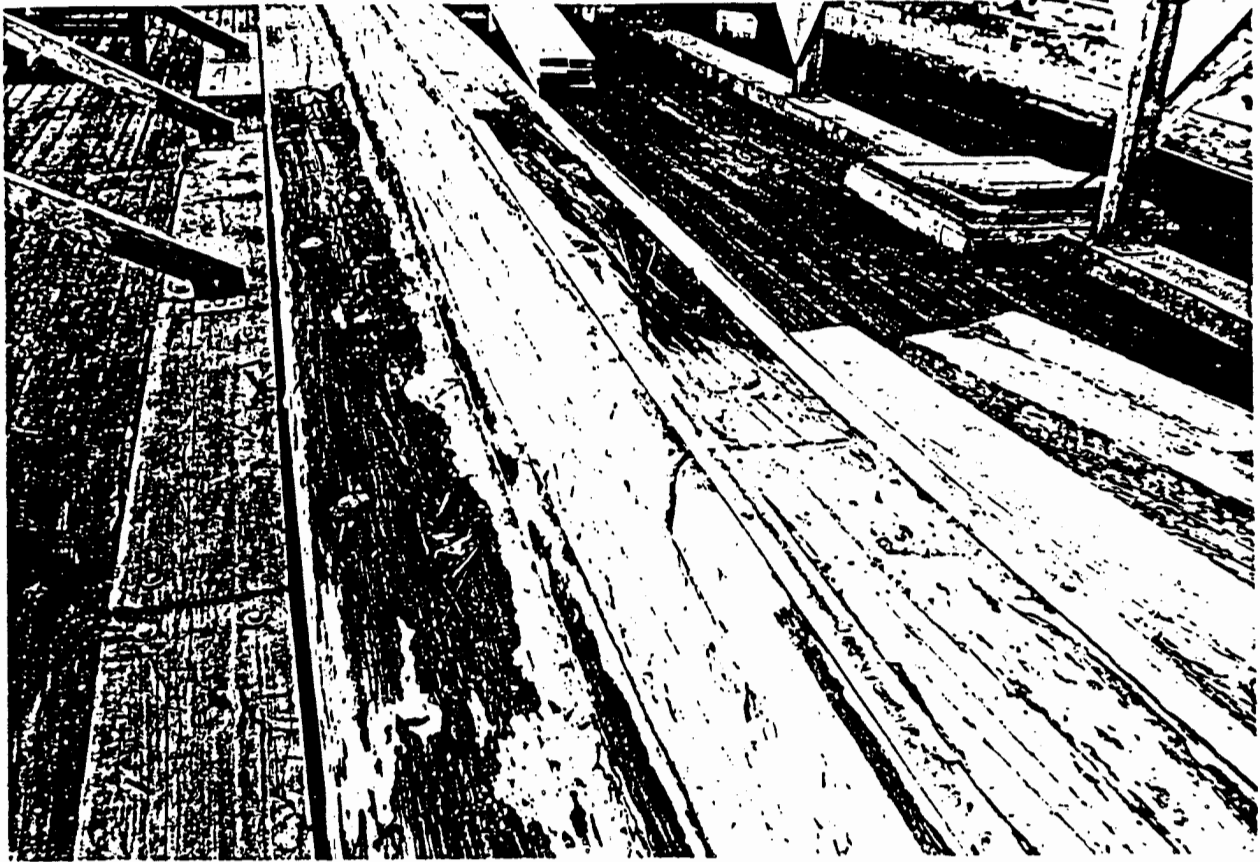
Fig. 12. View of main deck, port side, showing deck stringer and side stringer, area of severe rot localized around fastenings. Note former deck opening at samson post partners, upper right of photo. Beginning of main deck roof structure seen alongside side stringer. --Photo, TCM

An alternative preservation method would be renewal of all major members of the deck, as well as the deck planking. This would necessitate replacement of approximately 20 deck beams, as well as waterway timbers, deck girders and possibly some frame futtocks. The relative advantages of this alternative are discussed in section VI.D.6, Structural Renewals.

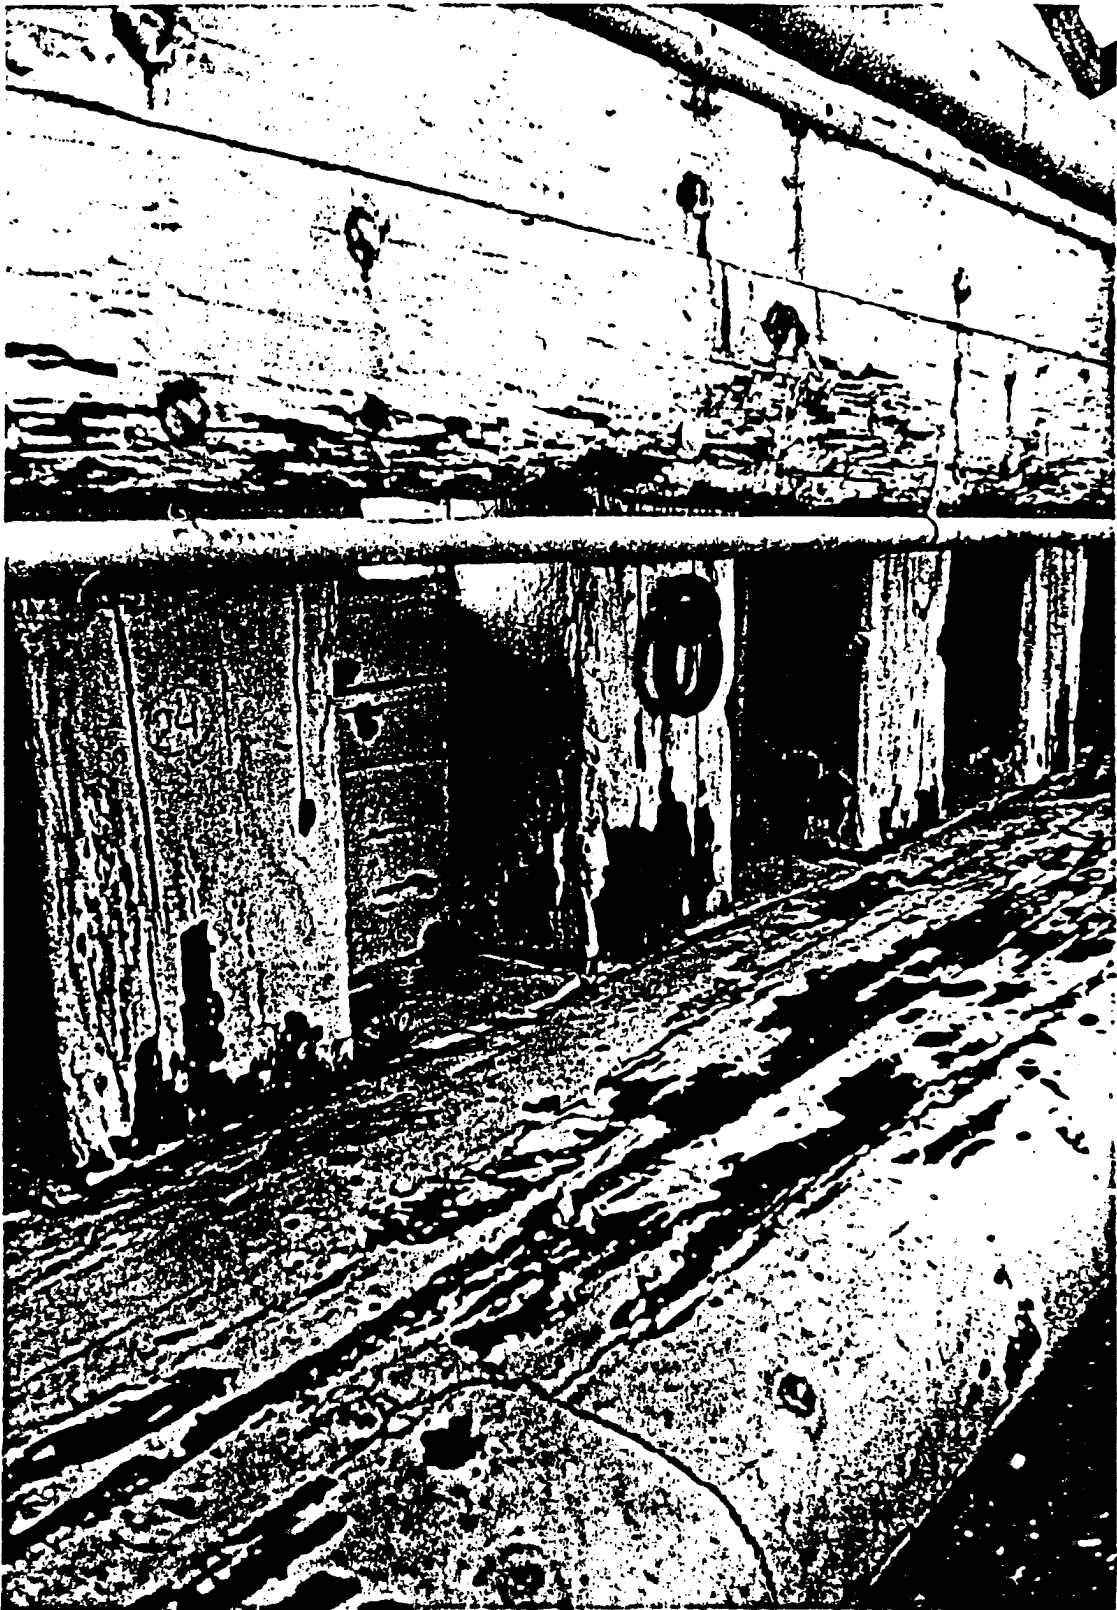
The bulwarks retain adequate strength to stay in place and are not a safety concern at this time. Extensive deterioration seen in the bulwark stanchions present a problem for interpretation. As in the early 1960s, these rotten timbers could be patched with cement or similar filler material, though this would be a stopgap measure and would do nothing to arrest ongoing rot. Any major rebuilding of the main deck should include renewal of at least some of the deteriorated stanchions. A rebuild of the bulwarks would necessitate loss of most of the weathered original fabric, such as the inwales, which are illustrative of the hard working life of the vessel.

Fig. 13. Deteriorated bulwark stanchions. Most severe rot is seen at the waterway timber, where moisture remains trapped.  
--Photo, TCM

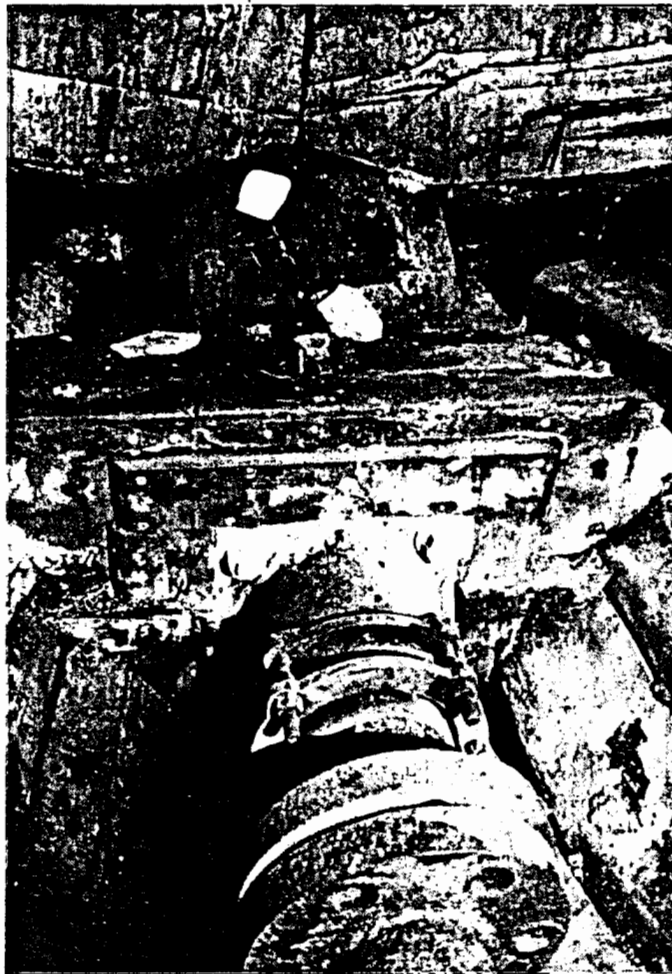
The afterpeak is, by design, not suitable for public access or viewing. Most of the deterioration seen in this compartment is old, though seepage through the main deck will eventually cause additional damage. A major concern in this area of WAPAMA is the movement seen in the stern section. Additional shoring will be needed under the counter in order to prevent further collapse of the structurally weakened stern. To help prevent further decay in the afterpeak, seepage should be stopped by repairing or covering leaking areas above. Forced air ventilation will also help to slow decay by moving stagnant air in this enclosed space.

Fig. 23. Afterpeak, looking aft; stuffing box and shaft coupling. Pointer butt is seen over horn timber at top of photo. Note offset in coupling due to hull distortion. --TCM

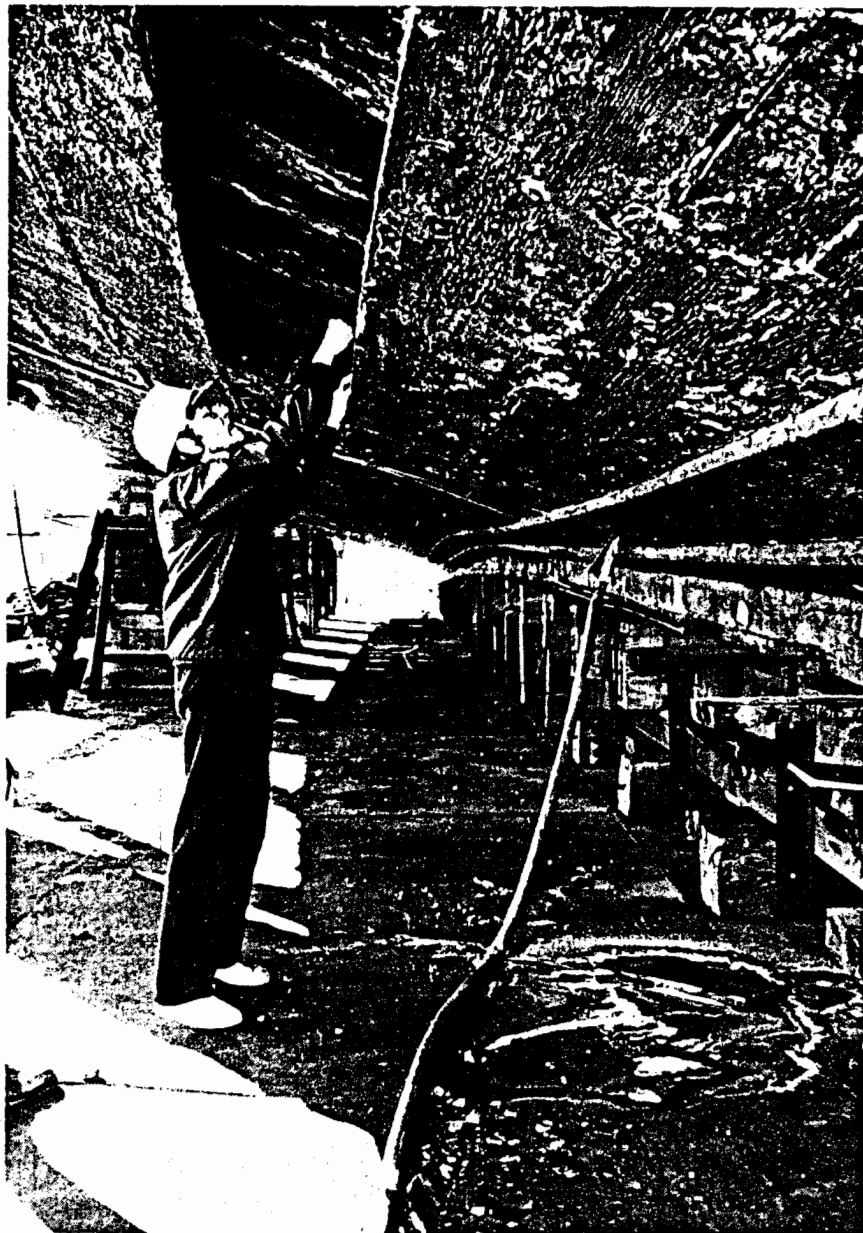
Approximately 40% to 50% of the iron spike plank fastenings show moderate nail sickness extending 1" to 2" around fastenings, and up to 3/4" deep. Most trunnels are still effective, though a few are seen to be partially decayed or abraded at the plank-to-frame faying surface.

Fig. 32. Bottom, stbd side, on barge, Nov, 1985. Double-sawn frames may be seen where planking has been removed (see Fig. 33). Note hog in keel. --Photo, TCM

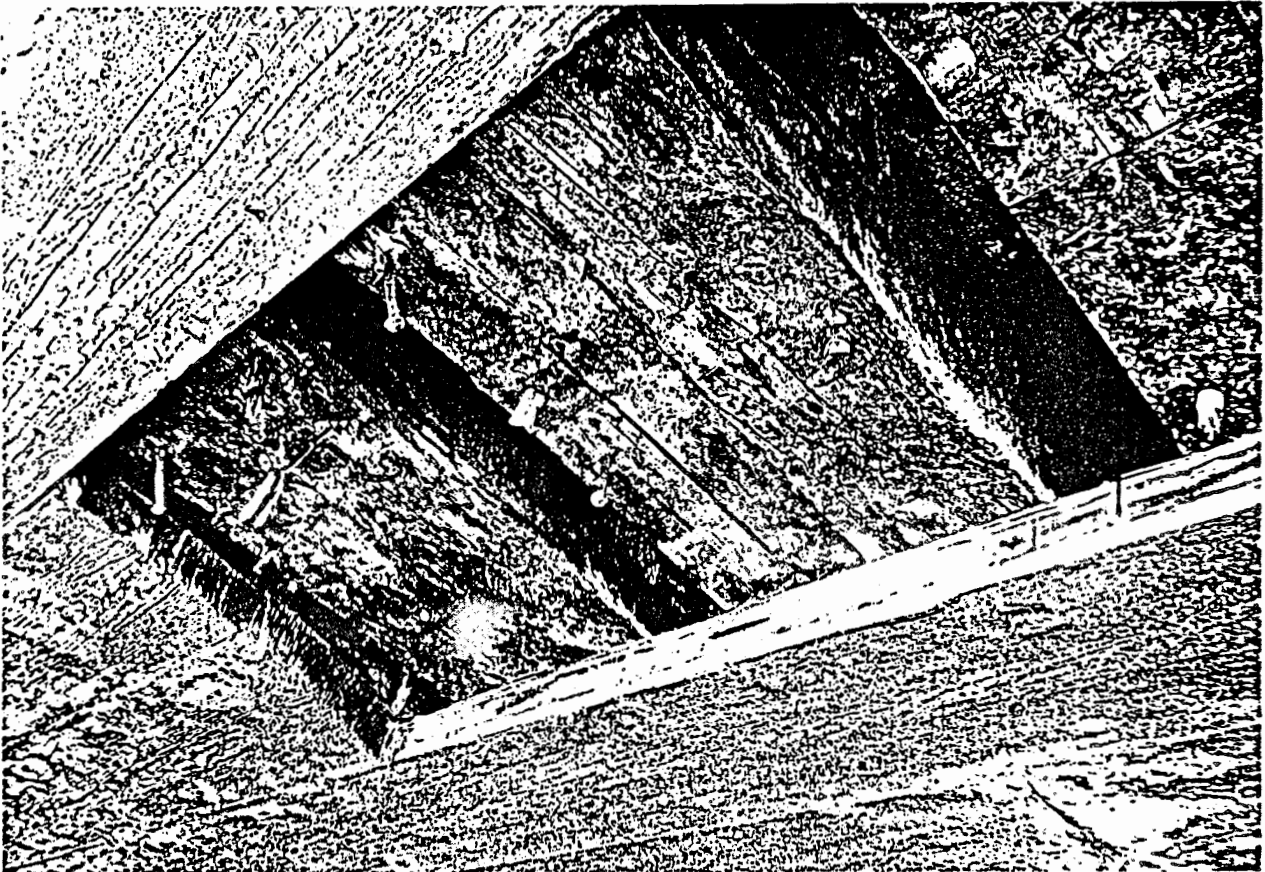
Fig. 33. Section of bottom planking removed for inspection during 1982 survey. Double-sawn frames can be seen with iron spikes and trunnels (wooden planking fasteners) projecting. --Photo, TCM

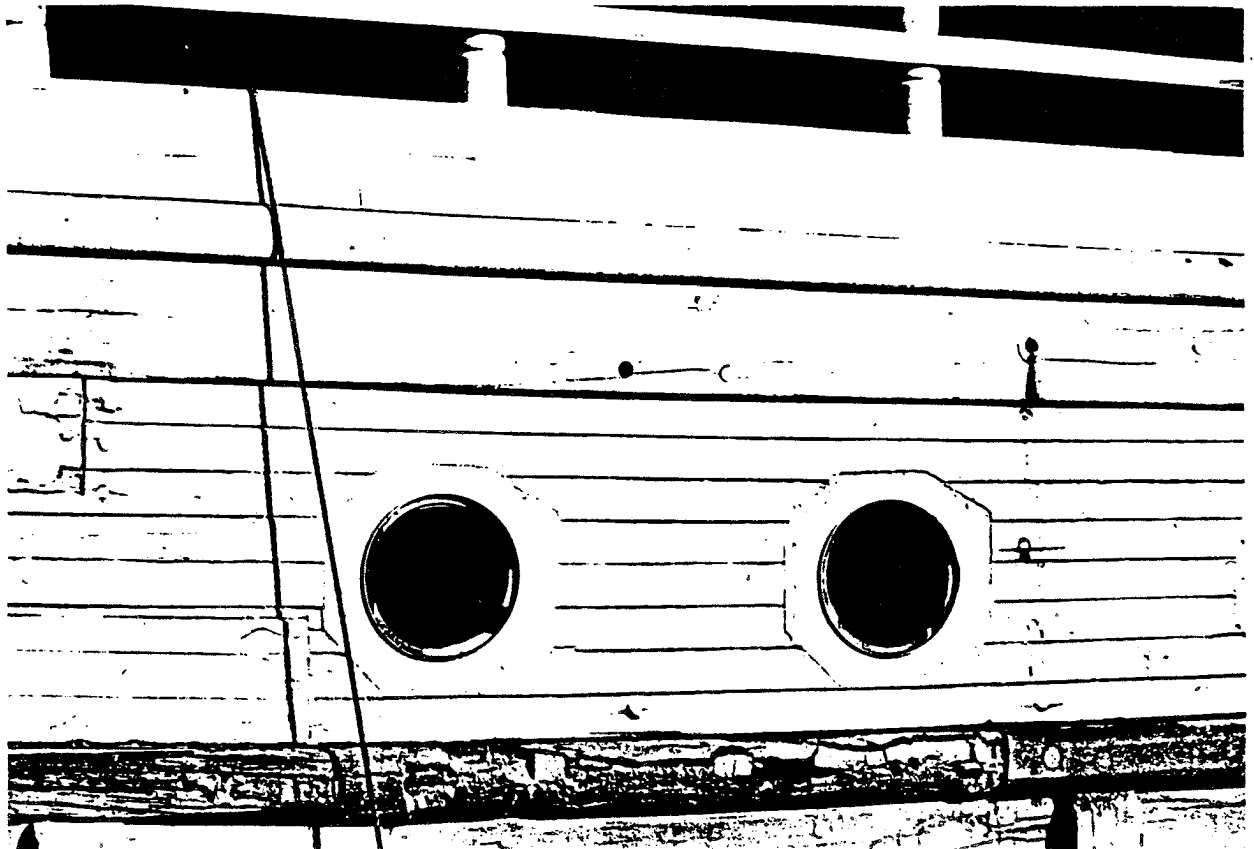
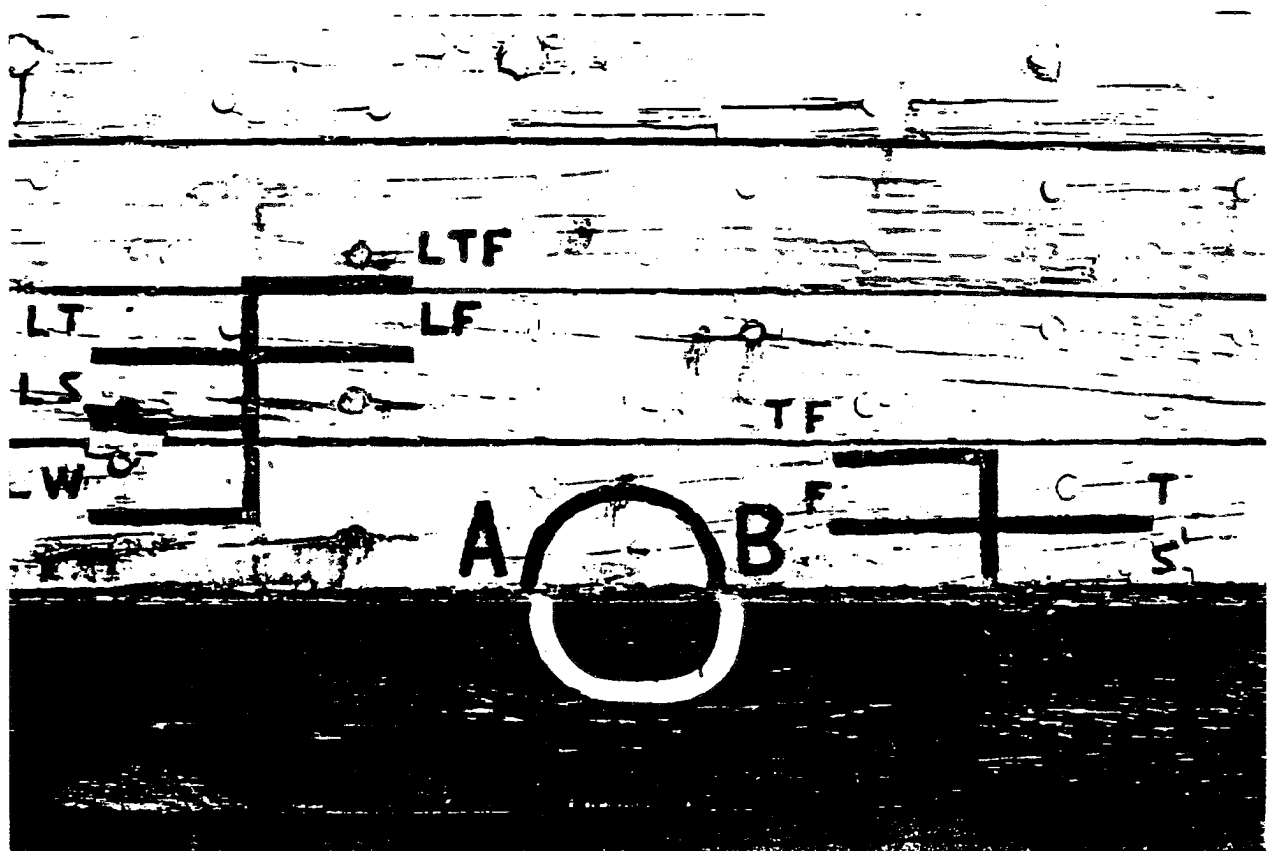
Fig. 34. View of starboard quarter showing decay in  
 rubstrake. Fig. 35. (below) Topsides at midships. Note  
 open seams in topside planking. --Photos, TCM

The hull is presently in need of additional support, particularly at the bow and stern. In the short term, this can take the form of additional wood shoring, though in the long term, interpretation would be best served by an engineered support system.

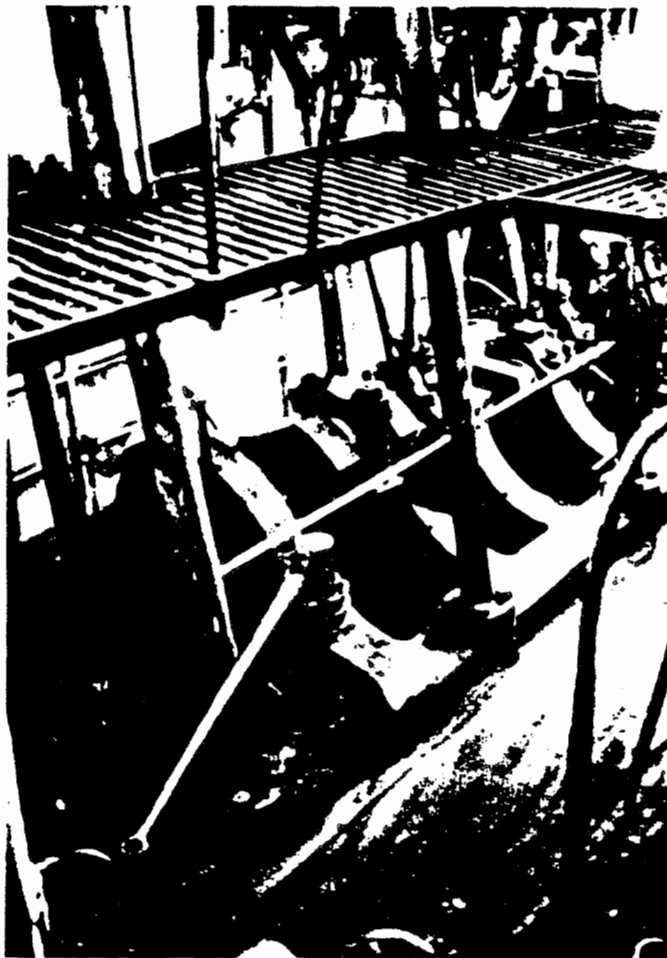
Fig.38. Main engine bed and crank shaft, port side looking fwd. Note worm-drive manual jacking gear in center of photo. Fig. 39. (next pg.) Aft side boilers, looking to port. Doors have corroded away, exposing boiler tubes. --TCM

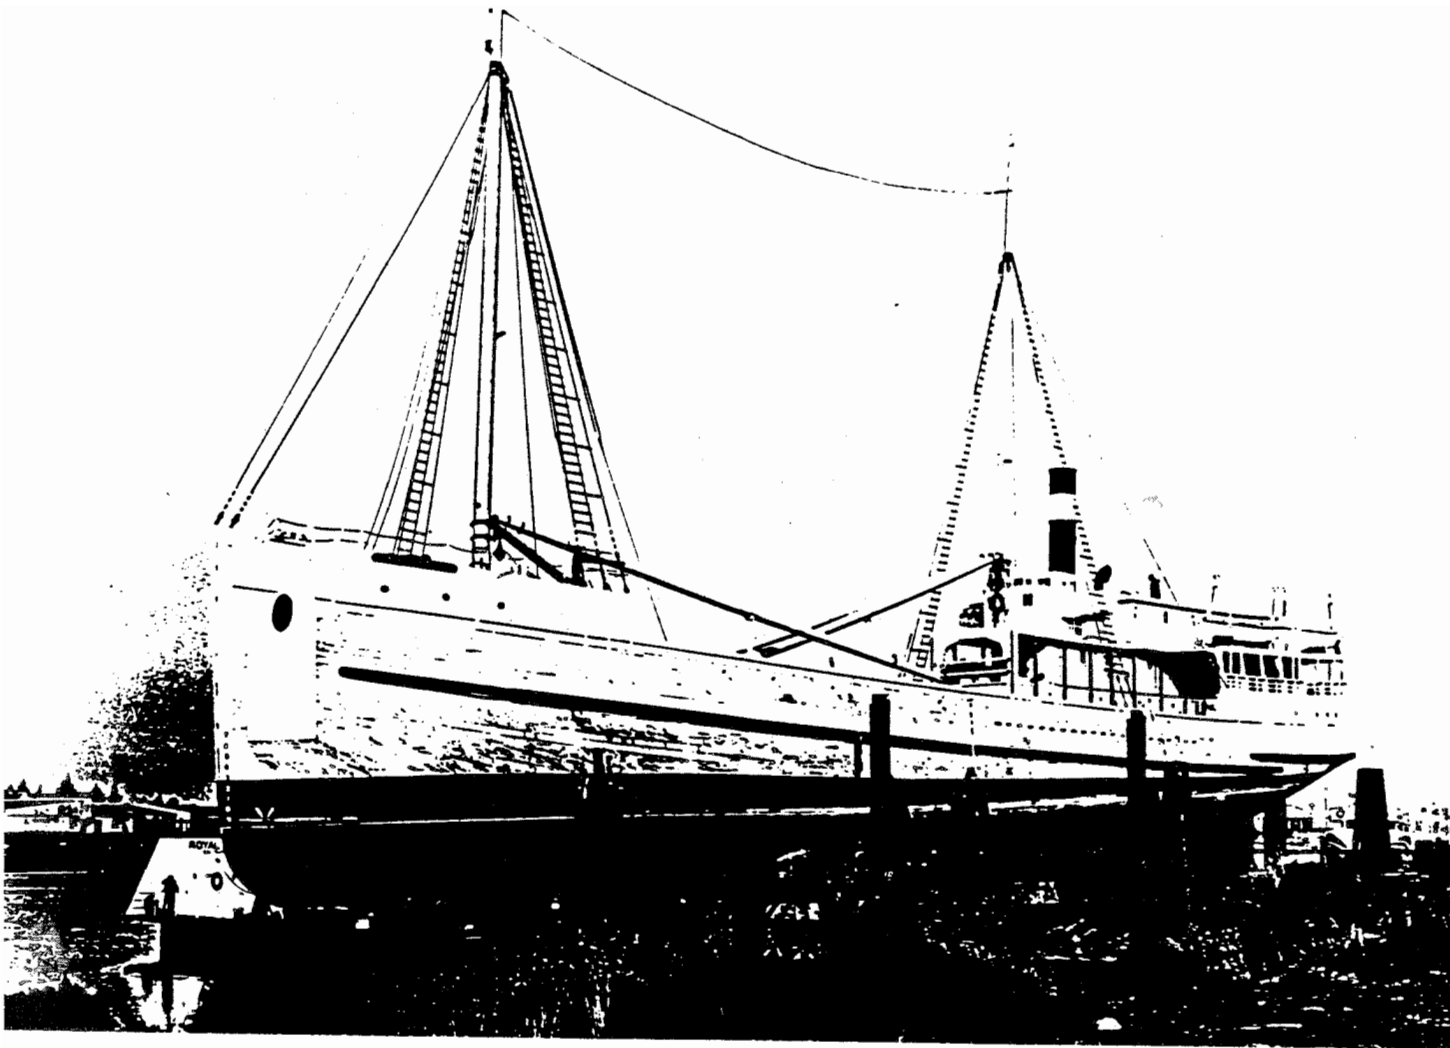
Fig. 42. WAPAMA on Barge 214 in 1980. This photo gives a good idea of the area of underwater hull relative to exposed decks and topsides. The badly weathered and rotten topside planking is visible, but the deckhouses still appear in fair condition. The masts and booms have not yet been removed and the slack in the spring stay may be indicative of the degree of hog that settled out when she was drydocked. --Photo, NMMSF

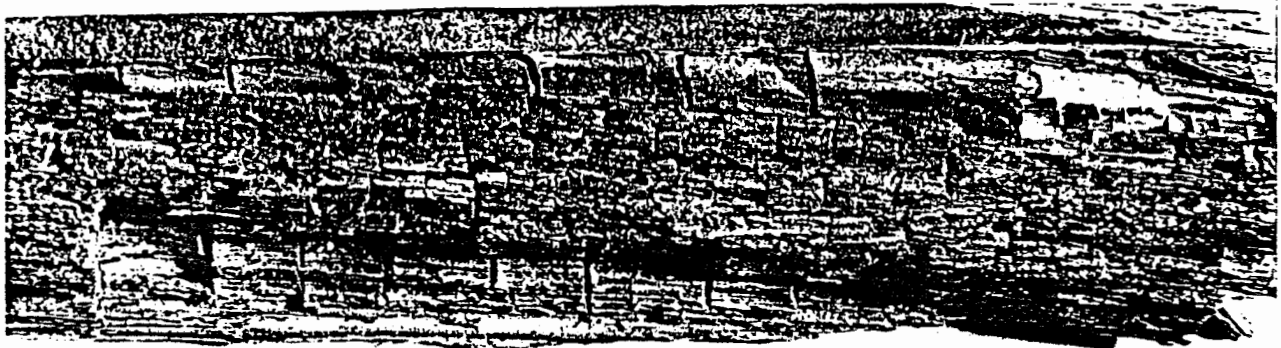
Fig. 46. Typical occurrence of brown rot decay. Sample section from covering board, port side of main deck. TCM

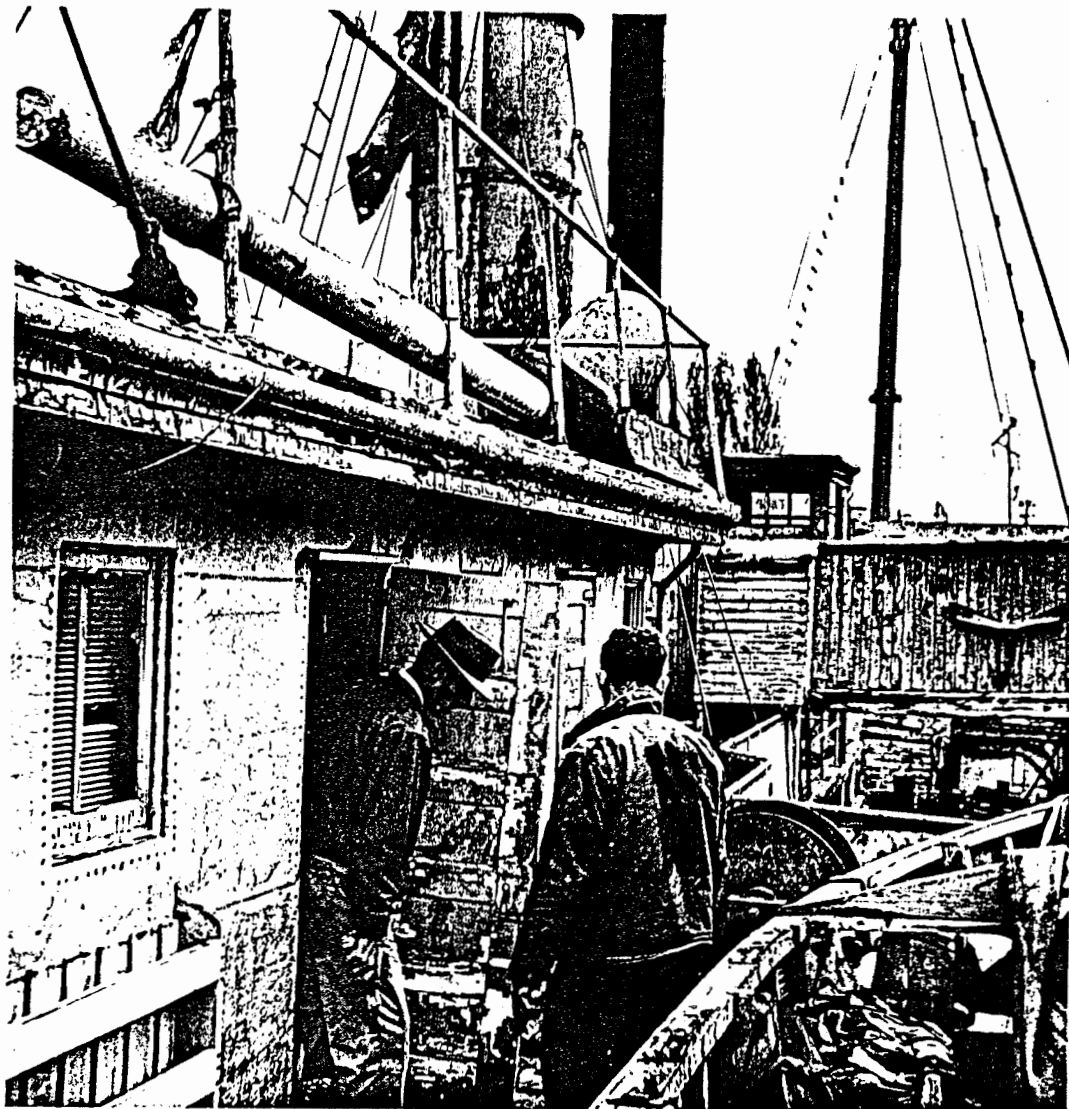
Fig. 54. WAPAMA in the 1950s, before initial restoration had begun. The canvas tacked over the deck house siding bespeaks an attempt to deal with rot and leaks that were present before she was laid up in 1947. The effects of years of lay up with no maintenance are plainly visible. The deck house had to be completely rebuilt in 1960.

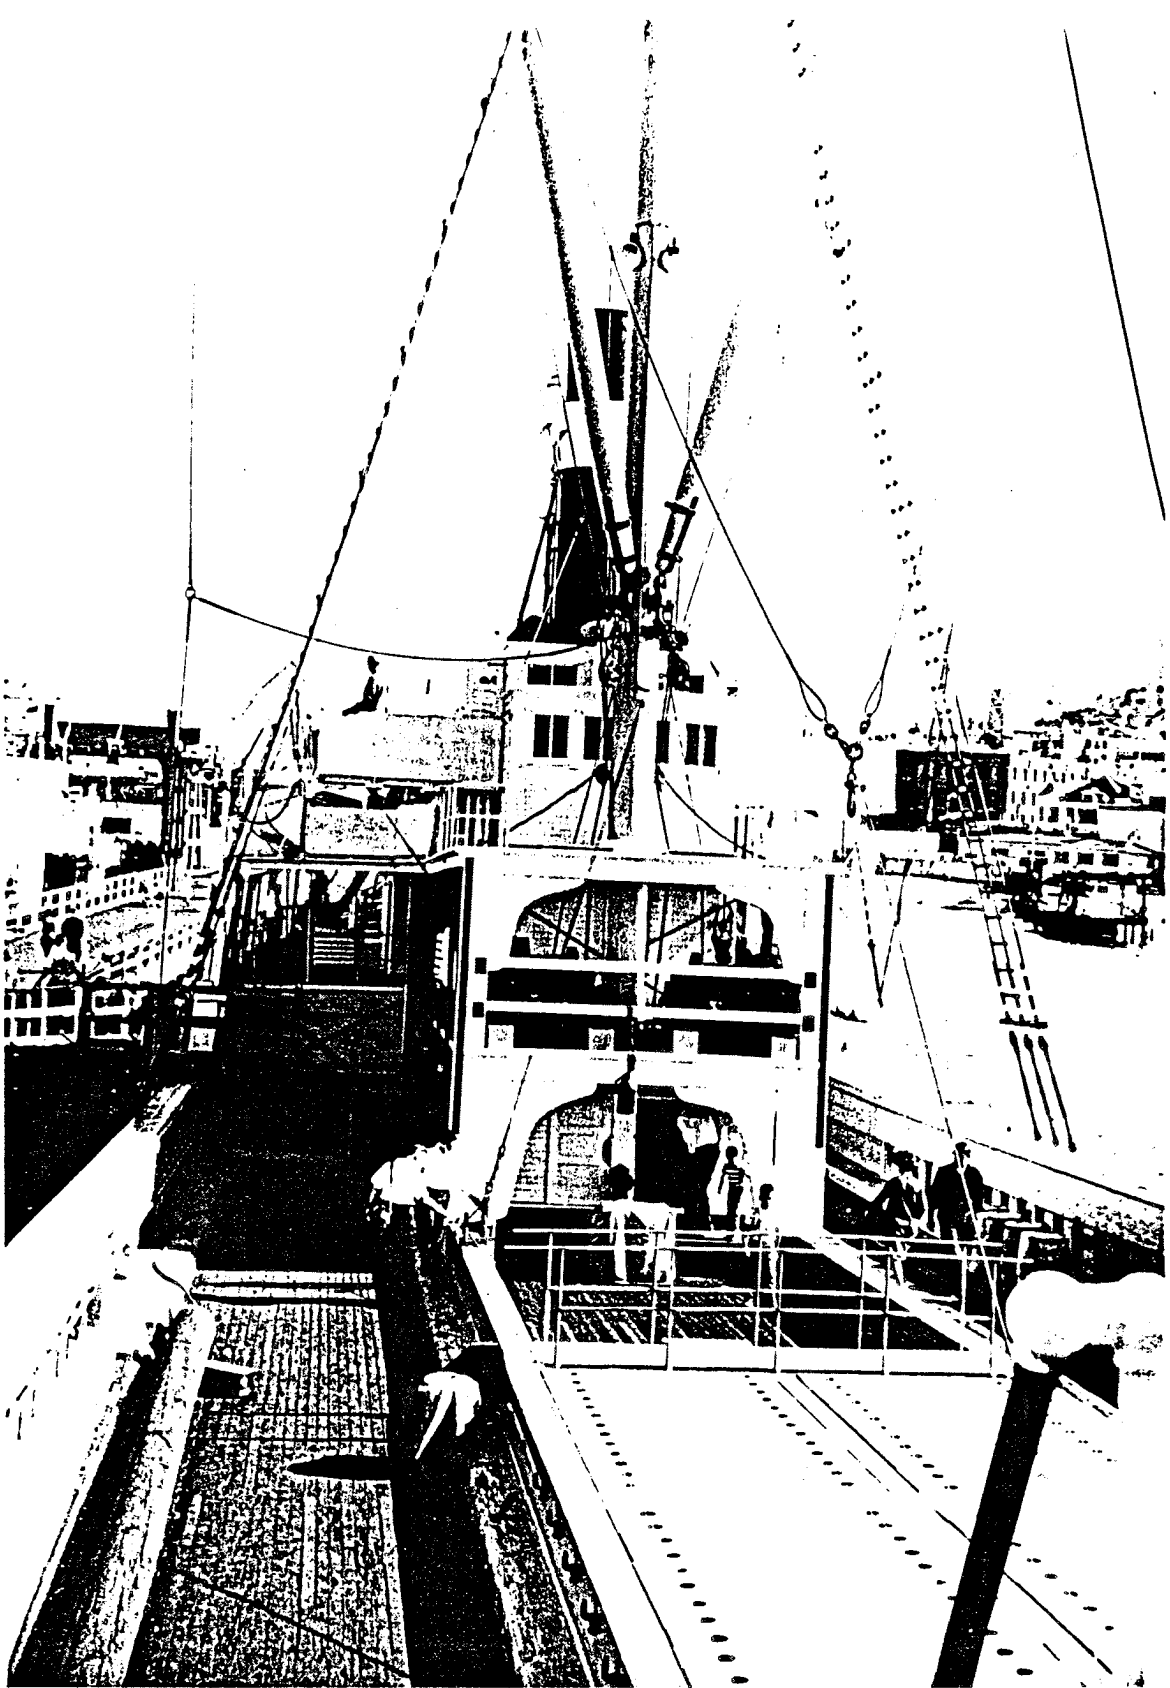
Fig. 55. Wapama in the 1960s. Her rigging is in place and functioning; she is well interpreted, and has a glistening coat of paint. She has undergone considerable restoration, but deterioration is here evident in her main deck. Rot is progressing.
