# HISTORIC STRUCTURE REPORT

## JAMES MORSE HOUSE LINCOLN HOME NATIONAL HISTORIC SITE SPRINGFIELD, ILLINOIS

HISTORICAL DATA SECTION  
ARCHITECTURAL DATA SECTION  
EXTERIOR RESTORATION PROPOSAL

HISTORICAL ARCHITECT ALAN W. O'BRIGHT  
OFFICE OF PLANNING AND RESOURCE PRESERVATION  
DIVISION OF CULTURAL RESOURCES MANAGEMENT  
NATIONAL PARK SERVICE  
UNITED STATES DEPARTMENT OF THE INTERIOR  
OMAHA, NEBRASKA

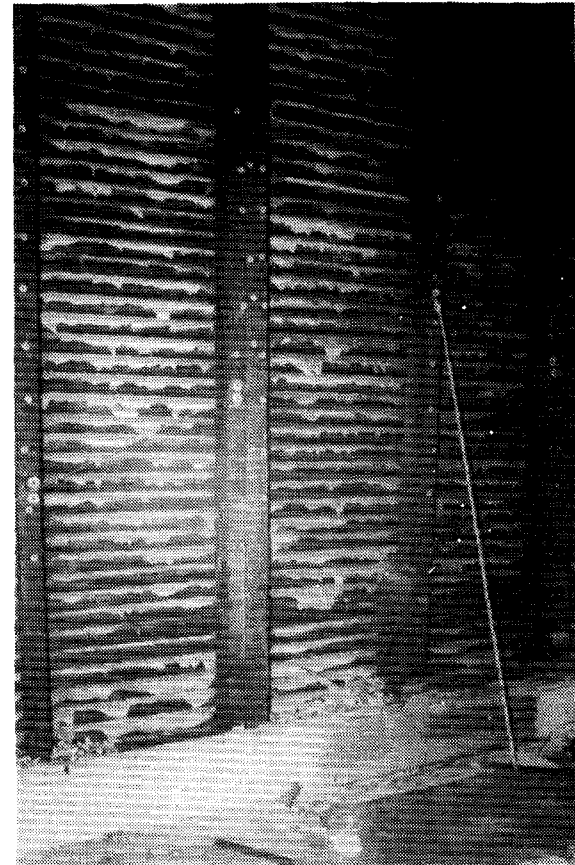
North wall of Room 204 showing pitch of the former  
south wing roof line and sealed window.

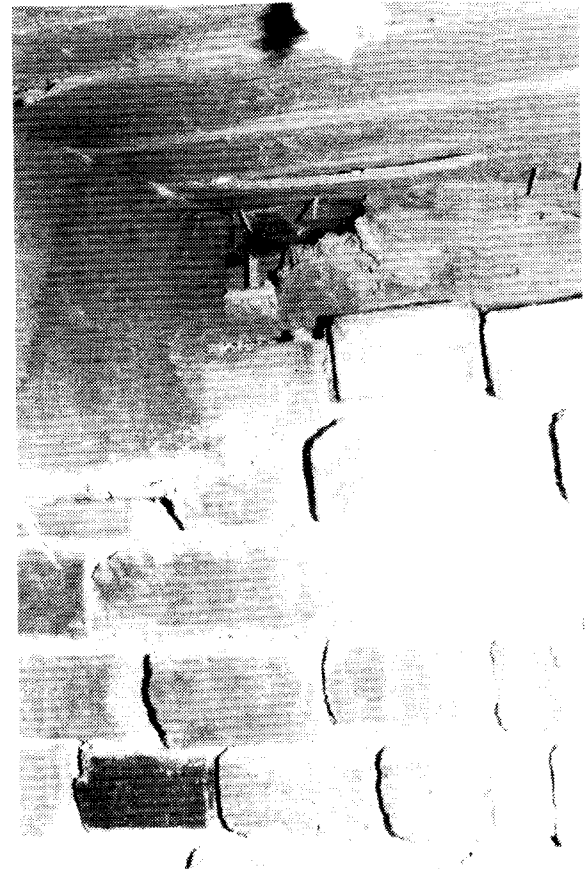
View of the south wall of Crawlspace (002) at the  
mud sill. Note the deteriorated joist end and sill  
pocket. This condition is typical of nearly the  
entire south wall.

The mud sill at the eastern half of the south wall of Room 002 is decayed. Water probably infiltrated the wall before the adjacent porch was enclosed to form a foyer and stairhall. Many of the joist pockets and ends are gone (see Figure No. 12).

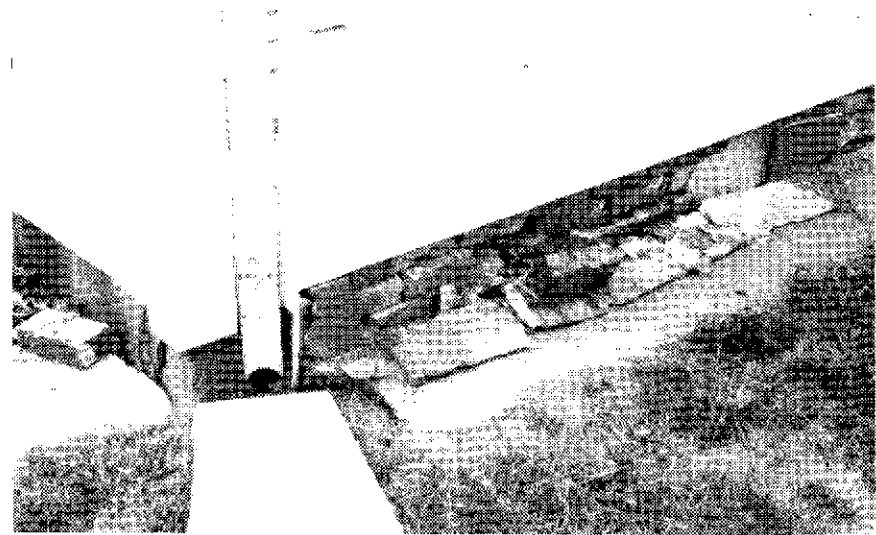
Pargetting was troweled to all exposed surfaces of the foundation at the exterior. The mortar is very hard and is virtually impossible to remove without severely damaging the brick and mortar joints. Some has spalled at the exterior southwest corner of Crawlspace 006 due to an unrepaired downspout and freeze-thaw cycles. The mortar bonded so well that whole bricks have fallen out with sheets of the mortar still clinging (see Figure No. 13).

View of the exterior southwest corner  
of Room 107 showing deteriorated brick  
foundation and flaking of siding paint.

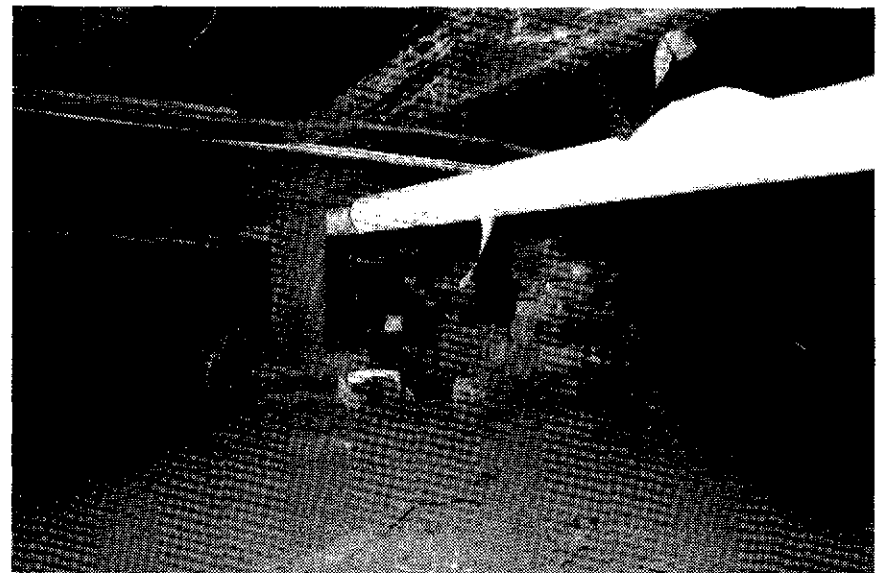
FIGURE NO. 14

View to the northeast in Crawlspace (002)  
showing termite damage to floor joists,  
beam supported by mechanical pipe, and  
brick piers supporting a single floor  
joist.

The 2- by 8-inch oak joists beneath Rooms 102 and 103 have been damaged by termites over their entire length (see Figure No. 14). The termite damage, an added interior partition, a concrete topping to the floors, and 16-foot joist spans have added an immense strain on the floor's structural system. The termite damage emanates from the north foundation wall of Crawlspace 002. The materials' advanced age may be responsible for mortar joint failure at the mud sill along the south foundation wall of Room 002 (see Figure No. 12). Previous owners attempted to shore up the joists at mid-span. Dry-laid brick and concrete block piers were constructed beneath the partition separating Room 102 from Room 103. A 4- by 4-inch beam in Room 002 at mid-span is supported at both ends by mechanical system piping (see Figure No. 14). Similar measures were taken in Crawlspace 001. The remainder of the joists on the first floor are in good condition.

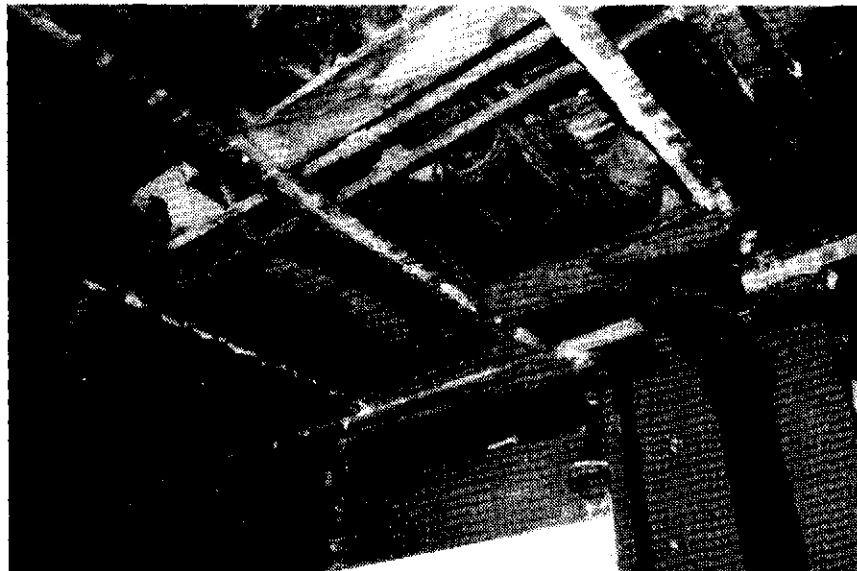
View of the ceiling at the east wall of Room 104 showing the plumbing tree to the second floor bathroom, and the poorly constructed header over Door 104-D1. Note also the wall plate cut to accommodate the waste stack.

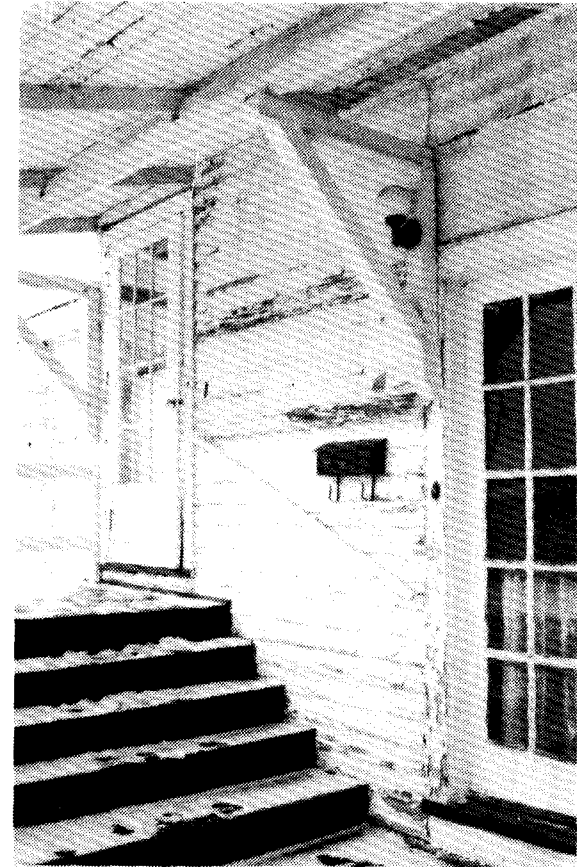
View of the east exterior elevation beneath  
Porch (111) roof showing water damaged paint  
finish and siding.

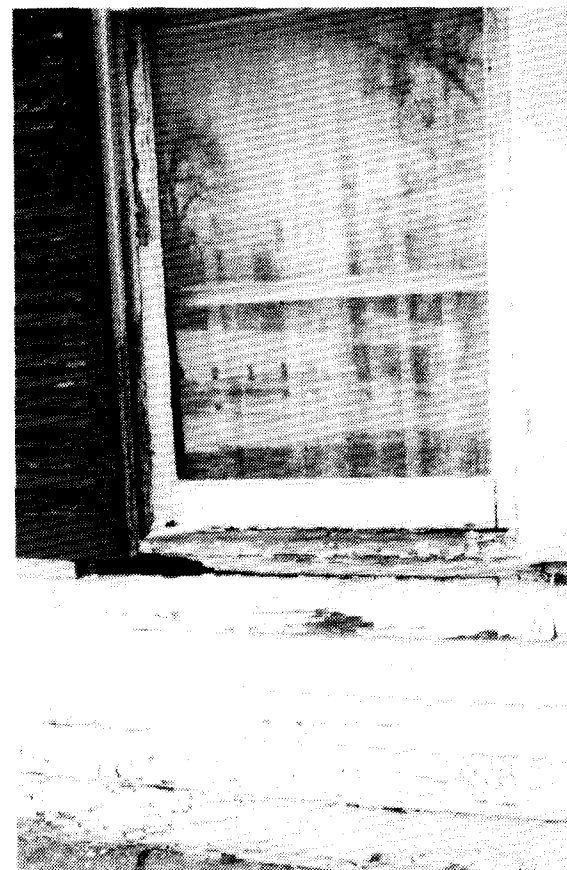
Exterior view of Window 101-W1 showing extensive  
deterioration of sill and jamb. Most windows  
throughout the structure are in poor condition,  
similar to the one shown.

include rotting at all wood components, sash painted shut, dried out and cracked putty, misaligned sash, and weak or totally rotted joints (see Figure No. 21). Other than sash weights and spring loaded sash pins, no historic window hardware remains. Factory built aluminum triple track storm and screen units have been installed by contractors at the interior frames of all windows. No wood screen or storm windows exist.

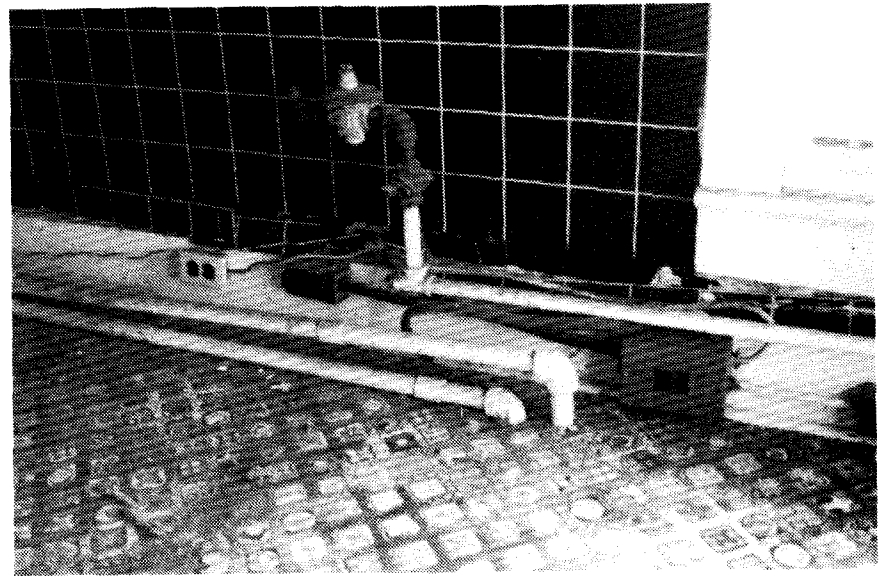
View along the south wall of  
Kitchen (206) showing the dangerous  
condition of the electrical system.  
Also shown are mechanical pipes, and  
a gas supply pipe with valve.

The meter and breaker panel replaced fuse boxes in 1978. Insulated branch circuit cable was installed at various times since 1926 and is in a dangerous operational state (see Figure No. 22). There are a variety of receptacle types, few of which appear to meet current code standards. There are a variety of types and ages of light fixtures, wall and ceiling mounted, none of which is noteworthy. General service to the house is currently shutdown to reduce the chance for fire, although one receptacle in the basement remains active and the fire detection system is switched on at the main breaker panel box.
