HISTORIC STRUCTURES REPORT

PART I

BUILDING NO. 2 - MEMORIAL SHAFT

Perry's Victory and International Peace  
Memorial National Monument

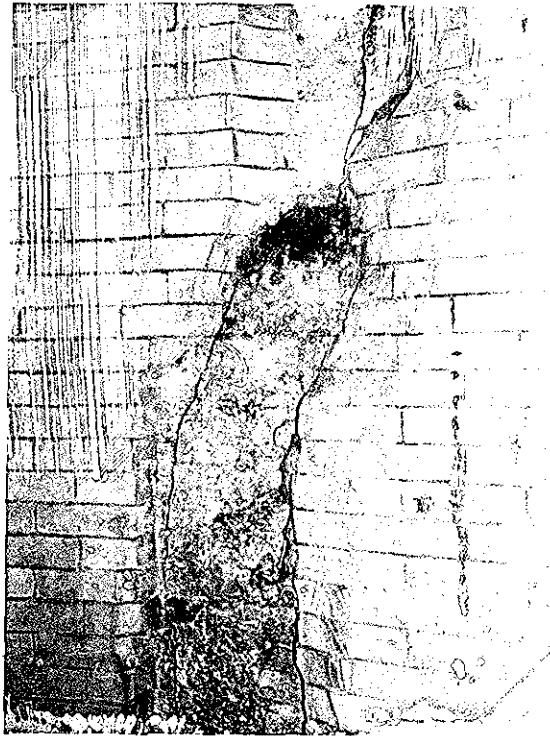
Northwest Wall (Inside)

This crack extends from

top of shaft to

elevator landing

Note Plucking

Crack  
extends  
from middle  
to bottom  
of Shaft
