MAURICE STEPHENS HOUSE (SITE OF HUNTINGTON'S QUARTERS)

Valley Forge National Historical Park

HISTORIC STRUCTURE REPORT

February 2008

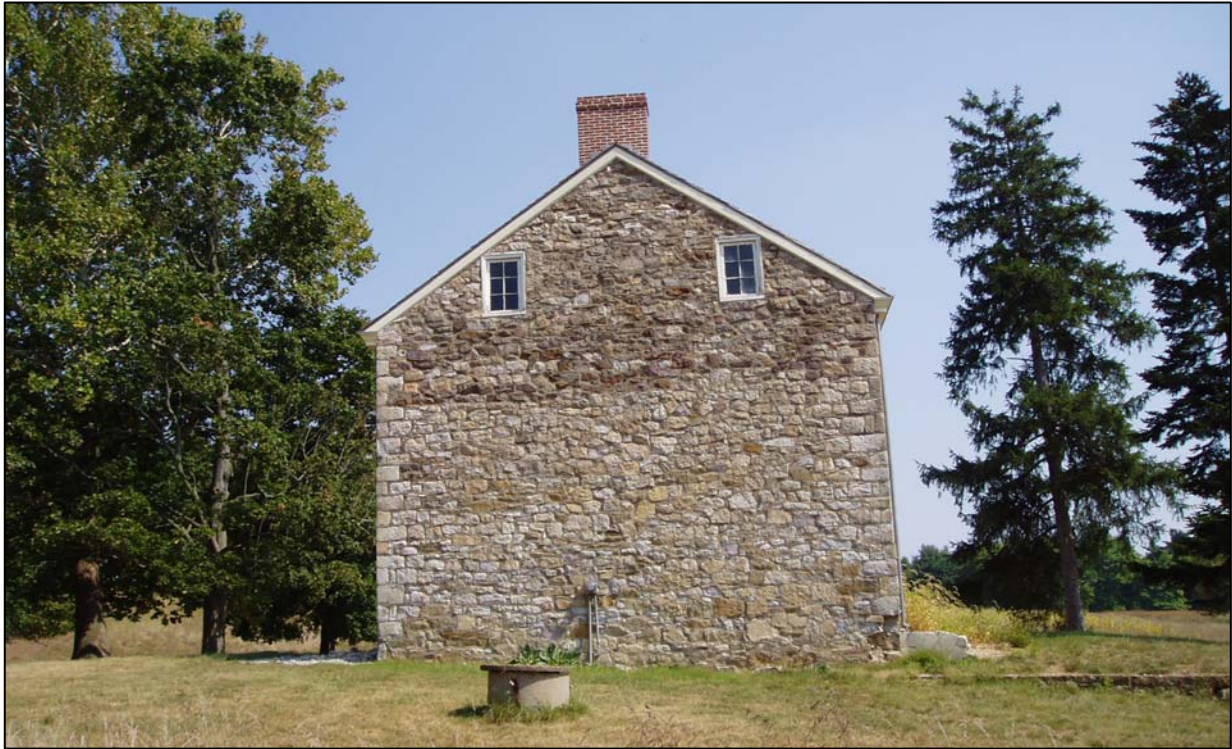
A curious detail can be seen in the upper portions of the building – a change in the stone used in the construction of the walls of the house. This difference in stone can be seen clearly in the 1902 photograph (fig. 3) and in modern photographs. There is no possibility that this anomaly resulted from a later enlargement of the original house into its present form. This is based on the building's consistent interior configuration, and on the similarity of its exterior and interior original architectural details, such as the reeding used on the cornice and on interior doorways and mantels. It thus would appear that most of the building's existing stonework is original to the construction of the building.

Figure 15. Main house, west elevation, showing the change in masonry partway up the wall.

Uneven weathering of the exterior masonry walls of the building has occurred, which is easily seen at the building's west elevation. Mortar analysis should be undertaken to determine an appropriate lime-based mortar for repointing. The replacement mortar should match the original mortar in terms of sand size and color,² and joint tooling. Existing inappropriate mortar joints should be carefully removed using only hand tools.

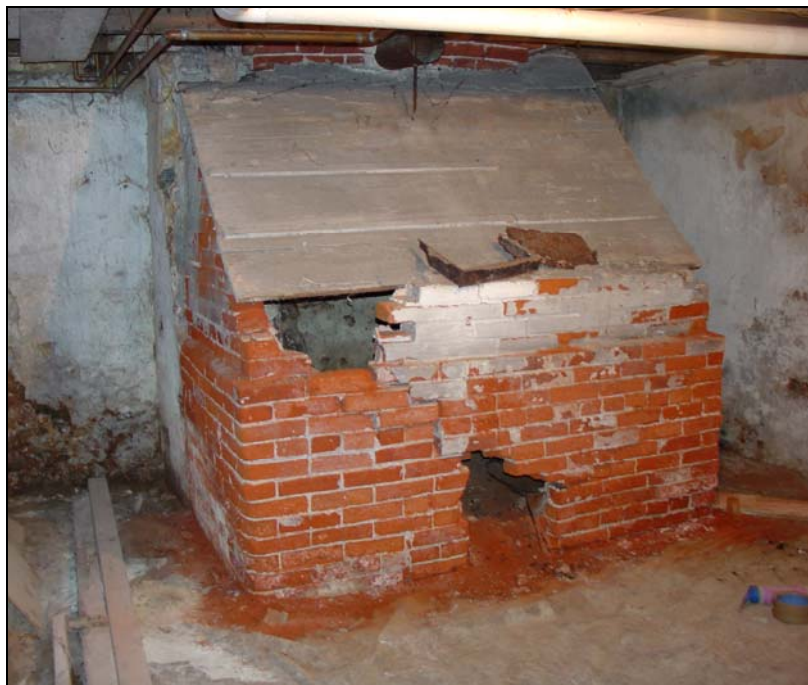
Figure 16. Ash box in Room 002 (south basement). In an attempt to fireproof the ash box, the structure was covered with a wood board- and- batten fixed lid that was lined on the interior side with metal. The remains of the cleanout door and frame once located at the bottom of the box rest on the lid of the ash box.

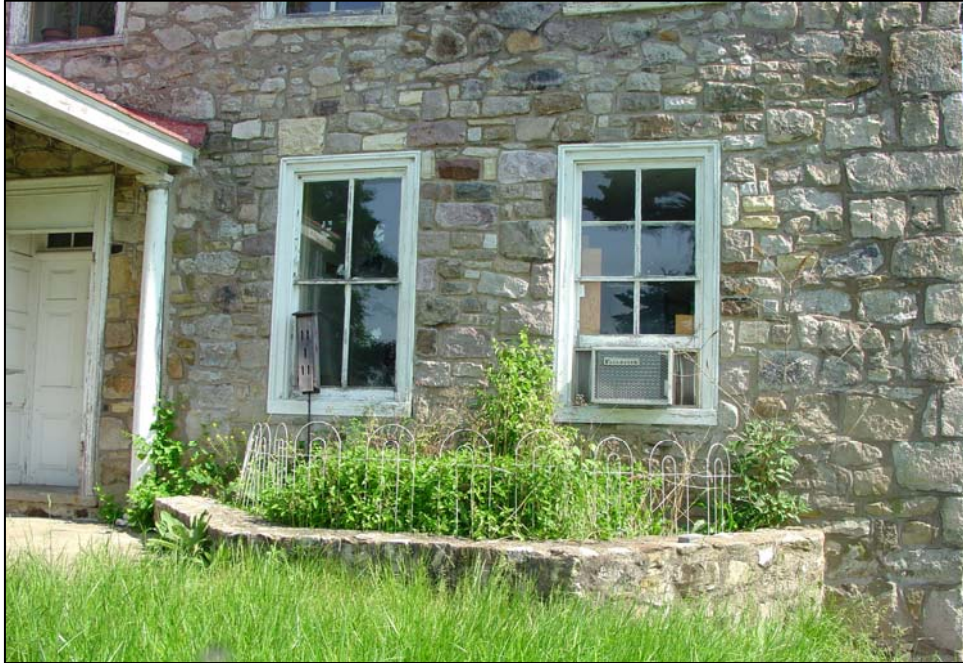
The window opening at the east end of the south wall has been bricked up, probably when the bay was built here ca. 1860- 1880. However, its heavy original frame retains mortises for the same type of horizontal bars. No “window well” was needed here, since the original opening was covered by the bay.

Figure 23. South elevation, east side, showing the masonry infill of the former opening for the one- story bay window, and the remaining foundation of the bay window. (Photograph taken in 2004.)

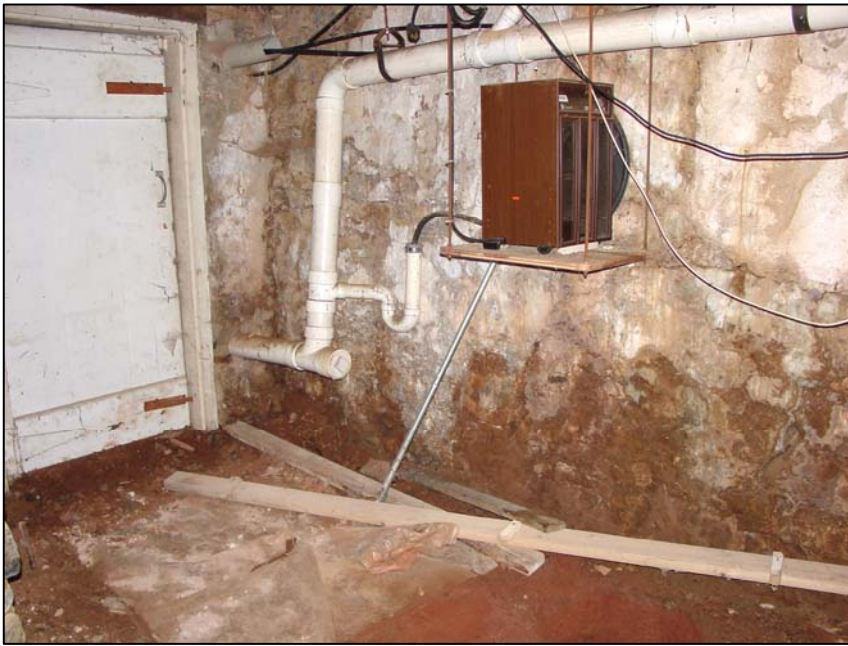
Figure 35. Room 002 (south basement), southeast corner, showing the narrowed bulkhead doorway, along with a later dehumidifier and drain pipe.

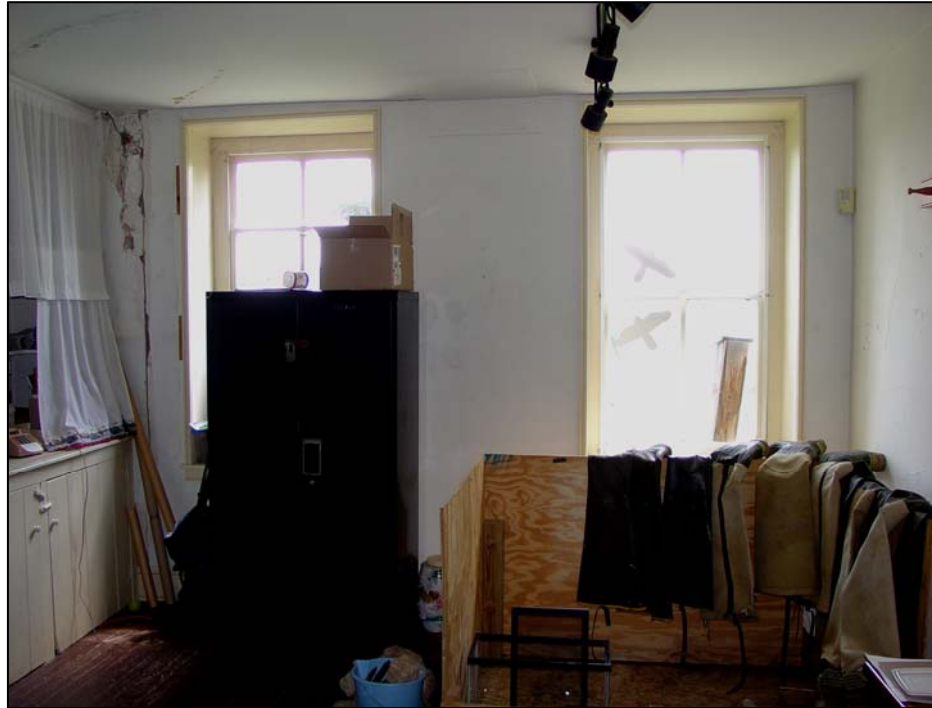
Figure 50. Room 103 (original kitchen), south wall (largely reconstructed after the removal of the bay window).

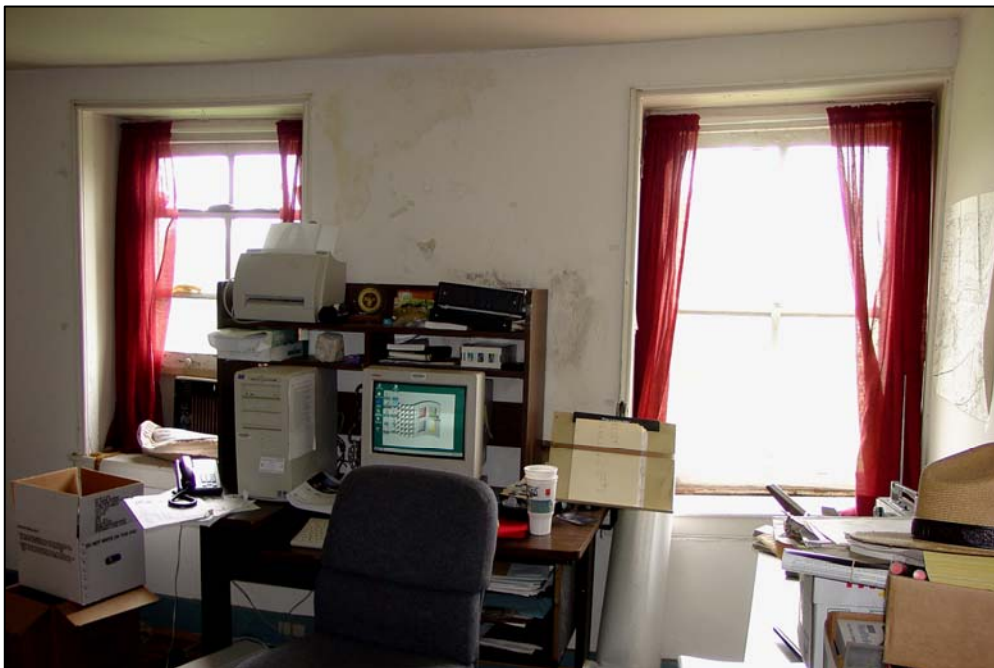
Figure 80. Room 206 (southeast bedroom), south wall, showing some deflection due to the insertion and later removal of the bay window in the first story of the house.

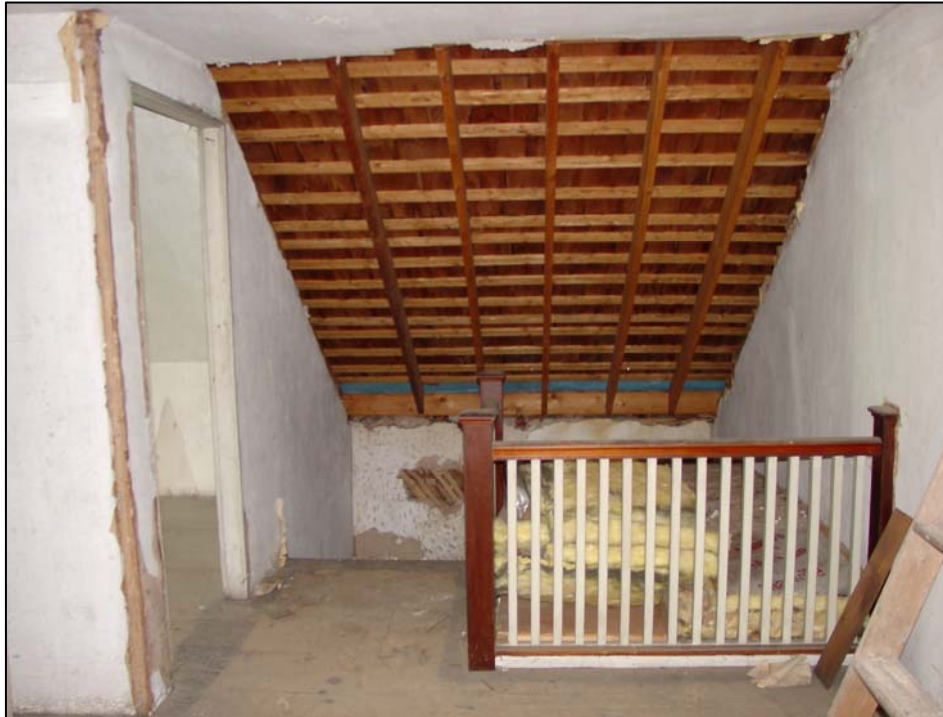
Figure 88. Room 302 (center attic room), looking north at the center stairway and the replacement balustrade. Also shown are the doorway to Room 303 (northwest attic room) at left, and an area of ceiling disturbed by the addition of an early 20th- century dormer (removed in 1978).
