HISTORIC STRUCTURE REPORT

WASHINGTON MONUMENT AND ASSOCIATED STRUCTURES

VOLUME I – WASHINGTON MONUMENT

PREPARED BY
John Milner Associates, Inc.

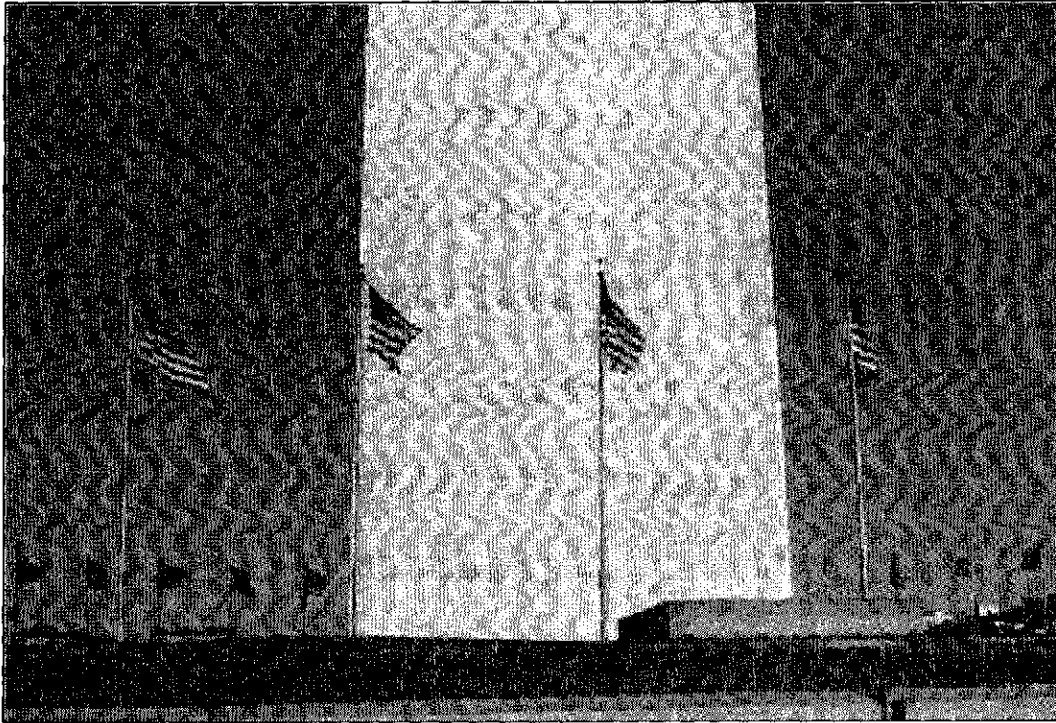
Figure 4.17: Washington Monument, view to the east. Note the bright-white stone dutchman repairs at the corners of the monument.

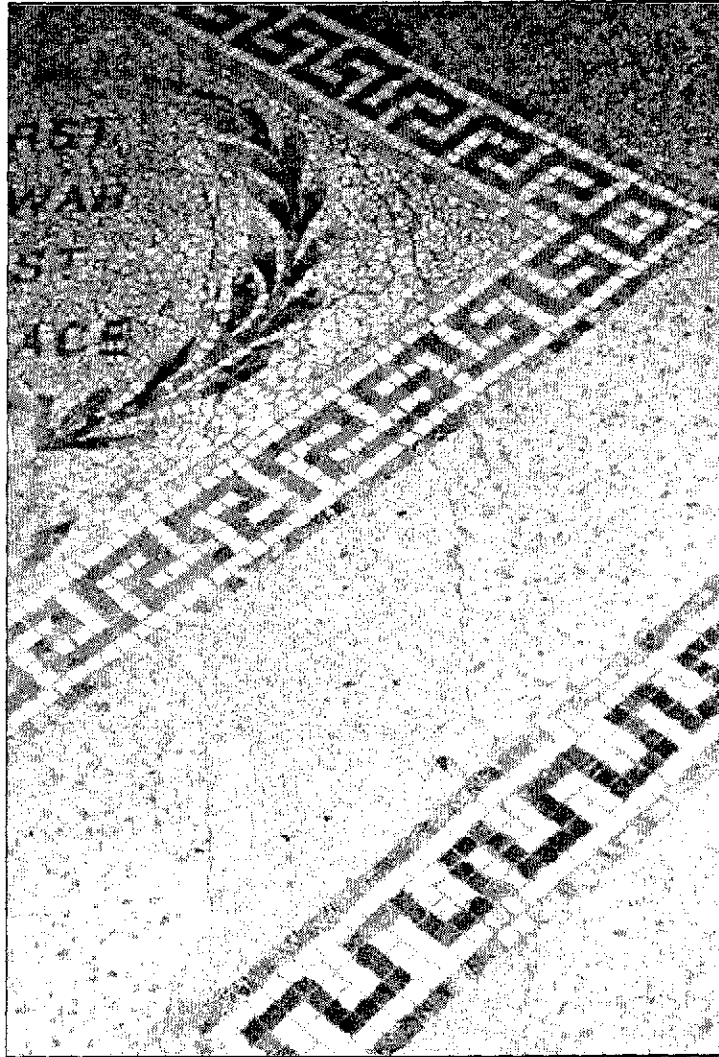
Figure 4.32: South corridor, east end showing terrazzo floor repair.

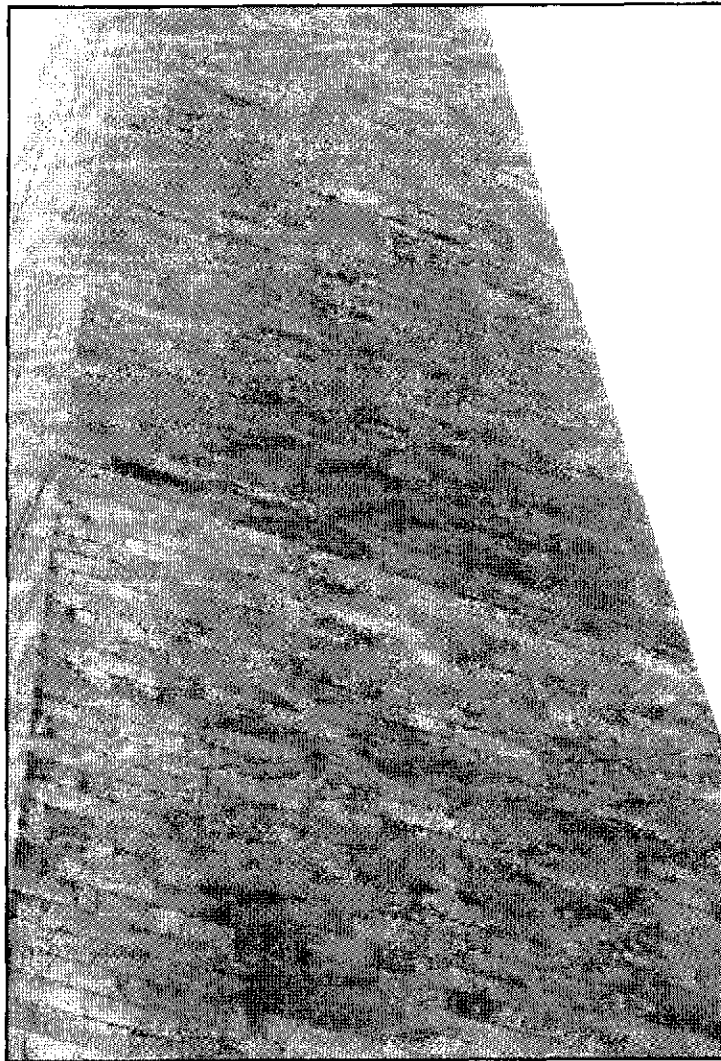
Figure 5.1: West elevation with significant vertical cracking in center of wall. The cracking begins just above the 150-foot level and continues approximately 40 feet. The cracking follows joint lines in some instances and goes directly through stone in others. This condition is typical for all four elevations of the monument. Note crack monitors strapped to façade.

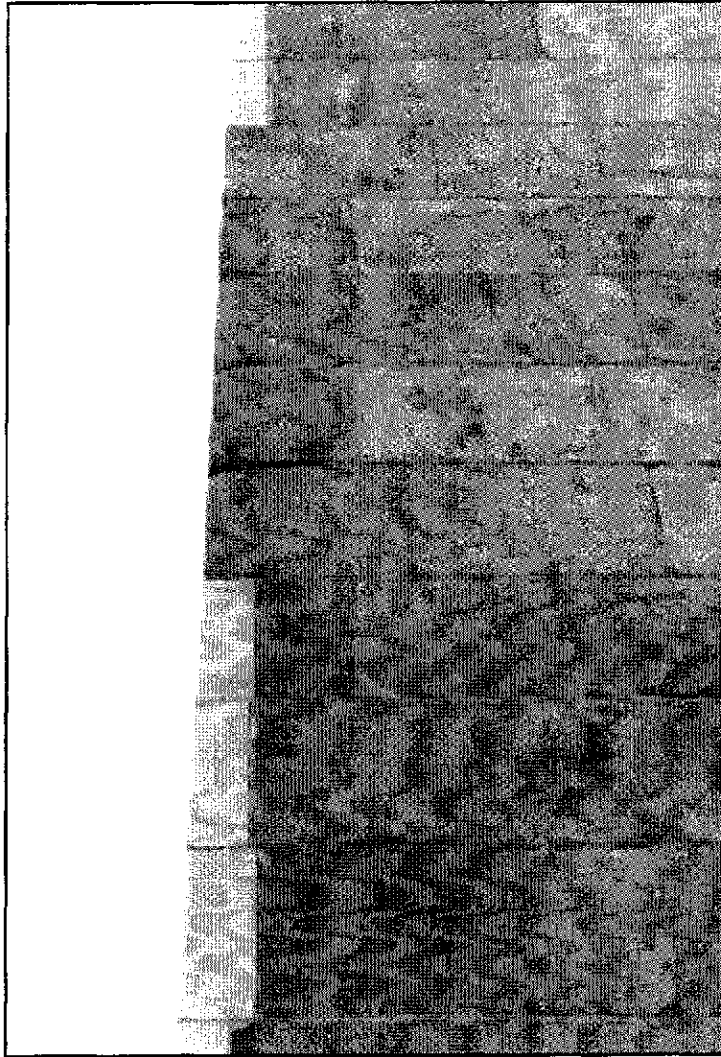
Figure 5.2: Northwest corner with dutchmen repairs showing bright white. Corner stones that have not been repaired show significant spalling and erosion at horizontal joint lines.

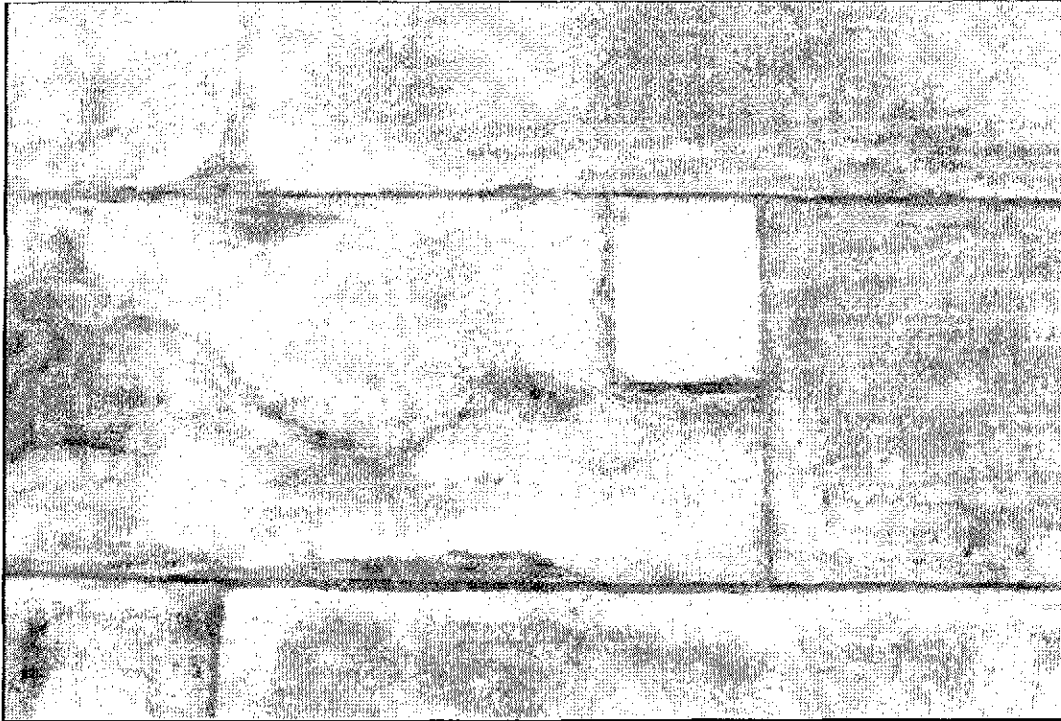
Figure 5.3: West elevation with particularly obvious dutchman repair and nearby patch material. This dutchman should have been full-course height (2 feet) to better blend with its surroundings.

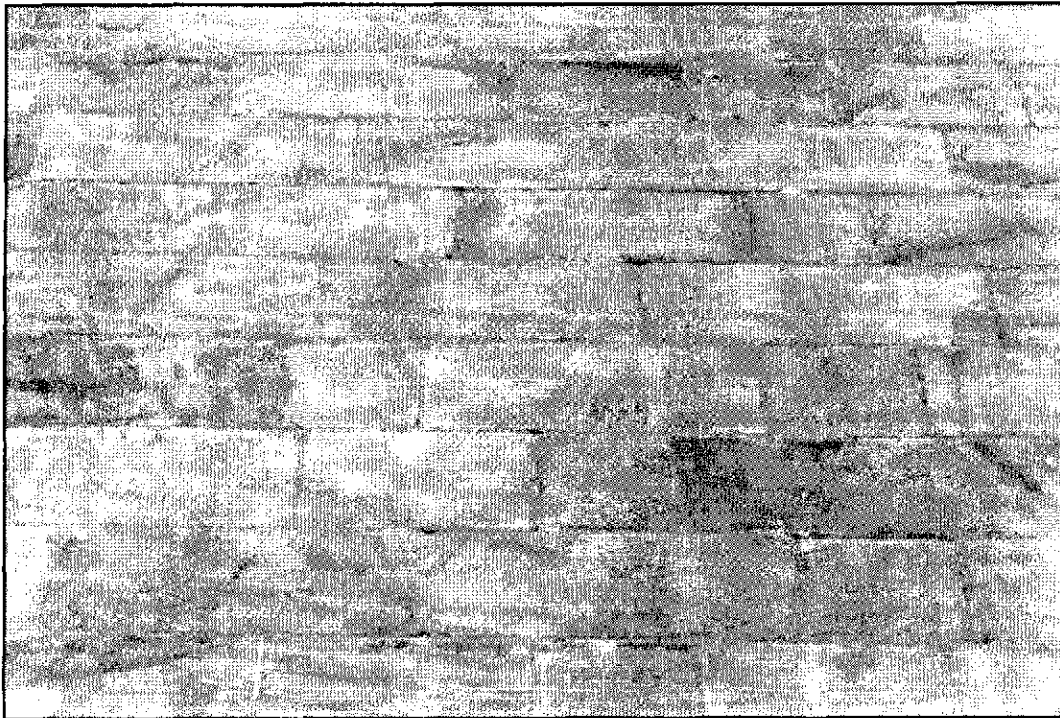
Figure 5.4: North elevation. Dark areas indicate small spall locations that have not been repaired.

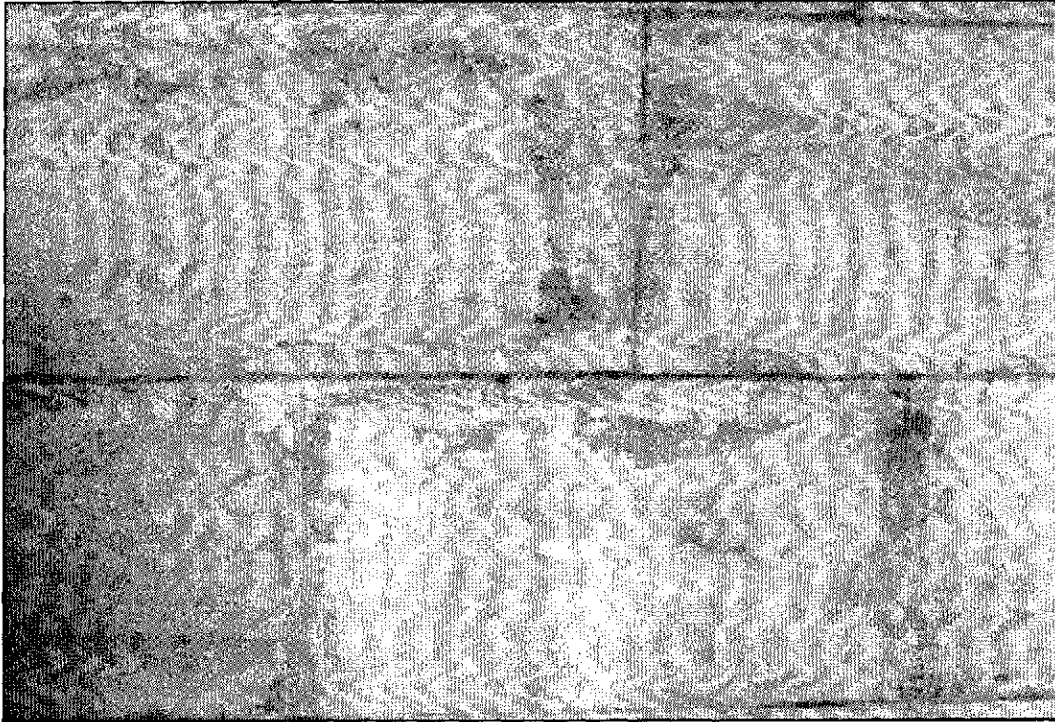
Figure 5.5: West elevation patches near ground level. The patch material absorbs and evaporates water at a rate that is very inconsistent. Dark areas of the patch are still damp hours after the last rainfall, which gives the patch a mottled appearance.

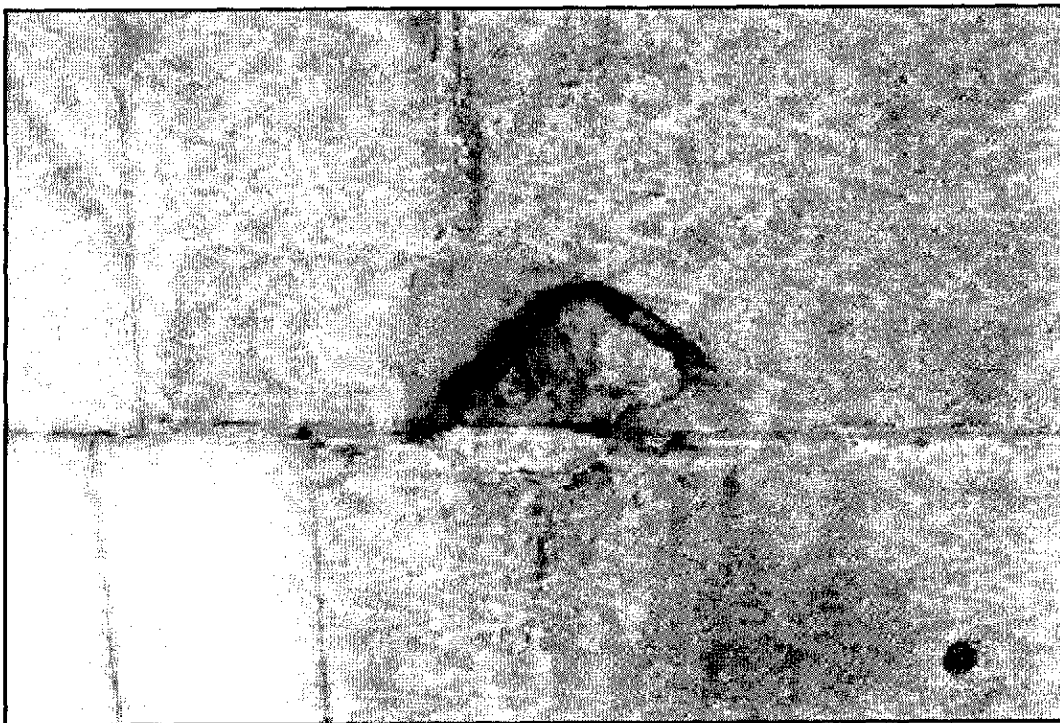
Figure 5.7: North elevation near ground level with failed patch. It appears that moisture behind the patch was supporting biological growth before the patch completely failed.

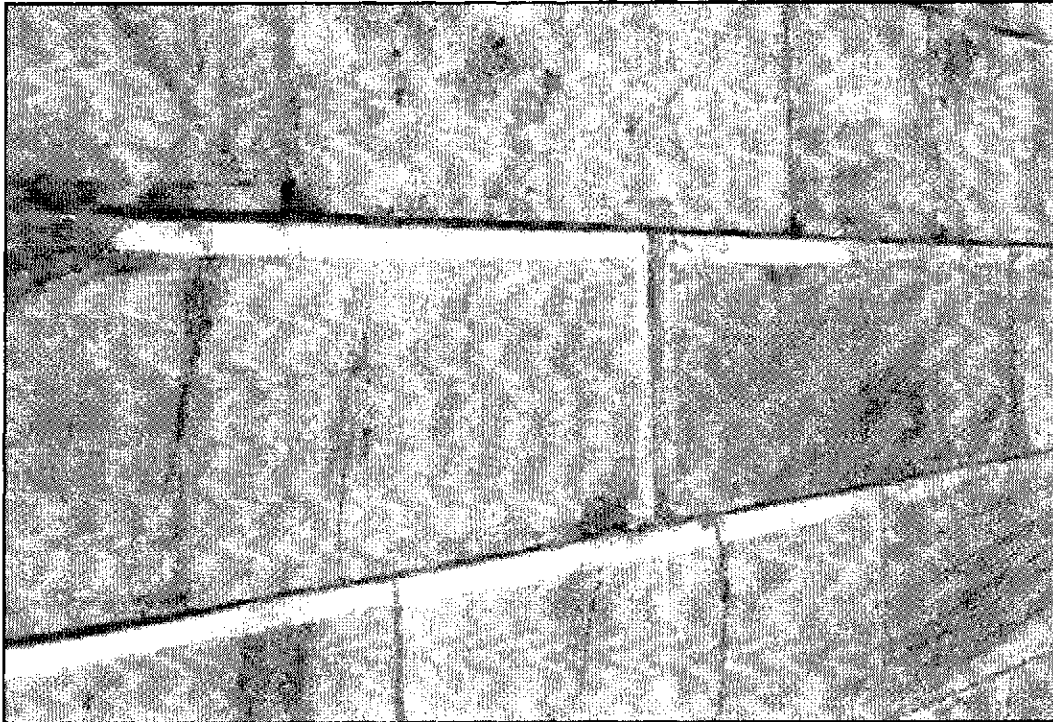
Figure 5.8: West elevation with original tool marks evident around perimeter of stones. There are also areas of red or pink staining indicating locations of inclusions in the marble.

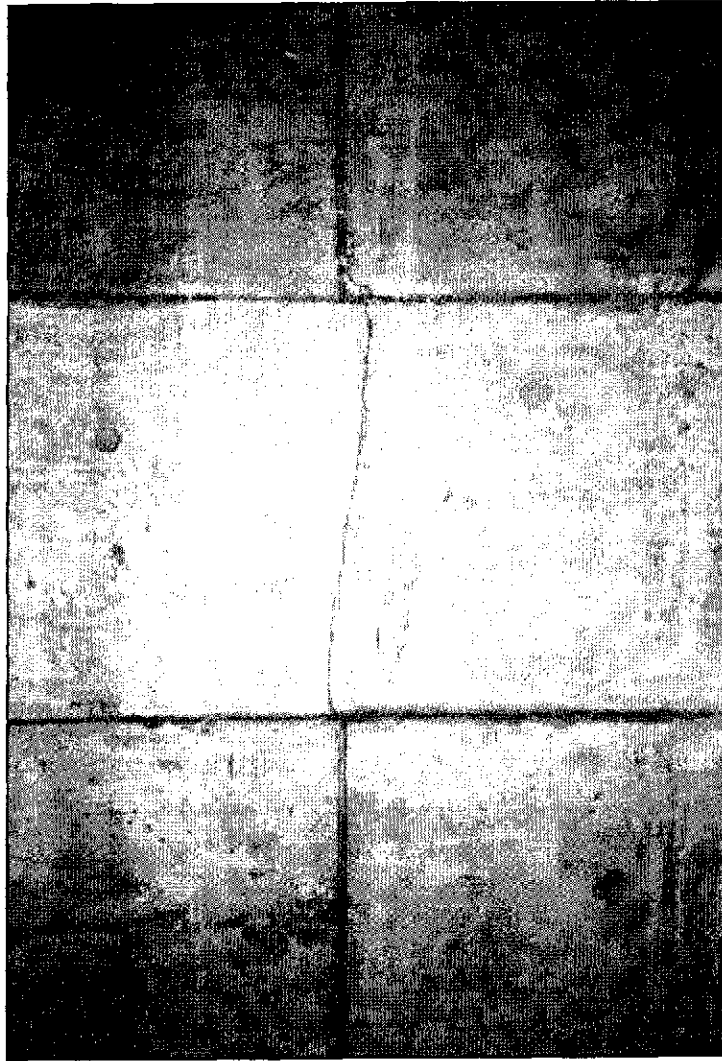
Figure 5.10: Washington Monument, interior, central shaft, cracking at masonry above 420-foot level.

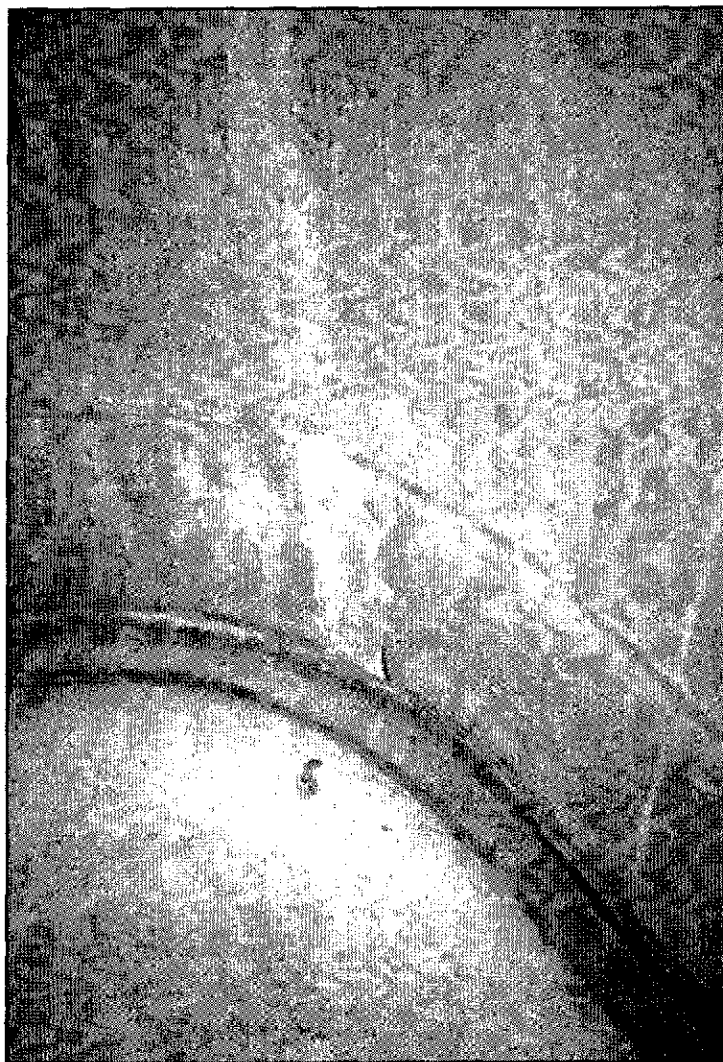
Figure 5.11: Washington Monument, interior, central shaft, delamination at corner stones.

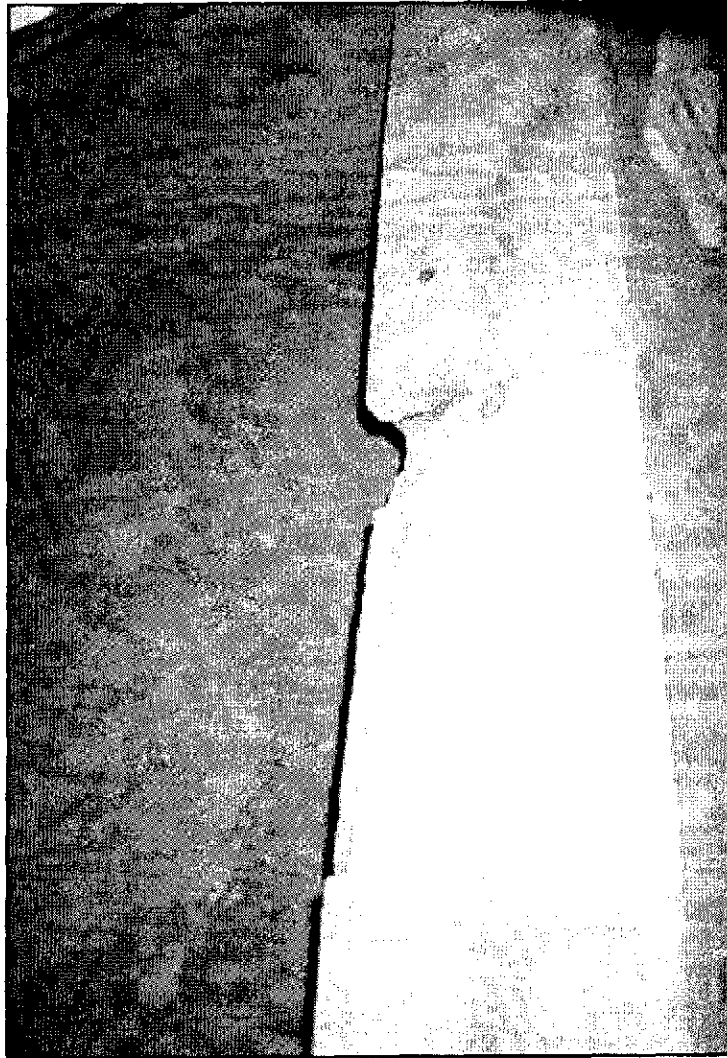
Figure 5.12: Washington Monument, interior, central shaft, spall on pier at 480-foot level.

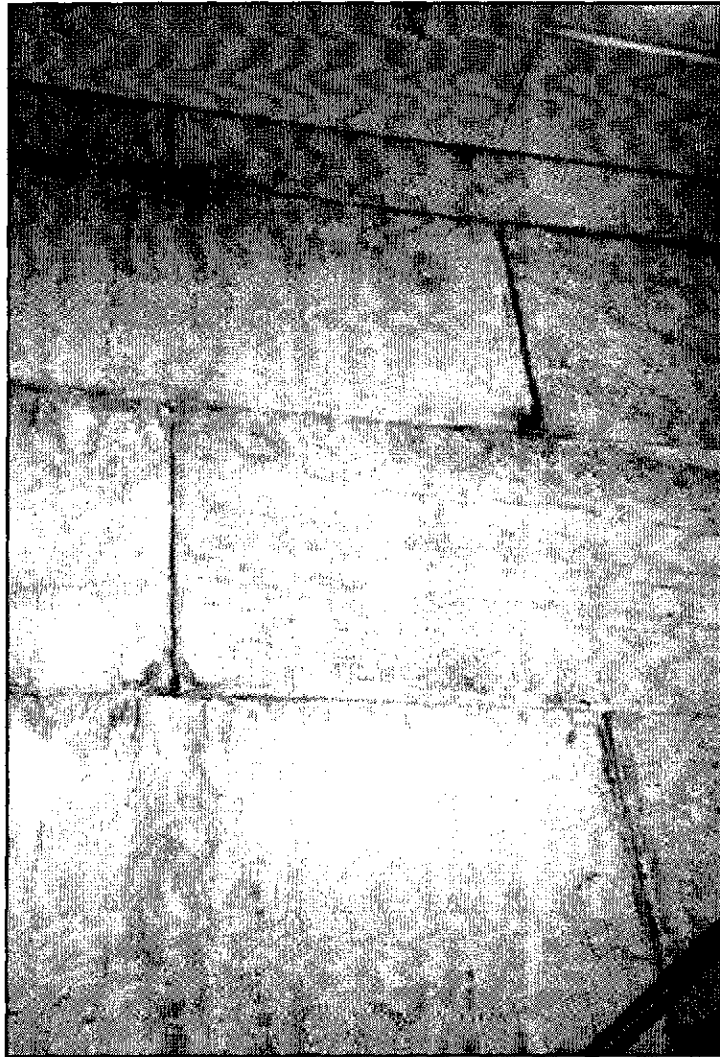
Figure 5.13: Washington Monument, interior, central shaft, open joints at 490-foot level stairs.

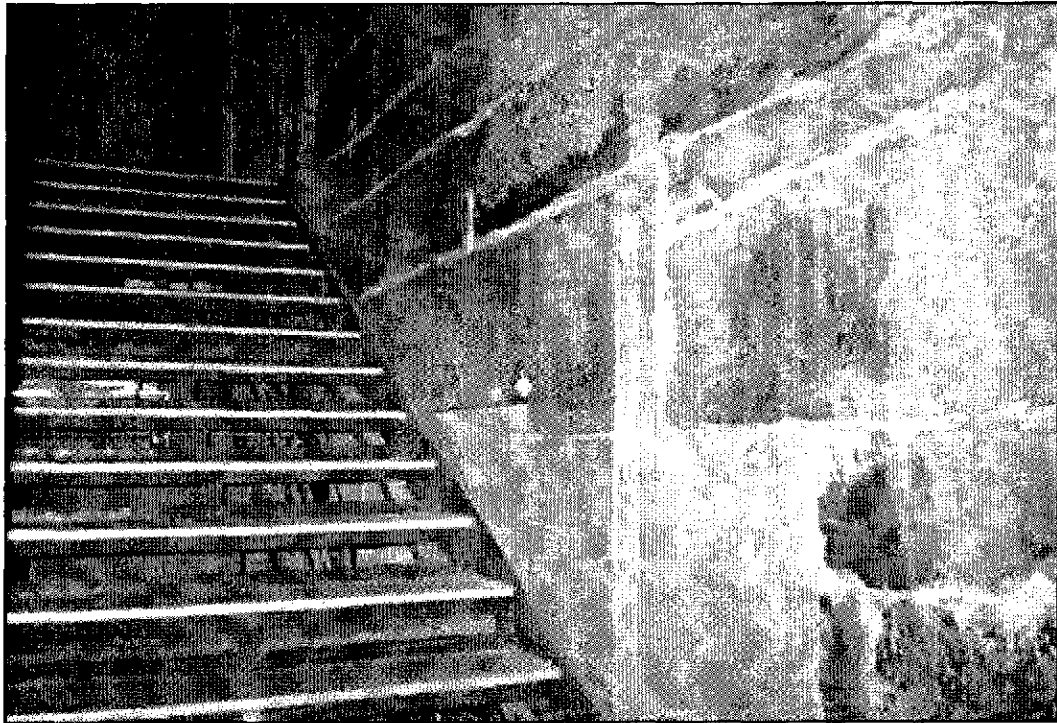
Figure 5.17: Washington Monument, interior, central shaft, discoloration of gneiss at 15-foot level.

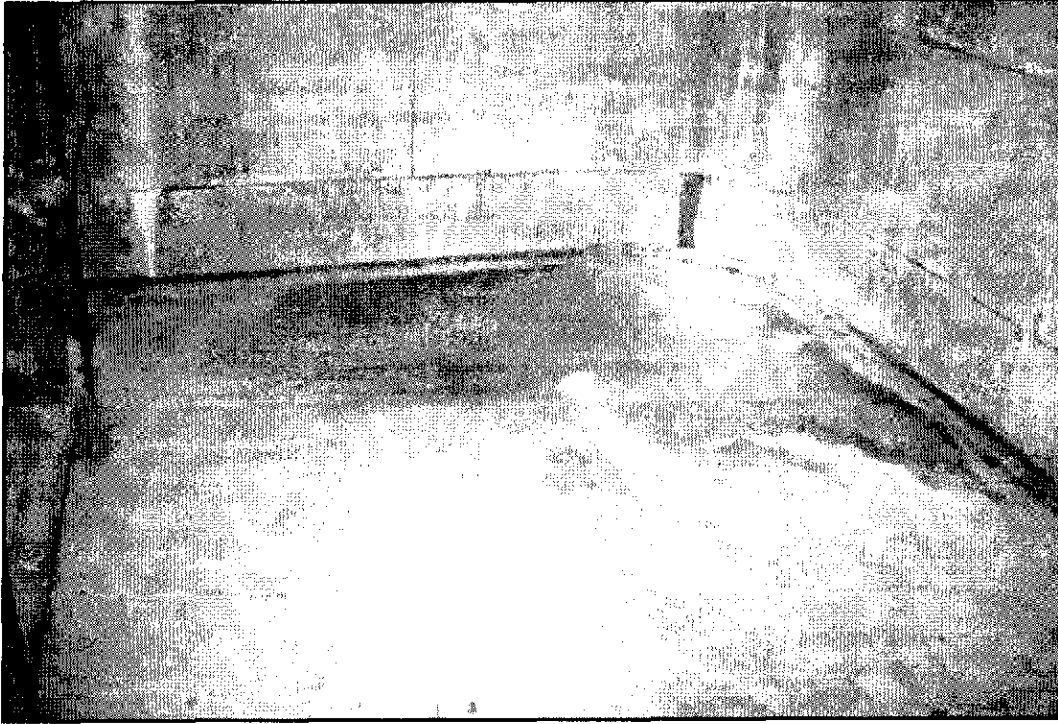
Figure 5.18: Washington Monument, interior, central shaft, 470-foot level, rusting angle iron, stained terrazzo, efflorescence, and water infiltration.

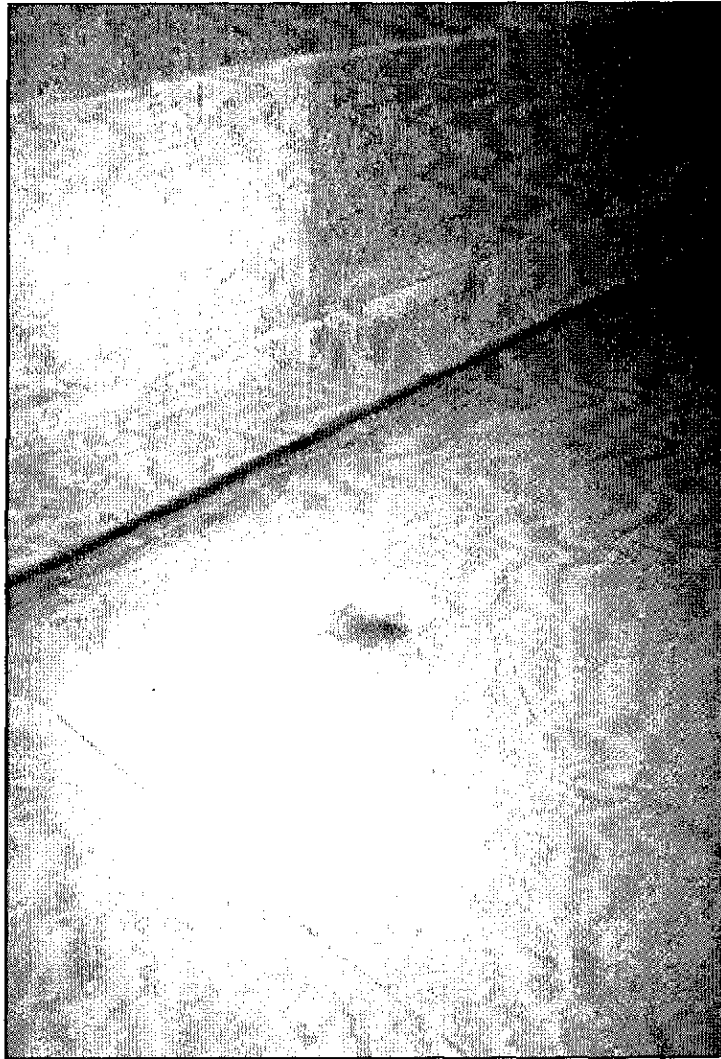
Figure 5.19: Washington Monument, interior, central shaft and stairwell, loss in terrazzo floor at 310-foot level.

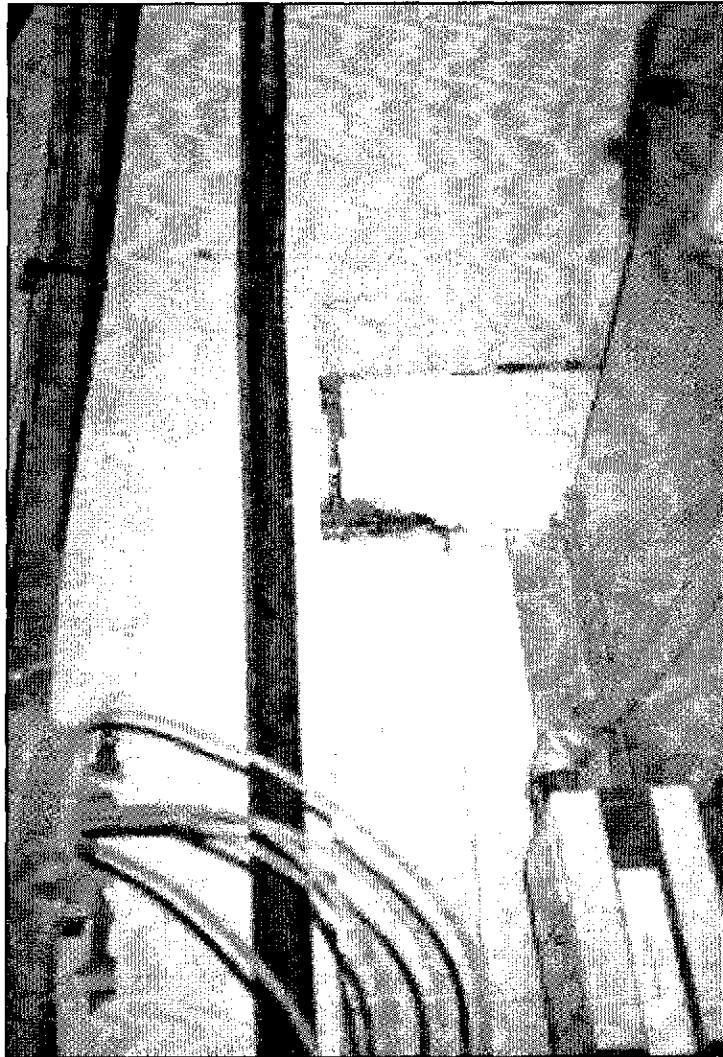
Figure 5.23: Washington Monument, Bunker 1, interior, mechanical room, north wall, rusting louver.

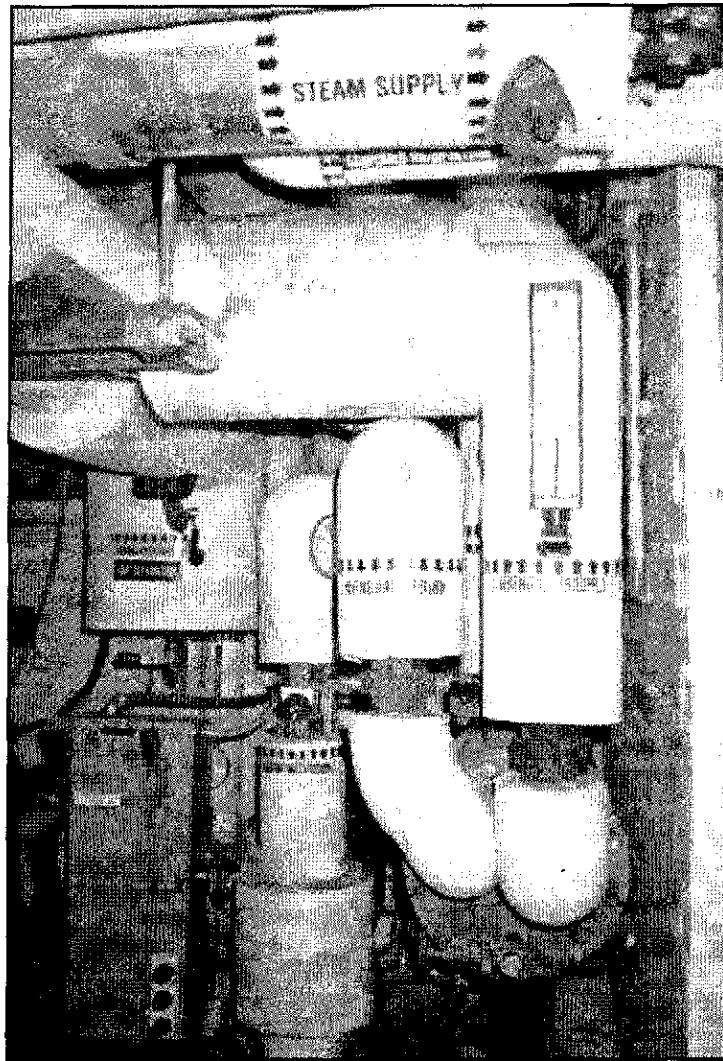
Figure 5.24: Washington Monument, Bunker 1, interior, mechanical room, staining at pipe casing under crack at west central ceiling.

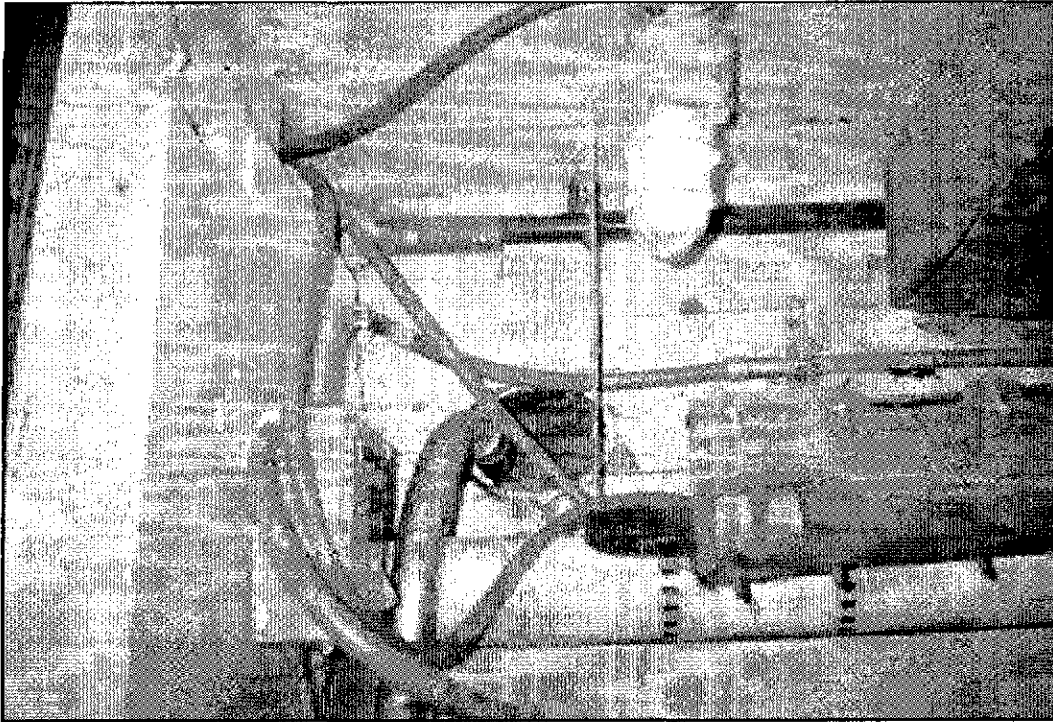
Figure 5.25: Washington Monument, Bunker 1, interior, mechanical room, southwest corner, movement in masonry.
