FINAL REPORT

JUNE 2004

WASHINGTON MONUMENT AND
ASSOCIATED STRUCTURES

VOLUME III – SURVEY LODGE

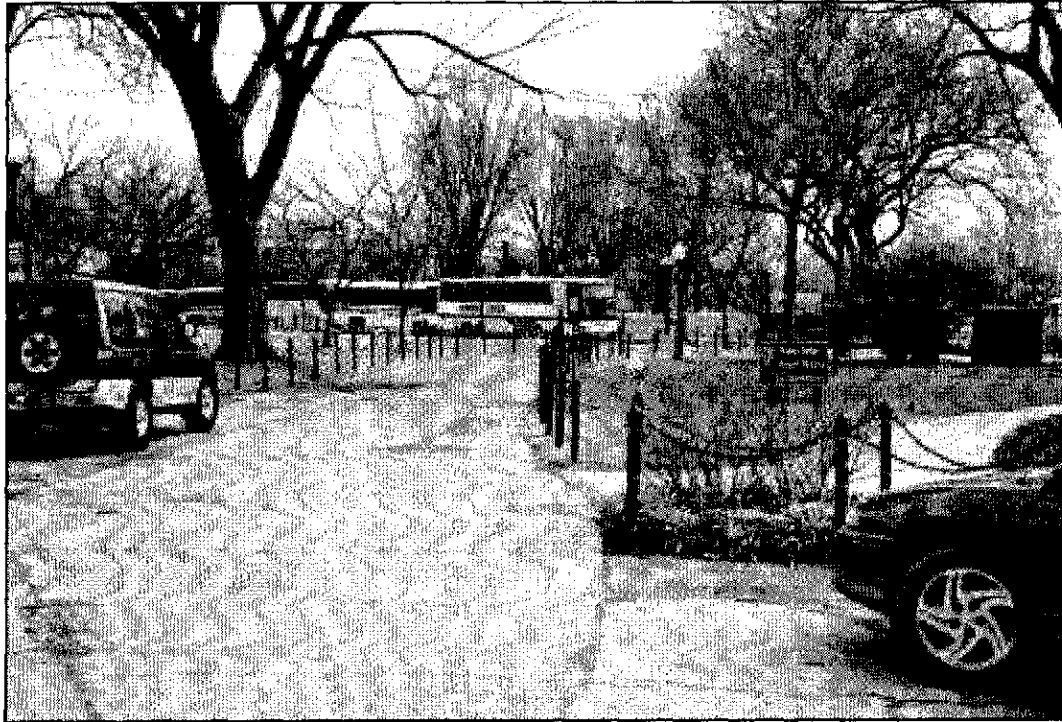
Figure 5.1: Asphalt service drive north of lodge, view to the southeast with serious cracking and previous patches evident.

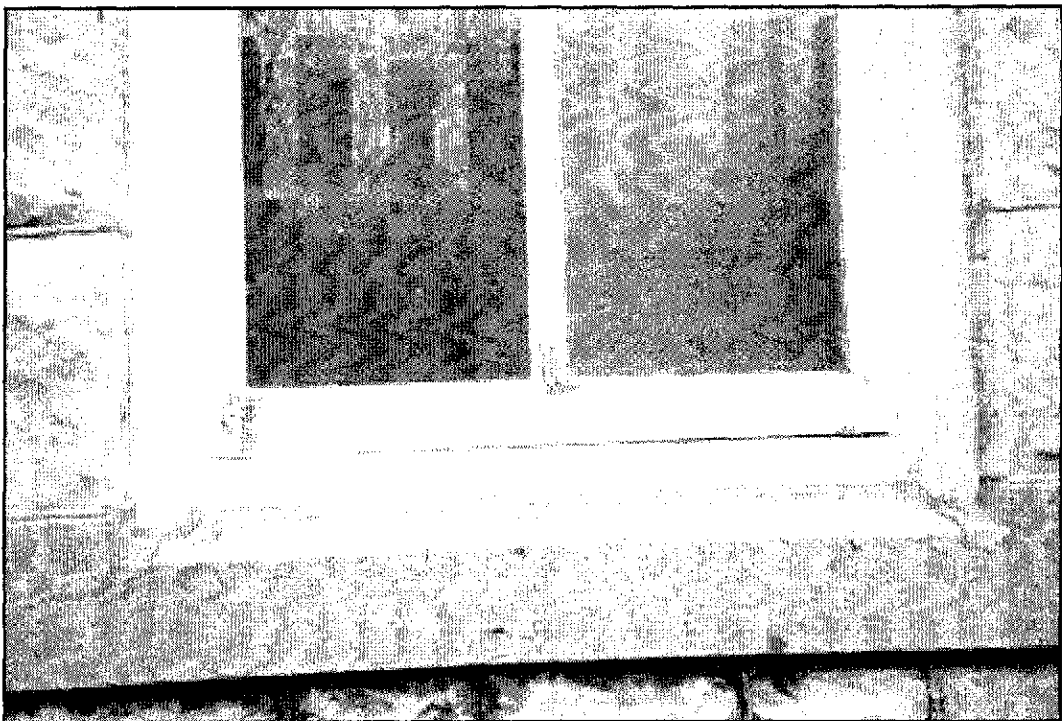
Figure 5.2: Lower sash of double-hung wood window with granite sill, northwest elevation. Note paint deterioration and loose pegs in the window, and drips of paint on the granite sill.

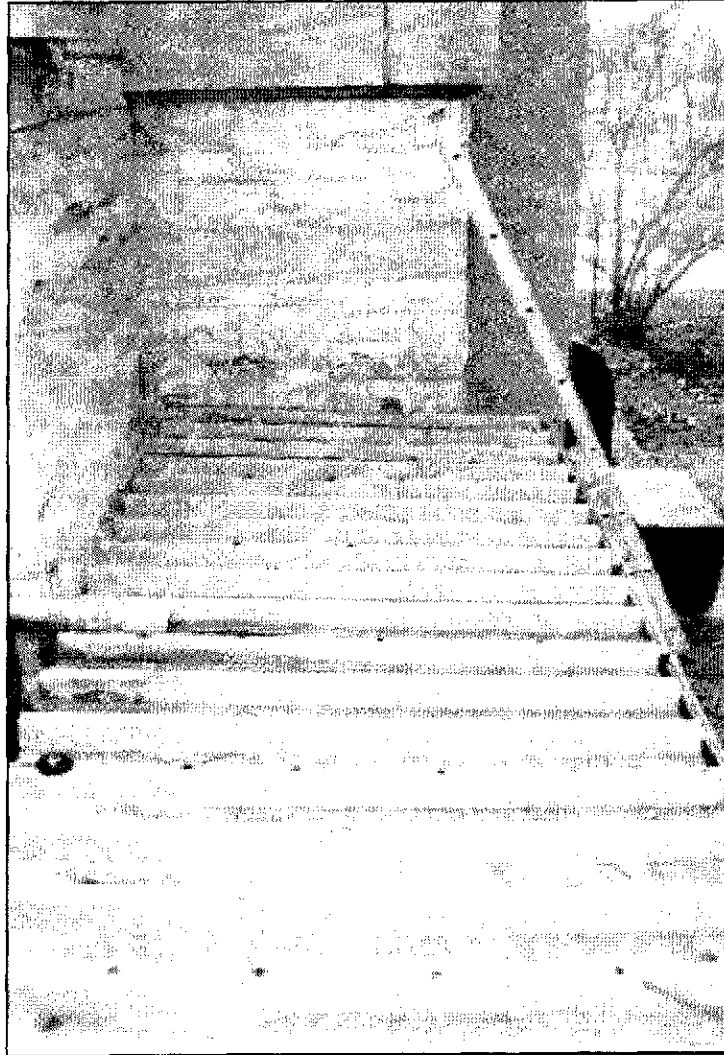
Figure 5.3: Southwest elevation and attached chimney, view to the southeast. Splashing rain is encouraging biological growth above the areaway roof, and ferrous fasteners on the roof deck are beginning to rust.

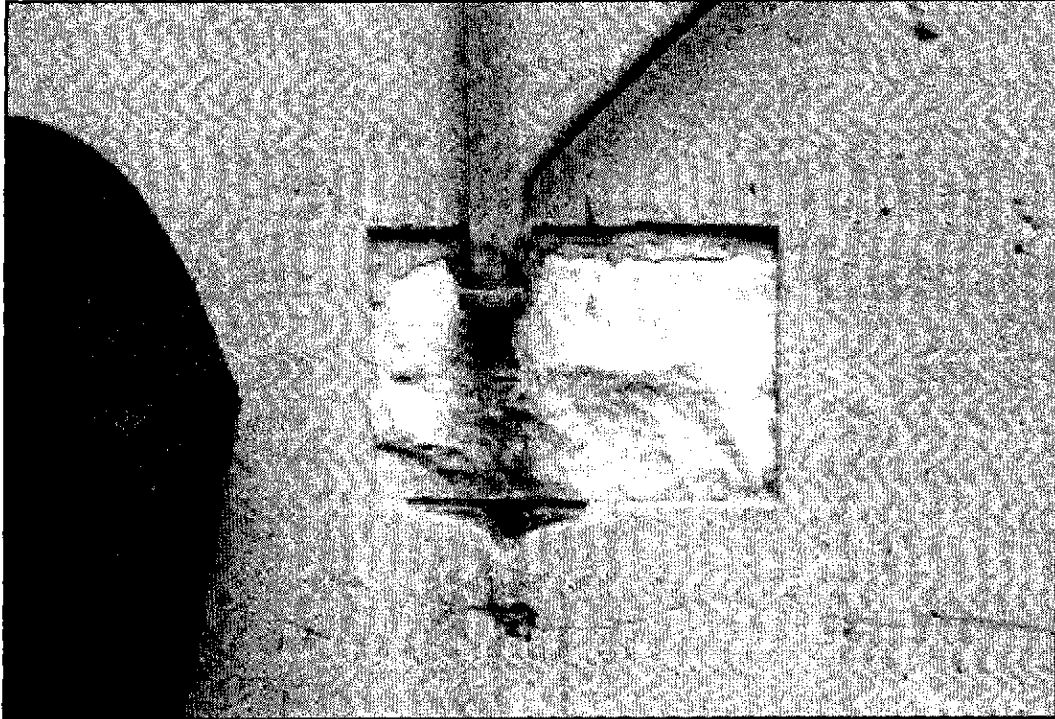
Figure 5.4; Detail of southwest elevation with ferrous staining under attached pivoting metal arm. The stucco has spalled, revealing the red brick back-up of the 1901 addition, and two penetrations are visible.

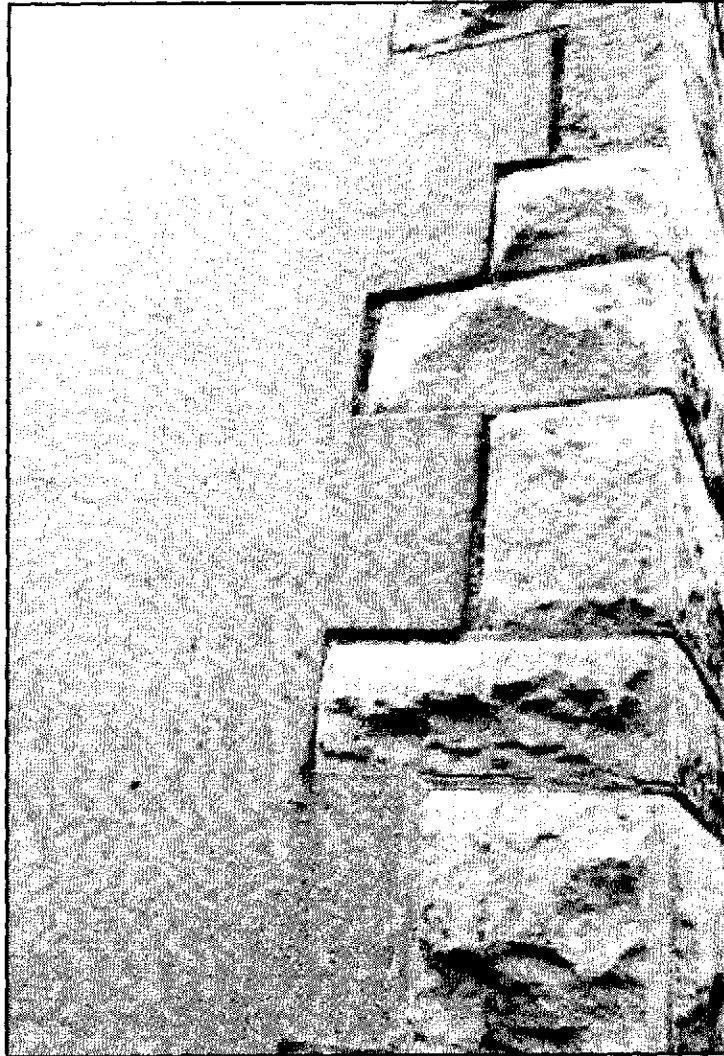
Figure 5.5: Detail of southwest elevation at south corner with open and improperly tooled mortar joints. The red brick back-up of the 1901 addition is visible at the edge of the stucco in some locations.

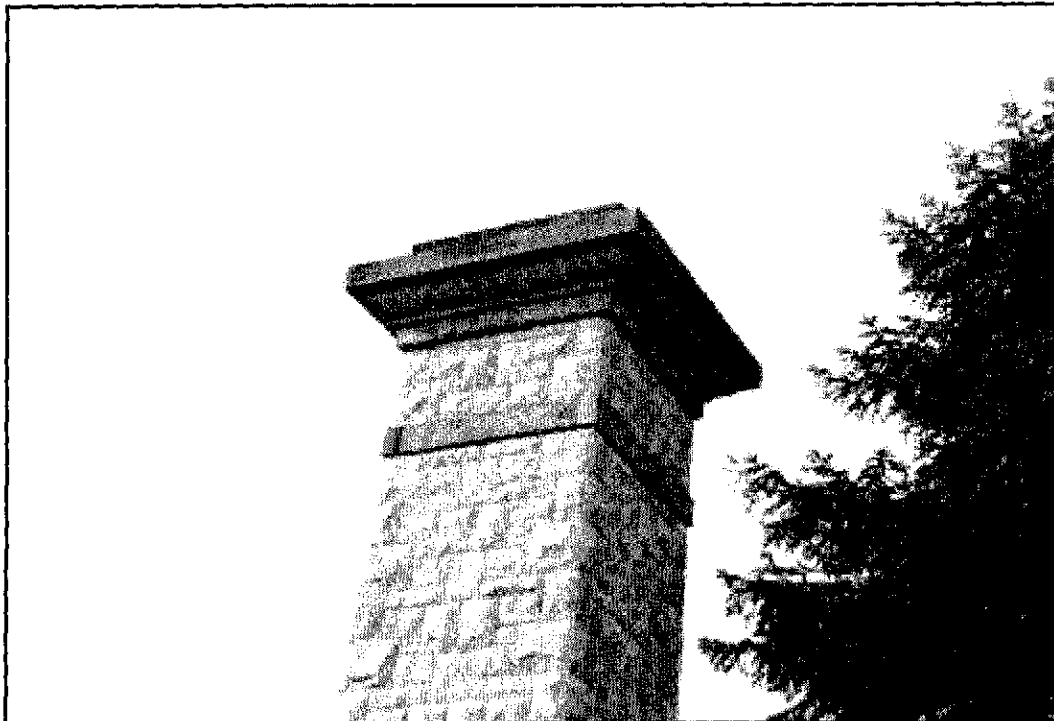
Figure 5.6: Attached chimney, view to the south. The granite belt course has spalled, and the metal chimney cap has stained the granite cornice.

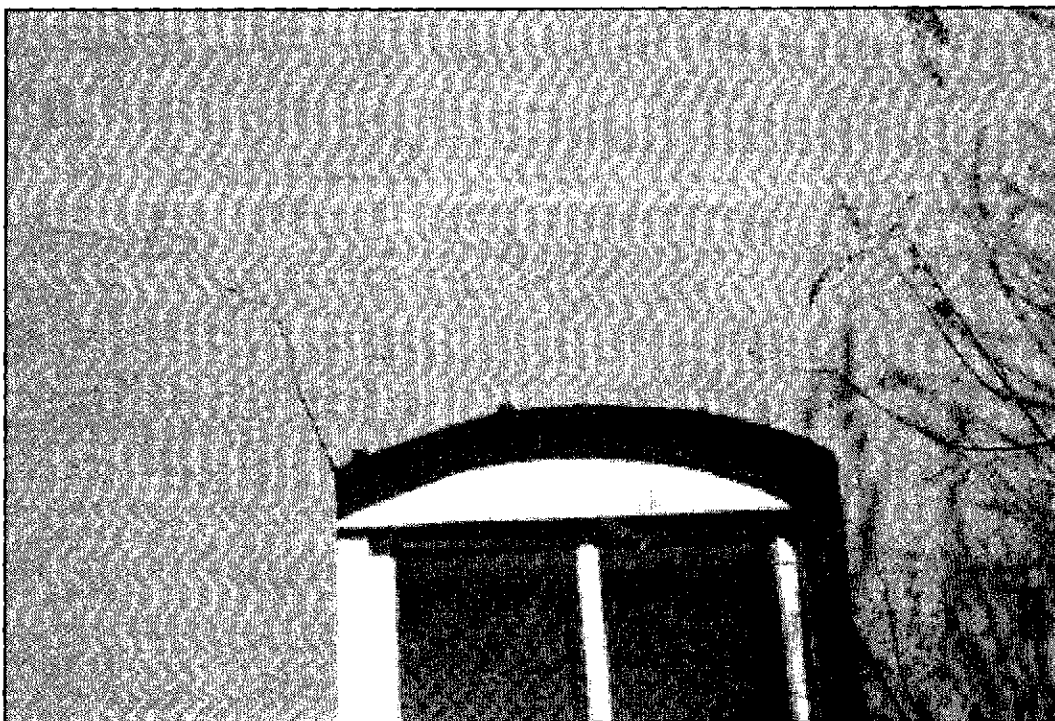
Figure 5.7: Detail of southwest elevation with severe stucco cracking and spots of ferrous staining at window head.

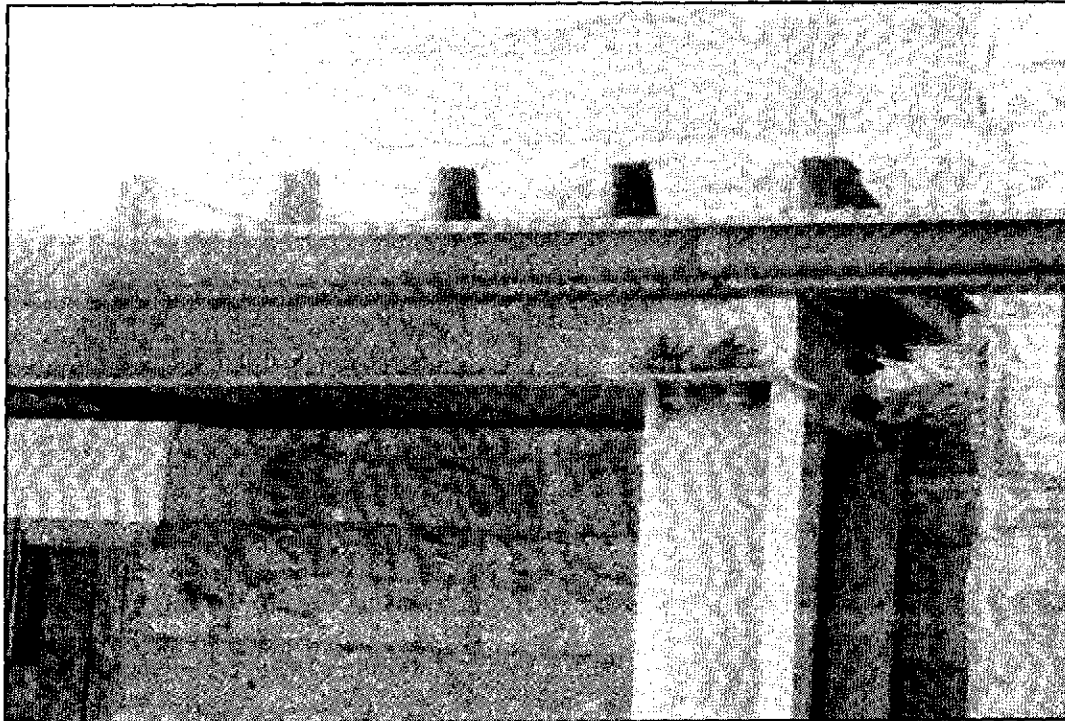
Figure 5.8: Detail of steel structure at northwest areaway roof with failing paint and rust bloom. The K-type hanging gutter and downspout are also experiencing paint failure.

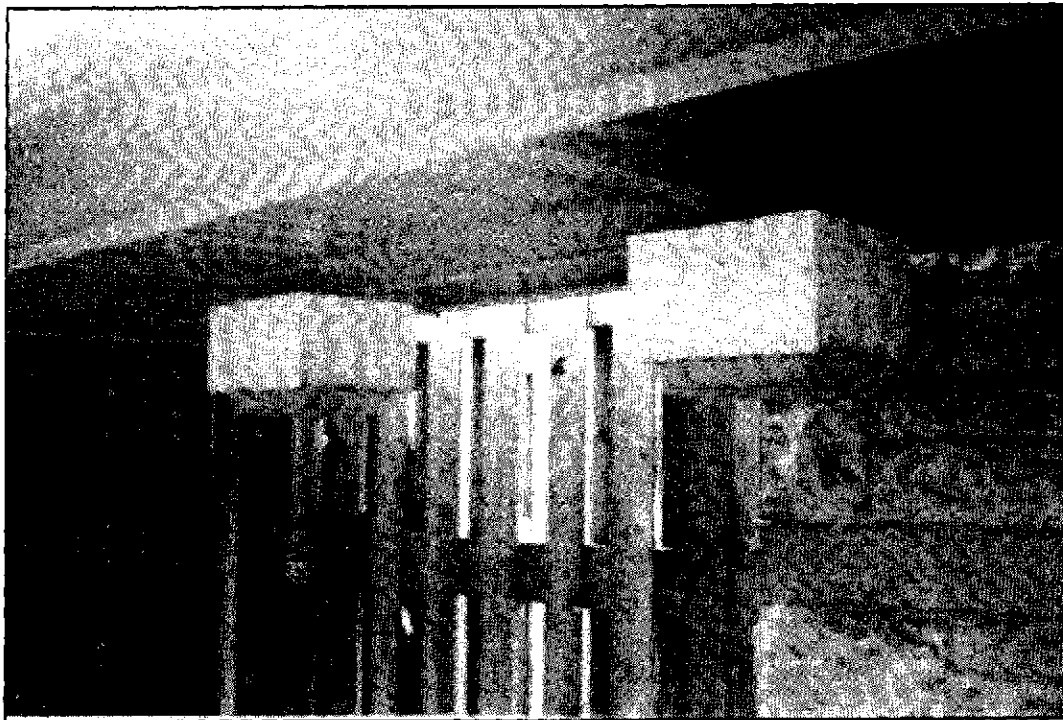
Figure 5.9: Light fixtures under areaway roof supporting bird nests.

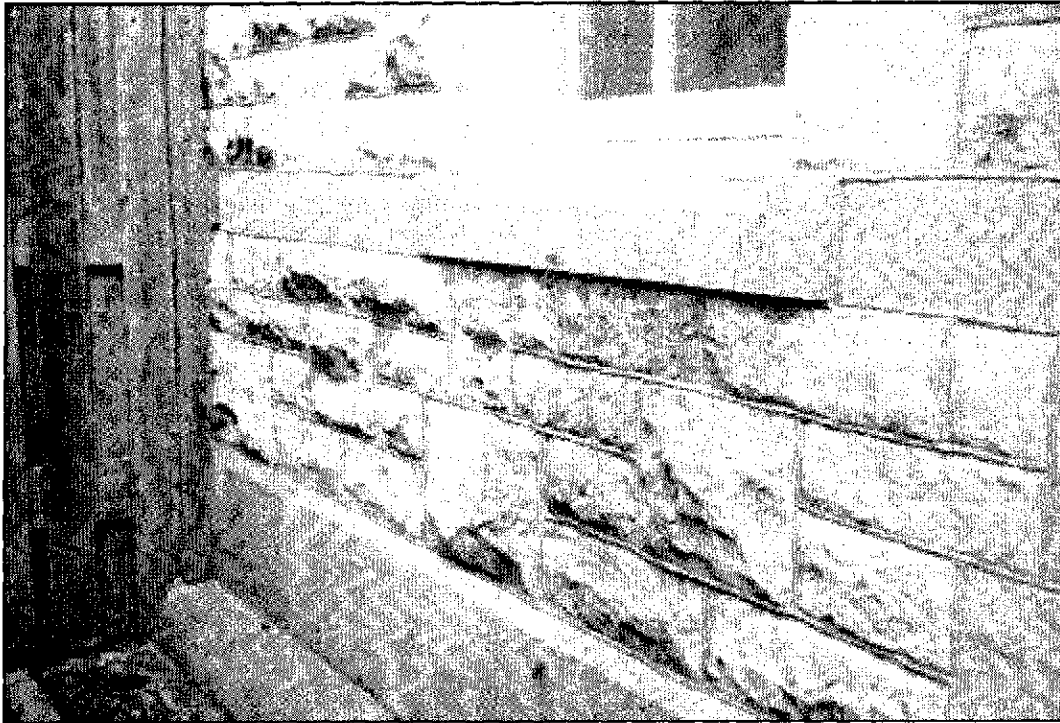
Figure 5.10: Detail of northwest elevation with significant biological growth under previous location of window air-conditioning unit. Ferrous staining and paint spatters are also visible at the granite window sill and water table.

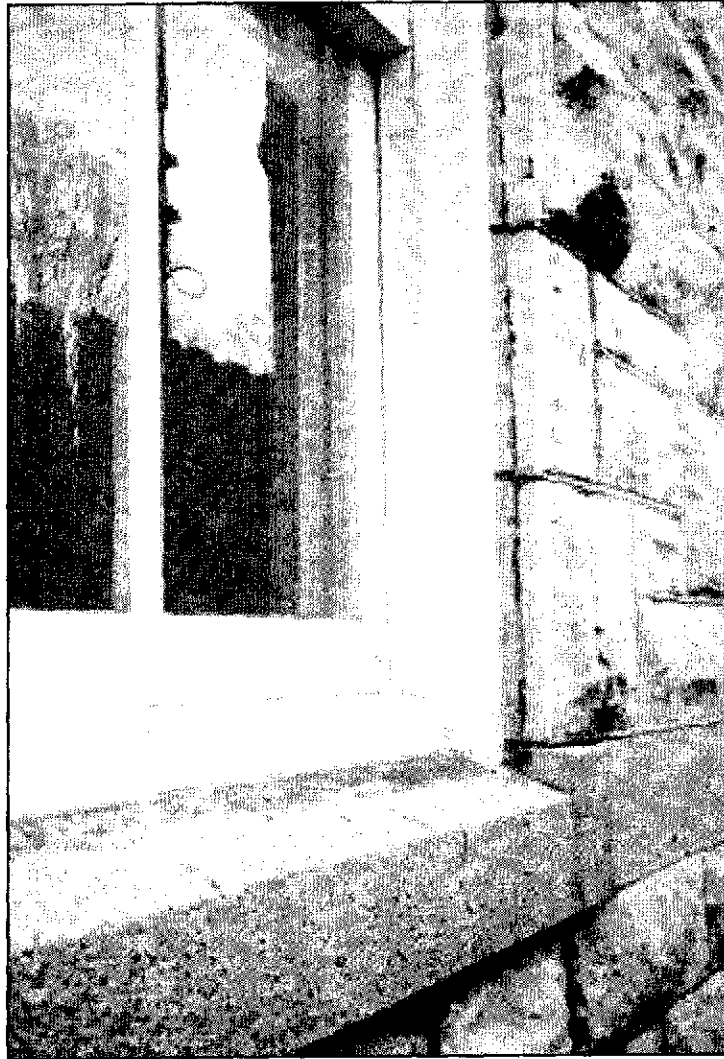
Figure 5.11: Lower sash of double-hung wood window with granite sill, northwest elevation. Note the line of paint at the masonry opening, drips of paint on the granite sill, and the remains of an anchor from a previously removed security screen.

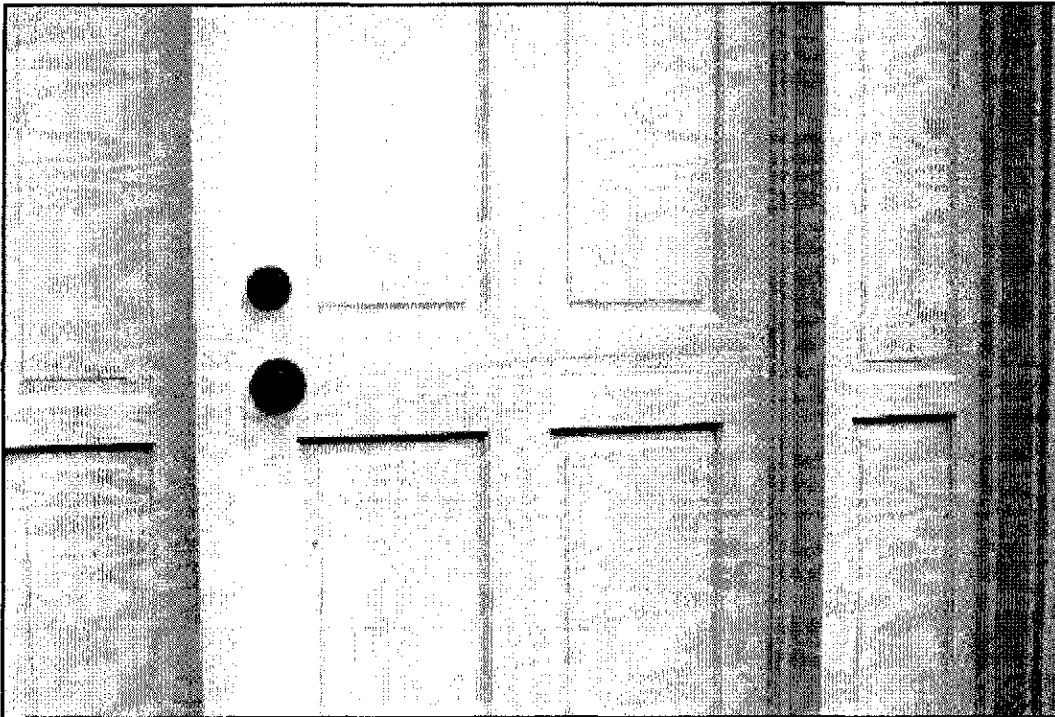
Figure 5.13: Detail of door at northeast elevation with damage to center rail.

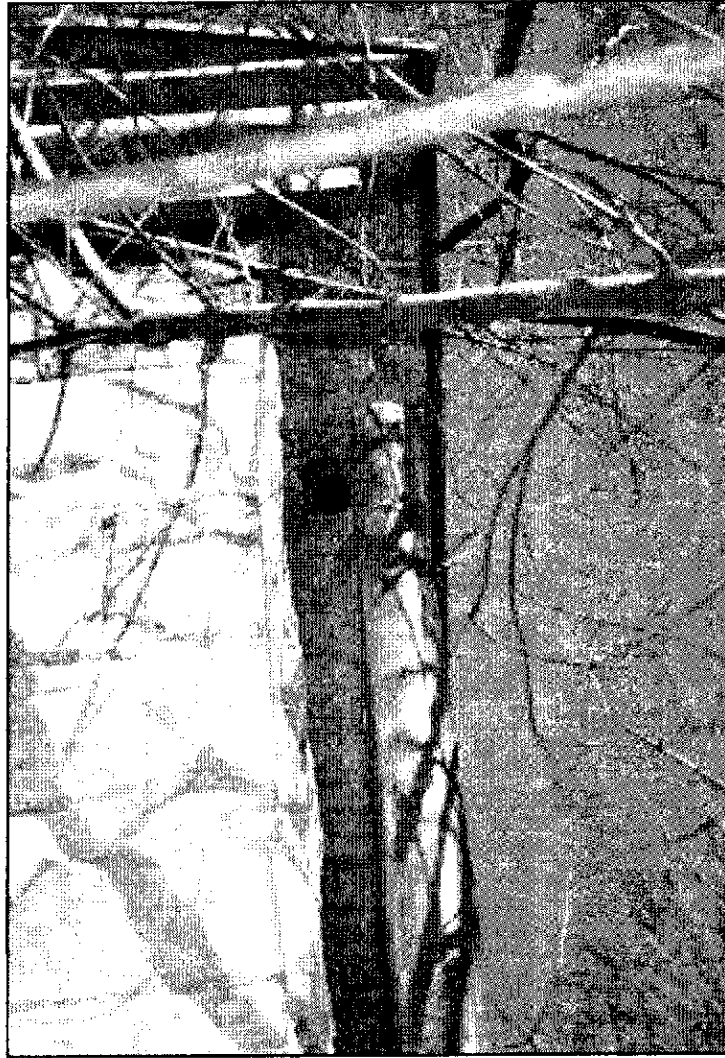
Figure 5.14: Detail of through-cornice downspout disconnected from rain leader at south end of southeast elevation. The downspout is clogged with branches and foliage.

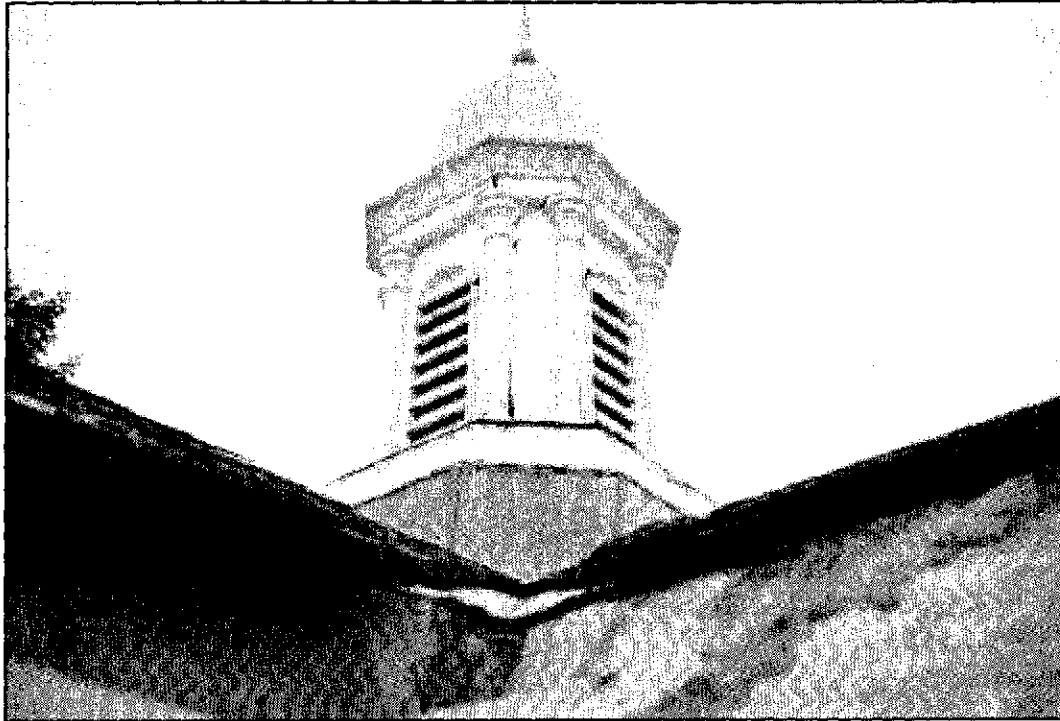
Figure 5.15: Cupola, view to the west with black sealant and failing paint.

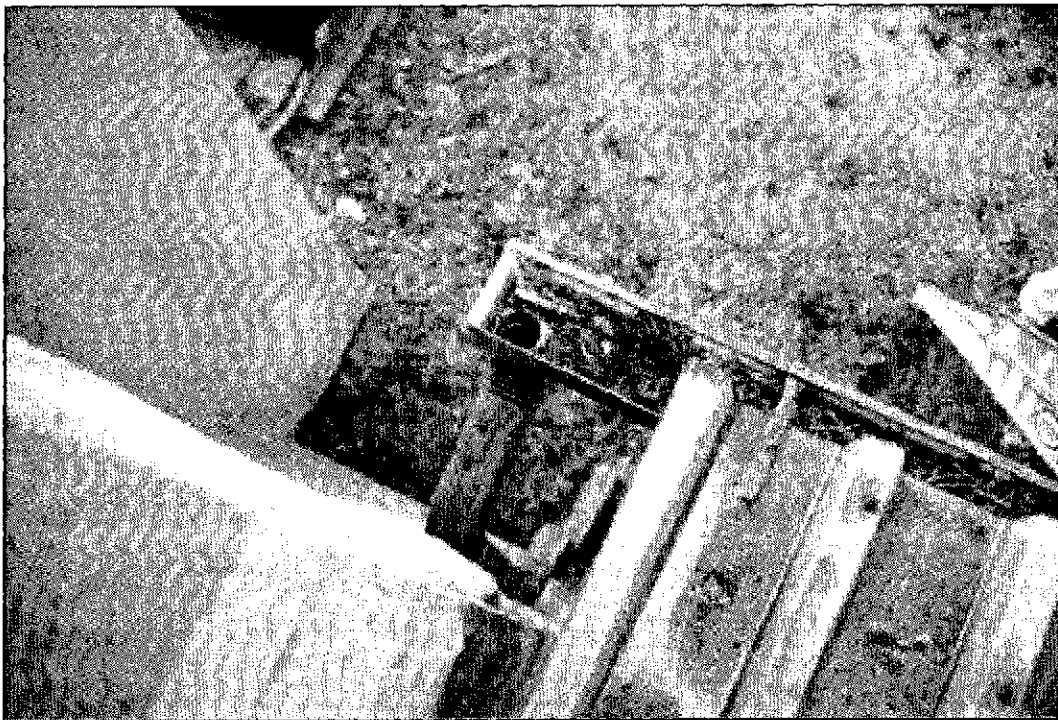
Figure 5.16: Gutter and downspout at southwest corner of areaway roof. Gutter is clogged with branches and foliage and contains standing water. Ferrous fasteners in the roof deck are beginning to rust and stain the galvanized steel. In the background, stucco patches adjacent to the attached chimney are visible.

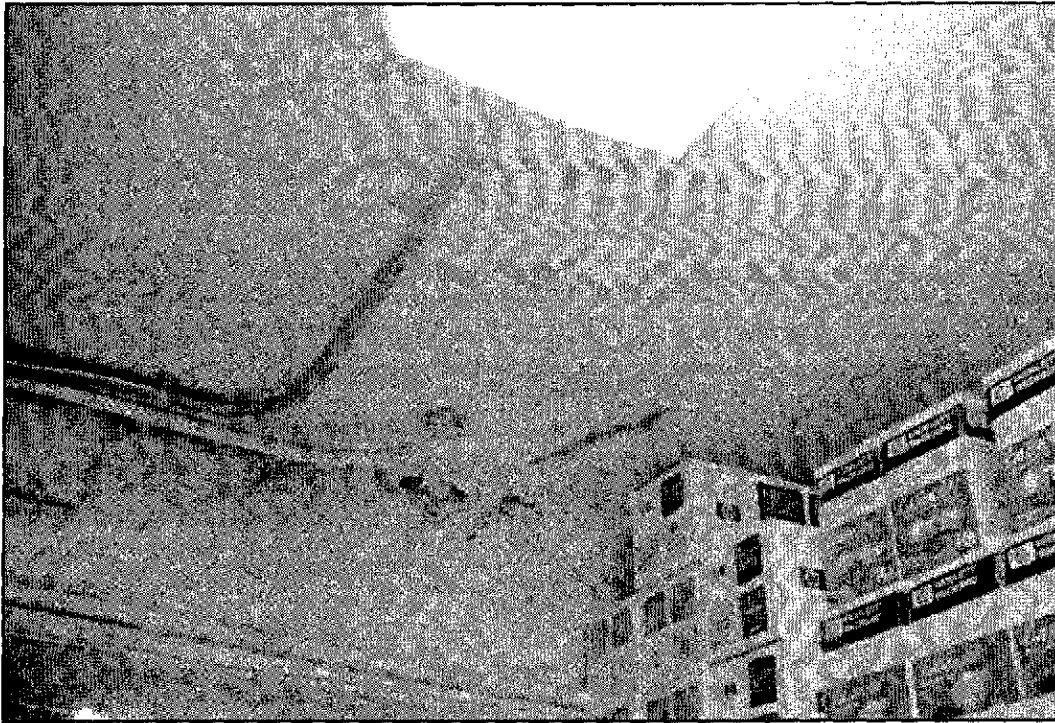
Figure 5.19: Detail of paint failure and water infiltration at concrete ceiling of north storage room. The painted concrete and brick wall at this location has also eroded and is showing signs of rust bloom from embedded ferrous elements.

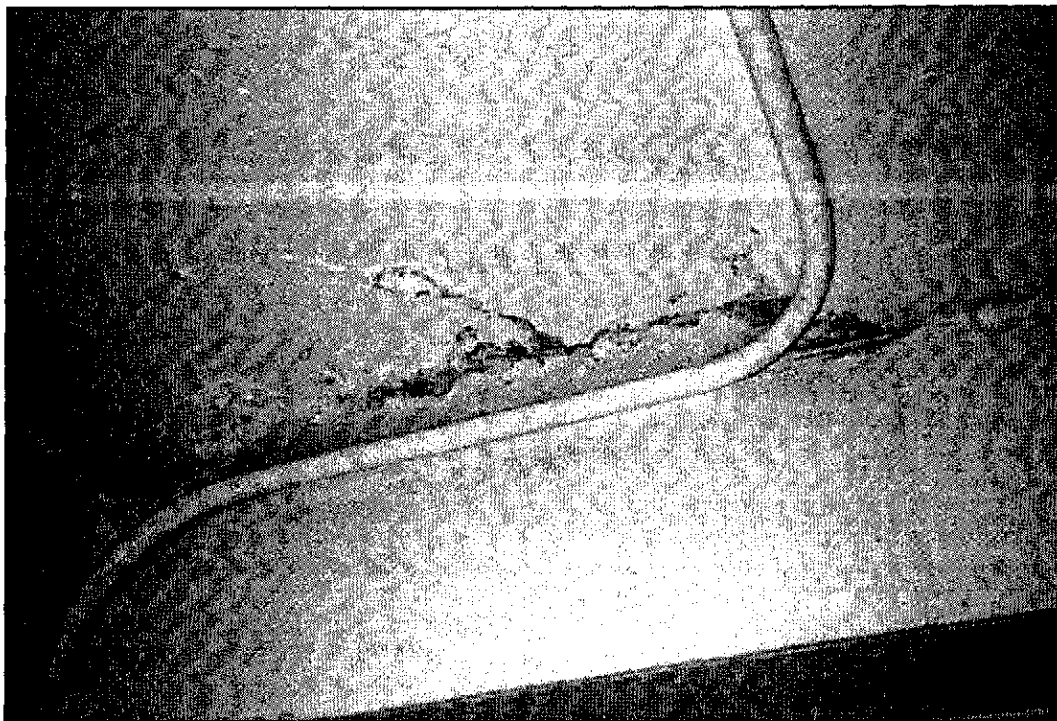
Figure 5.20: Detail of paint failure and water infiltration at concrete ceiling of staff break room.

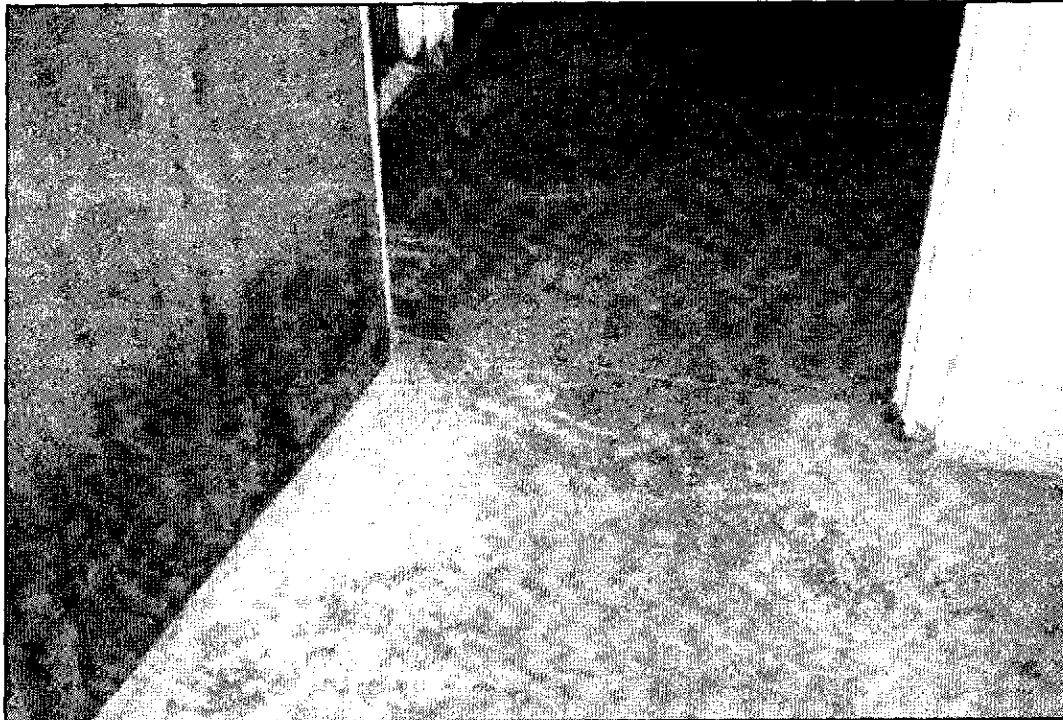
Figure 5.21: Detail of painted concrete floor at door of staff locker room. A large crack beginning at the door frame runs across the opening to an adjacent wall, and the paint has eroded in high-traffic areas.

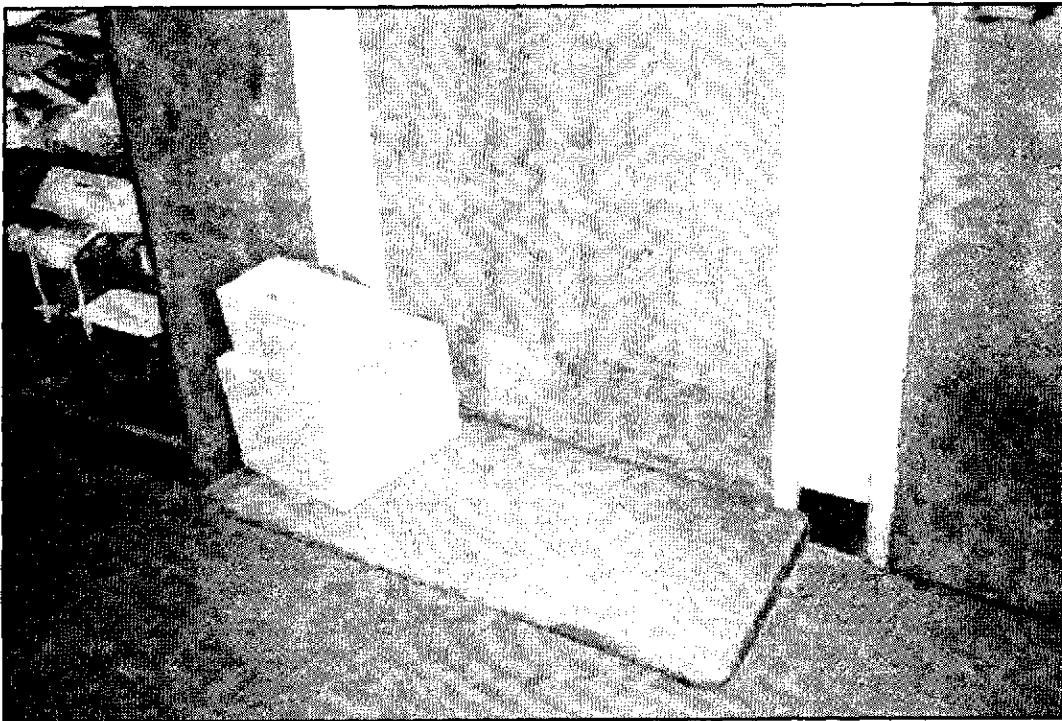
Figure 5.22: Detail of metal ramp at basement entry to handicapped lift with paint failure and rust bloom at perimeter. Also note the soiling and wear at the adjacent wall and door frame.

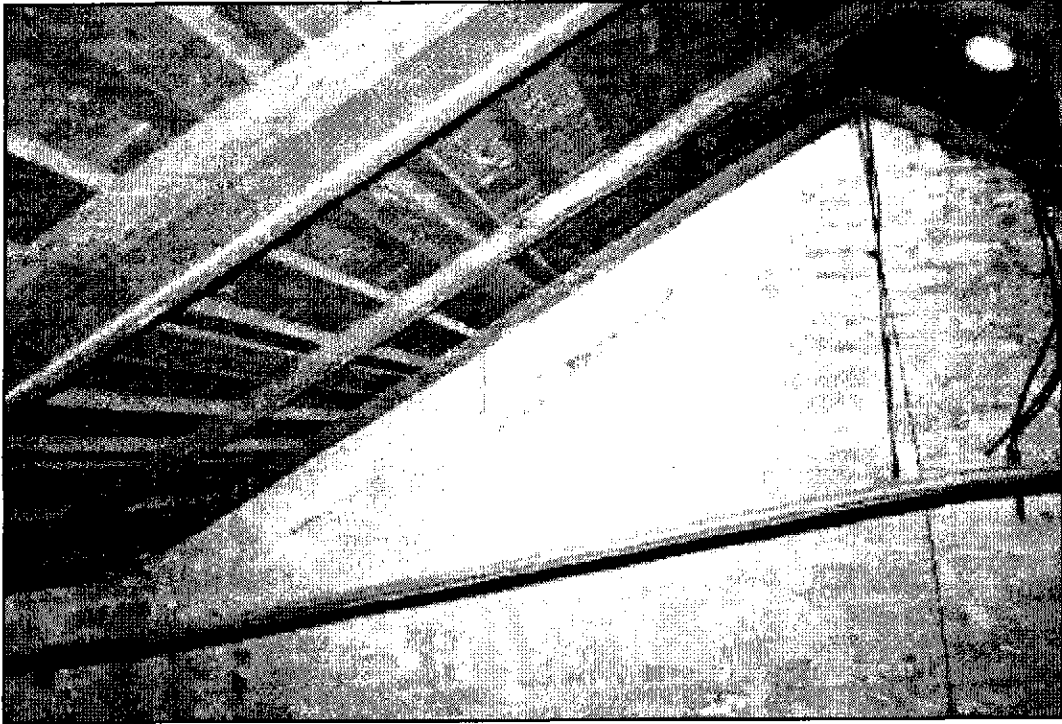
Figure 5.24: Attic, view to the southwest with remains of whitewash and deteriorated mortar under granite cornice.

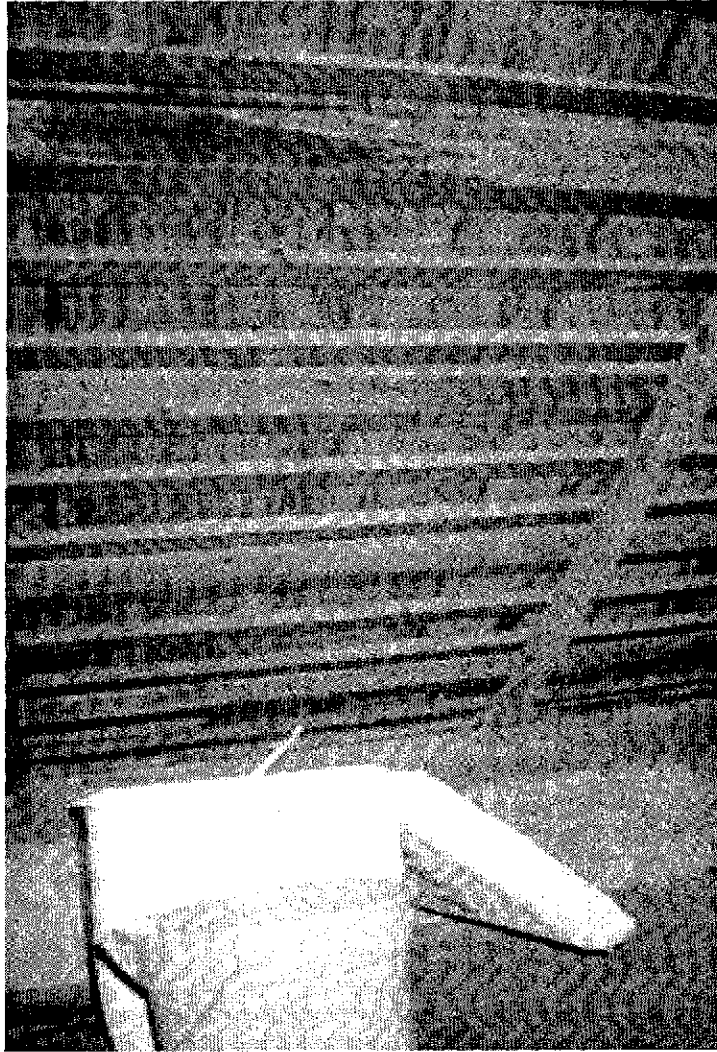
Figure 5.25: Attic, view to the northwest with plastic containers catching water from rain-dampened wood purlins and sheathing.
