NATIONAL AERONAUTICS AND SPACE ADMINISTRATION

APOLLO 13 MISSION REPORT

SEPTEMBER 1970

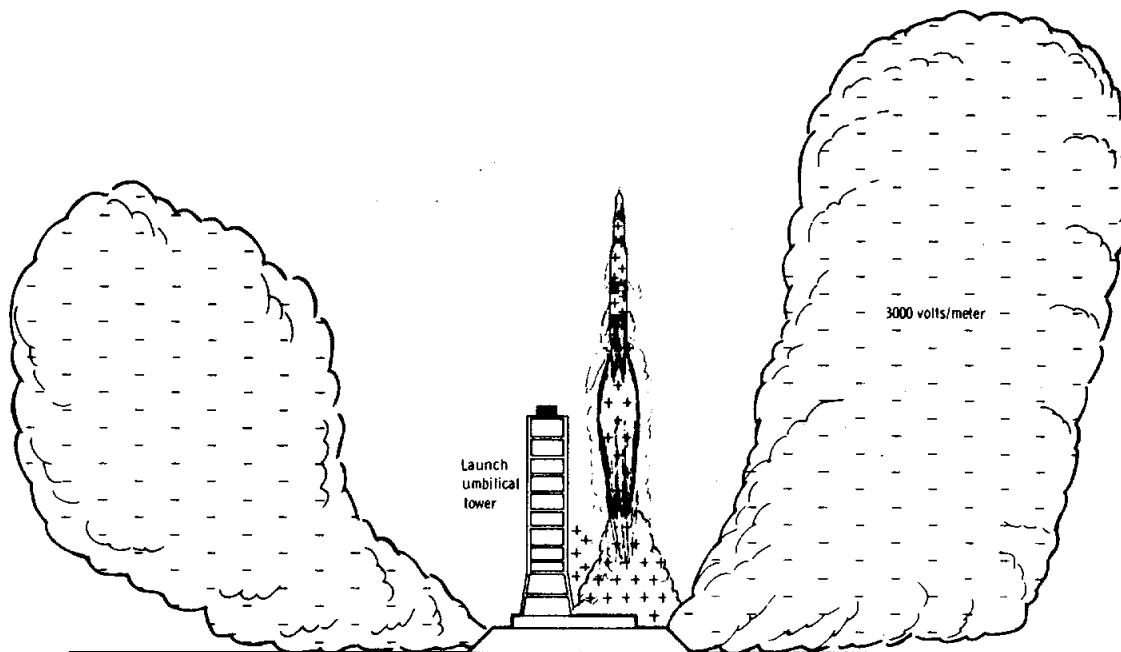
Figure 11.1-4.- Electrical charge characteristics.

Field meter records indicate the Apollo 13 vehicle carried aloft a net positive charge and that the trailing exhaust gases were negatively charged (fig. 11.1-4). Initial analysis indicates the total charge Q carried by the vehicle was about 0.04 coulomb. If the capacitance of the launch vehicle is about 100 picofarads, the vehicle is then at a potential of 4 million volts. A stored charge of 0.04 coulomb at a potential of 4 million volts provides an electrostatic potential energy of 160 000 joules. Although this energy is much less than that dissipated

in a natural lightning discharge, the level is still considerable and could significantly increase the potential hazard in an otherwise marginal weather situation. These numbers are consistent with the electrostatic discharge analysis performed on the Apollo 12 lightning incident. Engines in jet aircraft have been observed to produce similar charging effects.

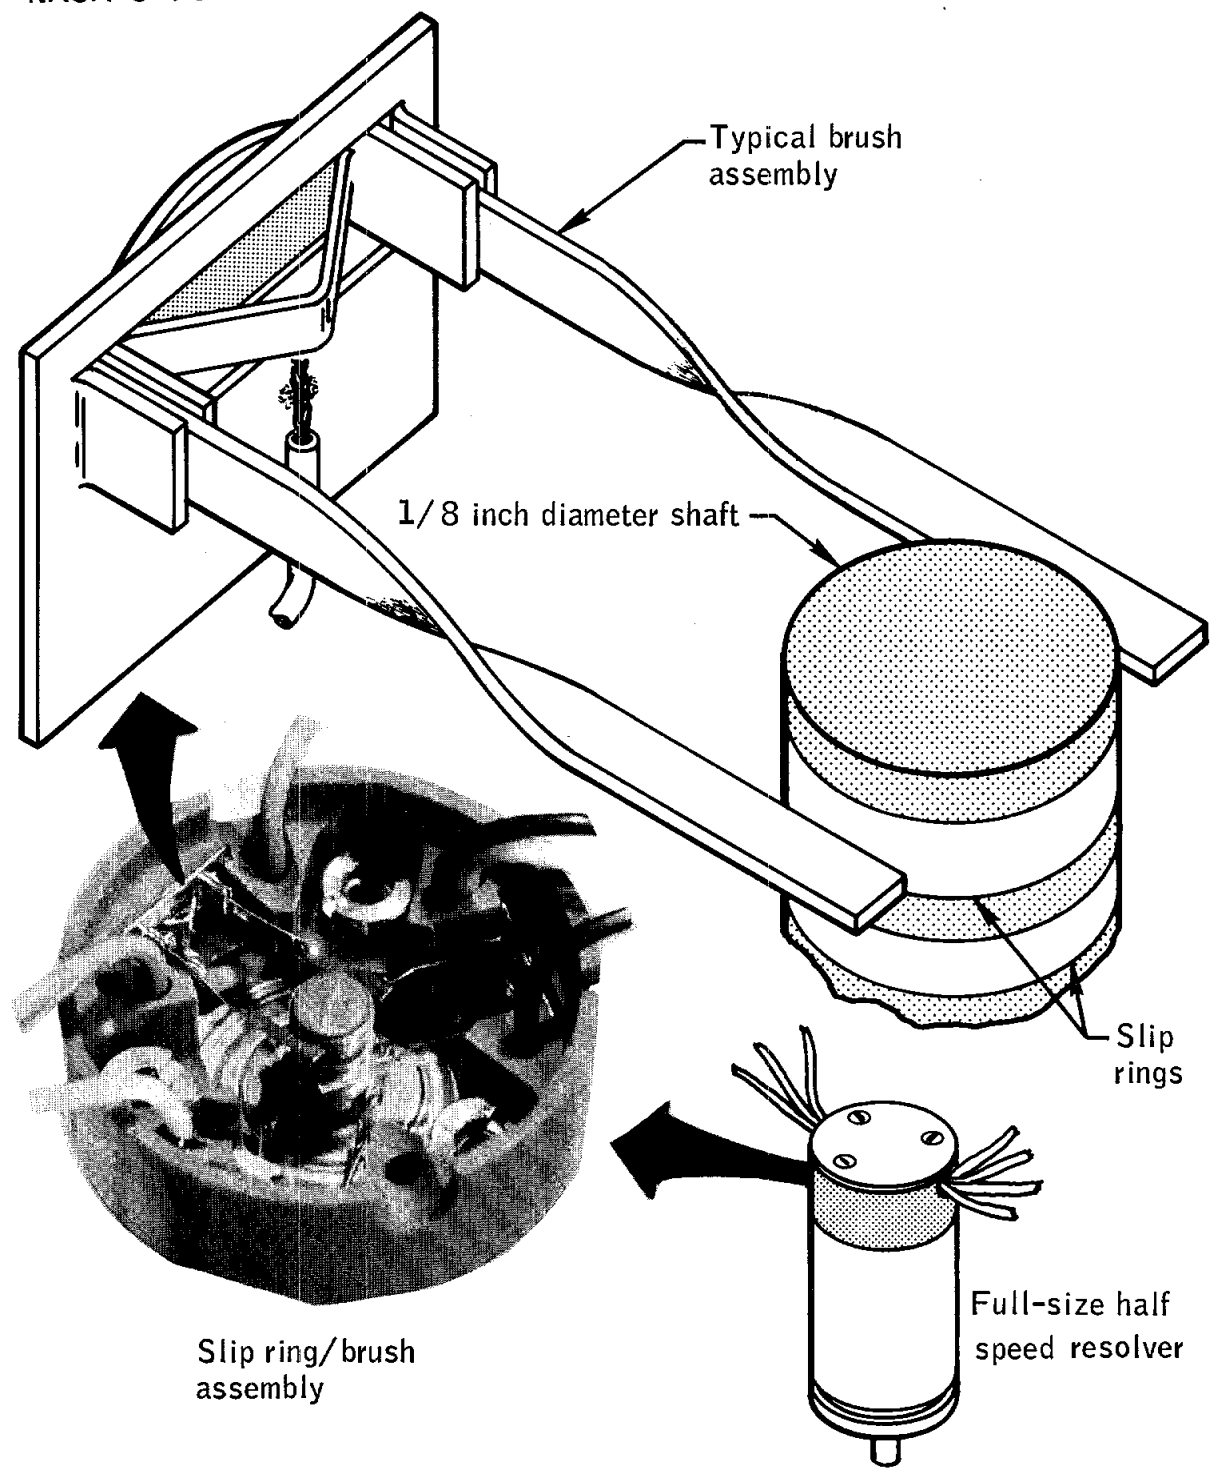
Figure 14-3.- Details of half speed resolver.

vacuum testing. The tests were run with the units rotating at 1 rpm, however, and the momentary resistance changes disappeared with the wiping action.

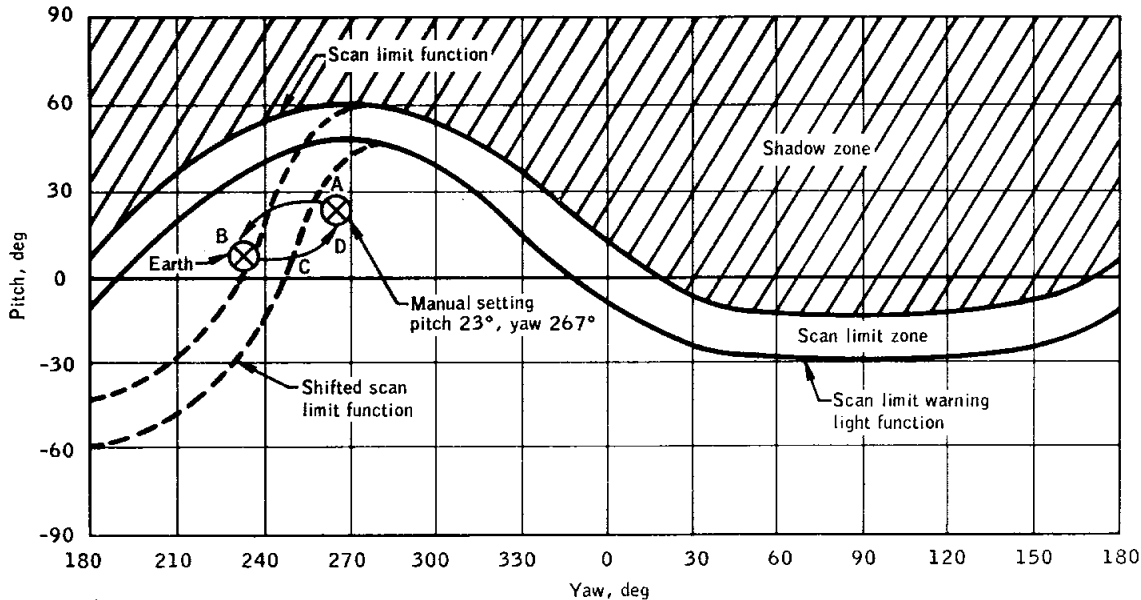
Figure 14-5.- Shift in scan-limit, scan-limit-warning illustrated.

mode and drive back toward the manual settings until the scan limit warning function line at point C was reached, thereby maintaining wide-beam operation. When the antenna reaches the scan limit warning function line, the system would automatically switch to the medium-beam mode and continue to drive in the manual mode until the manual setting error was nulled out at point A. The antenna would then switch to the auto-track mode and repeat the cycle. The most important feature of this cycle is that the antenna moves at the manual scan rate between points B and D, which is confirmed by the rapid changes in the downlink signal strength.

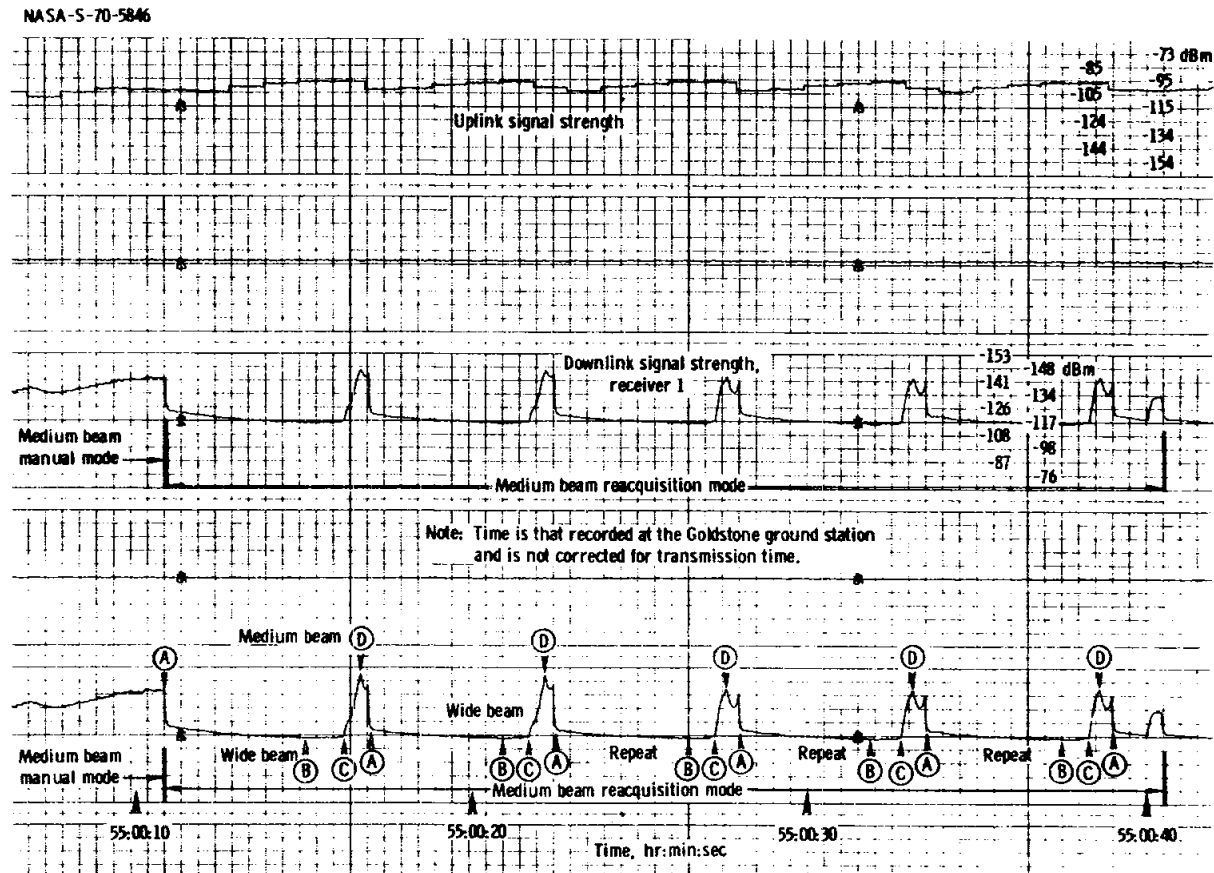
Figure 14-6.- Recorded signal strengths during high-gain antenna operation.

results of this test shifted the scan-limit functions but did not produce the necessary change in the scan-limit slope. Consequently, a failure in the electronic box is ruled out.

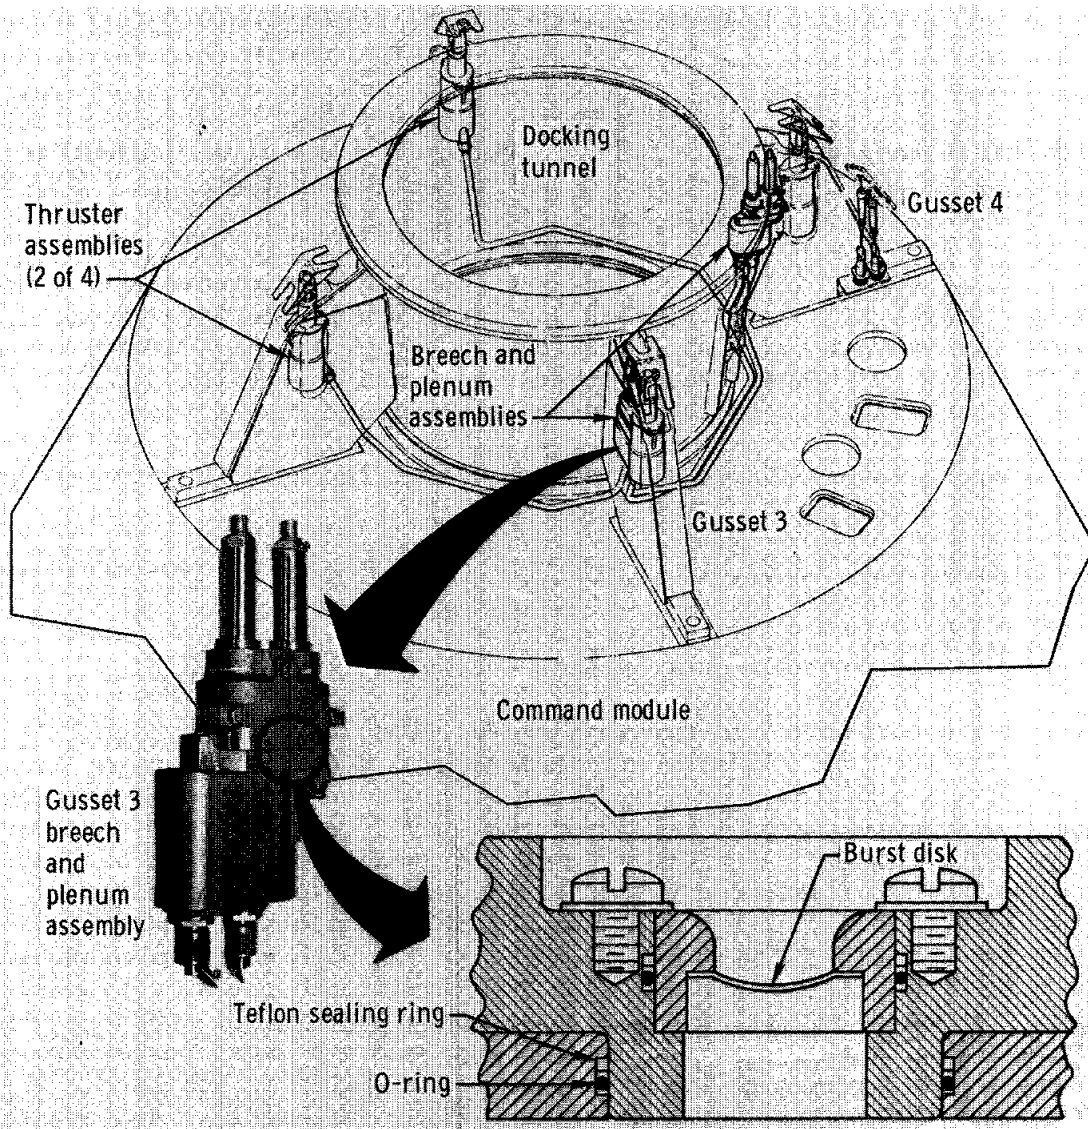
Figure 14-7.- Apex cover jettison system.

- a. Out of tolerance parts - Measurement of the failed parts indicate acceptable dimensions of the metal parts.
- b. Damaged O-rings - The 21 000-psi static proof-pressure test was successful.
- c. Gap in backup ring - The installation procedure specifies the backup ring may be trimmed on assembly to meet installation requirements,

but does not specify any dimensional control over the scarf joint. Since the gap portion was burned away, a gap in the backup ring could have caused the problem.

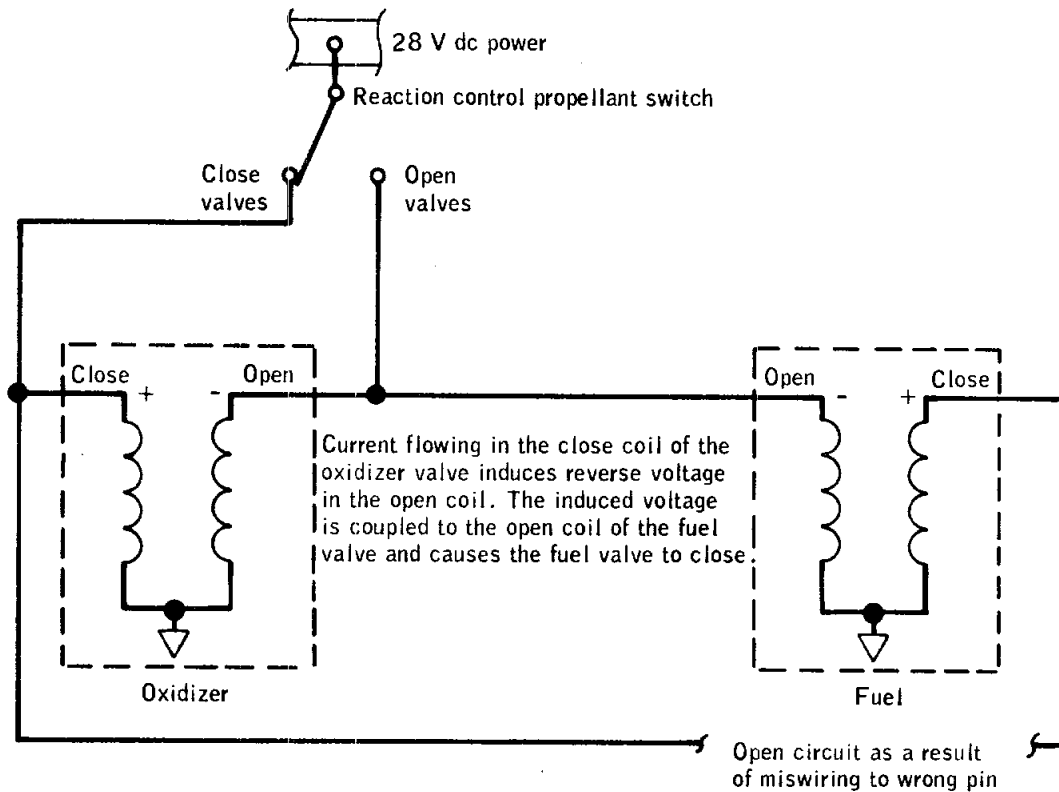
Figure 14-11.- Isolation valve circuit.

action. This voltage is applied to the fuel valve opening coil where it induces a magnetic field flux that closes the fuel valve. With 28 volts or more on the spacecraft bus, this phenomenon was consistently repeatable. With 24 to 28 volts on the bus, the valve would occasionally close, and with less than 24 volts, the valve would not close. Since preflight testing is accomplished at 28 volts, the functional tests did not disclose the miswiring. During the mission, the voltage was such that the valve did not close when commanded and therefore was found open after the flight.

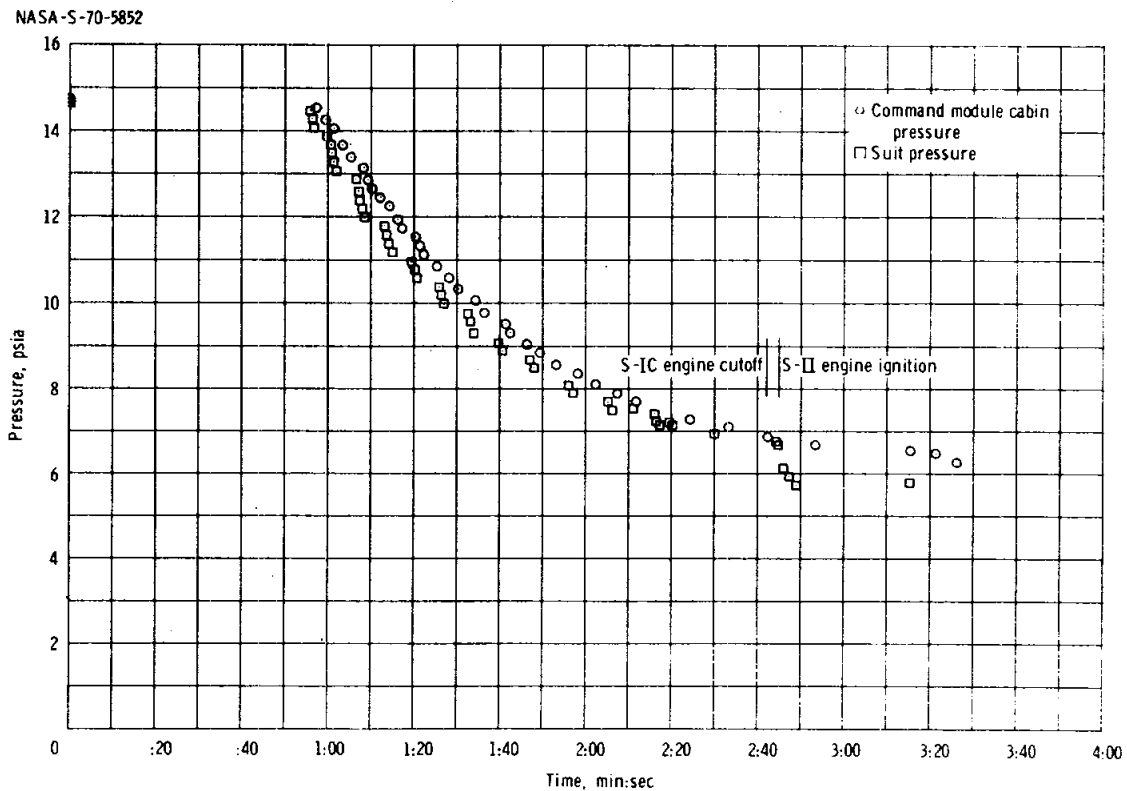
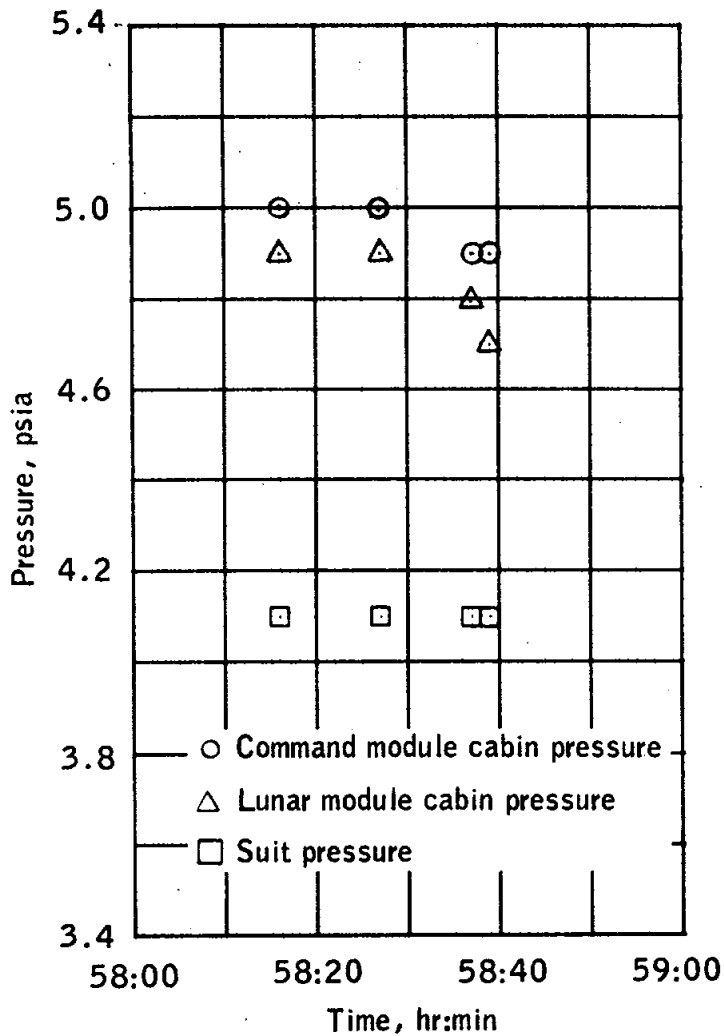
Figure 14-12.- Suit and cabin pressure.

During launch the suit pressure transducer reading remained consistent with cabin pressure until 00:02:45, then suddenly dropped from 6.7 to 5.7 psia coincidentally with S-II engine ignition (fig. 14-12). The difference between the two measurements decreased to only 0.2 by 1-1/2 hours, when the cabin reached its nominal regulated pressure of 5.0 psia. For this shirtsleeve mode, the suit and cabin pressure readings should be nearly equal. During normal variations in the command module cabin pressure, the suit pressure measurement responded sluggishly and indicated as much as 1 psi low. Subsequently, the measurement output decayed and remained in the 4.1 to 4.3 psia range for a cabin pressure of 5.0 psia until system deactivation at about 59 hours (fig. 14-12).

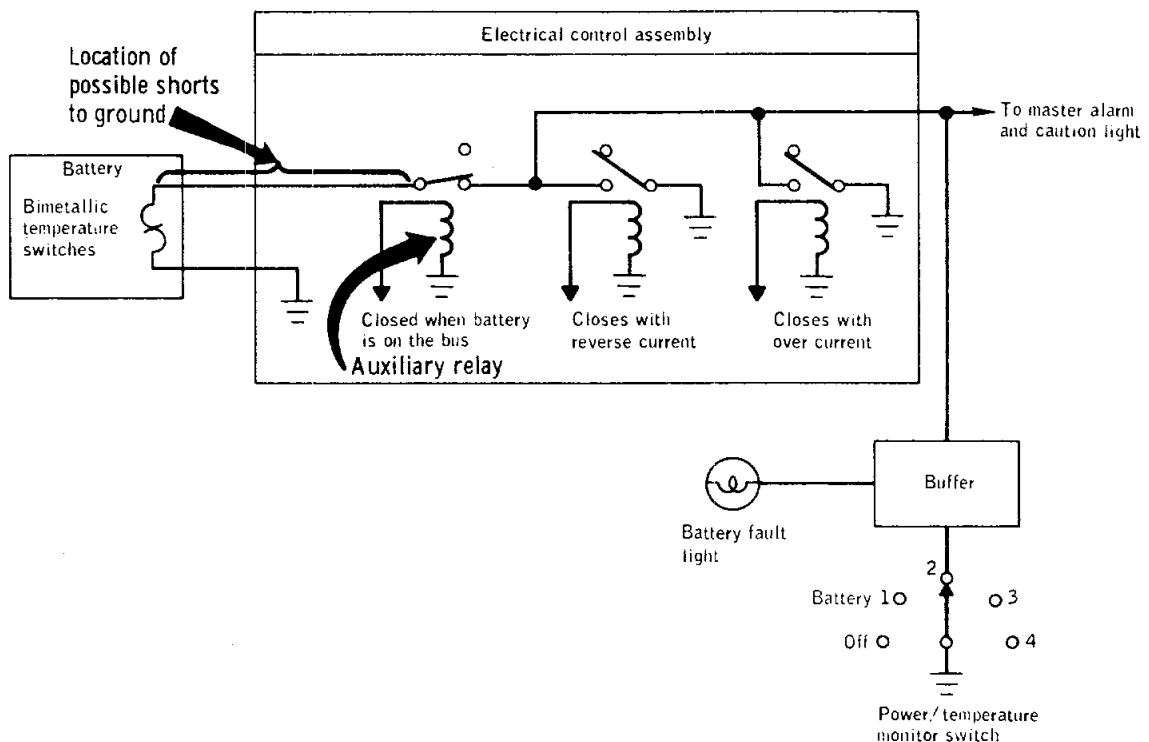
Figure 14-18.- Battery 2 malfunction circuit.

A battery overcurrent can be ruled out because automatic removal of the battery from the bus would have occurred.

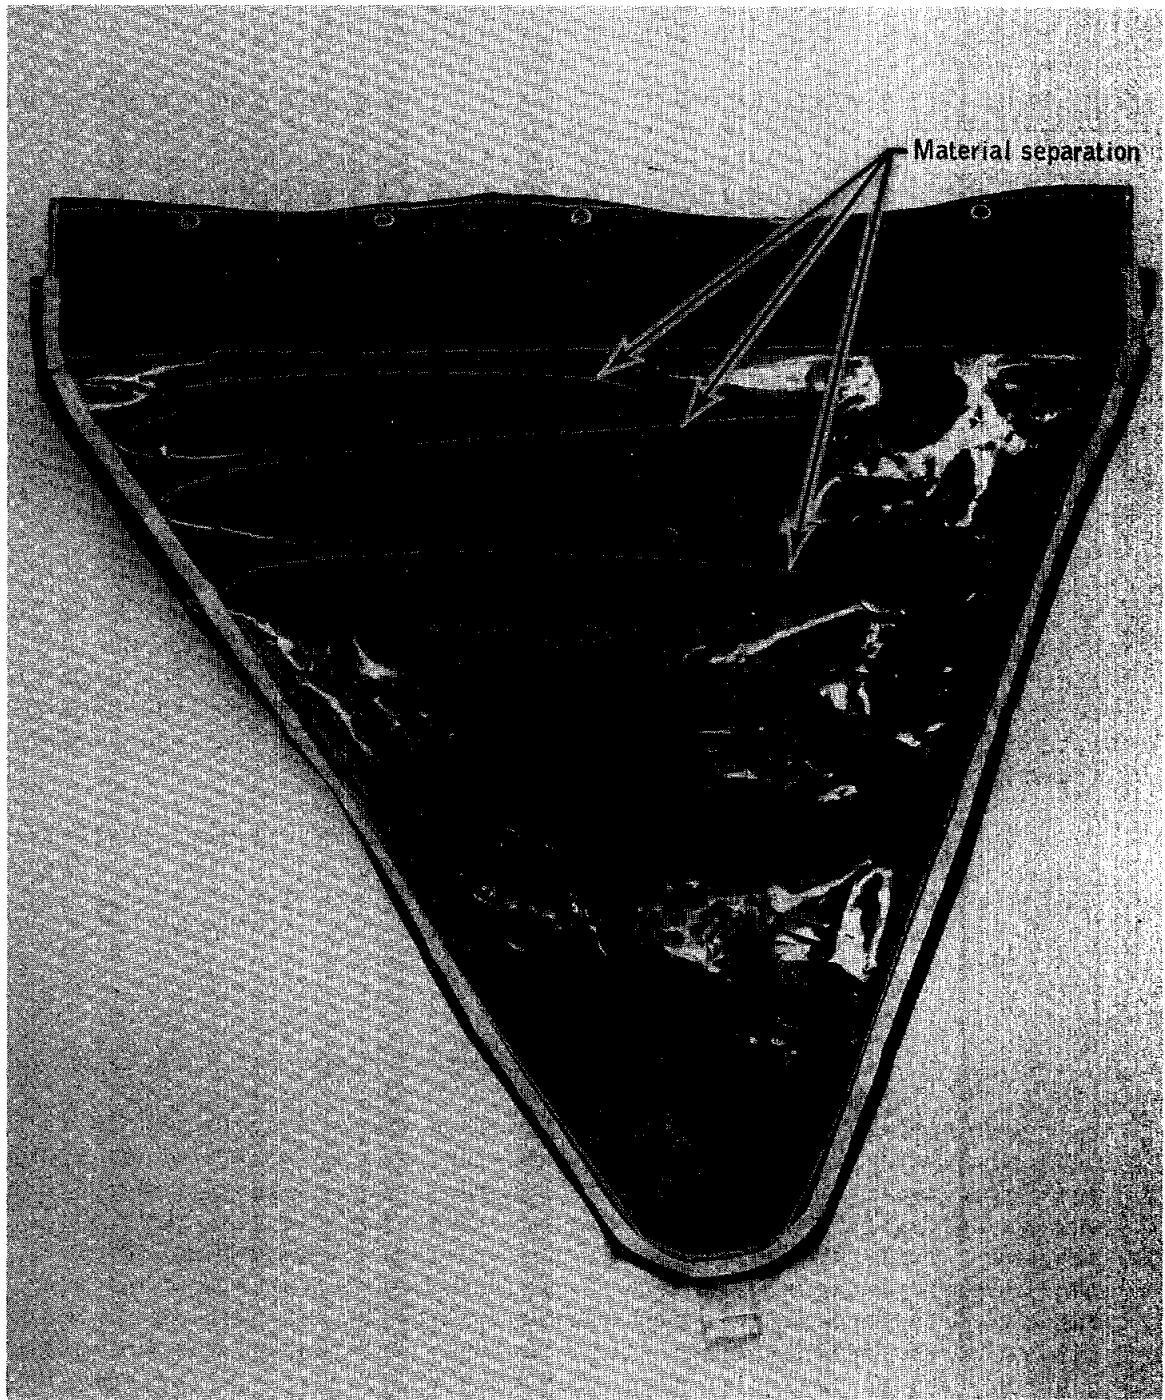
Figure 14-21.- Cracked left-hand window shade.

14.2.5 Cracked Window Shade
