NATIONAL AERONAUTICS AND SPACE ADMINISTRATION

APOLLO 8 MISSION REPORT

MANNED SPACECRAFT CENTER
HOUSTON, TEXAS
FEBRUARY 1969

Mission Evaluation Team

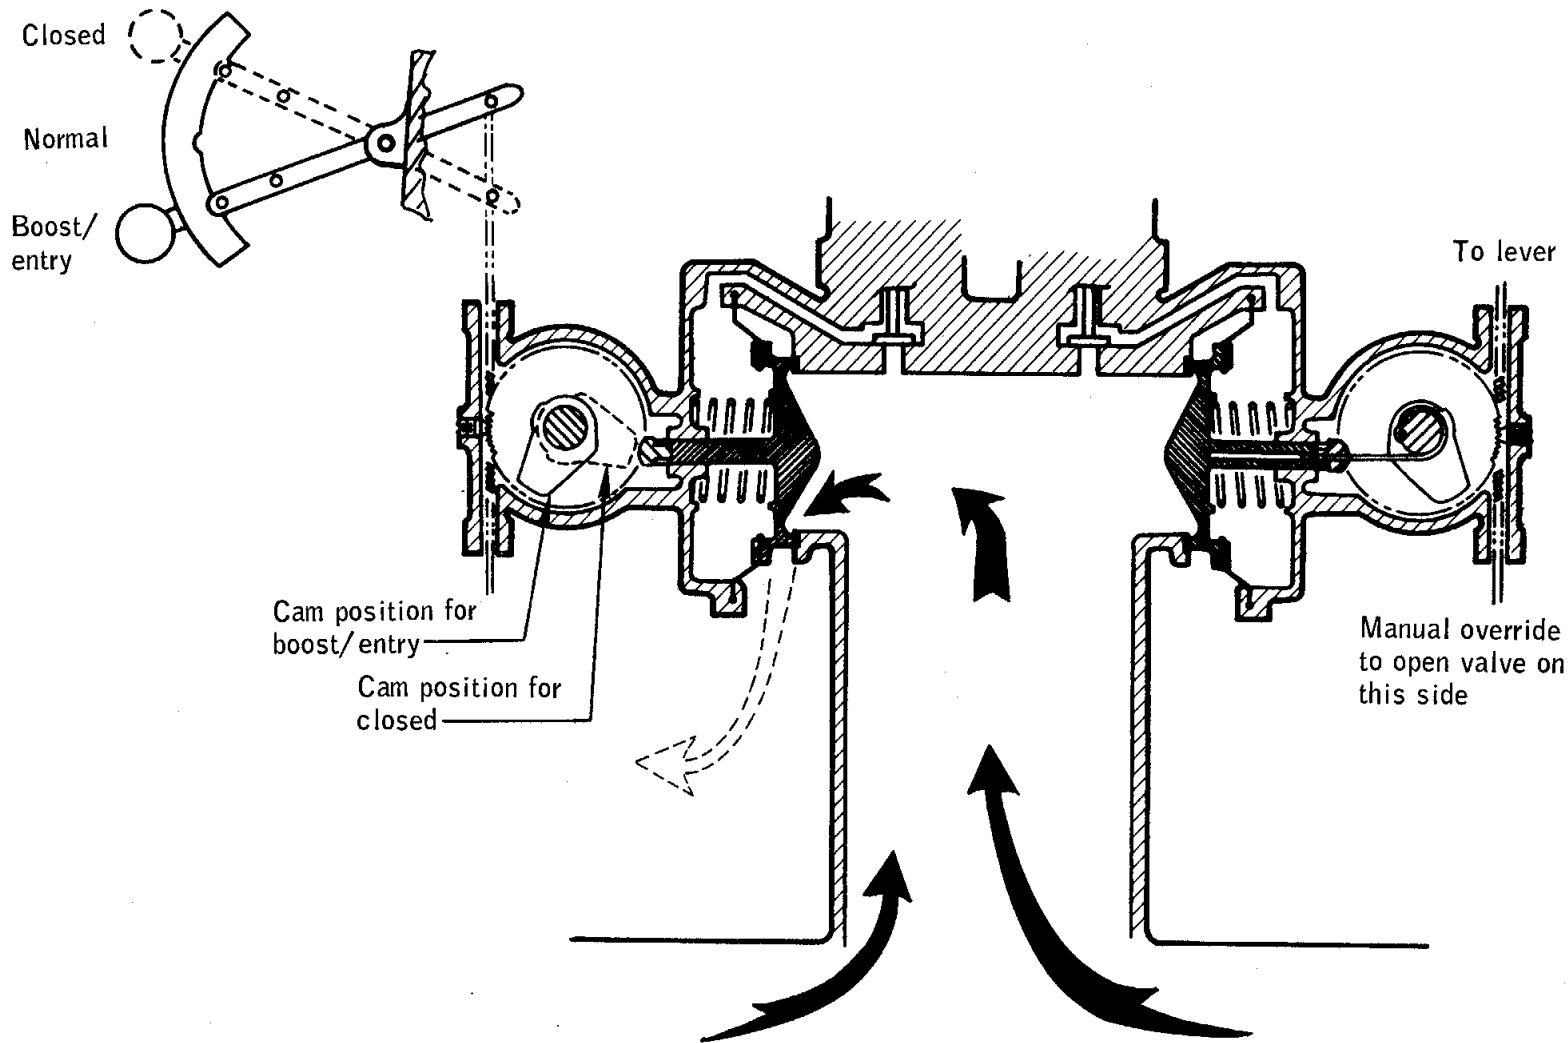
The crew estimated 2 to 3 quarts of water entered the cabin through the cabin pressure relief valve at landing. Postflight tests were conducted on the valve installed in the spacecraft. Test results indicate that, with both sides of the valve in the closed position, gaseous leakage through the system is 60 scc/min at a differential pressure of 18 inches of water. The differential pressure was increased up to 13 psi, with no significant increase in leakage. Test results indicate that the valve operated as designed and would not have allowed water ingestion if properly closed.

Figure 12-4.- Cabin pressure relief valve.

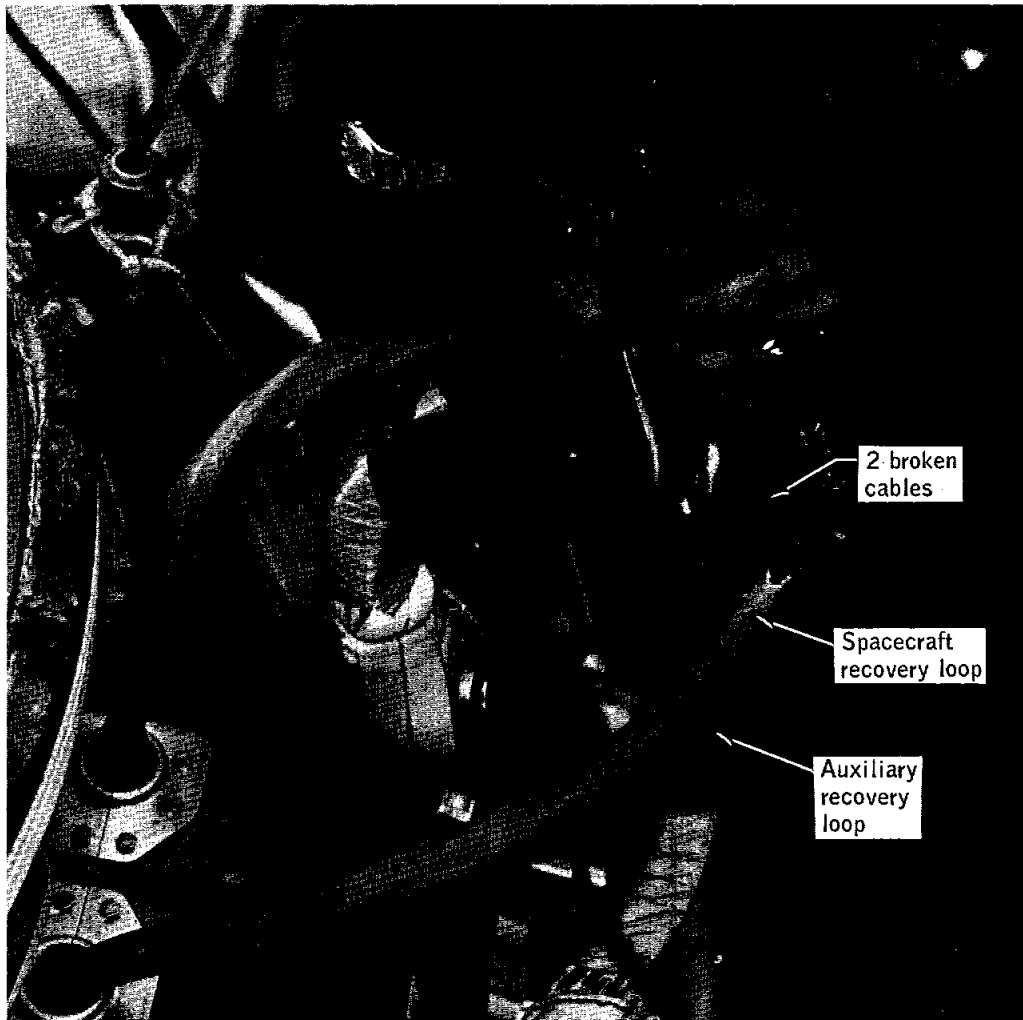
Figure 12-5.- Broken cables in spacecraft recovery loop.
