BORDER PATROL**Procurement of MD
600N Helicopters
Should Be Reassessed**

United States General Accounting Office
Washington, D.C. 20548

B-284951

September 29, 2000

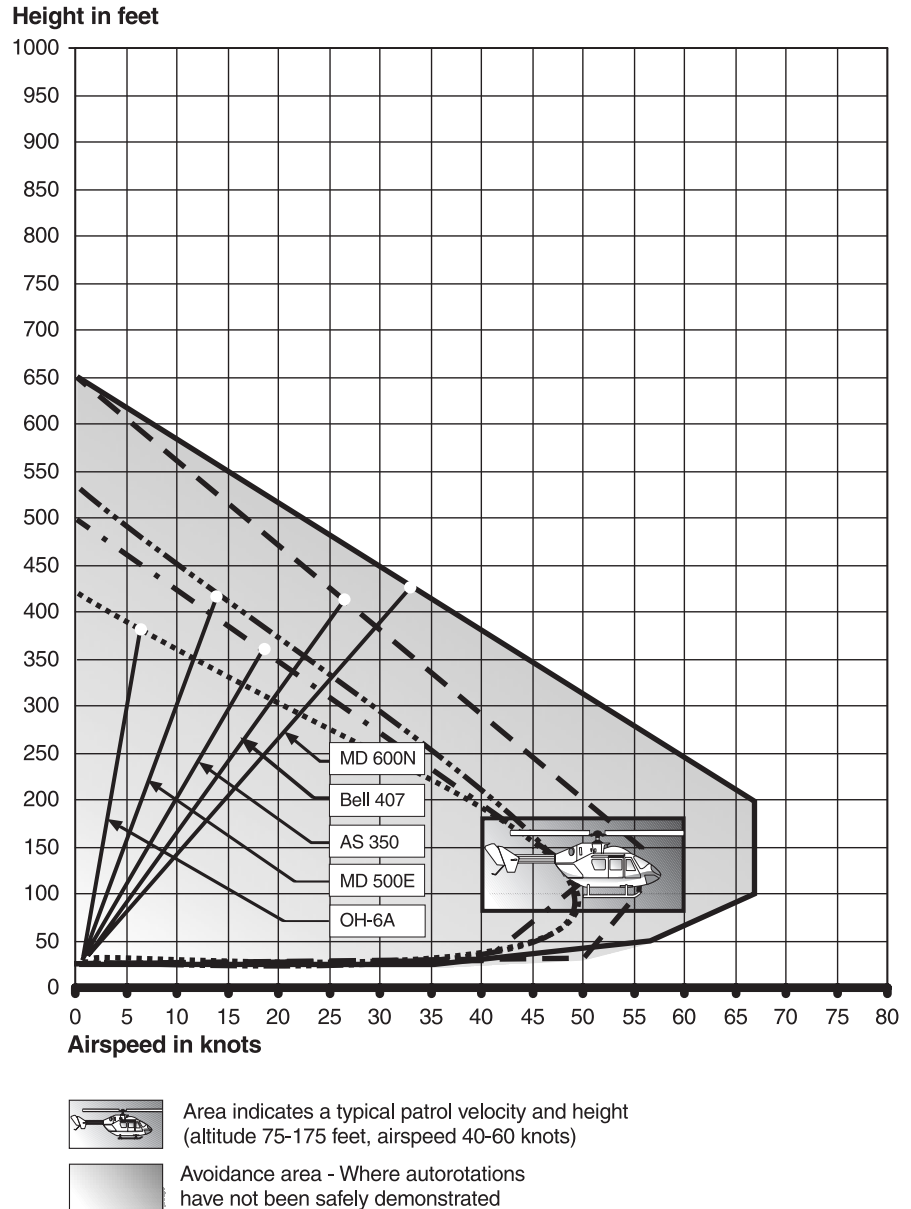
Figure 3: Height/Velocity Curves for MD 500E, MD 600N, Bell 407, American Eurocopter AS 350, and Hughes OH-6A

Most of the pilots we interviewed believed that the autorotation characteristics of the MD 600N are inappropriate for much of the flying performed during Border Patrol air operations missions. Autorotation is a pilot-recovery maneuver performed in the event of an engine failure that keeps the main rotor blades moving so that the aircraft descent can be controlled. Aircraft height and airspeed factors to be avoided during autorotation are depicted as a height/velocity curve.⁸ Pilots are instructed

MDH officials stated that the pilots based their concerns on a misunderstanding of the height/velocity curve rather than on the helicopter's operational characteristics. According to MDH, the MD 600N's height/velocity curve appears to cover more area because of more stringent testing conditions used for establishing the curve.⁹ However, we examined the height/velocity curves for several helicopters that were tested at or estimated for sea level. The MD 600N height/velocity curve had a larger area to avoid (see fig. 3). A senior FAA certification official said that this is a valid means for showing how different aircraft height/velocity curves relate to the height and airspeed of a typical Border Patrol mission.

An MDH official said they took a test pilot to one sector to discuss the autorotation concerns with Border Patrol pilots and provided additional

autorotation training to all Border Patrol sectors with MD 600Ns, at company expense. Based on feedback from Air Operations management to MDH, a company official said he believes that many of the concerns were addressed. MDH officials also said they were testing a 1 to 2 degree change in the angle of the rotor blades that will make the MD 600N easier to handle during autorotations. If testing goes well, the change will be made at no cost to customers, according to MDH officials. A proposed stability augmentation system may provide additional improvements, an MDH official said.

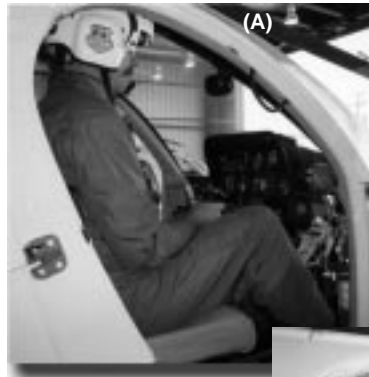
In addition to the heavy controls, some pilots said that the MD 600N is so uncomfortable that it affects their ability to do their work. The pilots said that after 2 hours, they must stop for a break; and several said that they suffered from pain in their knees, back, and buttocks caused by uncomfortable seats. Some pilots reported using cushions provided by Air Operations headquarters or their own cushions to relieve some of the discomfort. Several pilots also said that visibility is limited because of the door frames, particularly while using the cushions. They reported that they must get in awkward positions to look at objects below or behind them.

(A) Pilots explained that visibility is limited by the door frames, and that awkward positions are sometimes necessary to see objects below or behind them.

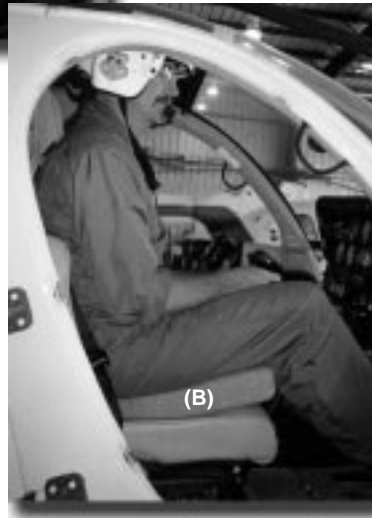
(B) Some pilots reported using seat cushions provided by Air Operations headquarters or their own cushions to relieve some of the discomfort caused by the seats in the MD 600N.

Air Operations officials agreed that the seats in the MD 600N are uncomfortable. Pilots had said they wanted padded seats, so the officials said they asked for high-quality seats during the procurement.¹⁷ Air Operations officials recently took action to replace the seats provided under the original procurement. Seats tested by Border Patrol pilots during the flight evaluations for the stability augmentation system have been ordered and are being manufactured, as of September 21, 2000, according to INS.
