## **Tanker Rollover Claims Life of Volunteer Fire Chief - Missouri**

### **SUMMARY**

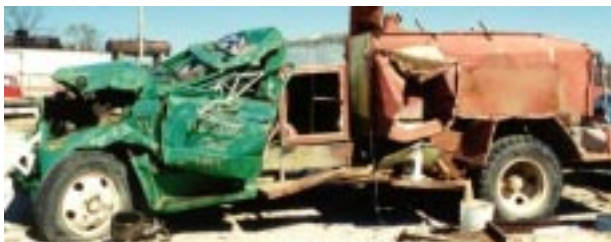
*Truck Involved in Incident*

The volunteer fire department involved in this incident serves a population of 696 in a geographical area of 75 square miles and is comprised of 21 volunteer fire fighters. The truck involved in this incident was a 1969 Chevrolet C-50 truck with dual wheels on the rear axle. The standard pickup bed was converted and a handmade water tank was attached. The T-shaped tank was made of steel and had a 641-gallon capacity. It was not equipped with baffles, and it was full at the time of the incident. The gross vehicle weight of the truck was 18,000 lbs including the 5,320 lbs of water. The truck was purchased by this department as an aftermarket truck in 1986. At the time of the investigation, the department did not have any written maintenance records for the truck.

The truck was equipped with a lap belt on the passenger side; however, it did not have a seat belt (lap or shoulder) on the driver's side. At some point, the seat belt on the driver's side had been removed. The holes in which the seat belt bracket had been mounted were visible and were not patched in any way. The department does not have a written policy on wearing seat belts.

***Recommendation #1: Fire departments should ensure all apparatus are kept under a maintenance schedule which is documented.<sup>1</sup>***

Discussion: Maintenance schedules should be established and recorded as an integral part of a well-planned maintenance program. The maintenance program should include daily, weekly, and periodic maintenance service checks. The daily maintenance check should follow the manufacturer's handbook and should include items such as oil level, coolant level, batteries, visible and audible warning signals, fuel levels, and tires for cuts and proper inflation. Additionally, maintenance checks should include a visual inspection of all safety equipment such as seat belts. This truck did not have a seat belt installed on the driver's side. The seat belt had been removed and the holes in which the seat belt bracket had been mounted were visible. If deficiencies are found during maintenance checks, the apparatus should be removed from service until deficiencies are corrected. At the time of the investigation, it was determined that the rear tires on the truck were in very poor condition. This is significant as the evidence suggests that the vehicle lost traction on the wet road and

***Recommendation #2: Fire departments should ensure all apparatus equipped with water tanks are provided with baffles to control the water's movement.<sup>2</sup>***

Discussion: Apparatus equipped with water tanks should follow the provisions set forth in NFPA 1901, Standard on Automotive Fire Apparatus, Chapter 17. This standard states that all apparatus equipped with water tanks should be baffled or have swash partitions to form a containment to control water movement.

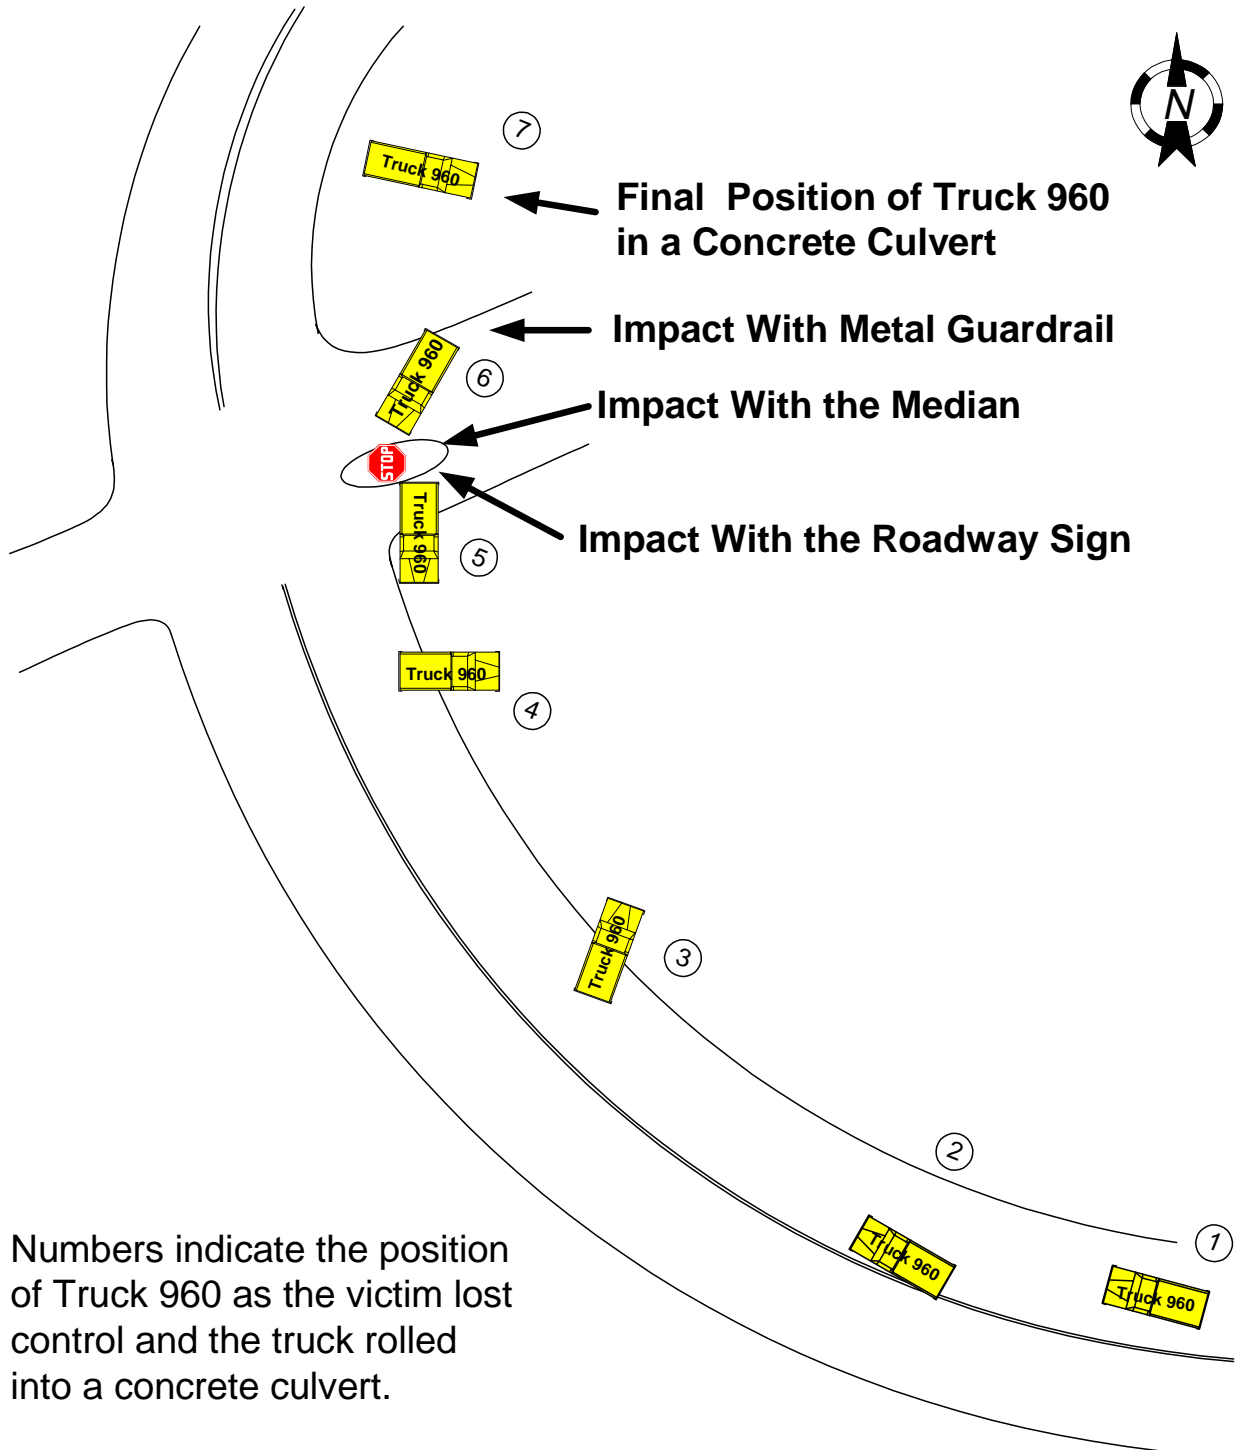
*Diagram. Overview of Incident Site*

On January 17, 2000, at 1512 hours, the volunteer fire department was dispatched to provide mutual aid at a working structure fire. The Fire Chief (victim) notified Dispatch at 1523 hours that Truck 960 was en route to the scene. The Assistant Chief and four other volunteer fire fighters responded to the incident in privately owned vehicles (POVs). The victim, driving with code three priority (lights and sirens), was traveling in the westbound lane of a two-lane state highway and approached a curve in the road (see Diagram and Photo 2). The State Highway Patrol estimated the truck was traveling approximately 58 mph. According to witness statements and evidence collected by the State Highway Patrol and the motor-vehicle reconstructionist, as the victim approached the curve, the truck began to cross the center line. As the victim steered the truck back into the westbound lane, it began a sideways skid. The truck's right front tires left the lane and continued onto the shoulder in a sideways direction. The truck started rotating in a clockwise direction. Continuing to rotate, it traveled through a ditch and became airborne, landed on a side street, struck a cement median in a backwards direction and struck a street sign (see Photo 1). The truck then crossed a second lane on the side street. The right rear corner of the truck struck a guardrail and flipped end over end until it landed on its cab in a concrete culvert (see Diagram and Photo 3). The truck rolled one-half to three-quarters times before coming to rest. The victim was killed instantly.

Numbers indicate the position of Truck 960 as the victim lost control and the truck rolled into a concrete culvert.

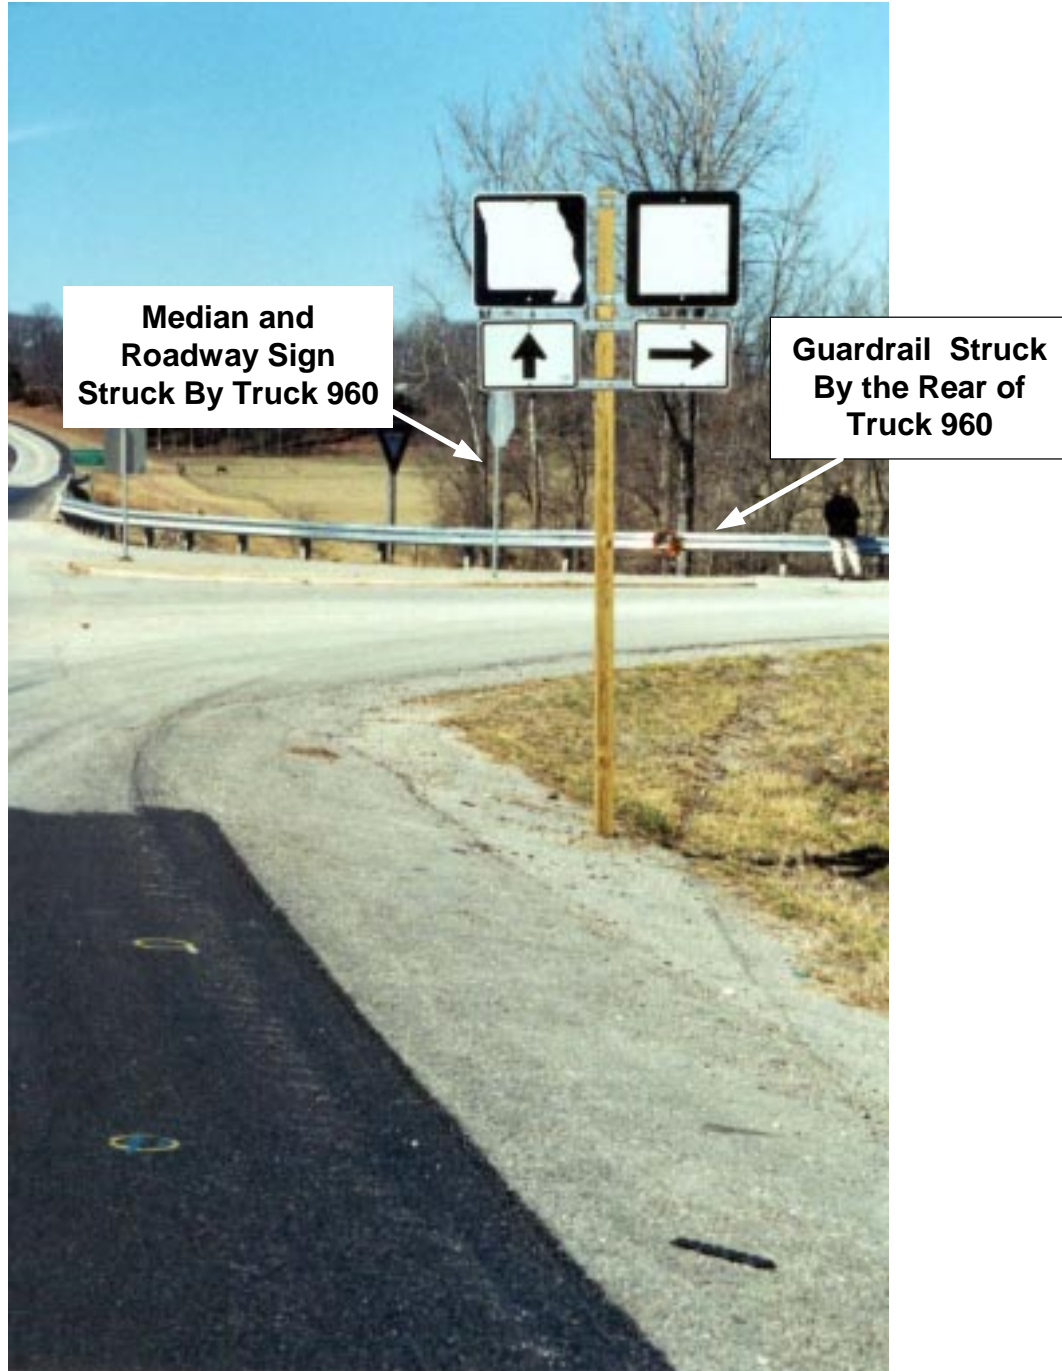
*Photo 1. Median and Guardrail Struck By Truck 960*

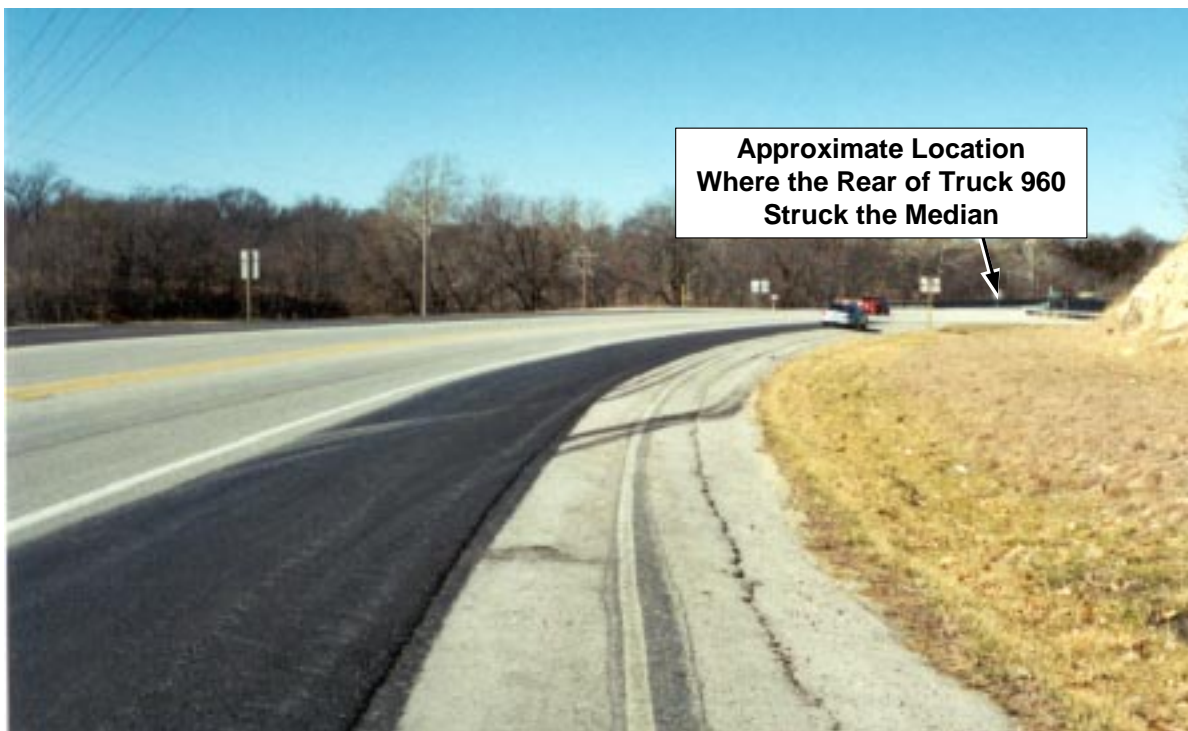
On the day of the incident, weather conditions were cloudy with misty rain. This was the first rain the area had received in approximately 2 months, causing the road surface to become slick due to the moisture from the rain mixing with oil and grease on the highway.

The road on which the truck was traveling was a two-lane, asphalt state road marked with a solid double-center yellow line and white fog lines. The road is classified as a right curve with a 1-degree grade (see Diagram and Photo 2). It had asphalt shoulders on both sides of the pavement, and they sloped into ditches. The road measures approximately 24 feet wide. The eastbound and westbound lanes were approximately 11 feet wide with the remaining 2 feet between the center lines. The road had a posted speed limit of 55 mph with a posted cautionary speed of 50 mph at the curve.

*Photo 2. The Curve on the Road Where the Victim was Traveling*

***Recommendation #4: Fire departments should ensure that all drivers of fire department vehicles are responsible for the safe and prudent operation of the vehicles under all conditions.<sup>4</sup>***

Discussion: Fire departments should ensure driver/operators of fire service vehicles are responsible for the safe and prudent operation of the vehicles under all conditions. The State allows emergency vehicles responding to an incident to exceed the

maximum speed limit if the driver does not endanger life or property. Additionally, when hazardous weather conditions and roadways are present, drivers should always maintain safe speeds to avoid losing control of their vehicles.

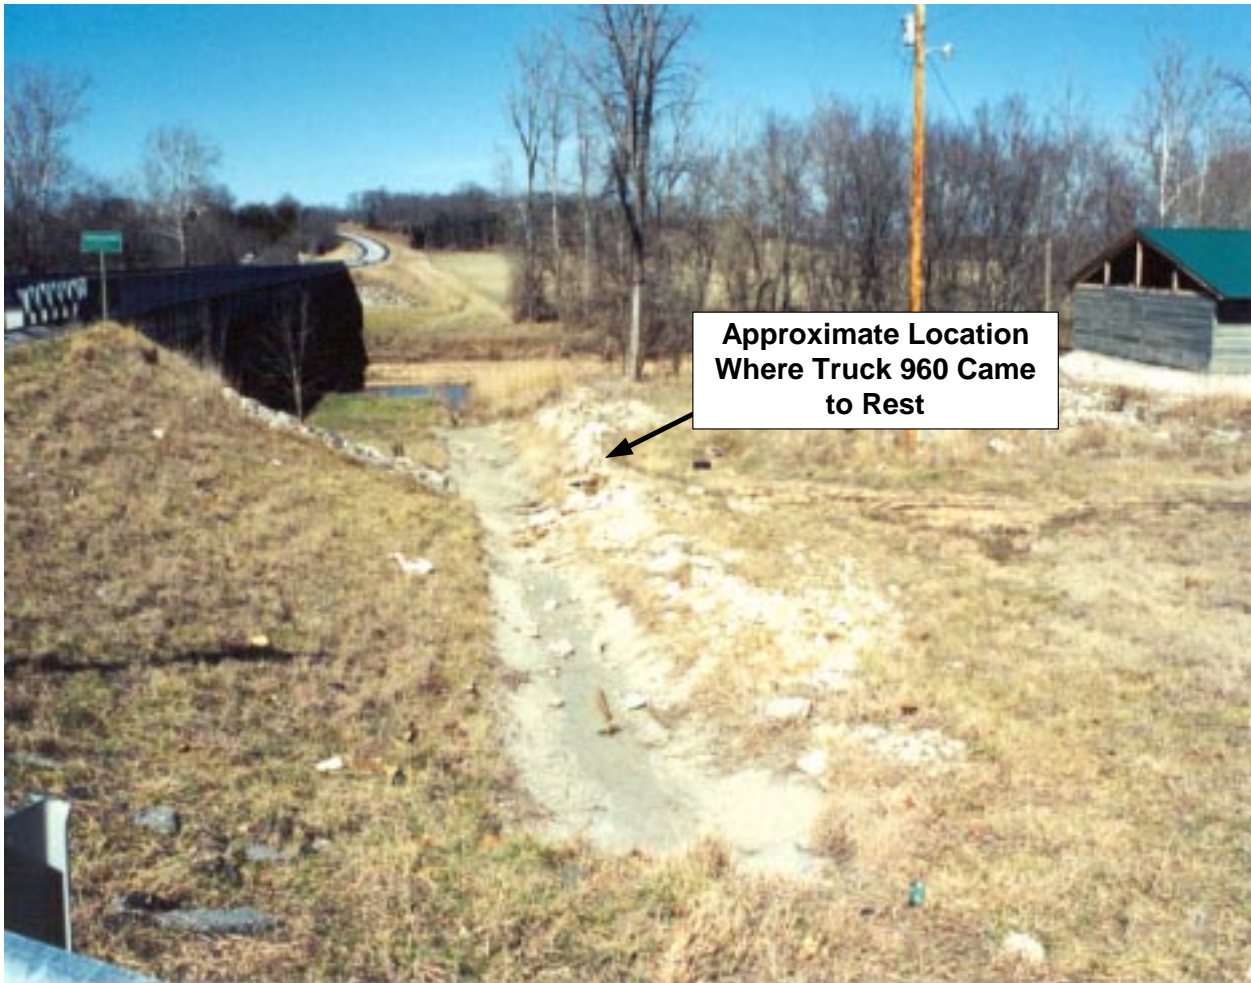
*Photo 3. Concrete Culvert Where Truck 960 Came to Rest*
