## **Motor-Vehicle Incident Claims the Life of a Volunteer Assistant Chief - Alaska**

## Fatality Assessment and Control Evaluation Investigative Report #F2001-17

### *Motor-Vehicle Incident Claims the Life of a Volunteer Assistant Chief - AK*

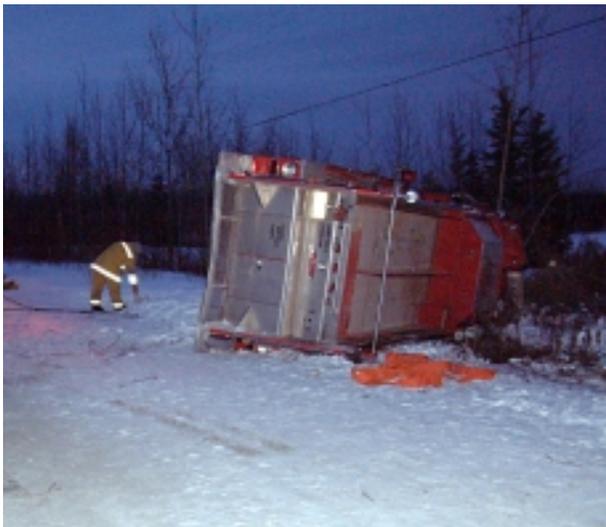
*Incident Site*

The site of the incident is a gravel road measuring 28 feet in width with no shoulders. The incident site is 2.2 miles north of the intersection of a paved county road and 337 feet south of the driveway to the structure fire. The engine struck a tree (measuring 12 inches in diameter) located 12 feet from the edge of the road (See Diagram). The incident site has a posted speed limit of 50 mph. The engine involved in this incident is an 18 year-old Class-A pumper that measures 8 feet wide and 25 feet long. The engine has a square-shaped 1,000-gallon water tank, not equipped with baffles. The engine is equipped with air brakes. The gross vehicle weight is 27,500 lbs, and at the time of the incident, the water tank was full, which added 8,500 lbs to the total weight of the engine. An inspection of the engine was completed by the state police, and no mechanical problems were identified as a contributing factor to this incident. At the time of the incident, the weather was reported as being cloudy with a temperature of 34° F. The road was covered with a thin layer of ice on top of packed snow.

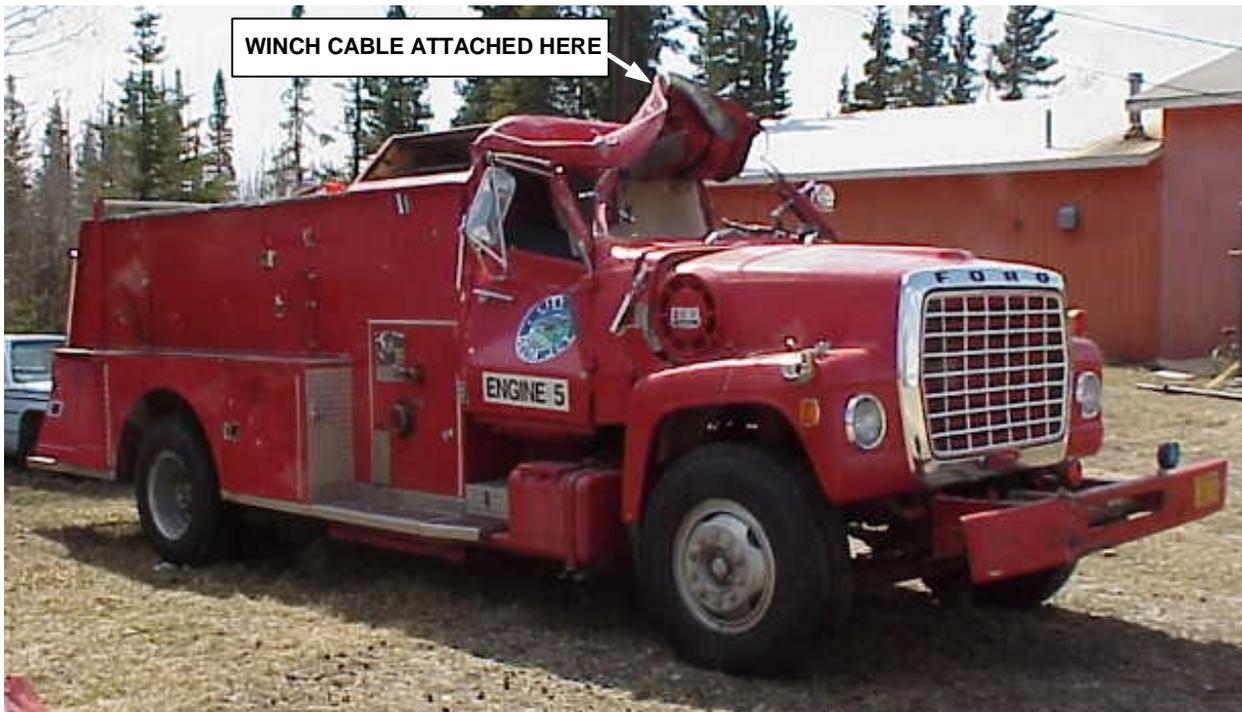
*Photo 2. Engine 5*

On March 6, 2001, a 41-year-old male volunteer Assistant Chief (the victim) died after the engine he was driving left the road, overturned, and struck a tree. The victim (driver) and a fire fighter had responded in Engine 5 at 1445 hours to a structure fire. At 1503 hours, the victim lost control of the engine on an icy, snow-packed gravel road. The engine left the road, overturned onto the passenger's side, and struck a tree. The victim was thrown into the passenger's side, landing on top of the fire fighter. The victim was entrapped and had to be extricated from the vehicle. Emergency Medical Technicians performed cardiopulmonary resuscitation (CPR) on the victim for approximately 20 minutes before pronouncing him dead at 1530 hours at the scene. The fire fighter (passenger) was able to climb out of the cab and was provided medical attention to ensure that he had not sustained any serious injuries. NIOSH investigators concluded that, to minimize the risk of similar occurrences, fire departments should

***Recommendation #2: Fire departments should ensure that apparatus equipped with water tanks are provided with baffles to control the water's movement.<sup>2</sup>***

Discussion: Apparatus equipped with water tanks should follow the provisions set forth in NFPA 1901, Standard on Automotive Fire Apparatus, Chapter 17. This standard states that all apparatus equipped with water tanks should be baffled or have swash partitions to form a containment to control water movement.
