## **First-Floor Collapse During Residential Basement Fire Claims the Life of Two Fire Fighters (Career and Volunteer) and Injures a Career Fire Fighter Captain - New York**

## Fatality Assessment and Control Evaluation Investigative Report #F2002-06

### *First-Floor Collapse During Residential Basement Fire Claims the Life of Two Fire Fighters (Career and Volunteer) and Injures a Career Fire Fighter Captain - New York*

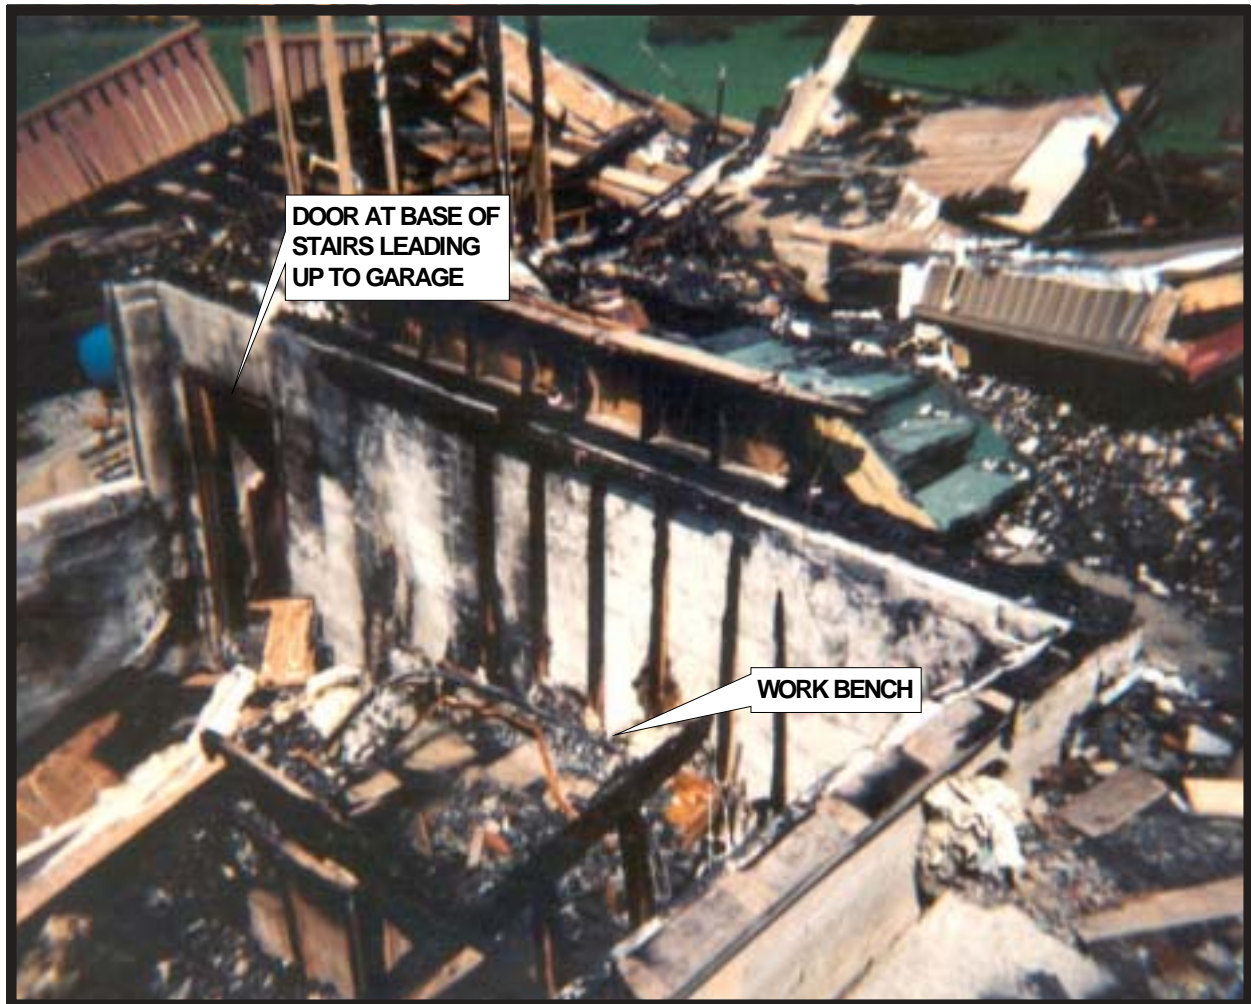
The two-man crew attempted to advance the handline down the garage stairs into the basement. Flames were exiting the basement through the top of the open door at the base of the steps (Photo #1). The crew operated the nozzle on the flames but could not reach the seat of the fire as the flames rolled up the ceiling of the stairs into the garage behind them. They pulled back to the top of the stairs. The nozzleman operated the handline on the flames while his backup checked for extension in a room just inside the house that was accessed through a man door in the garage. *Note: The room just inside the house was a laundry/bath area. The origin of the fire was in the suspended ceiling of the workshop in the basement directly under this room.* He found no extension with a moderate smoke condition and very little heat. He then returned to his position as backup on the handline at the top of the stairs in the back of the garage. The crew attempted to go back down the stairs but could not push back the flames. They took the hoseline with them to recheck the interior through the man door in the garage. The door was extremely hot. Just as they opened the door, the nozzleman's low air alarm sounded. They closed the door and set the handline on the garage floor (Diagram #1). Upon exiting the garage to exchange their air tanks, they saw a fire fighter arriving from a mutual aid department and requested to be relieved.

*Photo 1: Basement area into which victims fell*

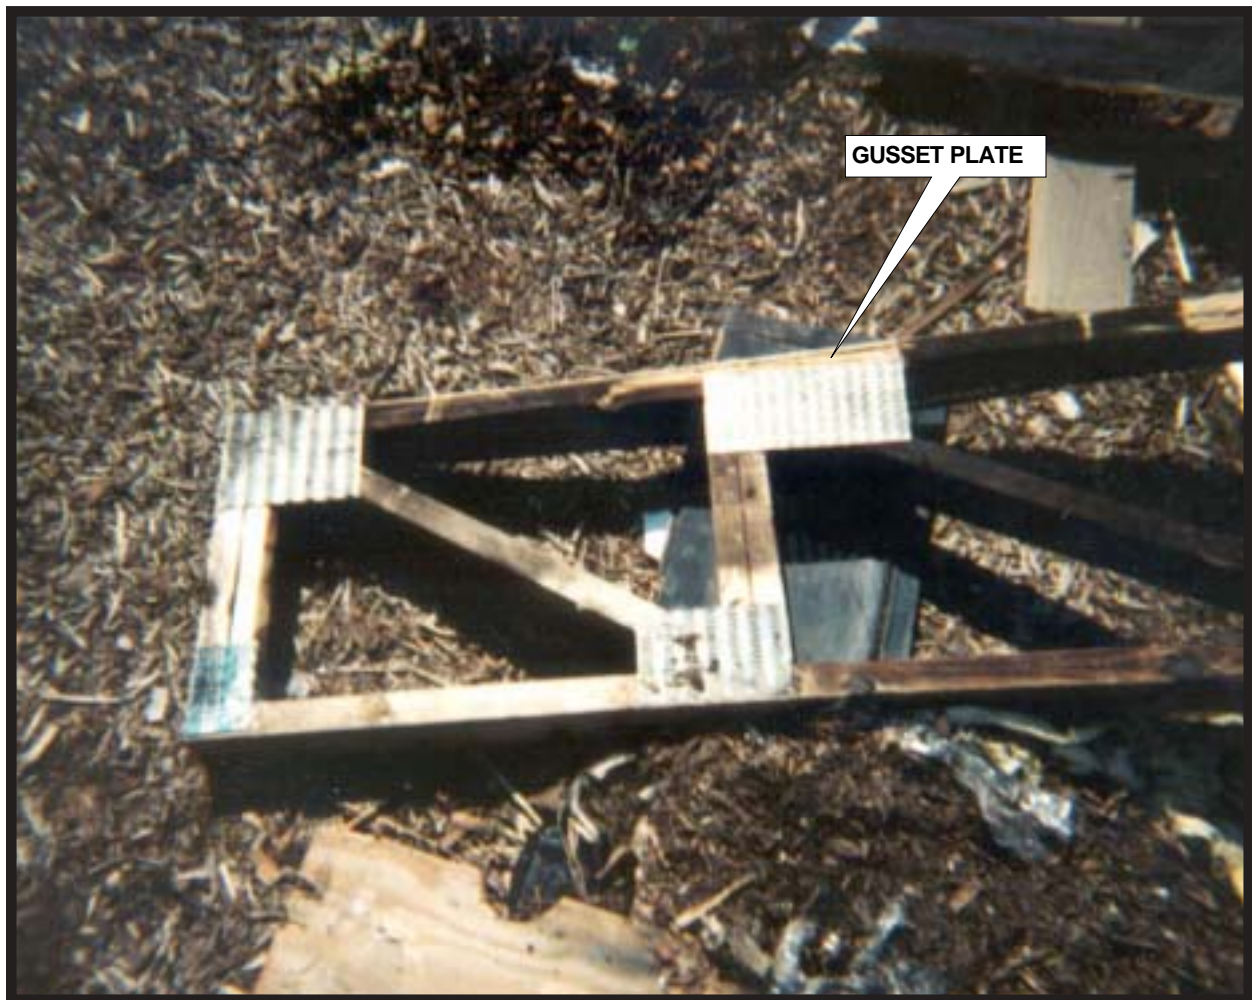
The floors of the structure involved in this incident consisted of a lightweight wooden parallel-chord truss system. These trusses typically consist of wooden members measuring 2 inches wide by 4 inches deep and are held together by sheet metal surface fasteners referred to as gusset plates (Photo #2 ). The gusset plates have numerous V-shaped points cut through them that may penetrate the wood's surface approximately 1/4 inch to 1/2 inch. This steel plate could act as a heat collector which can transfer heat to the V-shaped points, destroying the tensioned wood fibers holding the gusset plate in place (Photo #3). No specific time limit has been established for how long fire fighters should operate under or on truss floors that are exposed to fire. Even though standard fire engineering calculations show that lightweight trusses may be expected to collapse after about 10 minutes in a fully developed fire, it is not recommended that a time limit be set. When it is determined that the building's trusses have been exposed to fire, any fire fighters operating under or above them should be immediately evacuated.

*Photo 2. Lightweight wooden parallel-chord truss*

***Recommendation #6: Fire departments should ensure fire fighters are trained to recognize the danger of operating above a fire.<sup>12,13</sup>***

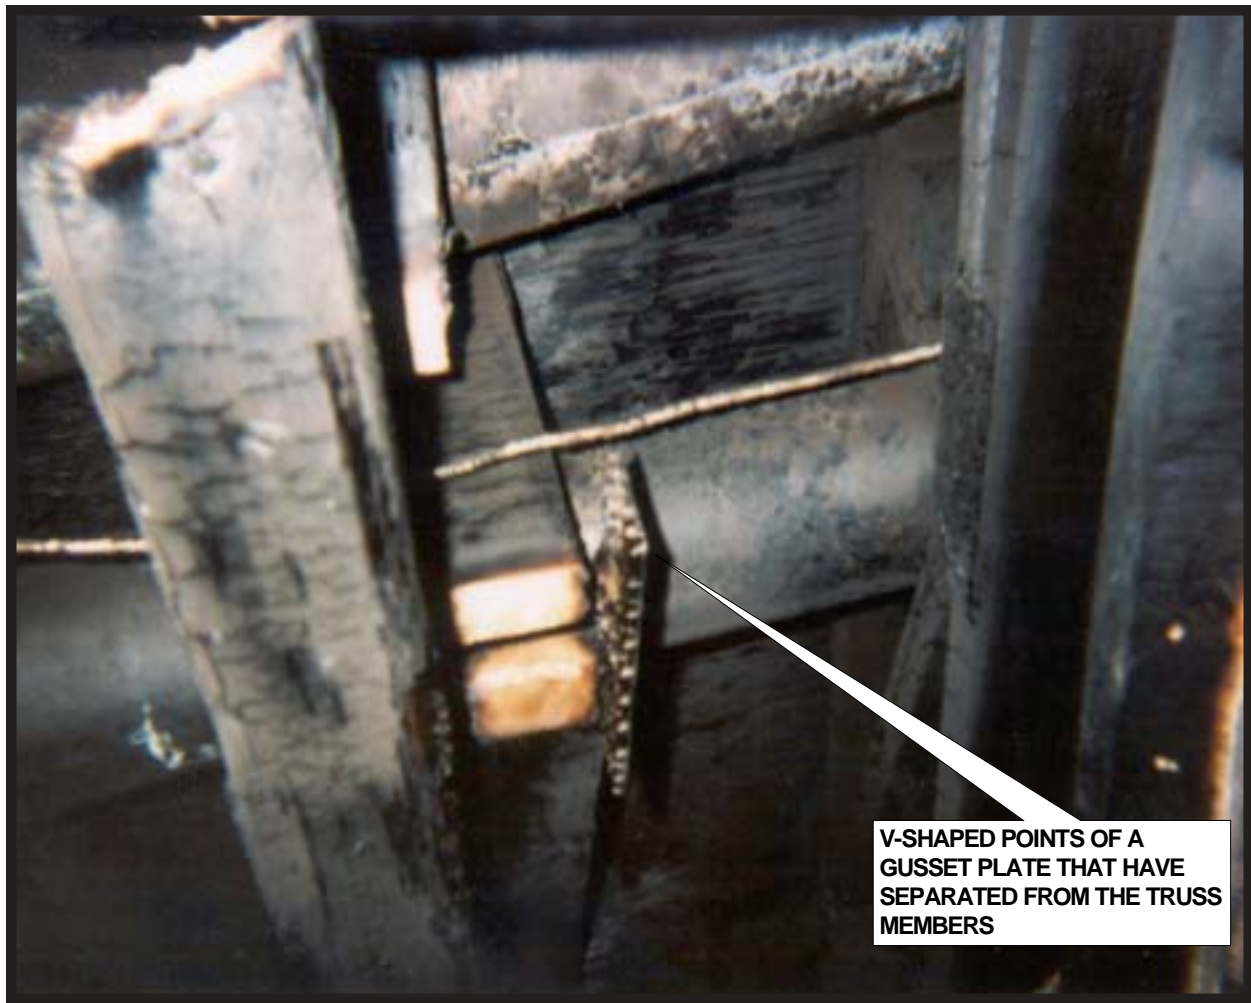
*Photo 3. Failed floor truss*
