Forest Ranger/Fire Fighter Drowned after Catastrophic Blow-out of Right Front Tire - Florida

Fatality Assessment and Control Evaluation
Investigative Report #F2004-15

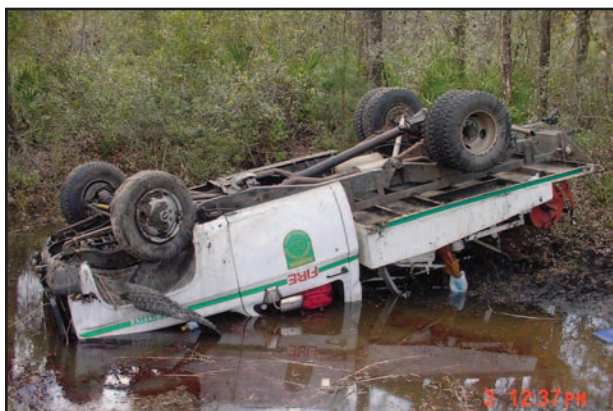
Overtaken truck

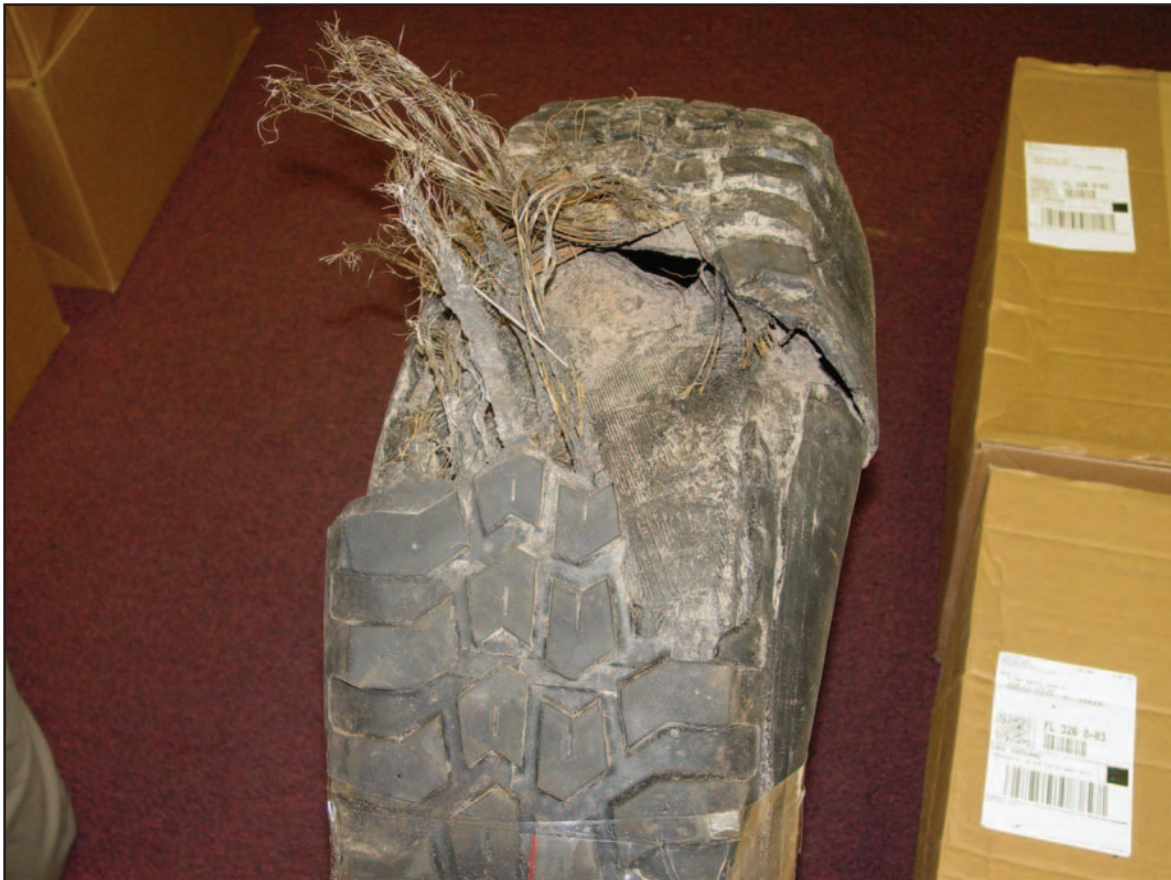
A post-crash examination by the crash reconstructionist determined the tire had undergone a catastrophic, burst type blow-out that compromised the casing integrity (radial casing cords), inner radial ply and liner. Tread depth of this tire was 9/32. According to the reconstructionist, the tire damage resembled similar damage documentation patterns resulting from a previous impact that may have compromised the inner tire radial ply and liner. The reconstructionist stated in his report that this type of damage is *nearly impossible to detect* because tires may still hold air and show no outward signs of deformation. He also noted that, post crash, there was *considerable tread deformation and separation along with complete cord disruption at the blow-out epicenter* (Photo).

Photo. Right front tire after blow-out

Recommendation #2: Fire management agencies and fire departments should, as part of the apparatus maintenance program, ascertain the age of tires and impose time restrictions for usage according to manufacturers' specifications and guidelines.

Discussion: Tires should be checked for signs of wear, for drying or cracking, for cuts, proper pressure inflation, adequate tread depth, and condition of the valve stems. As with any rubber product; however, degradation of tires occurs with age, regardless of tread depth and use.^{5,6} States with high average ambient temperatures have higher tire failure rates.⁶ Thus, imposing time restrictions is important. The tires in this incident were six years old and, according to the reconstructionist, showed no signs of degradation or excessive tread wear. However, neither the division nor the fire department from which the division bought the donor vehicle could document the age of the tires.

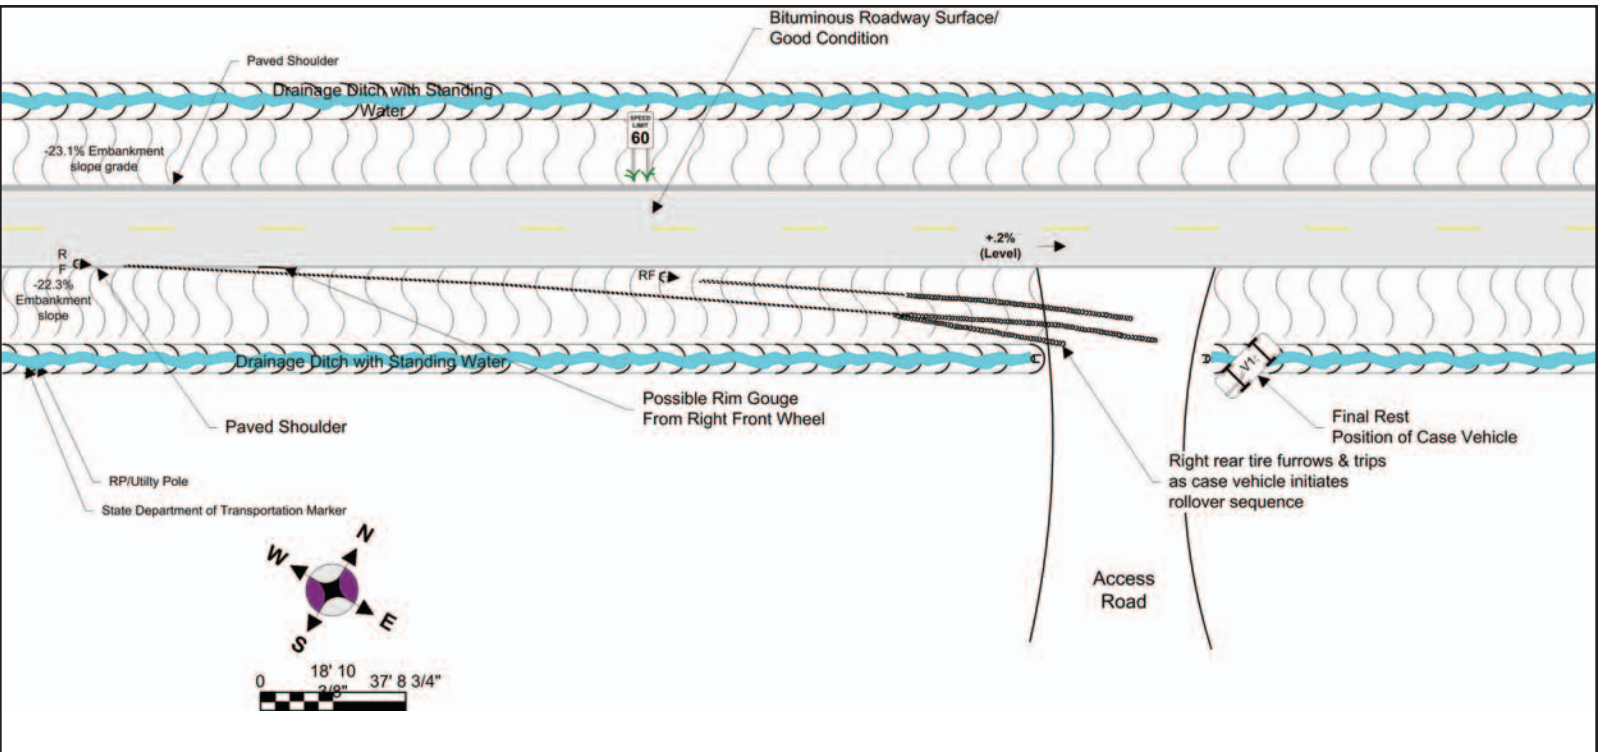
rotated counterclockwise, hit a culvert, and overturned ½ turn coming to rest on its roof in a ditch (Diagram). The drainage ditch contained approximately 2 feet of water at the time of the incident. The victim, who was wearing his seatbelt, was suspended upside down from his seatbelt with his head submerged beneath the water. He apparently was unable to unbuckle his lap and shoulder restraint and drowned.

Diagram. Aerial view of incident scene
