NIOSH
Fire Fighter Fatality Investigation
and Prevention Program

June 18, 2001

Electrical Panel Explosion Claims the Life of a Career Assistant Fire Chief, an Electrician, and Seriously Injures an Assistant Building Engineer—Illinois

Fatality Assessment and Control Evaluation Investigative Report #99F-28

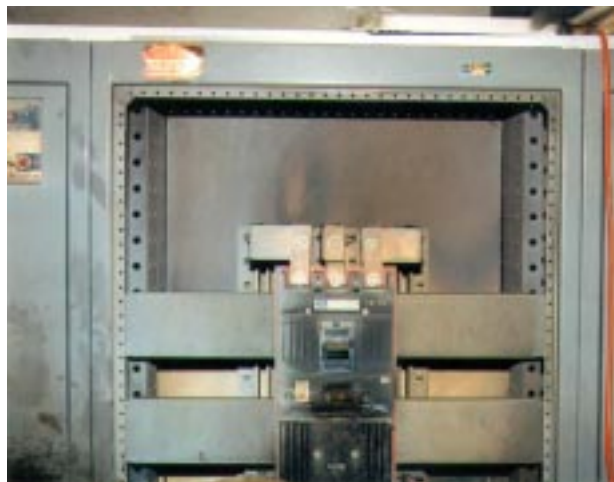
Emergency Power Breaker

emergency power system which controls the emergency generator and transfers the emergency lighting circuit from the utility to the emergency generator. After testing the transfer panel, he moved to the emergency breaker compartment (480 volts, 200 amps), removed the cover panel, and proceeded to test the circuits. Initial testing showed power on all terminals.

outage. After testing the transfer panel, he moved to the emergency breaker compartment (480 volts, 200 amps) where the utility power entered the store and fed the emergency lighting circuit as well as other circuits. The electrician removed the protective front panel and noted that there was a melted screw head in the compartment. The compartment contained the emergency power breaker which was fed from the main panel (see Photo #1). He then apparently proceeded to test the breaker for voltage at the incoming (line) terminals using an inexpensive analog multimeter borrowed from the department store maintenance department. The electrician apparently verified power on all terminals (A, B and C), which seems to have been contrary to his expectations. He tested terminal A, and when he tested terminal B, he stated, “that is not right,” and then tested terminal C. He then proceeded to repeat the measurements in reverse order. At approximately 1345 hours, he was placing the meter probe on the central terminal (B), when a fault occurred, resulting in the formation of a fireball. The fault persisted for a few milliseconds, during which time it vaporized the bus bar (see Photo #2) and the steel mounting structure in the vicinity. The fault burned itself out because it consumed the line side bus bars. The Assistant Chief was standing alongside (to the left) of the electrician when the fault occurred, and the Assistant Building Engineer was behind the electrician, observing his activity. Both the electrician and the Assistant Chief were critically injured within seconds by the intense heat (estimated to be in excess of 3000 degrees Fahrenheit) produced by the electrical discharge fireball. The Assistant Building Engineer was severely burned along his left side. All three were transported to local hospitals. The electrician received 3rd degree burns over 98% of his body and died the following day. The Assistant Chief received 3rd degree burns over 93% of his body and died 10 days later.

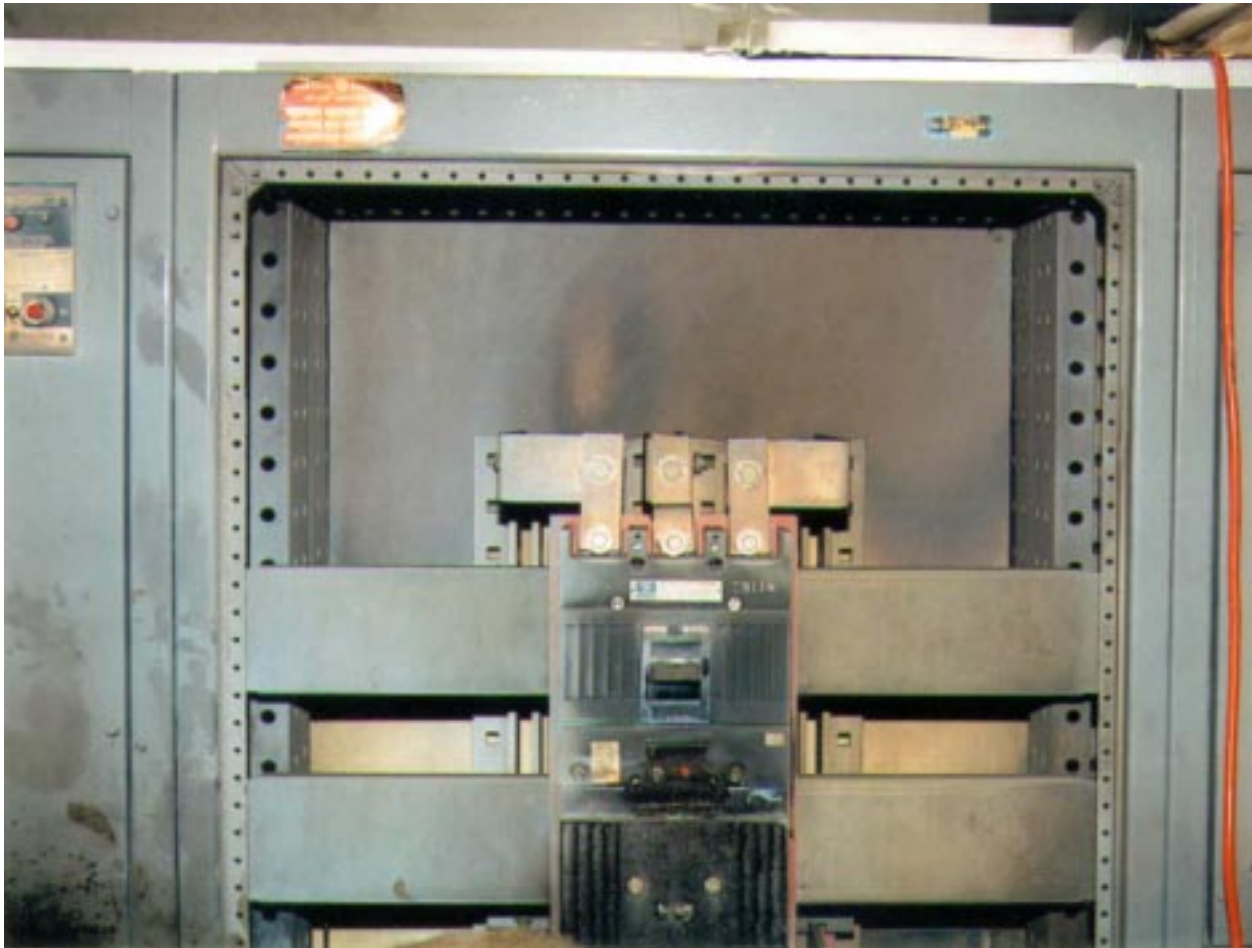
Photo 1. Emergency Power Breaker

The electrical system in this incident is a fixed emergency breaker compartment with 480 volts/200 amps. If the live components are not placed in electrically-safe work conditions, other safety-related work practices, such as personal protective equipment, should be used to protect employees who might be exposed to the electrical and/or burn hazards involved. Additionally, unqualified persons should maintain a distance from exposed energized conductors, including the longest conductive object being handled, so that they cannot contact or enter a specified area. This safe-approach distance is the limited-approach boundary to guard against the shock hazard from energized conductors or circuit components.

Recommendation #1: Employers should develop and implement a hazardous energy control program which includes procedures to de-energize, lockout, and tagout any electrical component/system that has a fault or potential fault prior to initiating work.^{1,2}

Recommendation #3: Employers should ensure that employees wear the appropriate personal protective equipment when working on energized parts, including voltage testing.³

Recommendation #4: A flash hazard analysis should be done before being exposed to an energized conductor or part that has not been placed in an electrically safe condition to determine the proper flash-protection boundary.⁴

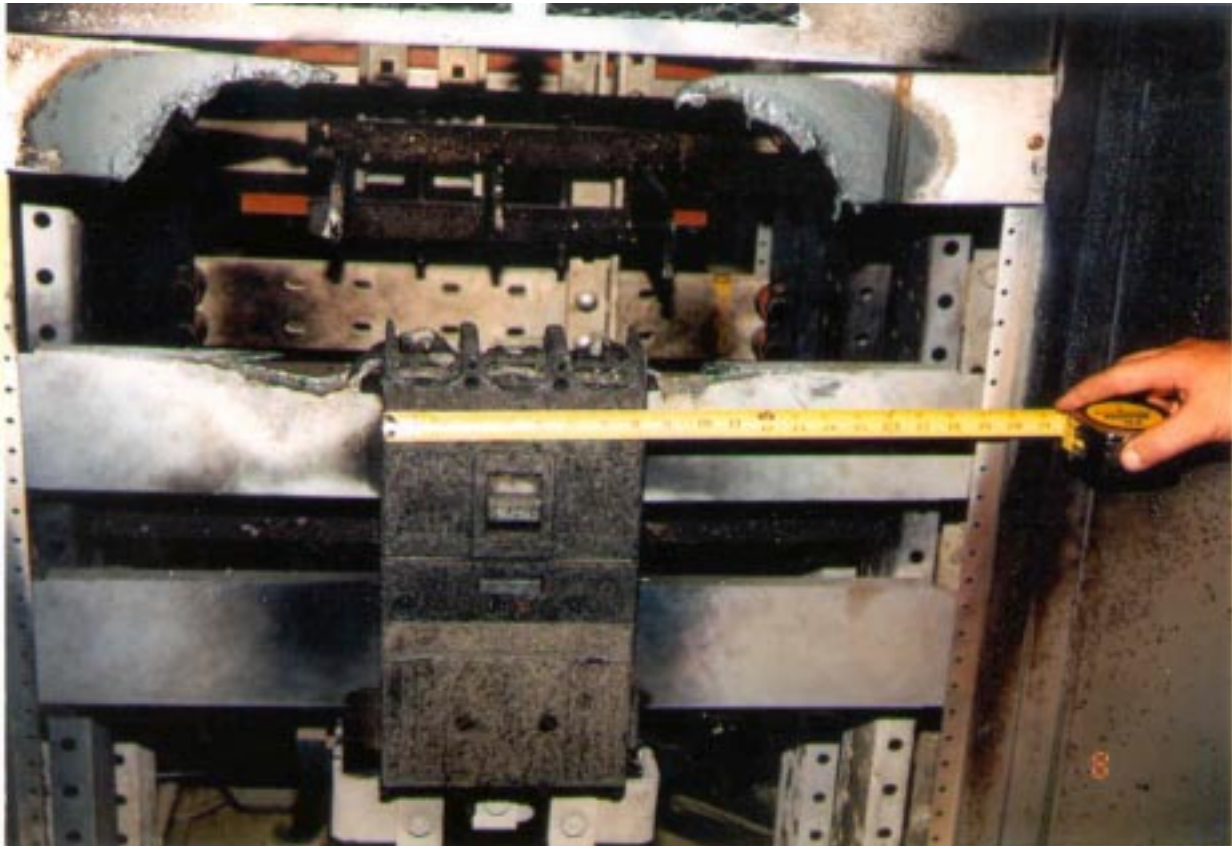
Photo 2. Vaporized Bus Bar
