Florida's Sunshine Skyway Bridge--  
Design And Construction Concerns

The state of Florida is building a new Sunshine Skyway Bridge across Tampa Bay to replace the existing bridge, part of which collapsed after being hit by a ship in May 1980. The new bridge is estimated to cost \$230 million of which the Federal Highway Administration is providing \$105 million.

GAO/RCED-85-32  
DECEMBER 14, 1984

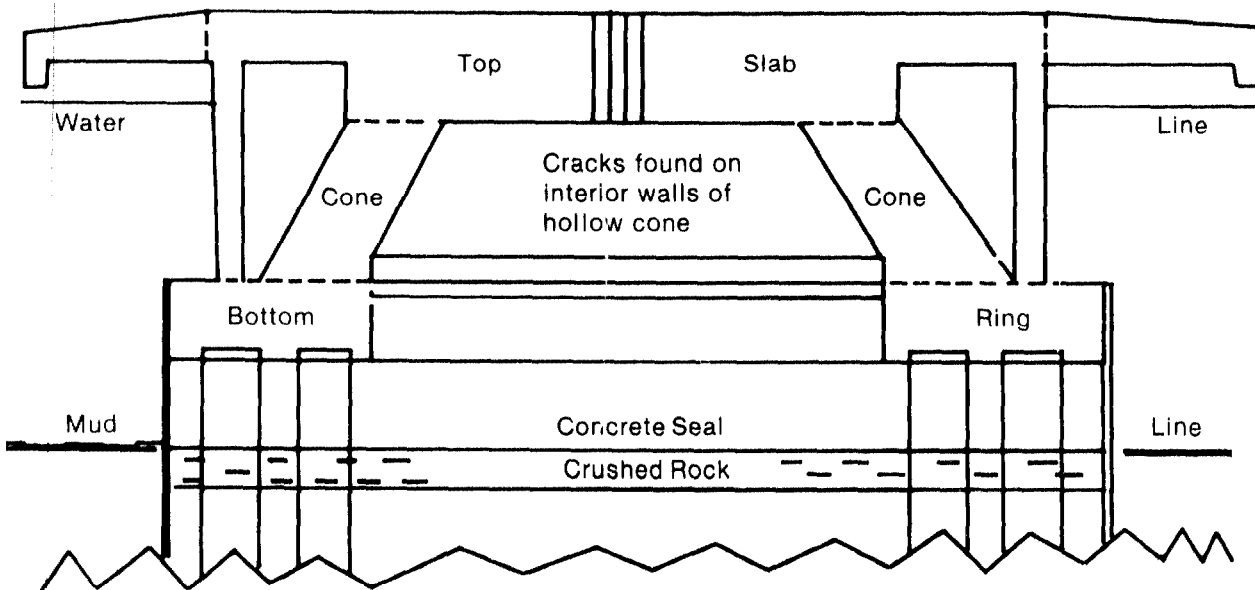
Figure 2

In June 1983, FDOT officials detected hairline cracks inside the hollow concrete cones of the main piers. The walls of the cones are about 8 feet thick and the interior areas of the two main support piers have about 22 hairline cracks ranging in width from .002 inches to .010 inches and in length from about 8 feet to over 15 feet. Some cracks were leaking water as of May 1984.

FDOT and FHWA inspected the cracks and said that they were shrinkage cracks. Shrinkage cracks in mass concrete, such as the main piers, occur because of stresses resulting from heat generated by the chemical reaction of cement and water, and the subsequent differential in coolings--the outside cools faster than the inside. At FDOT's request, the designer, Figg and Muller, and a consultant, Parsons, Brinckerhoff, Quade, and Douglas, inspected the cracks and concluded that they were shrinkage cracks, considered normal in large concrete pours, and would not impair the structural adequacy of the foundation. Also, FDOT sampled water from the leaking cracks, and the tests indicated that there was no rusting of the steel reinforcement bars within the concrete.

The engineers from the Corps, Bureau, and NBS agreed that shrinkage cracks can be expected in mass concrete and, at present, the cracks do not affect the structural integrity of the main piers. NBS pointed out that some of the cracks that were leaking water contained brown deposit. NBS suggested chemically analyzing the brown material alone and comparing the results with known deposits of rust to determine whether the brown material is rust. NBS also suggested that the efflorescence, or powdery deposits around the cracks, be cleaned so that any new deposits can be monitored. FDOT officials said that they had analyzed the brown deposits shortly after the cracks were identified and results showed the deposits to be largely carbonate of calcium and magnesium rather than steel rust. Also, FDOT continues to test the water leaking from the cracks, and the test results have not shown indications that rusting has occurred. The officials said that they will clean the efflorescence from the cracks so that any new deposits can be identified.

NBS reported that the long-term importance of the cracks is that they could allow seawater to come in contact with the steel reinforcing bars within the concrete and cause localized rusting of the bars. Although the reinforcing bars were epoxy-coated to deter rust, according to the Bureau and NBS, it is probable that there are breaks in the coating of some bars which occurred when the concrete was poured around the reinforcing bars. FDOT officials said that they were considering a number of possible ways of addressing the cracks. However, they do not plan to implement a solution until after the bridge deck is placed on the piers. FHWA officials said that they will analyze FDOT's repair method after FDOT decides how to address the cracks. One solution proposed by an FDOT consultant was to seal the inside cracks to a depth of one and one-quarter inches. After repairing the cracks, FDOT plans to fill the hollow cones with fresh water to offset the pressure from the seawater outside the cones.

The Federal Highway Administration and the state of Florida made the same judgments. Regarding the concrete cracks in the main pier, Florida officials advised that several proposals have been made to solve the problem. Corrective action will be taken after the superstructure is erected. (See pp. 15 to 17.)

At our request, the federal engineers commented on the proposal to seal the inside cracks. They said that surface sealing of the cracks on the inside to a depth of one and one-quarter inches would not eliminate the possibility of corrosion of the steel reinforcing bars. NBS suggested investigating the feasibility of sealing the cracks for their entire depth and that careful consideration be given to the repair method to be used. FDOT

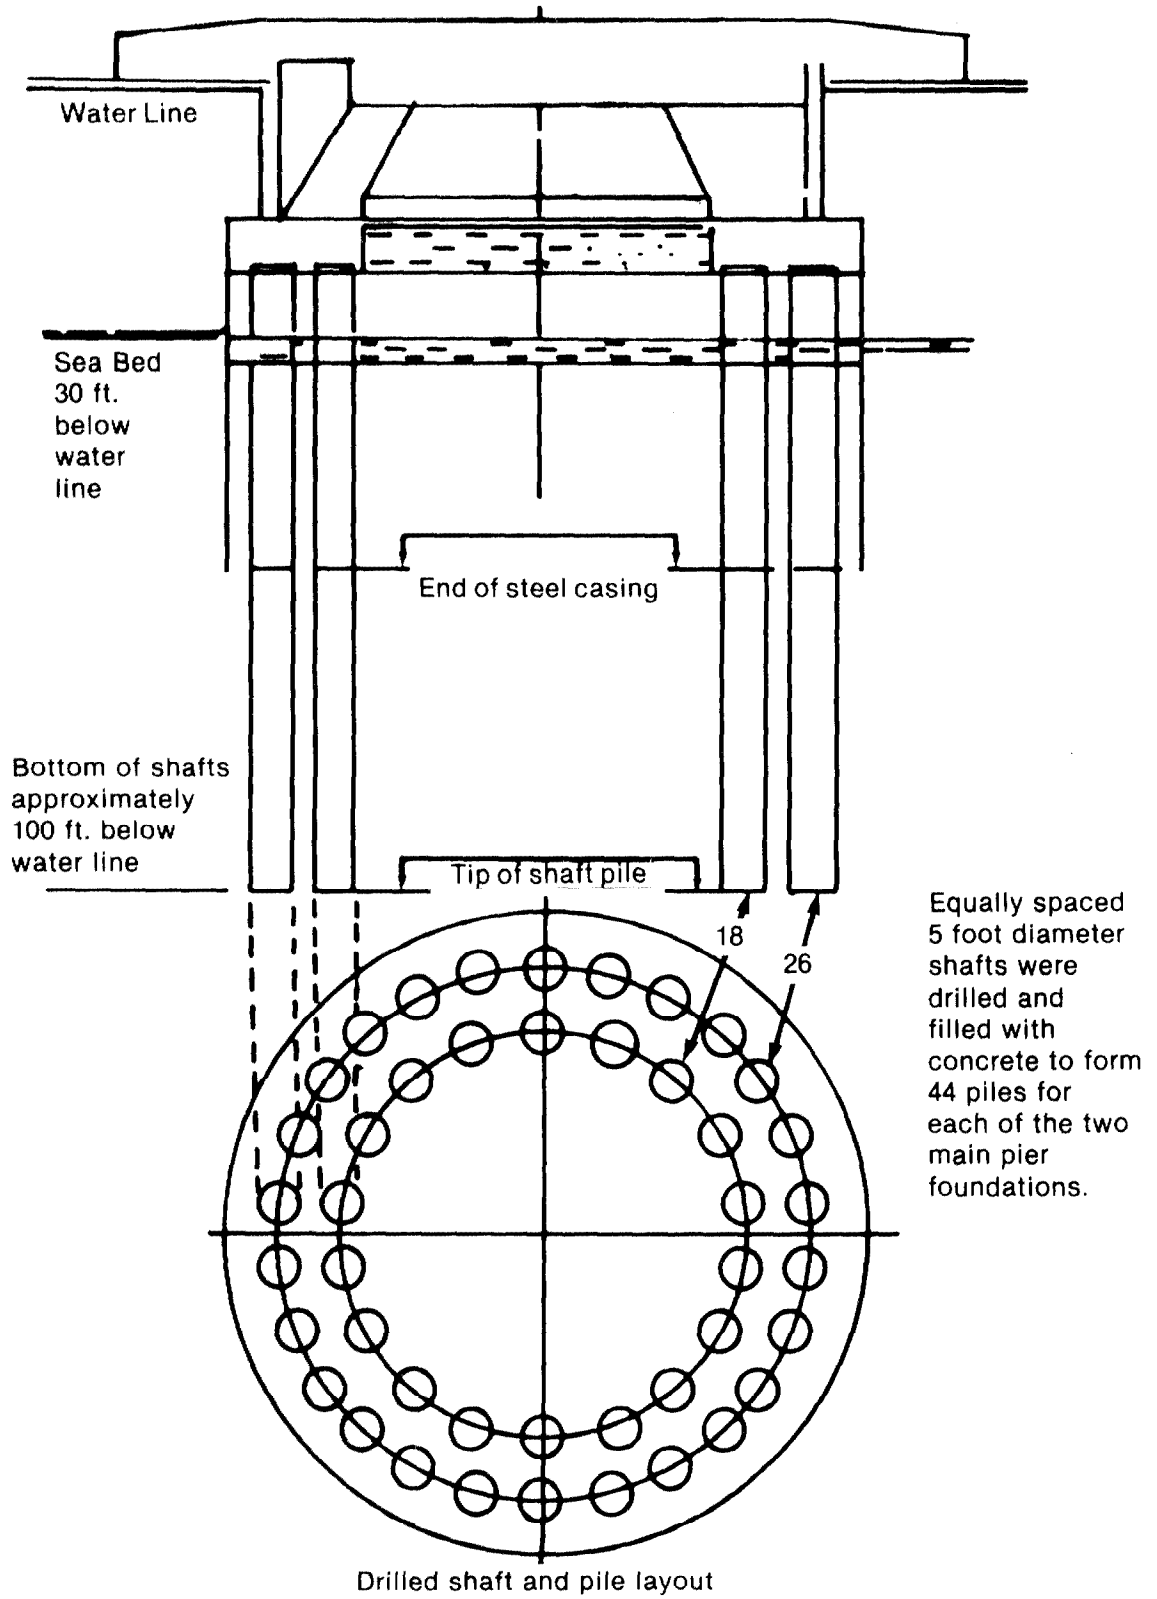
Figure 3

During construction of the south main pier, the contractor had difficulty obtaining core borings from the bottom of the shafts. The shafts were drilled to specified depths in the seabed, core borings taken, and then the concrete piles were poured into the shafts. (See fig. 3 on p. 18 showing the foundation shafts.) The core borings were used to determine the composition of the soil at the tip of the shafts and verify prior geotechnical work. The contractor was unsuccessful in obtaining core borings from the first two shafts of the south main pier. FDOT officials directed the contractor to modify the core boring equipment. The

shaft drilling and concrete pouring continued while the equipment was being modified. On the 15th shaft, the contractor, with modified equipment, obtained a boring that indicated the subsoil was not as expected. However, the boring had been infiltrated with water and broken up when removed from the core boring equipment. FDOT requested the assistance of its geotechnical consultant who observed two more drillings and then recommended drilling the remaining 27 shafts 6 to 7 feet deeper than originally planned. FDOT adopted the recommendation as a conservative measure based on safety.

Core samples were taken on the remaining 27 shafts which confirmed the geotechnical survey results. According to the consultant, drilling the shafts deeper, which places the piles deeper, actually increased the safety factor of the piers. FHWA regional officials agreed and explained that much of the piles' support capability comes from the side friction of the shaft walls adhering to the concrete pile. Placing the piles deeper exposed more of the concrete pile surface to the shaft walls, thus obtaining greater side friction. FHWA concurred with FDOT's decision and has approved the main support piers as meeting construction standards.
