**CO Migration from Trench Blasting in Amherst, New York**  
by Marcia L. Harris and Richard J. Mainiero

The New York State Department of Transportation recently commenced highway widening and drainage improvement projects in Clarence and Amherst, NY. Drainage improvements including the installation of storm sewer lines required excavation to a depth of 2.5 m (8.2 ft).

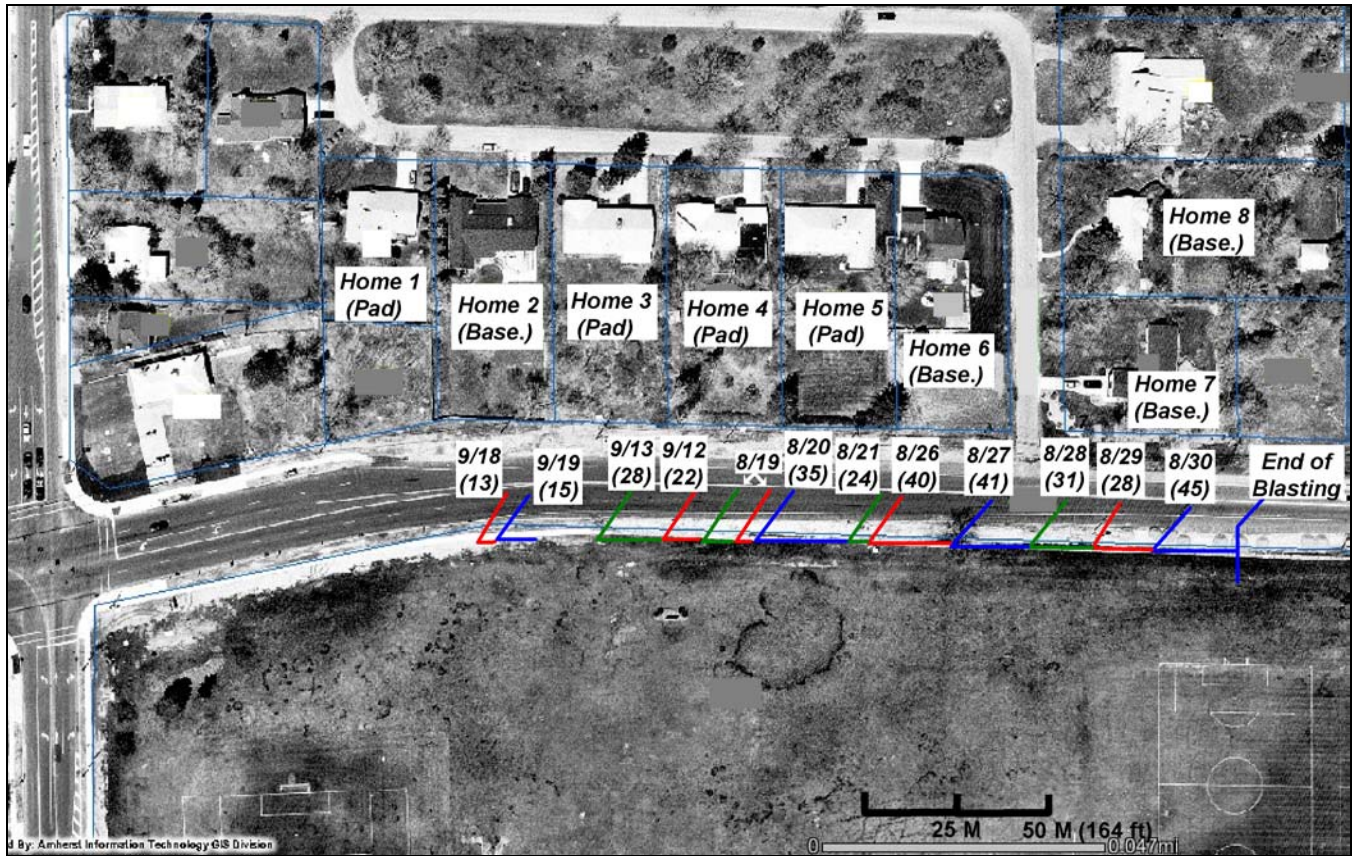
The first occurrence of CO on this project, took place August 27, 2002, see Figure 1, and was attributed to an automobile running in the garage. The first definite sign that CO was migrating from the blasting occurred on August 28, 2002, when 213 ppm was recorded in a basement. This incidence was followed by two occurrences of elevated CO recorded on September 12. In the first instance, the CO alarm located in the basement adjacent to a crack in the foundation alarmed when the concentration of CO peaked at 67 ppm. In the second instance on September 12, a resident living just beyond 100 meters from the blasting area contacted the EIC to report their own CO monitor had been periodically alarming. They initially disregarded the alarm. An investigation disclosed that CO was present in an unlined sewage ejection pit in the basement at 90 ppm. This appeared to be the avenue by which the CO entered the home. No other source of CO was identified.

**Figure 1 - Area blasted during August and September, 2002. Pad and Base indicate whether the corresponding home is built on a pad (slab) or has a basement. The dates and the number of blast holes are indicated. Each blast hole was loaded with three to four pounds of ANFO.**

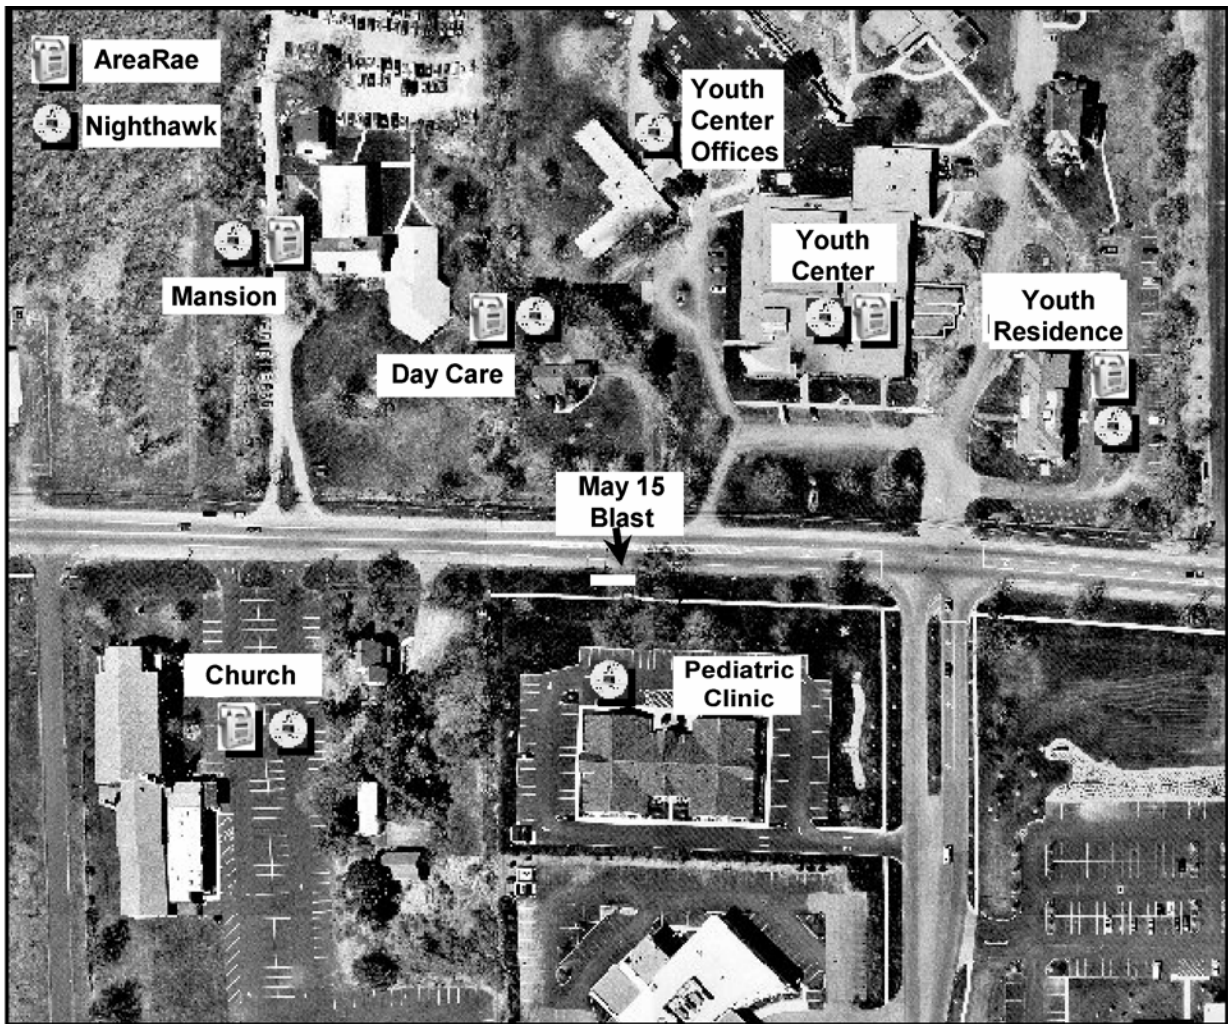
The blasting plan also required that toxic gas monitoring instrumentation be employed. The contractor's environmental consultant set up five AreaRAE monitors (<http://www.raesystems.com/area.html>) in five buildings of special concern for continuous remote monitoring of CO, nitrogen dioxide (NO<sub>2</sub>), and oxygen (O<sub>2</sub>) concentrations.♦ The AreaRAE monitors are electrochemical-cell based instruments that sample every 2 minutes and radio transmit the data to a central laptop computer. Nighthawk CO monitors were also placed in each home and business within 100 m (330 ft) of the blast.♦ The Nighthawk CO monitors were intended to alert residents in the event that the CO concentration reached levels of concern. These units were designed to alarm within 90 min at 100 ppm CO, 35 min at 200 ppm CO, and 15 minutes at 400 ppm CO.<sup>6</sup> The Nighthawks also recorded the peak CO level occurring since the last time they were reset. Periodically, the consultant's personnel would check the Nighthawks and reset them. The NYSDOT environmental consultant continued to act in an advisory and backup monitoring capacity. The AreaRAE multiple gas detectors were to be put in place at least 24 hours prior to blasting. Action levels were set at 9 ppm for CO and 0.25 ppm NO<sub>2</sub>. If concentrations exceeded the action levels, the person monitoring the instrumentation was to notify a contact person in the affected building, the fire department, the contractor, and NYSDOT. The instrumentation is illustrated in Figure 2. Figure 3 shows the placement of toxic gas monitoring instruments and the location of the first blast.

Figure 3 - Locations of instrumentation for May 15, 2003 blast.

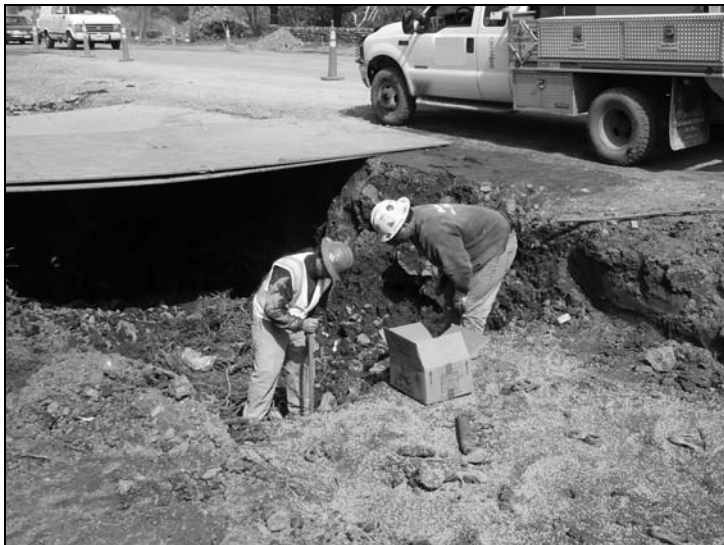
Figure 4 - Steel plates cover the open trench area.

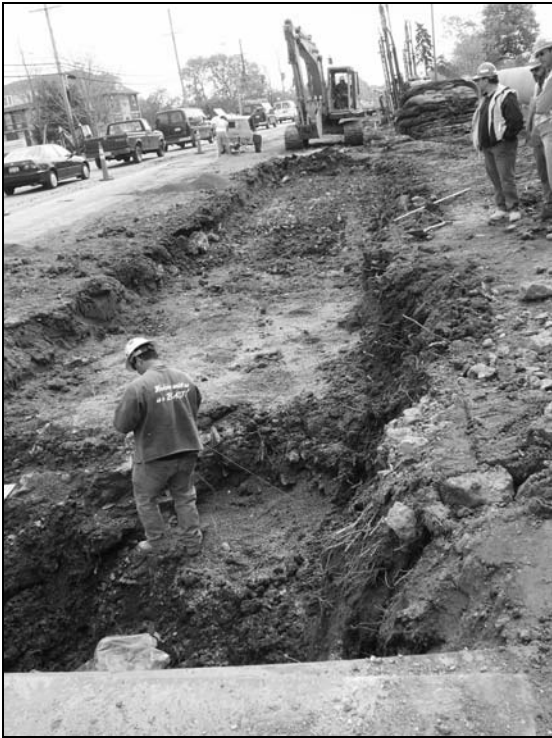
Figure 5 - Overburden is removed from the rock.

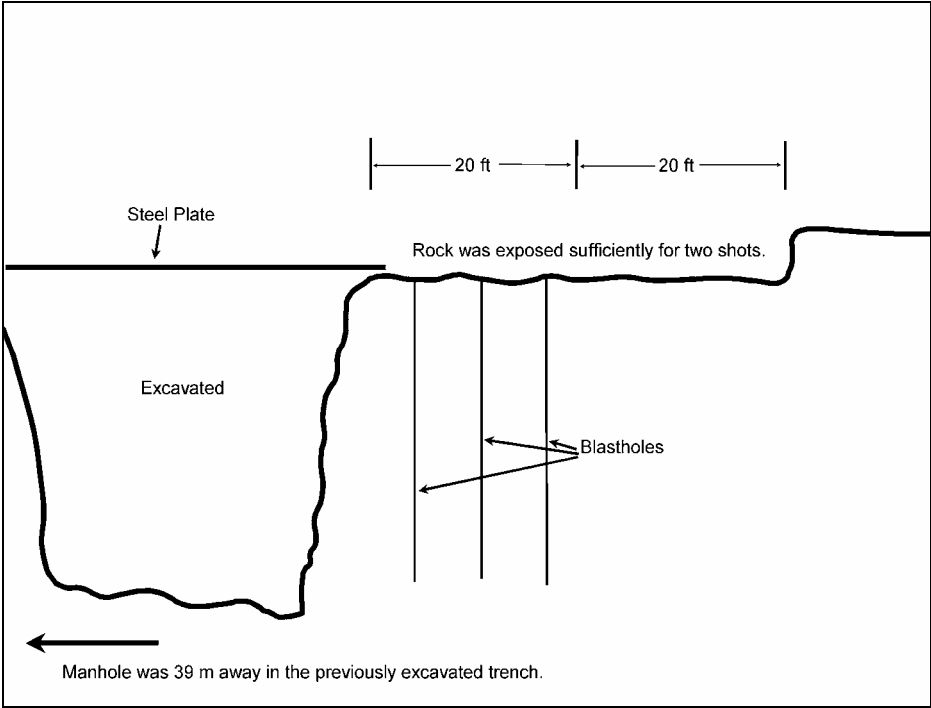
Figure 6 - The blast was designed so the broken rock could move into the excavated space, allowing the gases to vent.

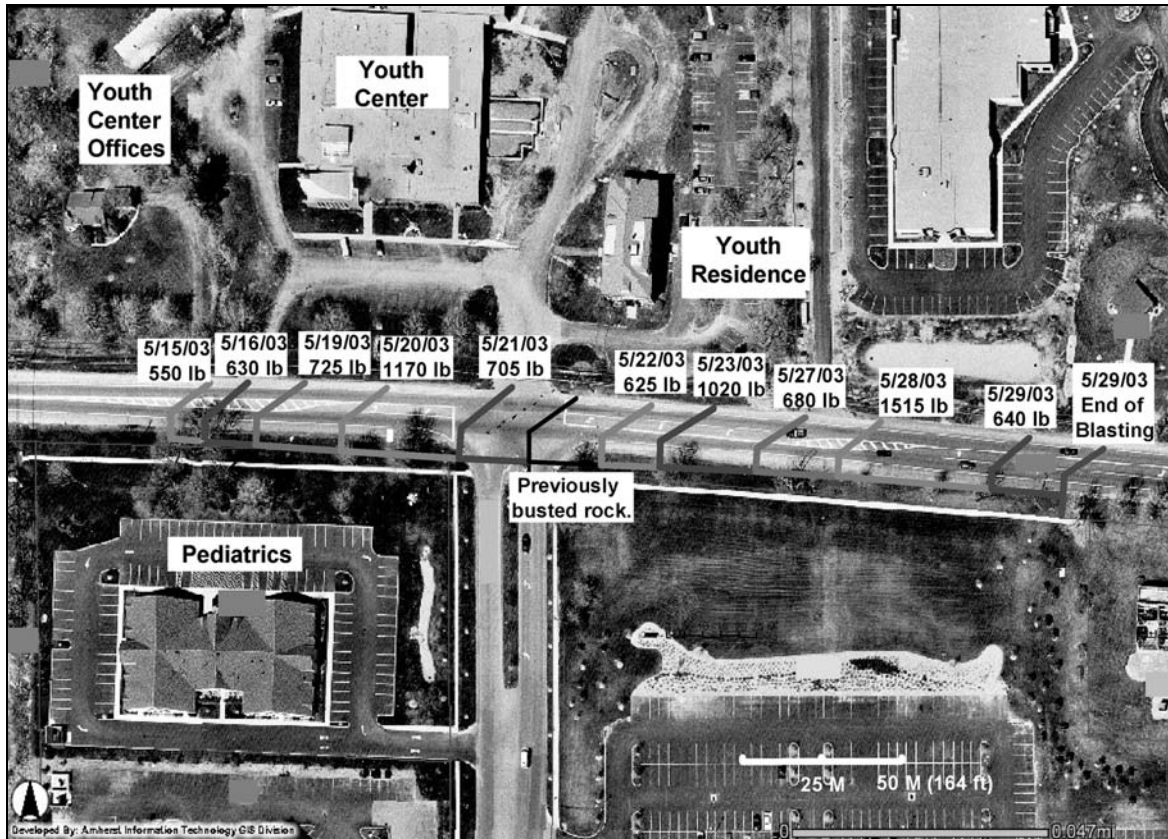
The first blast was scheduled for the morning of May 15, 2003 (see Figure 7). On the evening of May 14, the environmental consultants for the contractor and NYSDOT set up the AreaRAE and Nighthawk monitors. The consultant for NYSDOT also spoke with the residents and explained the functioning and purpose of the monitors; he reported that all the residents were receptive and cooperative. In the early morning hours of May 15, the AreaRAE at the Youth Center alarmed when it detected 0.4 ppm NO<sub>2</sub>. Following an investigation it was determined this was a false alarm and the NO<sub>2</sub> alarm level was reset to 1 ppm.

Figure 7 - Locations of blasts during May, 2003.

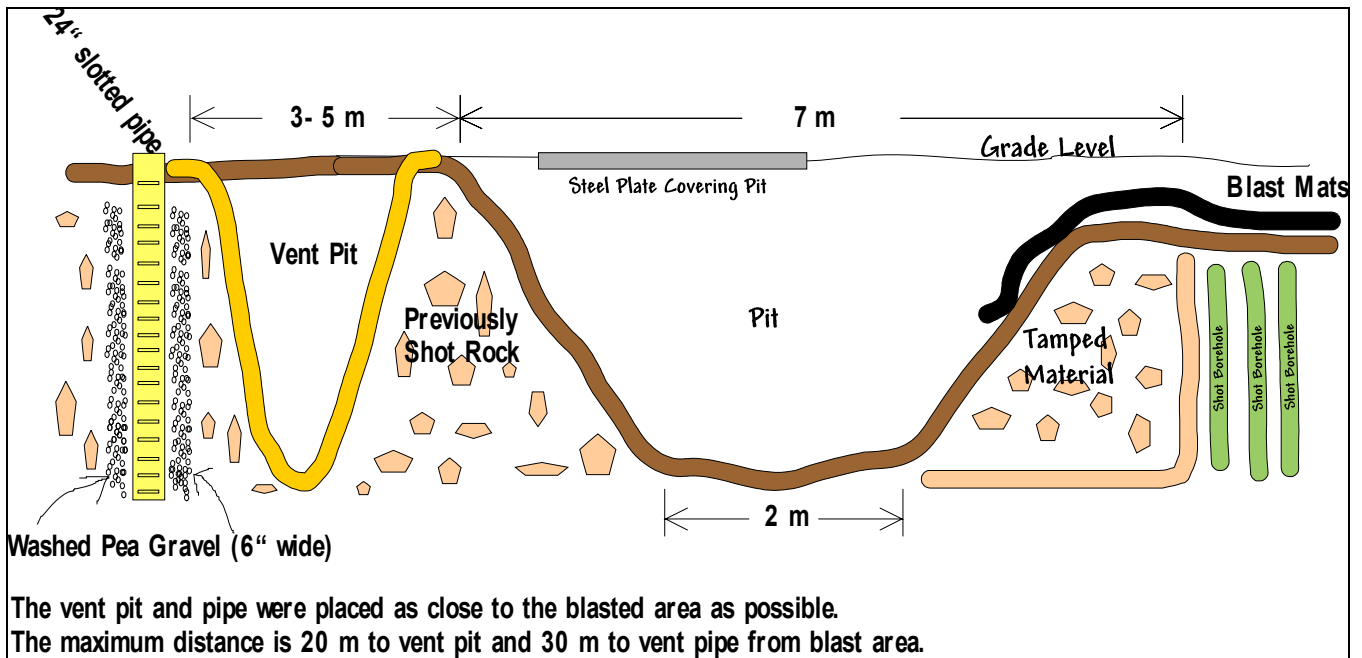
Figure 8 - Final Blast Layout.

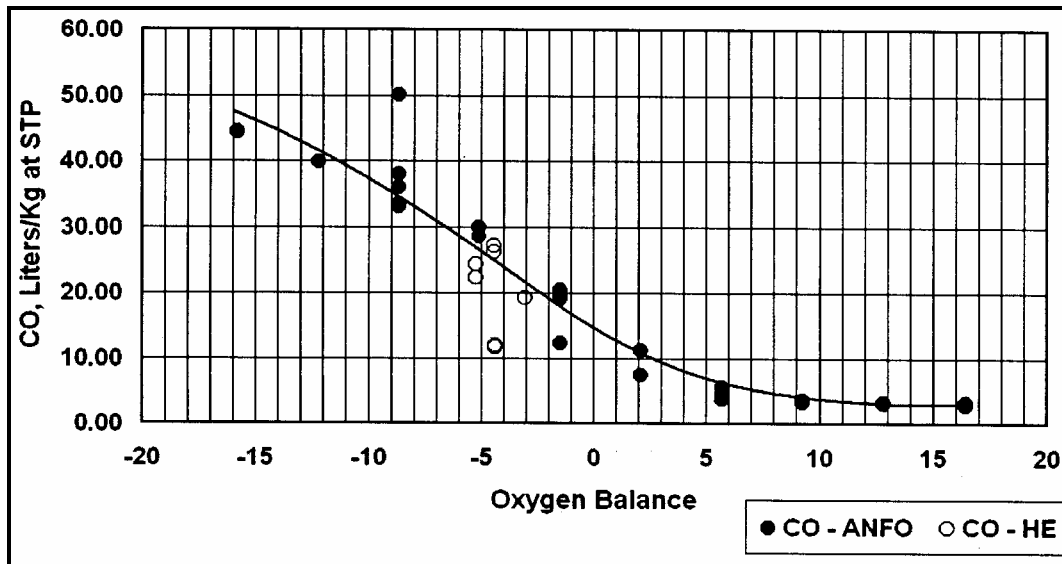
A factor that can be controlled and can contribute significantly to the CO produced by the blast is the oxygen balance of the explosive used. Figure 9 shows that the CO production of ANFO increases significantly as the oxygen balance becomes more negative.<sup>11</sup> This is confirmed in Explosives and Rock Blasting which states "An excess of oxygen in the explosives can result in the formation of nitrogen oxides (NO and NO<sub>2</sub>) and a deficit of oxygen can cause carbon monoxide (CO) to form."<sup>12</sup> This means that an explosive formulated with too much fuel will produce excessive CO. An explosive formulation with too little fuel will generate excessive nitrogen oxides.

**Figure 9 - Effect of Oxygen Balance on carbon monoxide production for 94/6 ANFO and high explosives (cap-sensitive explosives).<sup>7</sup>**

The ISEE Blaster's Handbook recommends, "Where fumes can be a problem, proper formulated and manufactured explosives and blasting agents will give minimum quantities of toxic gases."<sup>13</sup> If ANFO is mixed on site, the blaster should ensure that the ratio of fuel oil to ammonium nitrate is correct. However, the blaster has no control over the formulation of premixed explosive products. For premixed products, only the manufacturer can control the formulation. The manufacturer must ensure that the explosive is properly formulated to minimize toxic fumes production.
