Blasting-Related Carbon Monoxide Incident in Bristow, Virginia
By Marcia L. Harris, James H. Rowland III, and Richard J. Mainiero

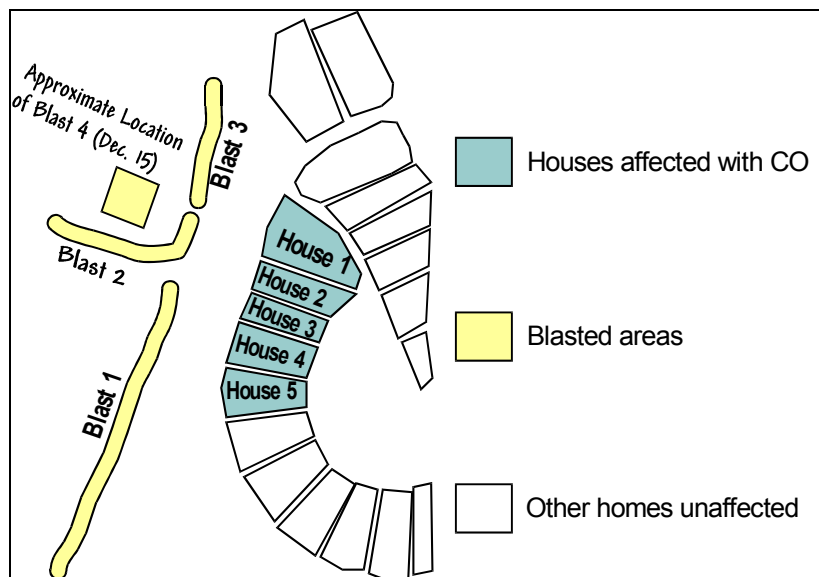
During the evening of November 8, a CO monitor in a home located approximately 90 ft (27.4 m) from the blast (see Figure 1) alarmed. The residents called the gas company and the local fire department of Prince William County. The gas company measured in excess of 800 parts per million (ppm) of CO near the water sump in the basement of the house. The fire department also took CO readings on the first floor of the house and in the basement. The CO readings were 100 ppm on the first floor and more than 200 ppm in the basement. Exposures for long periods of time at these levels can be hazardous to a person's health. The NIOSH recommended exposure limit (REL) is 35 ppm time weighted average (TWA) for an 8-hour period.⁴ In the range of 200 ppm, slight headaches, tiredness, dizziness, and nausea (after 2-3 hours) may be experienced. A person could experience frontal headaches within 1-2 hours when the CO is in the 400 ppm range. In the 800 ppm range, dizziness, nausea and convulsions may occur within 45 minutes of exposure. If exposed to 800 ppm for 2-3 hours, death will occur.⁵

Figure 1 - Locations of houses and blasts.

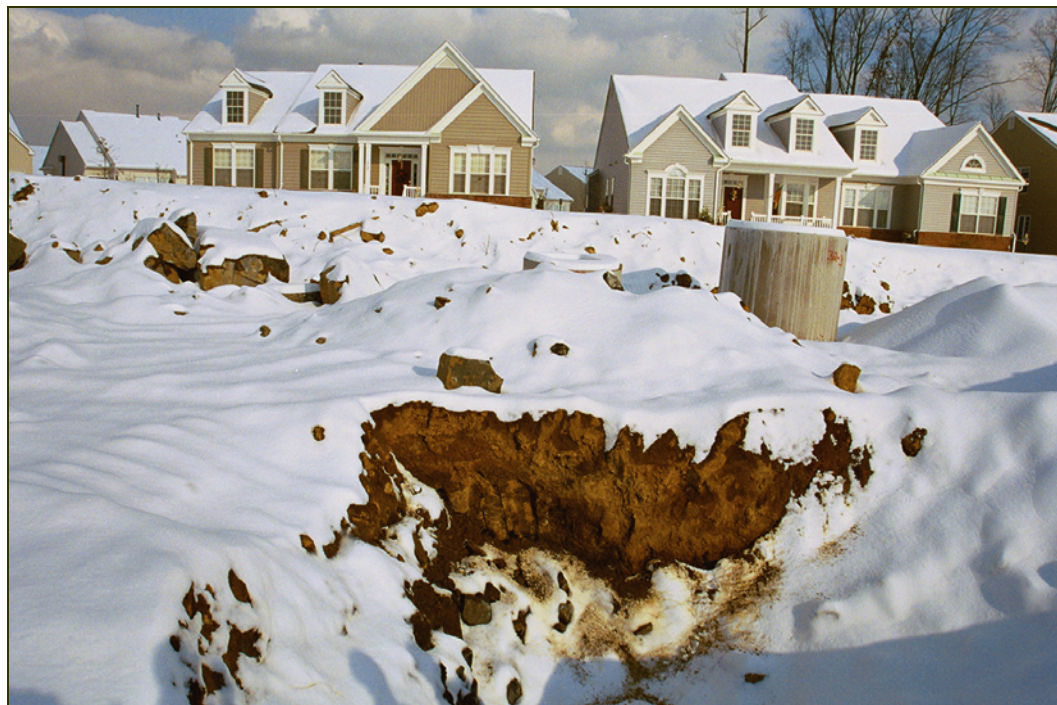
In this study, the first shot was not immediately mucked out, which may have contributed to CO migrating through the ground into the homes. Four excavated pits measuring 6 ft x 6 ft x 5 ft (1.8 m x 1.8 m x 1.5 m) were installed on the second and third shots to vent any generated fumes. No CO accumulated in the nearby homes after the second shot. However, the venting pits still were not sufficient to ventilate the detonation fumes of the third shot. CO appeared in the homes the same day as the shot.

Figure 2 - The first of four pits dug at the location of the trench blast in an effort to vent CO. Homes 1 and 2 can be seen in the background.

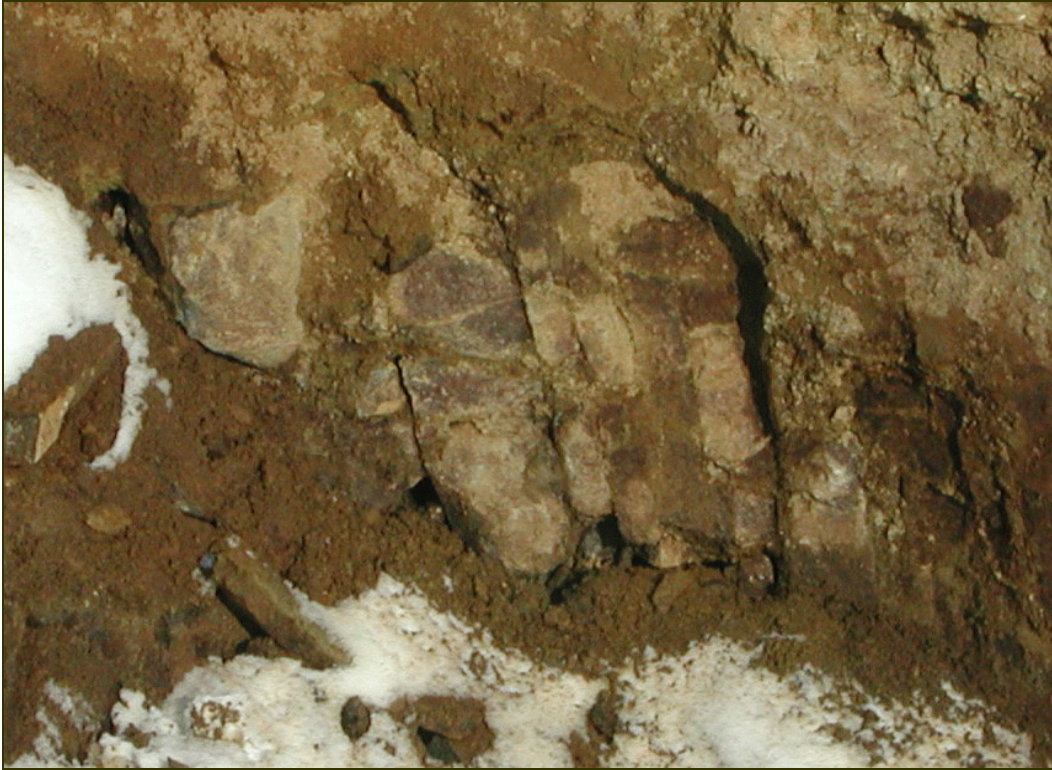
Before the meeting on December 6, the blaster took NIOSH personnel to the construction site where the incidents occurred to assess the geology and their blasting operation. In the venting pits, fractures with an orientation of approximately 20 degrees east of north were observed in the bedrock; this orientation lines up perfectly to intercept the homes affected by the CO migration after the blast shots 1 and 3 (Figures 2 and 3). Another observation was that the fractures appeared to be naturally occurring and not caused by blasting. It was not determined how deep the fracture system may extend. It may be entirely possible the fracture system may extend below the blast site and trenches. Also, the elevation of the bedrock in the pits excavated after blast shot #3 visually appeared to be at the same elevation as the basements of the houses affected by the CO migration. It appears that a fracture system is in place that is positioned just right to result in a strong conduit from the blasted material to the homes.

Figure 3 - A close-up of the bedrock seen in Fig. 2. Note the fractures are oriented towards nearby homes.
