## **Atmospheric Hazards**

### **Solvents**

## **FACE 85-09: Worker in Vermont Dies in 20,000 Gallon Gasoline Bulk Tank While Wearing Closed Circuit SCBA**

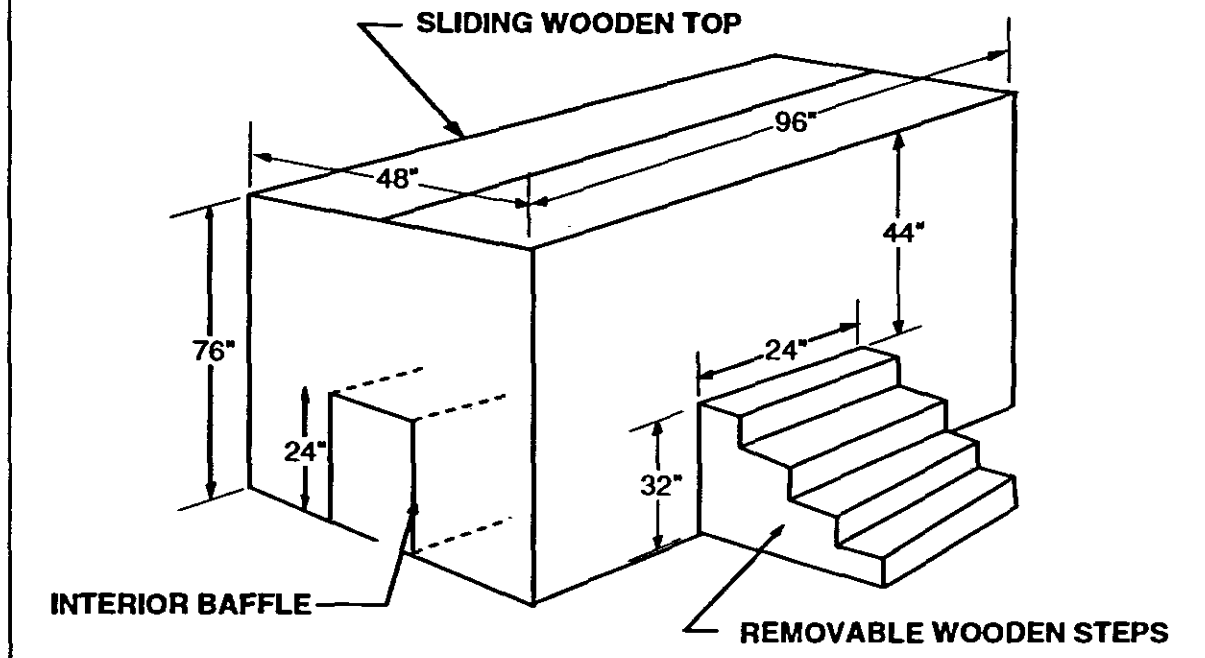
87-17 FIGURE. VAPOR/ULTRASONIC DEGREASER

It was reported that all four men were using air-purifying (half-mask, cartridge type) respirators. These respirators are designed for limited use with organic solvents, not in an oxygen deficient or immediately dangerous to life and health (IDLH) atmosphere.

***Recommendation #1: The employer should perform a preliminary hazard analysis to determine hazardous areas (physical, chemical, environmental, etc.) within the company and then complete a more detailed task specific job hazard analysis for hazardous task identified. Based upon this analysis existing procedures can be updated or new procedures developed and implemented.***

***Recommendation #2: The employer should initiate comprehensive policies and procedures for confined space entry.***

***Recommendation #3: The employer should develop and implement a more comprehensive respirator program, including either quantitative or qualitative fit testing and training in the use and limitations of air-purifying respirators. The respirator program should be under the auspices of the safety department rather than the medical department.***
