Archeological Monitoring,
Installation of Fire Suppression System,
Fort Scott National Historic Site,
Bourbon County, Kansas: 1997-1998

Archeological Monitoring,
Installation of Fire Suppression System,
Fort Scott National Historic Site,
Bourbon County, Kansas: 1997–1998

By
Scott Stadler

Midwest Archeological Center
Technical Report No. 57

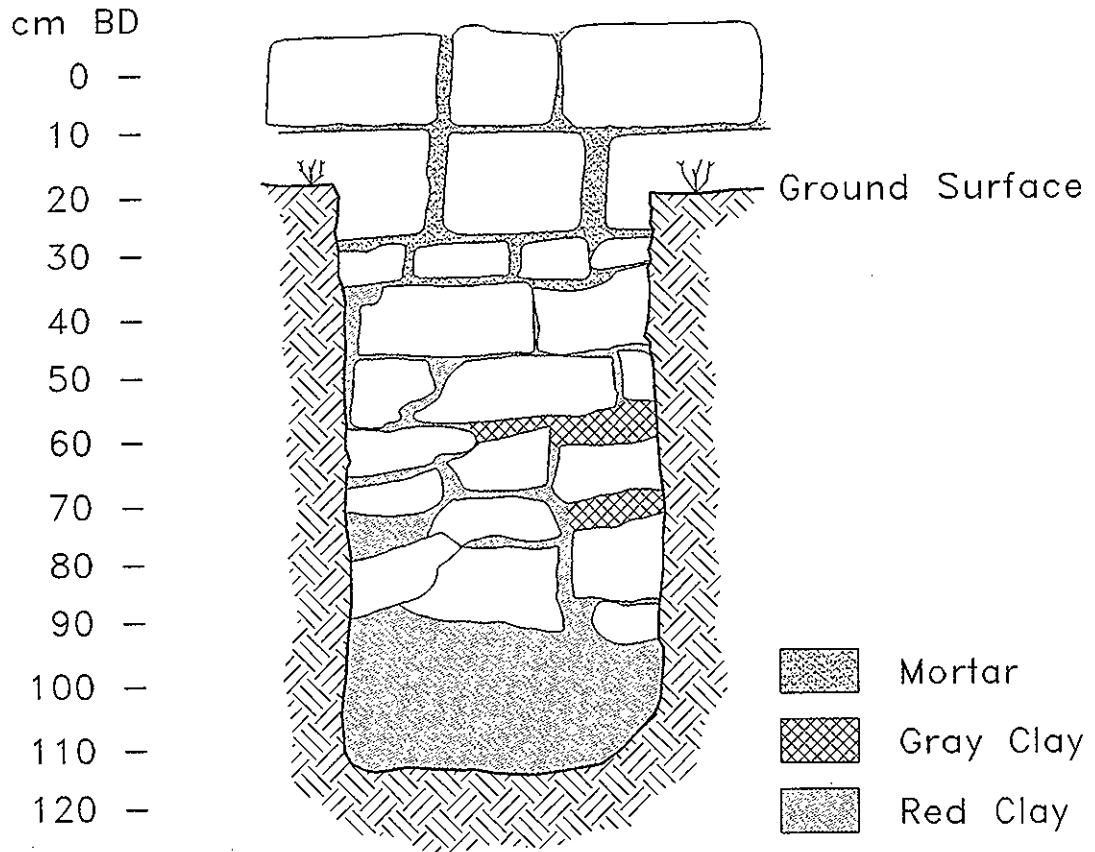
Figure 4. Foundation of HS-1, west wall.

This is a segment of the old Marmaton Avenue. There were no features in this segment. However, trenching did expose the foundation of HS-1. It is constructed of unmortared limestone blocks to a depth

of 95 cm (37 in) (Figure 4). This is the original 1840s foundation. Four metal or ceramic pipes were within 60 cm (2 ft) of the foundation and parallel to it.

During Phase III the foundations of the structures with concrete foundations were breached using a coring device that bored a 25-cm (10-in) hole for the entry of the water line. The foundations of HS-1, HS-2, and HS-4 should not be disturbed, since the water line will be brought into the building by passing under the footings.

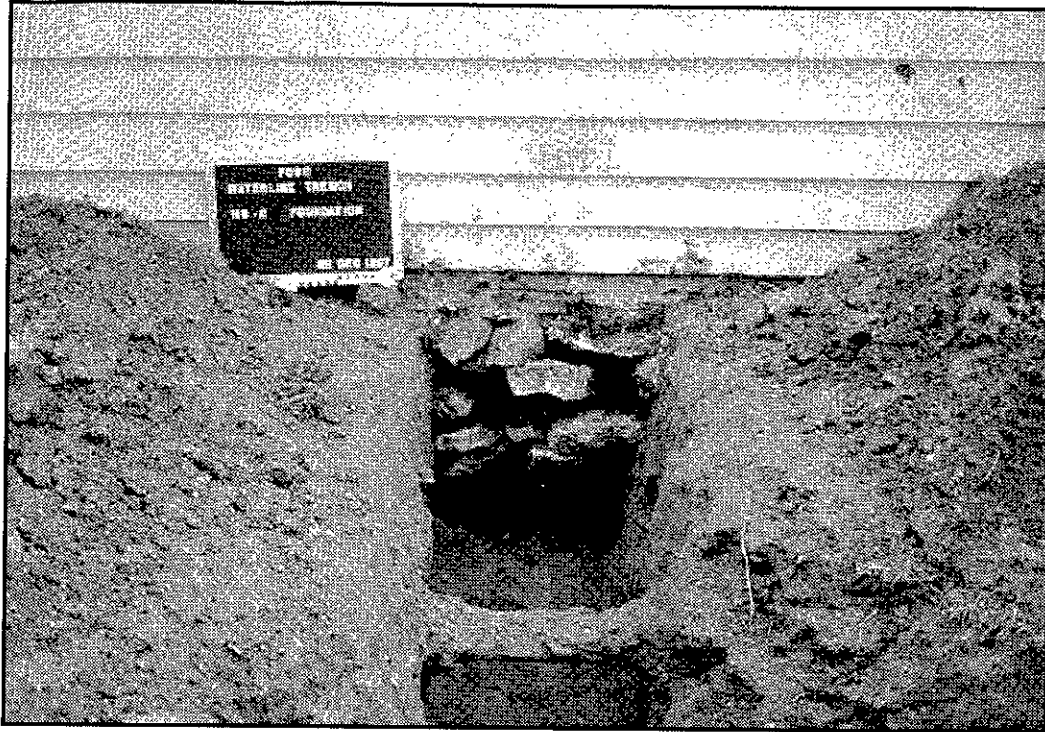
Figure 5. Exterior of HS-2 foundation.

There were no features located in this segment. One piece of tabular limestone (flagstone?) turned up in the north end of the trench. During Phase III no other artifacts were recovered. The foundation of HS-2 is made of small limestone blocks with no mortar. The bottom of the footing is 46 cm (18 in) below surface (Figure 5). One red ceramic drain pipe 10 cm (4 in) in diameter and two ferrous pipes, either water or gas, were found running parallel to the building within 61 cm (2 ft) of the foundation. All pipes appeared to be abandoned.

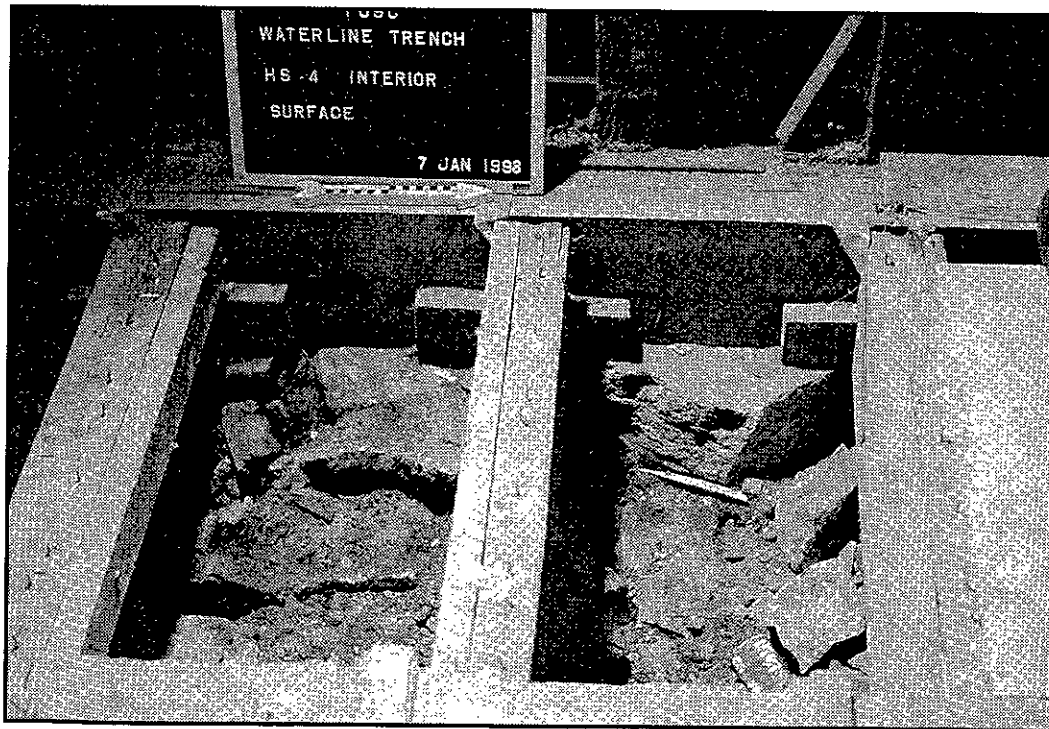
Figure 6. Interior of HS-4 foundation.

No features were located in this segment. Plain whiteware and curved glass were the only artifacts noted in trenching outside of HS-4. The foundation of HS-4 is composed of small limestone blocks with no mortar. The bottom of the footing is 74 cm (29 in) below surface.

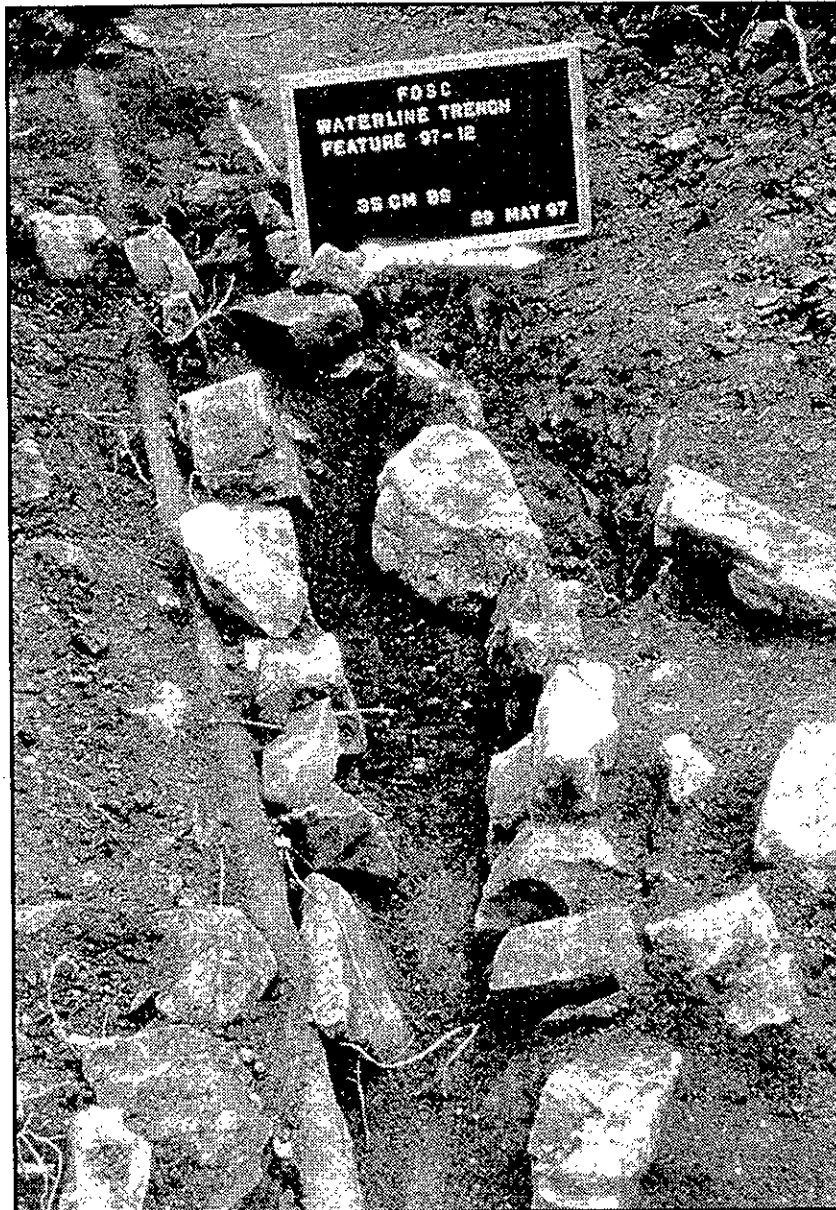
Figure 7. Feature 97-12, stone drain.

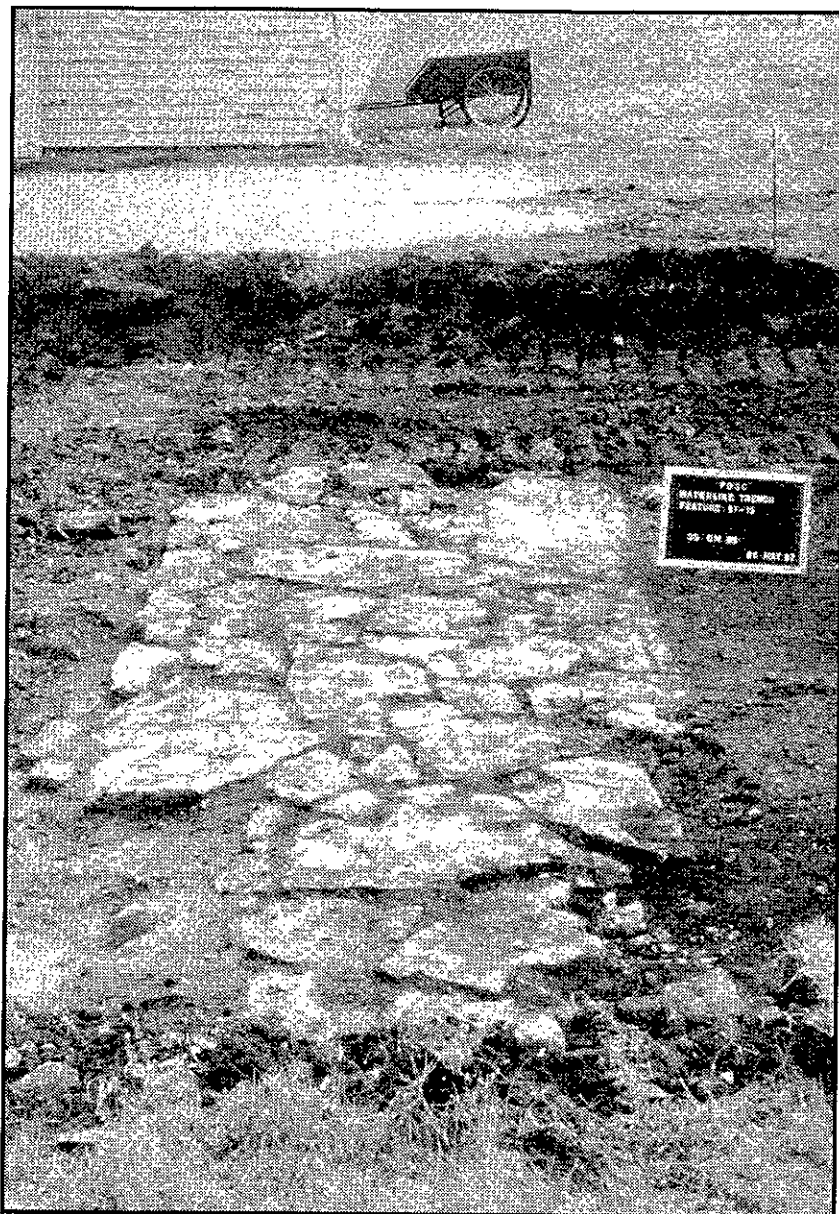
Figure 8. Feature 97-11, stone walk. The feature number that appears on the menu board is incorrect.

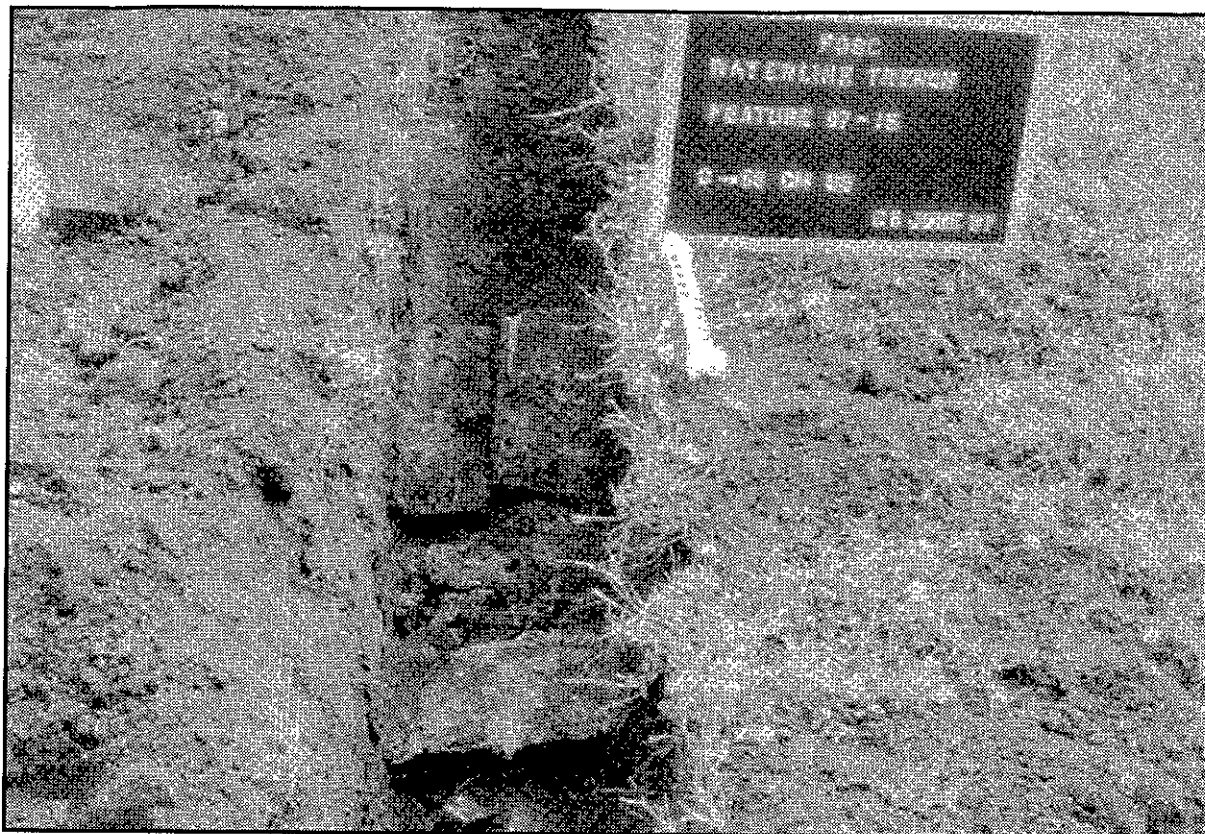
Figure 10. Feature 97-15, stone drain.

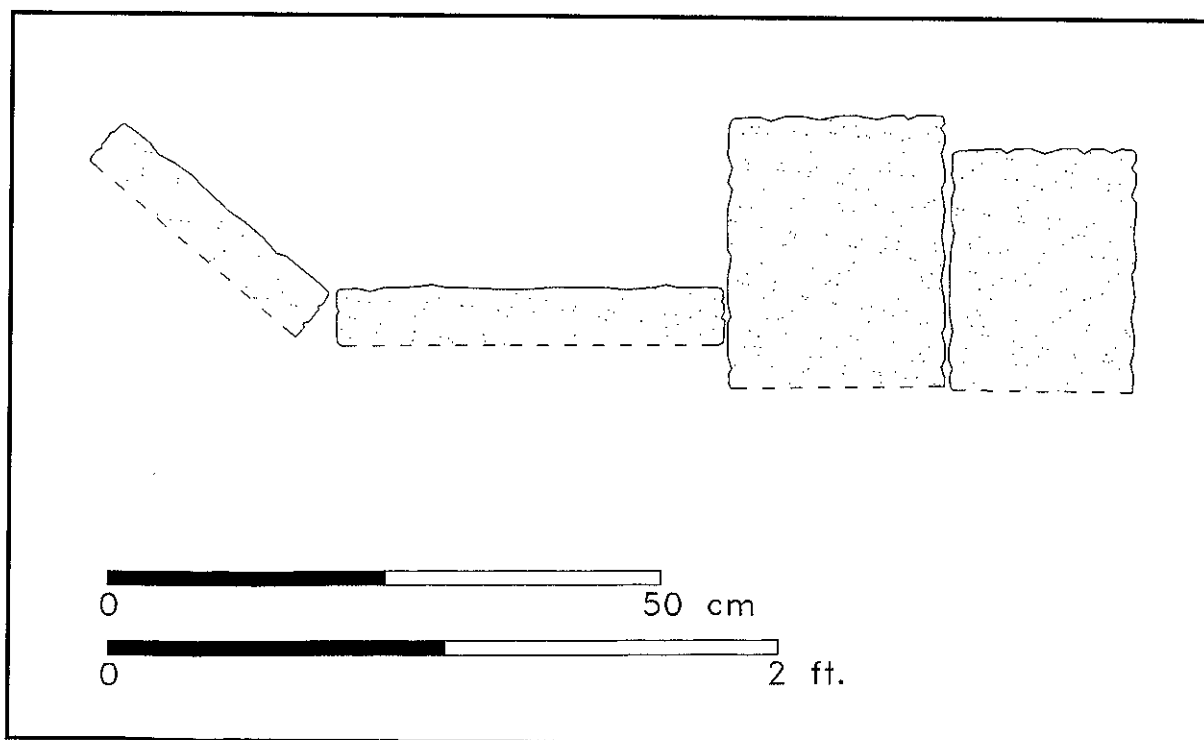
Figure 11. Profile of Feature 97-15, stone drain.

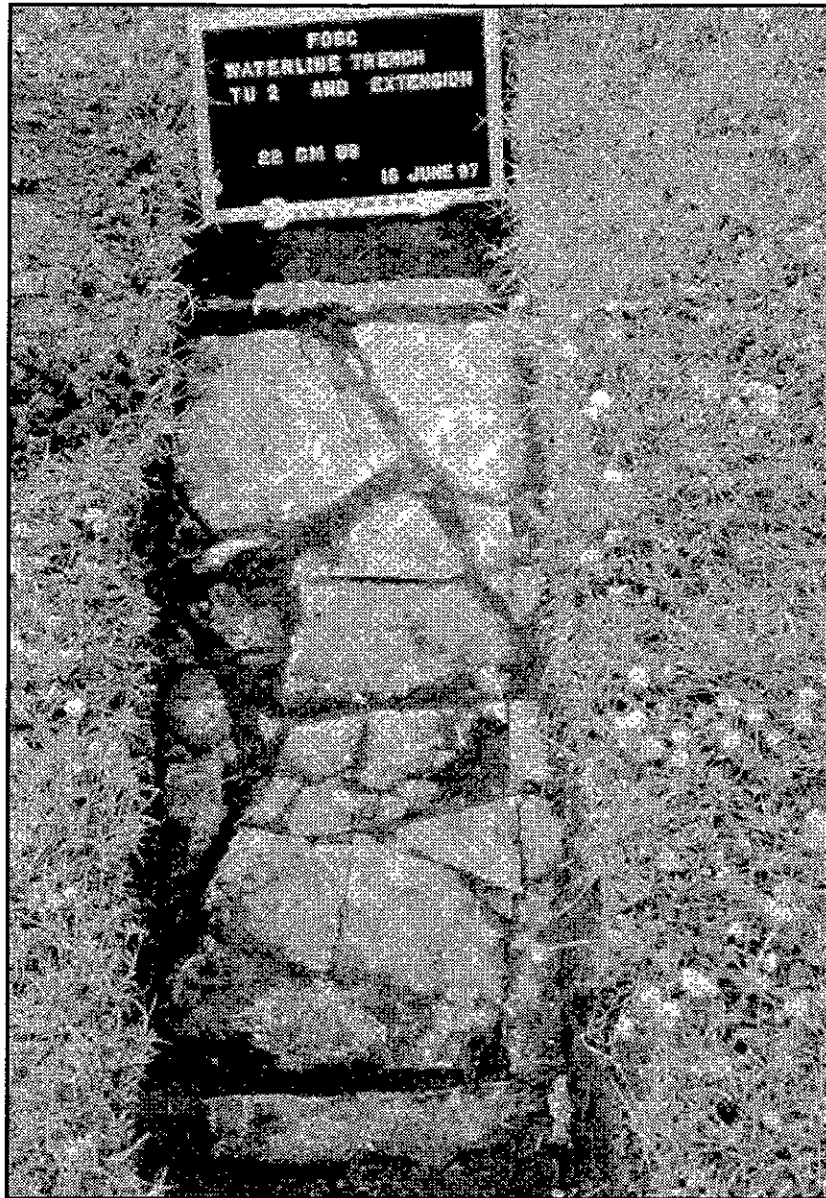
Feature 97-19. At 22 cm (8.6 in) below surface, a walkway was encountered (Figure 13). It is constructed of a single layer of tabular limestone, is 140 cm (56 in) wide, and is intact and in good condition. The edges of the walk are bounded by narrow pieces of limestone curb. This feature is extremely similar to the walkway uncovered by Clark in 1993 (Clark n.d.:10-11). That walkway went from HS-2 to an outbuilding (HS-35).

Figure 13. Feature 97-19, stone walk.
