[Docket No. 2004-SW-12-AD; Amendment 39-13884; AD 2004-24-08]

Airworthiness Directives; Bell Helicopter Textron Canada Model 206A, B, L, L-1, L-3, and L-4 Helicopters

2004-24-08 Bell Helicopter Textron

Canada: Amendment 39-13884. Docket No. 2004-SW-12-AD.

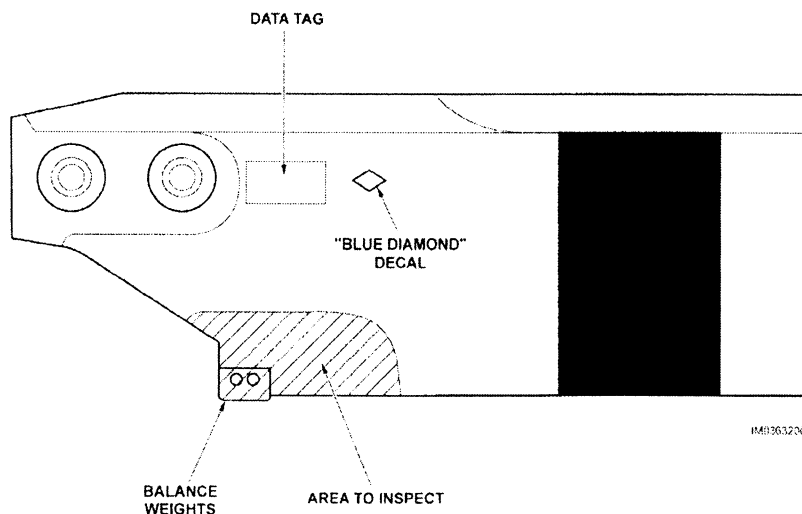
Figure 1. Tail rotor blade inspection.

replacing each blade with an airworthy blade if a deformation, a crack, or a bent or deformed weight is found. This amendment is prompted by three reports of skin cracks originating near the blade trailing edge balance weight. In two reports, a loss of the weight and a strip of material along the trailing edge led to an imbalance and fracture of three of the four tail rotor gearbox attachment bolts. In one of these incidents the gearbox shifted resulting in failure of the drive shaft and loss of yaw control. This condition, if not detected, could result in blade failure and subsequent loss of control of the helicopter.

installing any blade with a P/N and S/N listed in the applicability section of this AD, clean the blade. Using a 10X or higher magnifying glass, inspect both sides of each blade for a deformation, a

crack, and a bent or deformed weight in the area shown in Figure 1 of this AD.

Note 1: Paint irregularities on the blade may indicate a crack.

(1) At intervals not to exceed 12 hours time-in-service (TIS), using a 10X or higher magnifying glass, inspect both sides of each blade for a deformation, a crack, and a bent or deformed weight in the area shown in Figure 1 of this AD, or

(2) Inspect and check both sides of each blade for a deformation, a crack, and a bent or deformed weight in the area shown in Figure 1 of this AD as follows:

(c) Before further flight, replace any blade that has a deformation, a crack, or a bent or deformed weight with an airworthy blade.
