[Docket No. 2002–NM–128–AD; Amendment 39–13269; AD 2003–16–16]

**Airworthiness Directives; Boeing Model 747–400 Series Airplanes Equipped With General Electric Model CF6–80C2 Series Engines**

**2003-16-16 Boeing:** Amendment 39-13269. Docket 2002-NM-128-AD. Supersedes AD 2000-09-03, Amendment 39-11711.

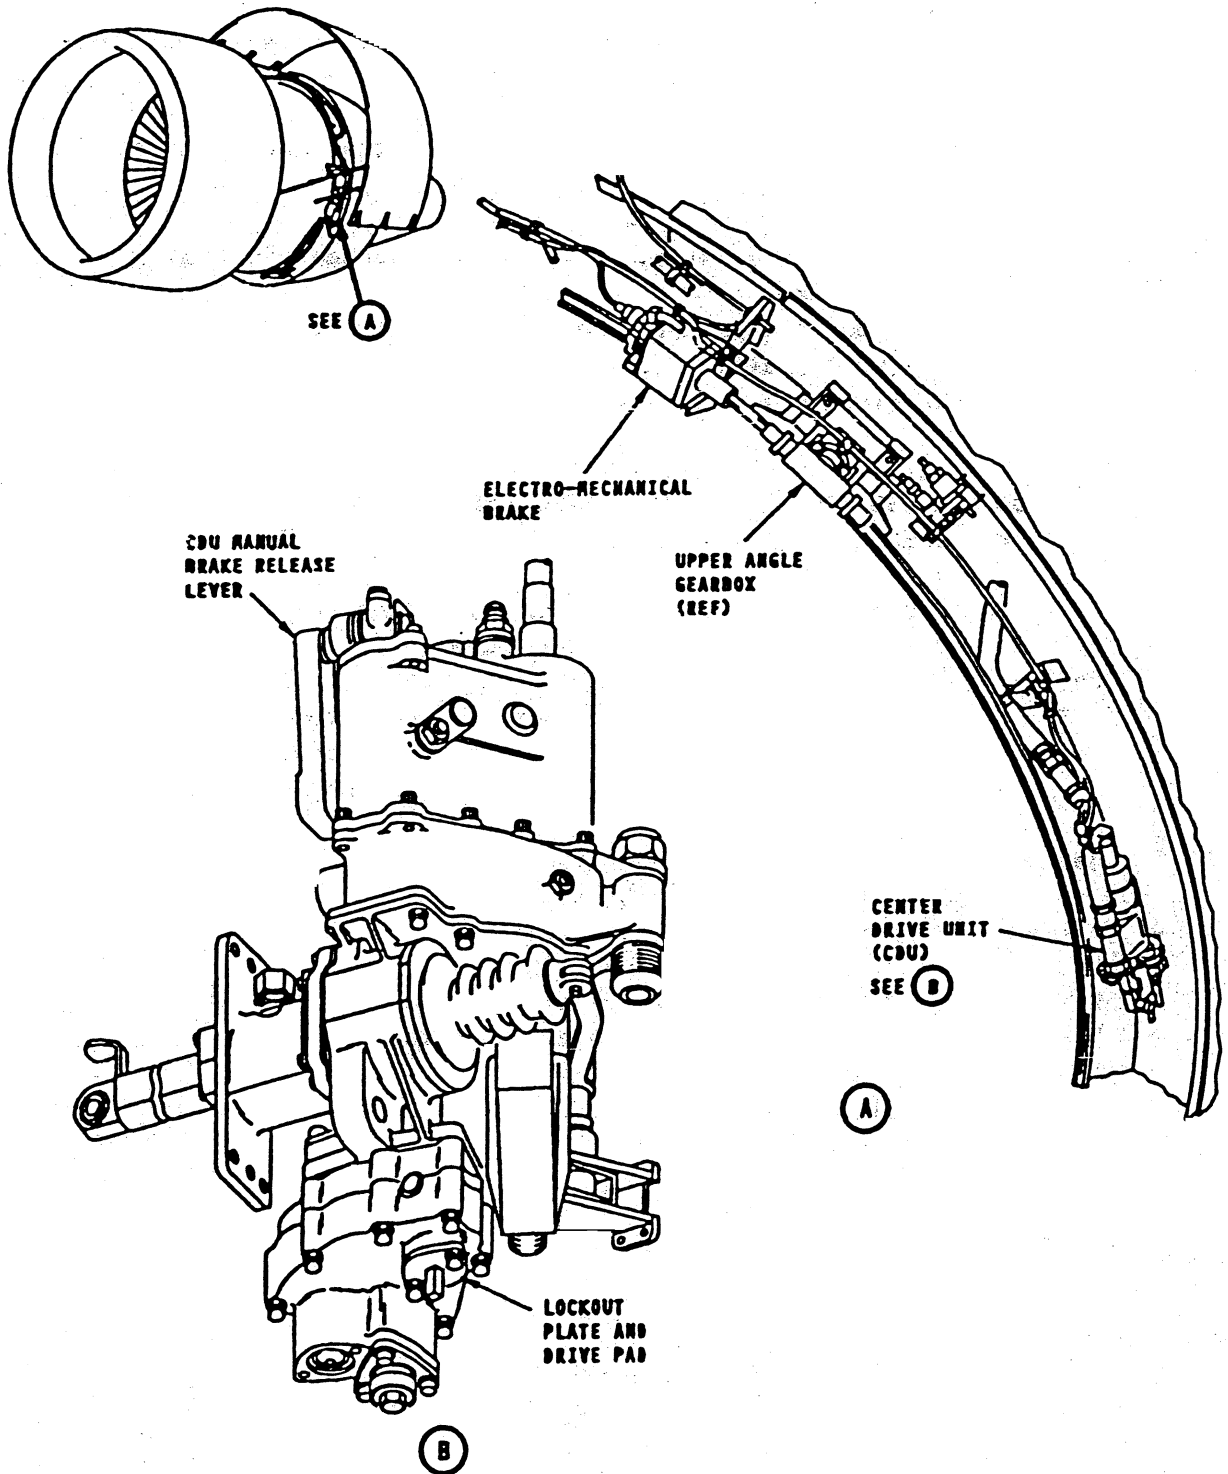
Electro-Mechanical Brake and CDU Cone Brake Torque Check  
Figure 1

1. This procedure contains steps to do a check of the holding torque of the CDU cone brake.

**Note:** The cone brake prevents movement in the extend direction only. If you try to measure the holding torque in the retract direction, you will get a false reading.

(8) If the torque is less than 15 pound-inches, you must replace the CDU.
