[Docket No. 2000-SW-12-AD; Amendment 39-13354; AD 2003-22-06]

Airworthiness Directives; Eurocopter France Model AS350B, B1, B2, B3, BA, C, D, D1, and AS355E, F, F1, F2, and N Helicopters

2003-22-06 Eurocopter France:
 Amendment 39-13354. Docket No. 2000-SW-12-AD. Supersedes AD 98-24-35, Amendment 39-10921, Docket No. 98-SW-41-AD.

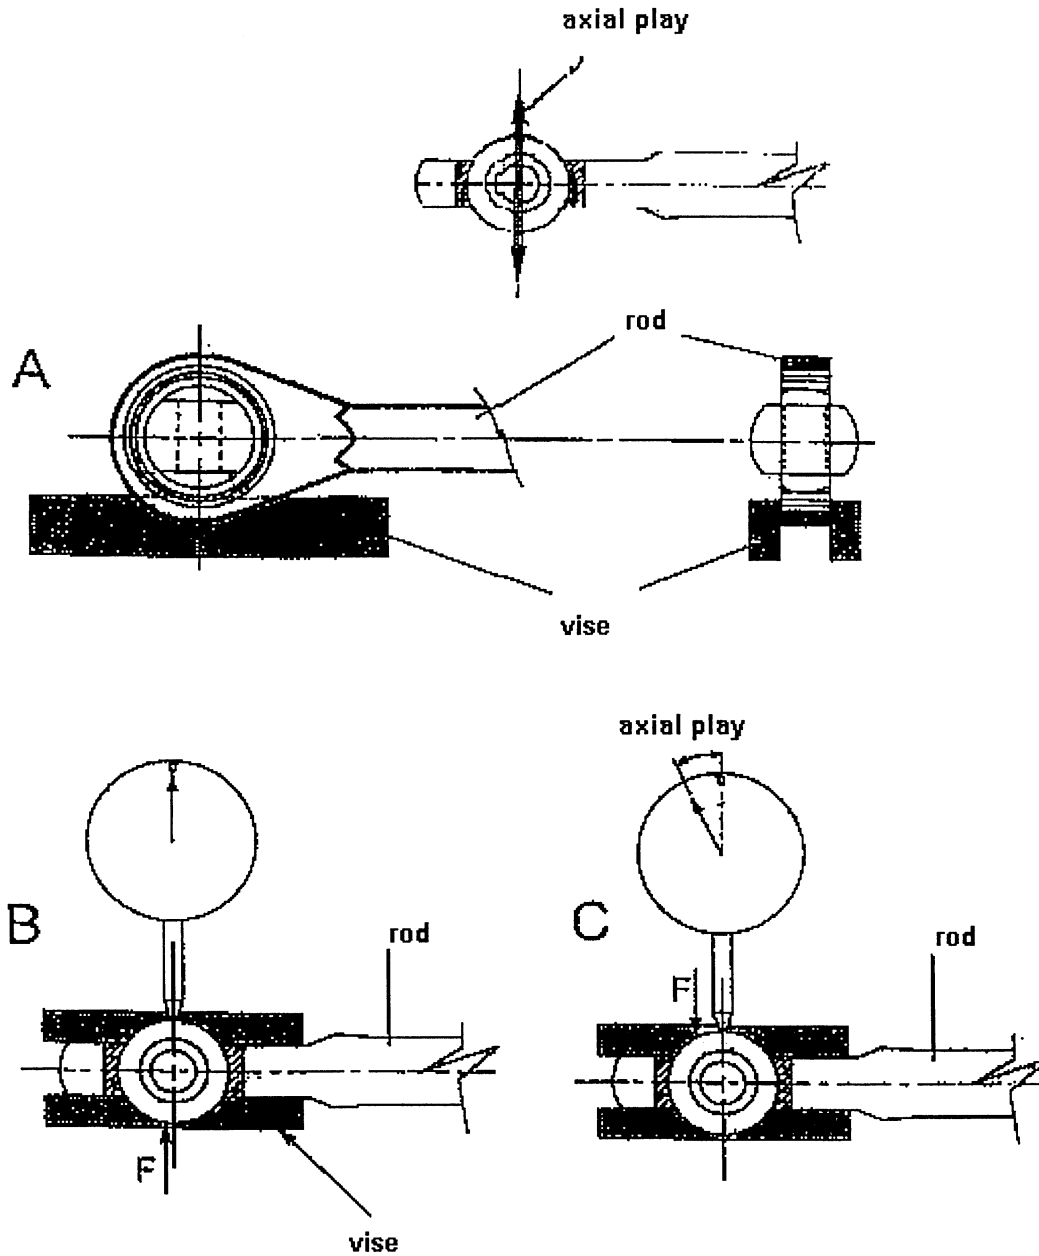
Figure 2: Measurement of the Axial Play (A) of the Bearing

(3) Using a dial indicator, take axial play readings by moving the spherical bearing in the direction F (up and down) as shown in Figure 2 of this AD.

(7) If the radial play exceeds 0.008 inch or axial play exceeds 0.016 inch, replace the control rod with an airworthy control rod before further flight.

(2) Mount the control rod in a vise as shown in Figure 2 of this AD.

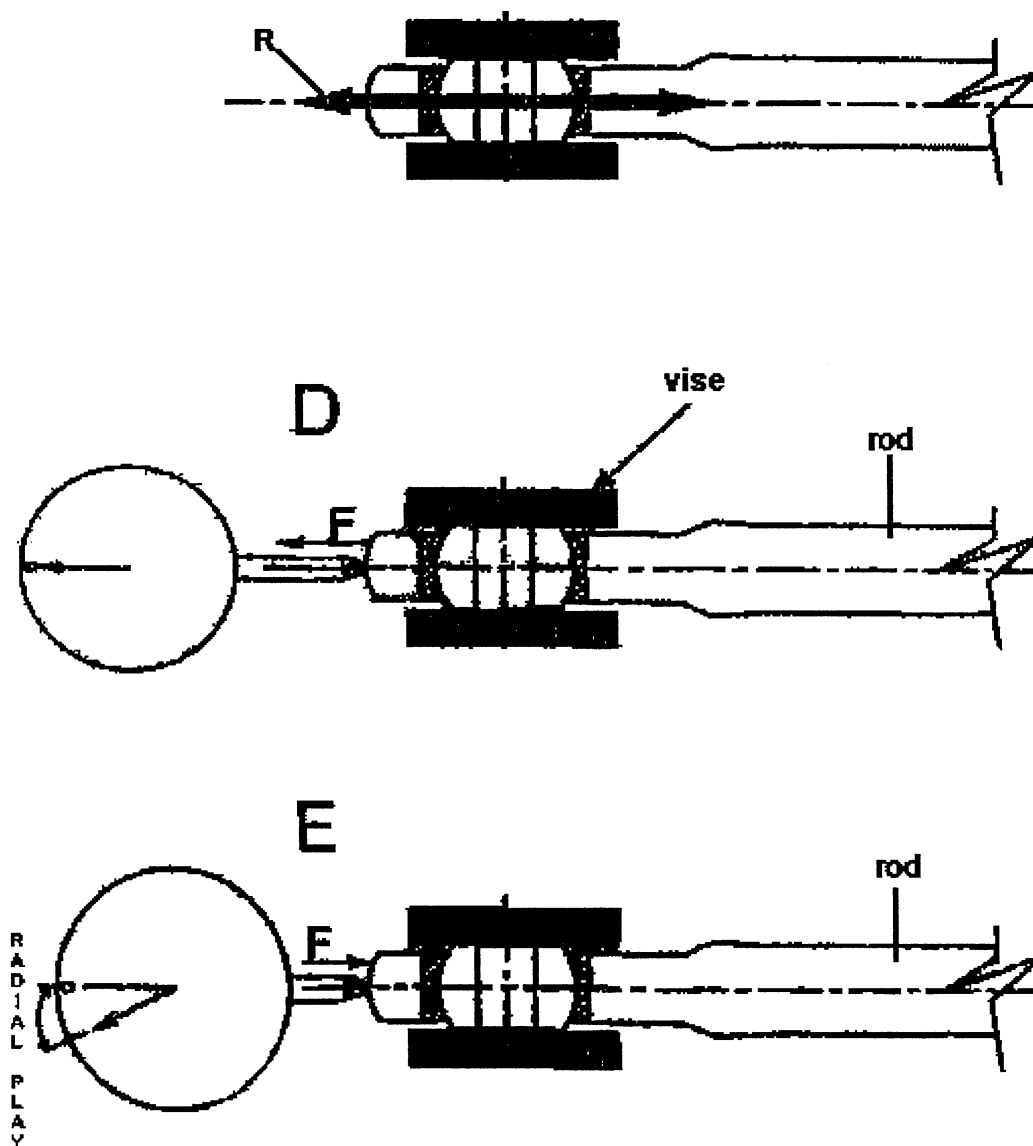
Figure 3: Measurement of the Radial Play (R) of the Bearing

(5) Using a dial indicator, take radial play measurements by moving the control rod in the direction F as shown in Figure 3 of this AD.

(4) Mount the bearing in a vise as shown in Figure 3 of this AD.
