## **Appendix L: Metallurgical Analysis of PCCV Liner Tears**

## **Metallurgical Analysis of PCCV Liner Tears**

K. H. Eckelmeyer, J. A. VanDenAvyle, A. C. Kilgo, and L. D. Lambert

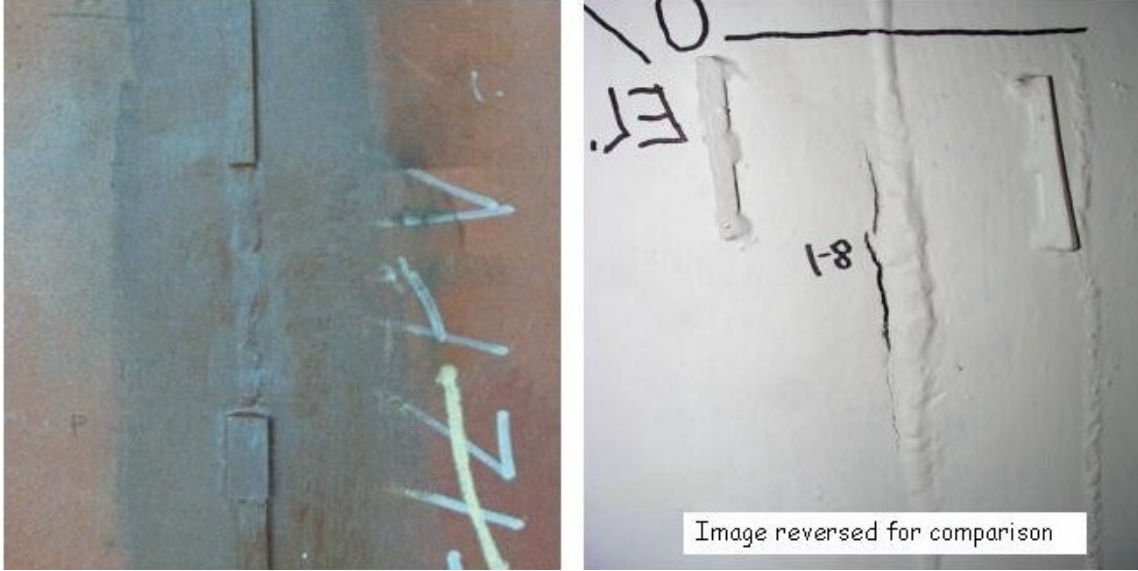
Figure 7. Photographs showing region of tear #8-1 from outside of liner (left) (prior to concrete placement) and inside of liner (right) (prior to removal of paint). Note missing segment of back-up bar in vicinity of repair weld and tear.

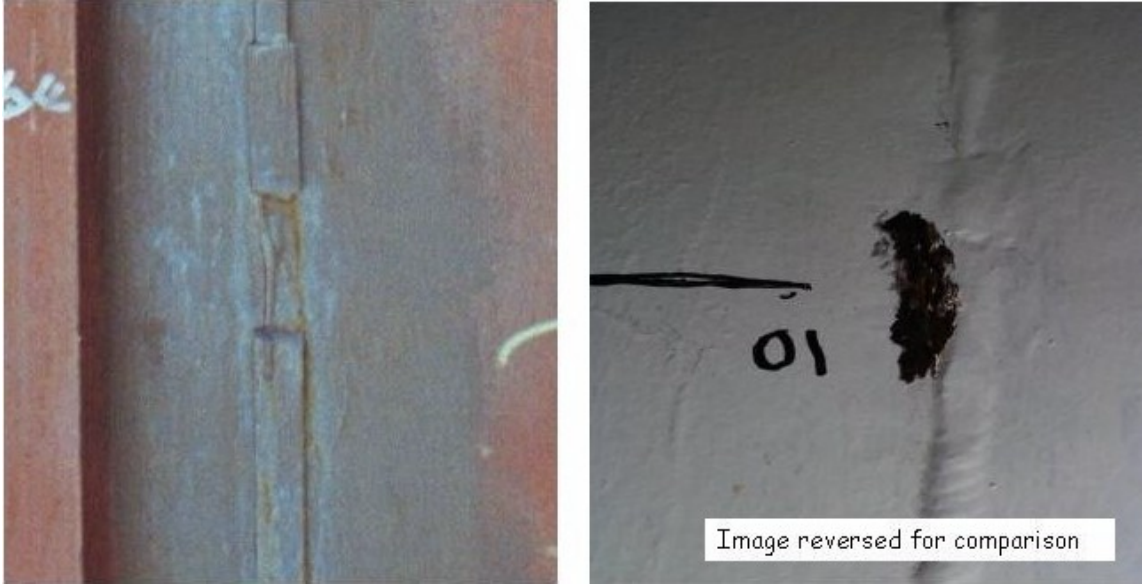
Figure 9. Photographs showing region of tear #10 from outside of liner (left) (prior to concrete placement) and inside of liner (right) (prior to removal of paint). Note missing segment of back-up bar in vicinity of repair weld and tear.

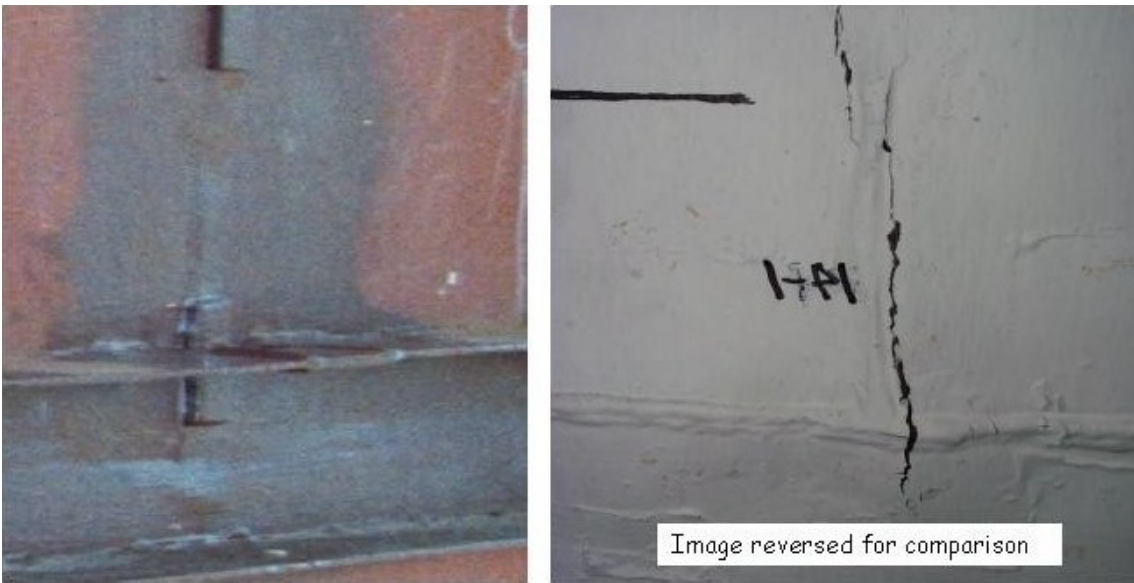
Figure 10. Photographs showing region of tear #14-1 from outside of liner (left) (prior to concrete placement) and inside of liner (right) (prior to removal of paint). Note missing segments of back-up bar in vicinity of repair weld and tear.

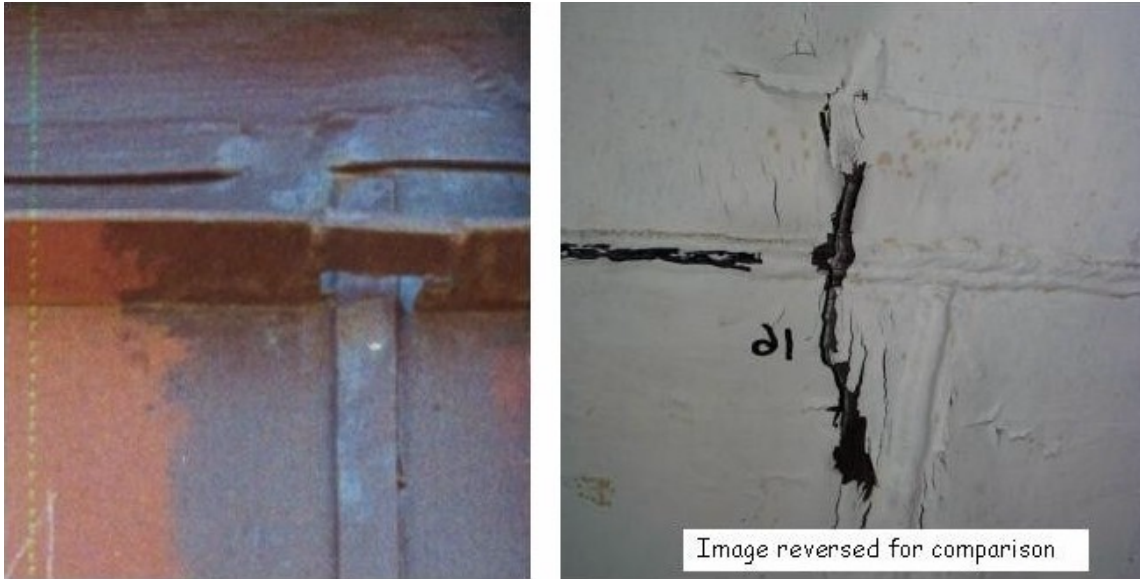
Irregularities were also observed in the back-up bars. It is important to note, however, that while permitted by ASME Code (Ref. 2), MHI does not typically use back-up bars in fabrication of full-sized liners; they were used here because of difficulties associated with fabricating a 1/4-scale model. The irregularities observed included use of varying sizes of back-up bar (ranging from 3 mm thick x 13 mm wide to 6 mm thick x 25 mm wide), areas in which segments of back-up bar were removed and not replaced during repair welding, and the absence of welds between adjacent sections of back-up bar. All of these provide discontinuities that could facilitate strain localization, and would not be allowed in full scale liners (Ref. 2). Subsequent investigation did not suggest that such back-up bar irregularities in the *vertical* welds were primarily responsible for any tears. A missing back-up bar segment in a *horizontal* field weld appeared to be primarily responsible for tear # 16, as will be described in more detail in later sections.

Figure 11. Photographs showing region of tear #16 from outside of liner (left) (prior to concrete placement) and inside of liner (right) (prior to removal of paint). Note missing segment of back-up bar on horizontal weld in vicinity tear.

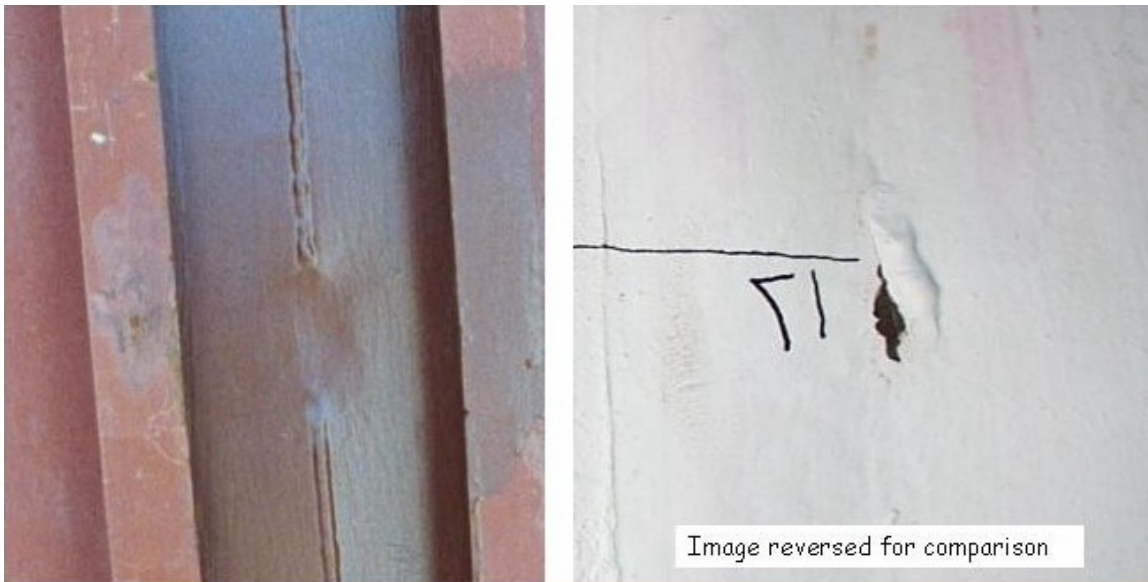
Figure 12. Photographs showing region of tear #17 from outside of liner (left) (prior to concrete placement) and inside of liner (right) (prior to removal of paint). Note how weld bead is ground off on outside surface in vicinity of repair weld (made from inside of liner) and tear.

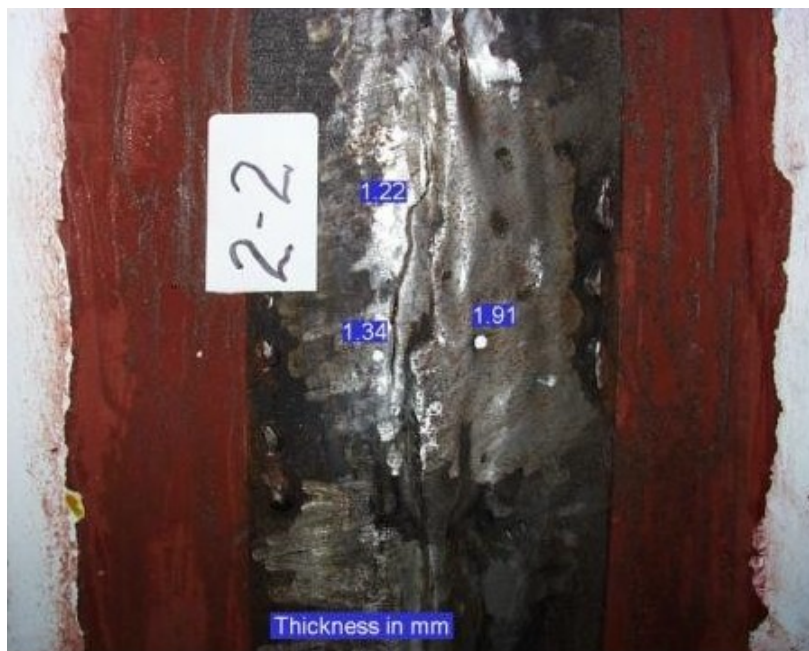
Figure 20. Liner thicknesses (in millimeters) measured ultrasonically in the vicinity of tear #2-2. Note the very wide region of repair welding and grinding. Note also that one measurement is greater than the initial plate thickness due to previous weld repairs.

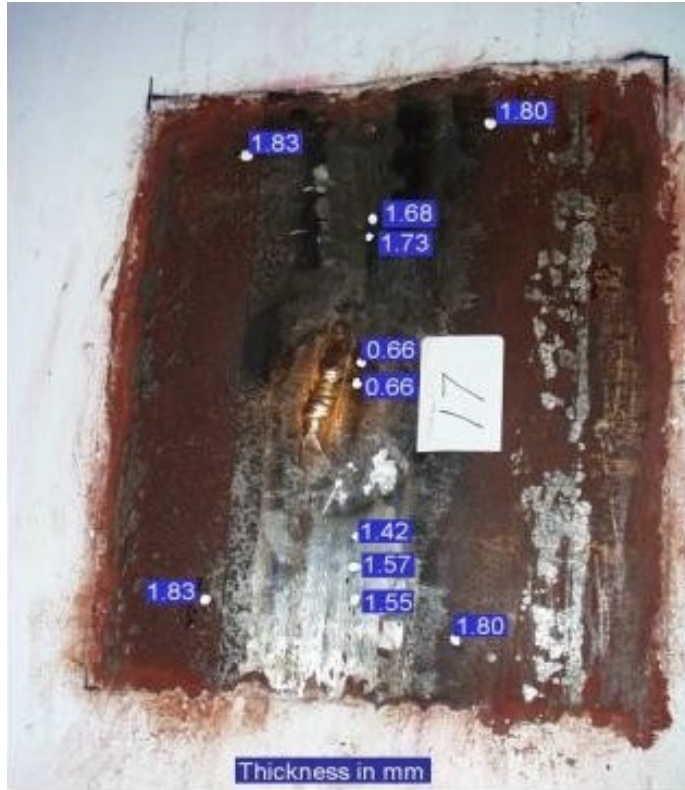
Figure 31. Liner thicknesses (in millimeters) measured ultrasonically in the vicinity of tear #17. Note exceptionally thin areas adjacent to repair weld and tear.

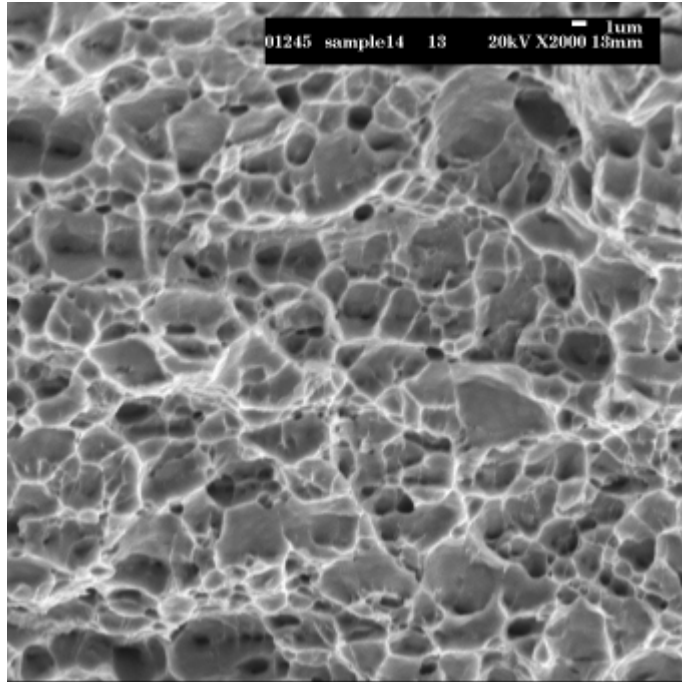
Figure 64. Scanning electron micrograph of fracture surface from tear #14-2. Failure occurred by ductile rupture, as was seen on fracture surfaces from tensile samples shown in Figures 42-44.

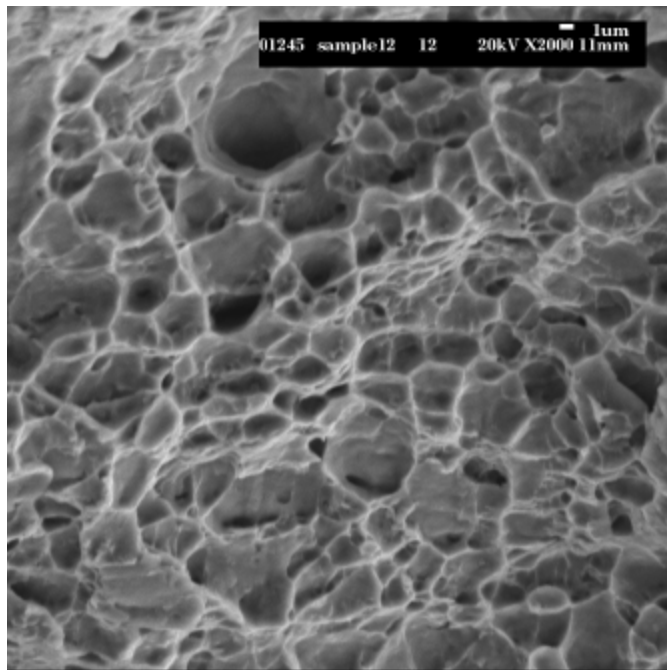
Figure 65. Scanning electron micrograph of fracture surface from tear #12. Failure occurred by ductile rupture, as was seen on fracture surfaces from tensile samples shown in Figures 42-44.

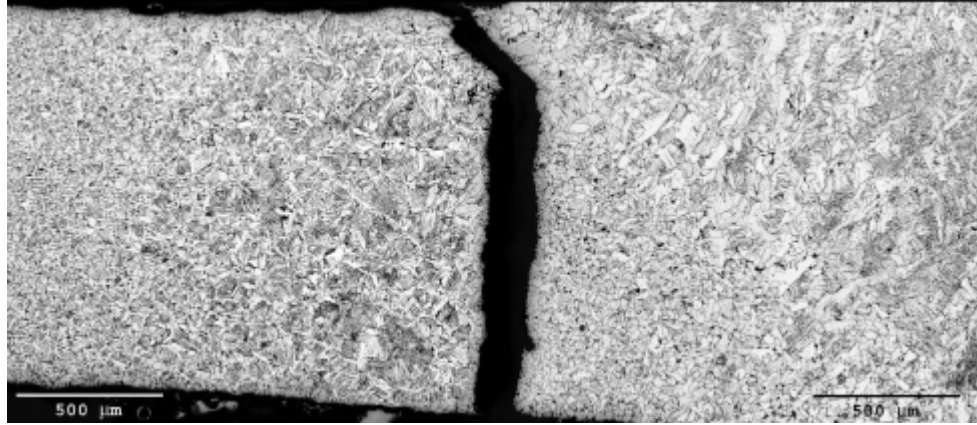
There was no indication that deficiencies in the liner material or welds contributed to tearing, other than as described above. The only exception to this was tear #1, which occurred at a lack-of-fusion defect in the region of a repair weld.

Figure 66. Metallographic cross section of tear #1. This cross section was taken at the location of widest crack opening, corresponding to where the tear apparently initiated. Note that the opening is flat and perpendicular to the liner circumference, and that the microstructure is not continuous across the separation. The “fracture” surfaces were also covered with a layer of foreign material (too dark to be seen here). These features indicate that this area represents a lack of fusion defect, i.e., a region in which the repair weld failed to bridge the gap being welded.

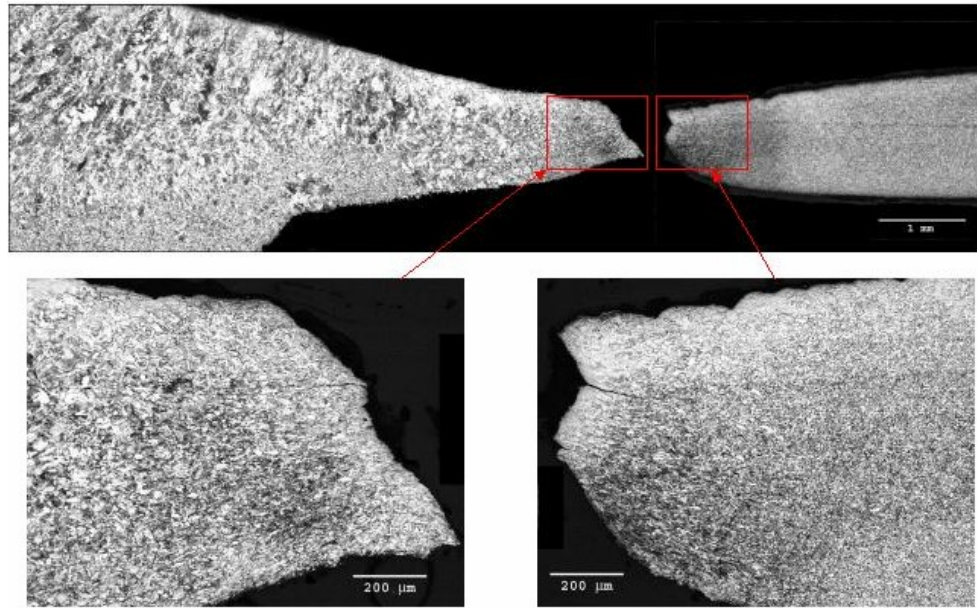
Figure 67. Metallographic cross section of tear #1 approximately 2 cm distant from the cross section shown in Figure 66. Note that failure occurred by more typical shear, and that microstructure shows evidence of substantial localized deformation having occurred prior to final separation. This represents an area removed from the lack of fusion defect where liner tearing occurred as the tear grew in length during testing of the structure. Tearing occurred through the fine grained portion of the heat affected zone.

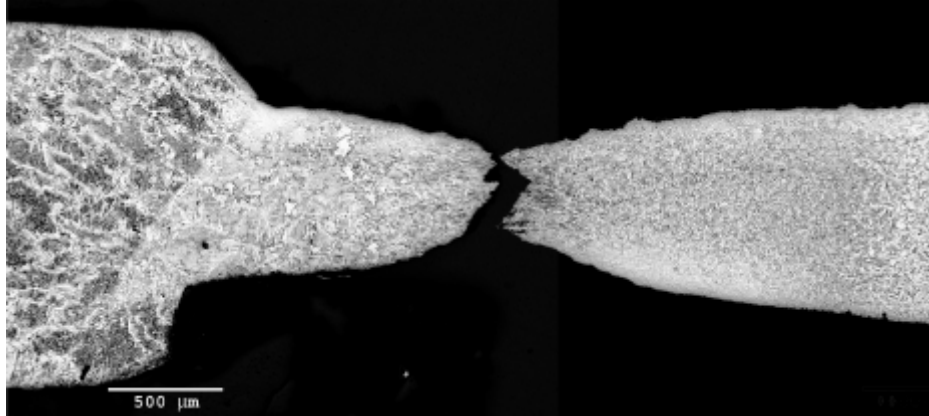
Figure 68. Metallographic cross section of tear #2-1. Tearing occurred in heat affected zone adjacent to repair weld. Note how grinding ends abruptly at edge of fusion zone, providing for measurement of as-ground liner thickness at edge of weld and close to location of tear. Tearing occurred in the adjacent heat affected zone.

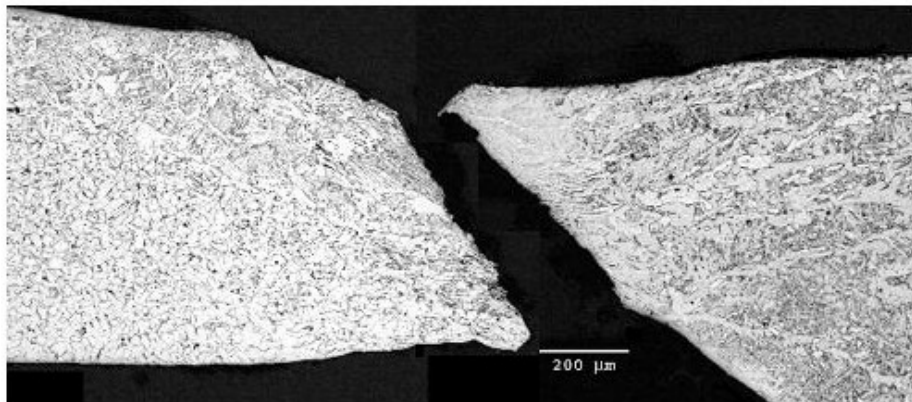
Figure 69. Metallographic cross section of tear #2-2. A very wide region (~29 mm) representing many sequential side-by-side welds was observed in this sample. The fusion zones of many of the early welds had been recrystallized by the heat input from subsequent welds, whereas many of the later welds retained the coarse columnar grain structures characteristic of single pass welds. Tearing occurred in by shear following substantial plastic deformation near the boundary between recrystallized weld metal and a region that could be either unrecrystallized weld metal or coarse grained heat affected zone.

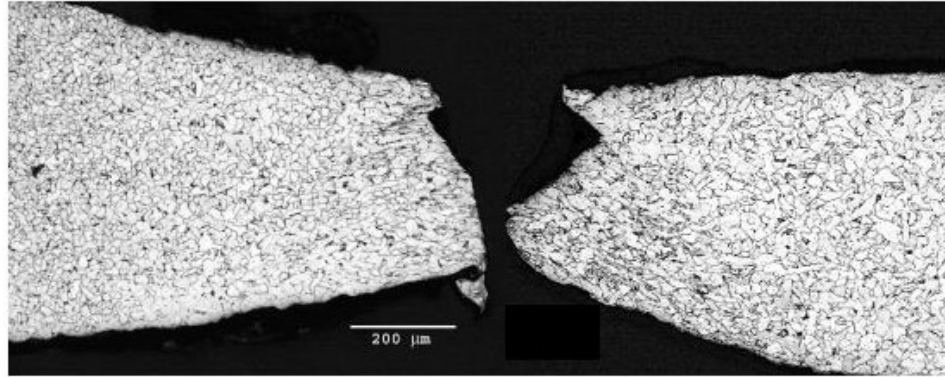
Figure 70. Metallographic cross section of tear #2-3. This sample was similar to #2-2, except that tearing occurred in a completely recrystallized fusion zone of an earlier weld. A portion of the fracture appears to have been mashed flat; this represents an artifact which occurred during unloading or when samples were being removed from the liner.

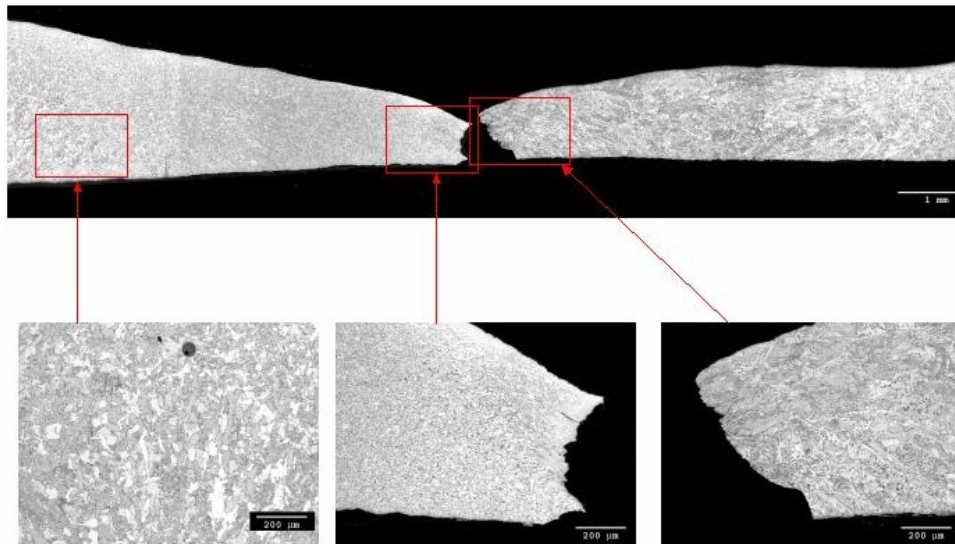
Figure 71. Metallographic cross section of tear #4-1. This sample was similar to #2-2, except that the region of sequential side-by-side welds was even wider, approximately 51 mm. Tearing occurred in an area of mixed recrystallized and unrecrystallized weld metal, and was accompanied by substantial localized plastic deformation.

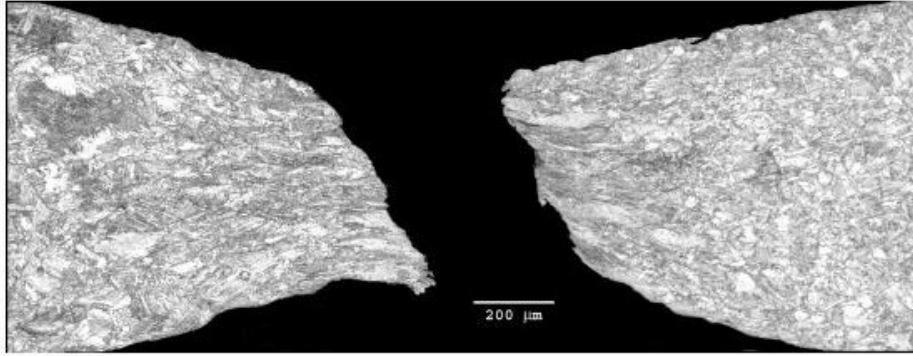
Figure 72. Metallographic cross section of tear #4-3. This sample contained the primary weld and several associated repair welds, plus a second weld approximately 25 mm in from the primary weld. This secondary weld was apparently made to repair the liner where it had been ground through when repairs were being made to the primary weld. Tearing occurred in a coarse grained region of heat affected zone between these two welds, and was preceded by extensive plastic deformation.

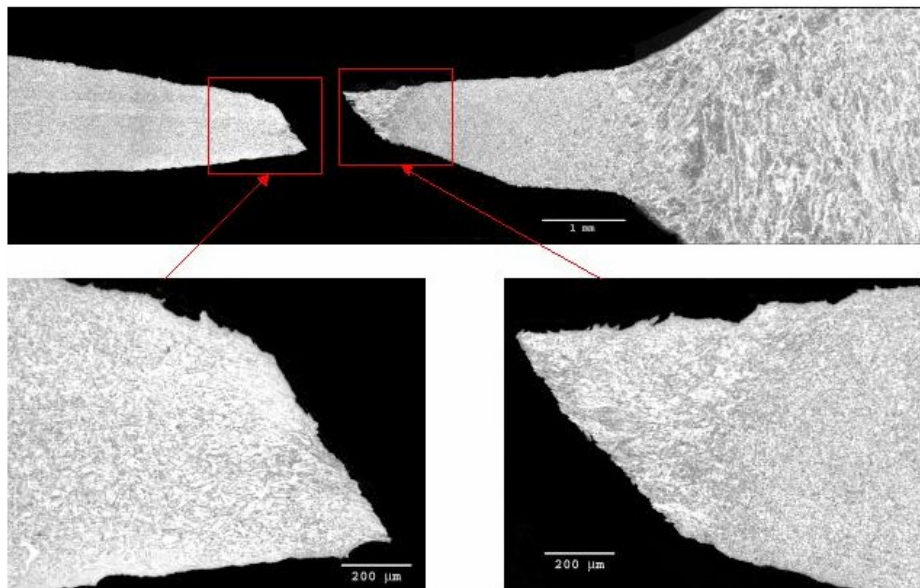
Figure 73. Metallographic cross section of tear #6-2. This sample contained a single repair weld. Grinding on the outside surface ended fairly abruptly at the edge of the back-up bar, resulting in a fairly deep but narrow region of liner thinning. Tearing occurred in the heat affected zone adjacent to the weld, and was accompanied by substantial localized plastic deformation.

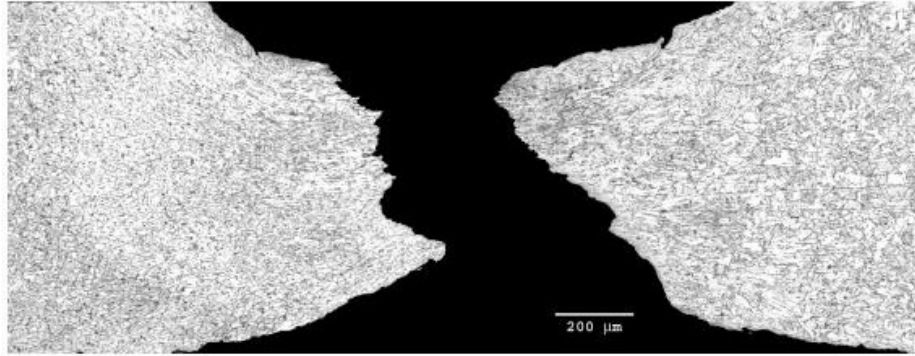
Figure 74. Metallographic cross section of tear #8-1. This sample contained a single repair weld surrounded by a region of recrystallized weld metal representing the original weld. Tearing occurred in either the recrystallized weld metal or the heat affected zone adjacent to the weld, and was accompanied by substantial localized plastic deformation.

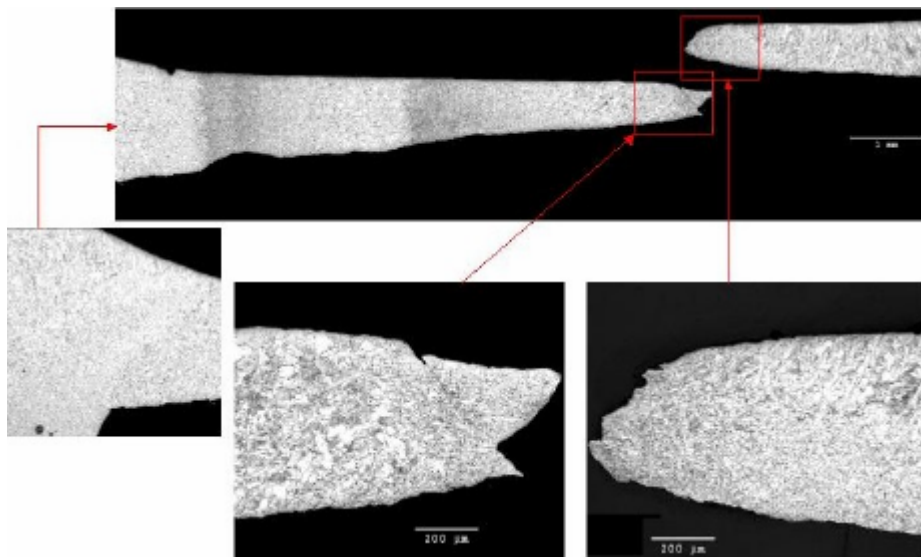
Figure 75. Metallographic cross section of tear #8-2. This sample contained the primary weld, plus a second weld approximately 13 mm in from the primary weld. This secondary weld was apparently made to repair the liner where it had been ground through when repairs were being made to the primary weld, similar to sample #4-3. Tearing occurred adjacent to the secondary weld in what appears to be recrystallized weld metal. Substantial localized plastic deformation accompanied tearing.

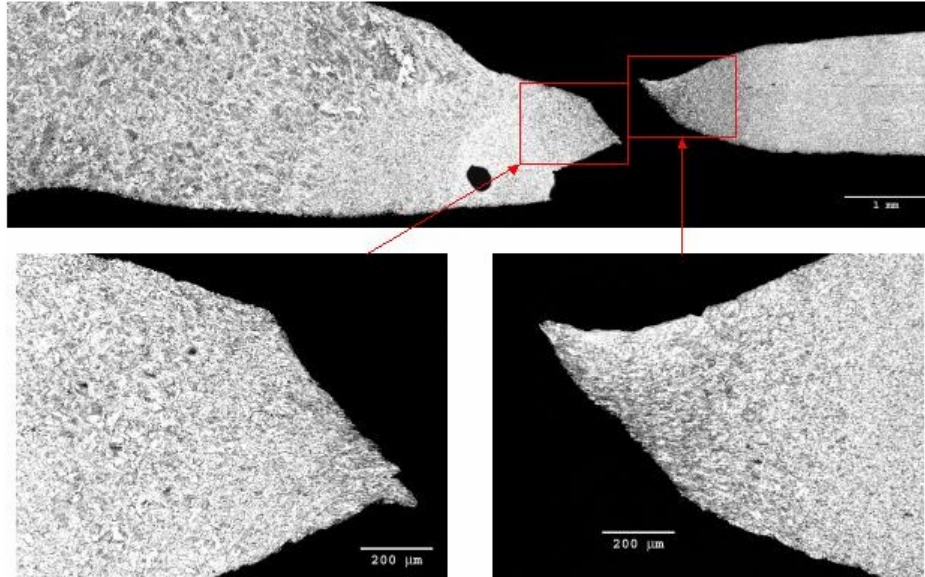
Figure 76. Metallographic cross section of tear #9. This sample contained a single repair weld. Grinding on the outside surface ended abruptly at the edge of the back-up bar, resulting in a deep but narrow region of liner thinning. Tearing occurred in the heat affected zone adjacent to the weld, and was accompanied by substantial localized plastic deformation.

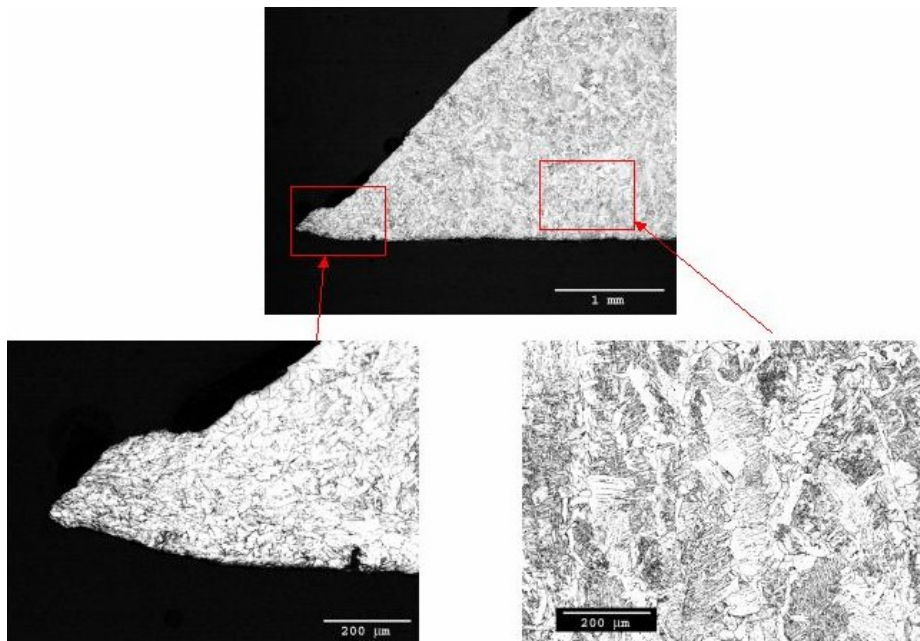
Figure 77. Metallographic cross section of tear #17. This shows the fusion zone of the primary weld, plus the tear adjacent to it. The tear appears to have occurred in a region of recrystallized weld metal from a previous weld. Tearing was accompanied by substantial localized plastic deformation.

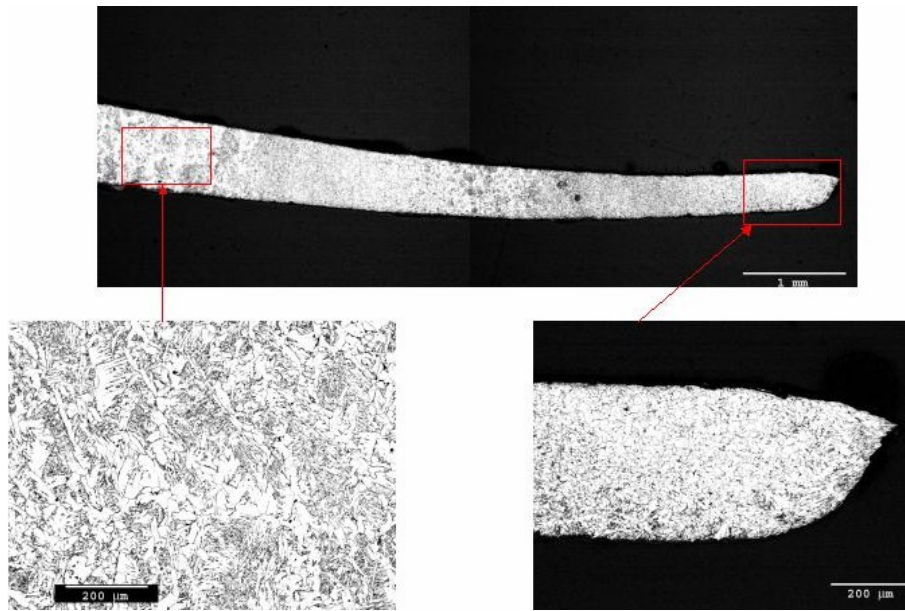
Figure 78. Region of tear #17 adjacent to that shown in Figure 77. Note columnar fusion zone at left; this corresponds to a secondary weld made to repair the liner where it had been ground through when repairs were being made to the primary weld, similar to samples #4-3 and #8-2. Note that the liner thickness was greatly reduced by grinding over the entire region pictured here.

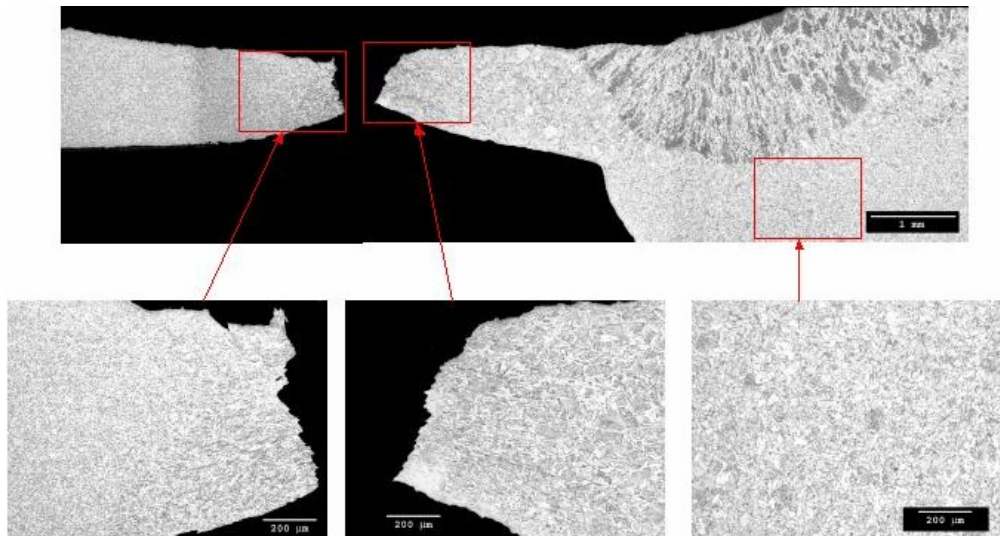
Figure 79. Metallographic cross section of tear #7. Columnar grained region represents repair weld; underlying recrystallized region represents earlier weld. Tearing occurred in heat affected zone adjacent to weld. Less shear and localized deformation appears characteristic of this tear, suggesting that it may have occurred due to more complex stresses.

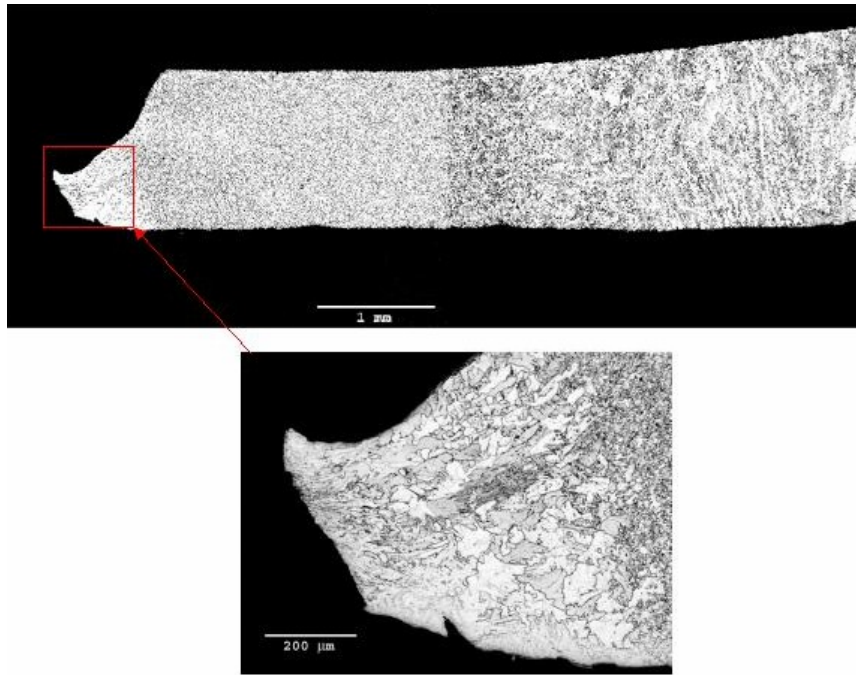
Figure 80. Metallographic cross section of tear #15. Region at right is columnar fusion zone of repair weld. Region at left is recrystallized fusion zone of former weld. Tear (at far left) occurred just left of where recrystallization stopped, either in unrecrystallized weld metal or coarse grained heat affected zone.

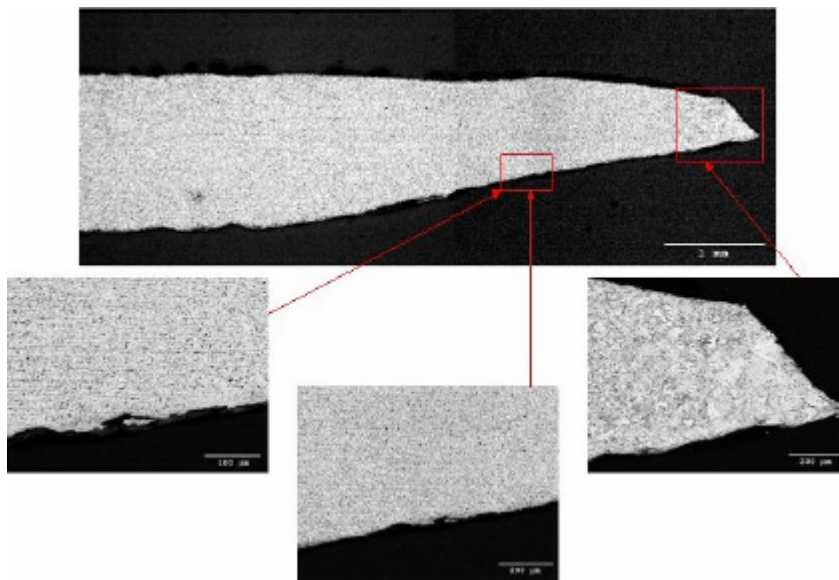
Figure 81. Region of tear #15 adjacent to that shown in Figure 80. Tear (at far right) occurred in coarse grained portion of heat affected zone. Note substantial angle between surface and segregation bands in metal, indicative of grinding in tapered area.
