5. TESTING

5.1 Test Planning

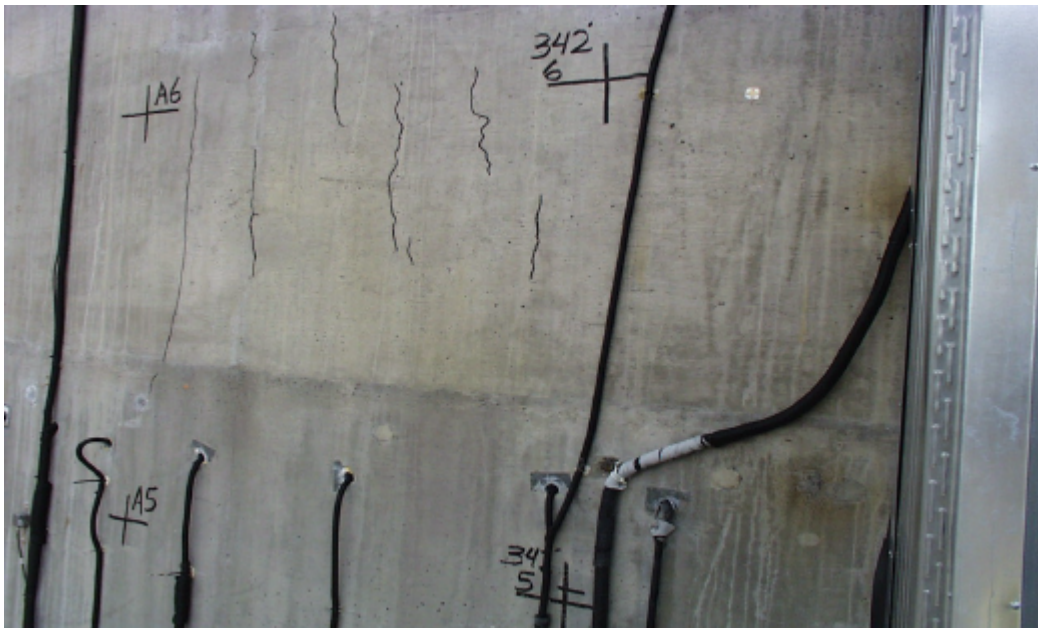
Figure 5.10 Pre-SIT Cracks at Azimuth. 350 degrees, Elev. 4680 to 6200 (Grid 45)

While holding at the ILRT pressure, a limited amount of crack mapping was performed. This was accomplished by tracing all new cracks in predetermined areas and taking still photos of these areas. Cracks in the area to the left of the E/H prior to the SIT were traced in black and are shown in Figure 5.10. New cracks, traced in blue during the ILRT, are shown in Figure 5.11. Cracks widths were not measured.

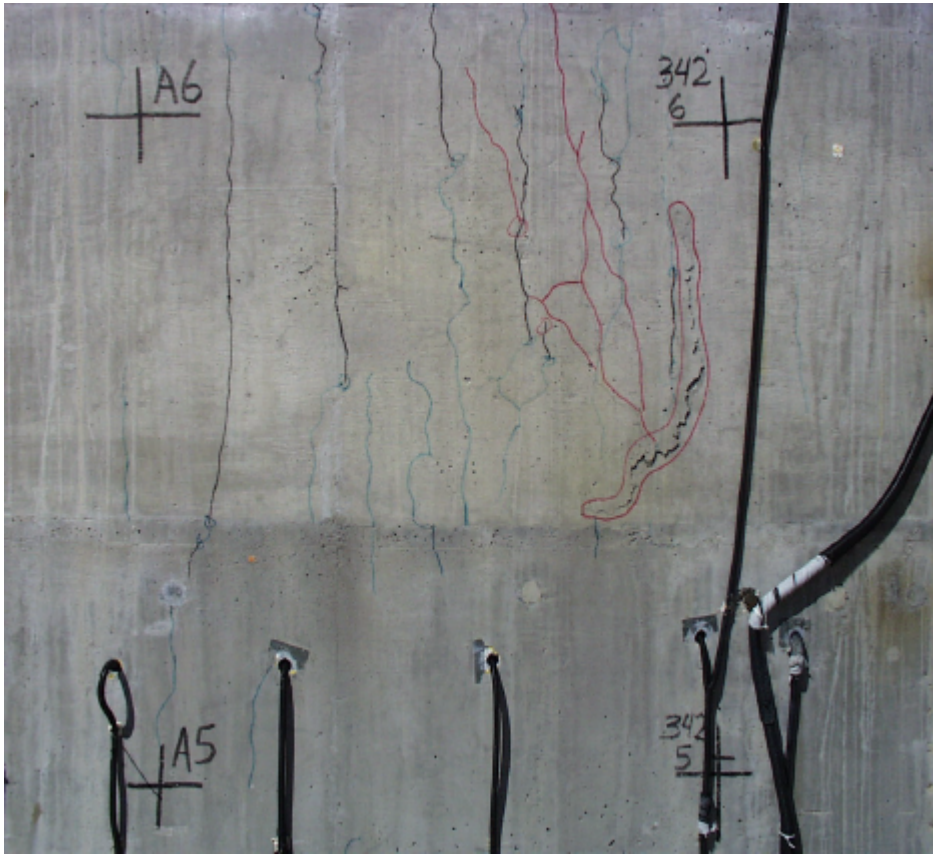
Figure 5.22 Post-LST Cracks at Azimuth 350 degrees, Elev. 4680 to 6200 (Grid 45)

After the model pressure was reduced to $1.0 P_d$, test personnel were able to inspect the model close-up. Nitrogen gas was observed (heard and felt) escaping through many small cracks in the concrete around the penetration sleeves and at the tendon anchors. It was speculated that the liner acted as a leak chase, allowing nitrogen gas escaping through a tear or tears in the liner to travel between the liner and the concrete until it found an exit path through a crack in the concrete or a conduit in the tendon duct.

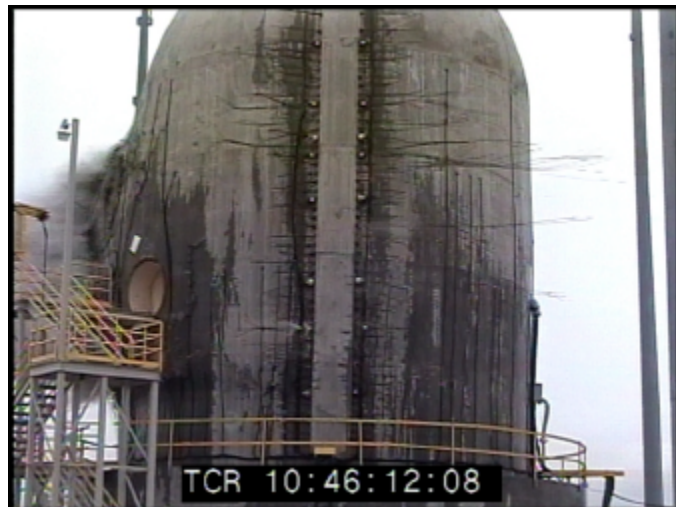
(b) 270 degrees Azimuth

Figure 5.34 SFMT: Rupture of the PCCV Model

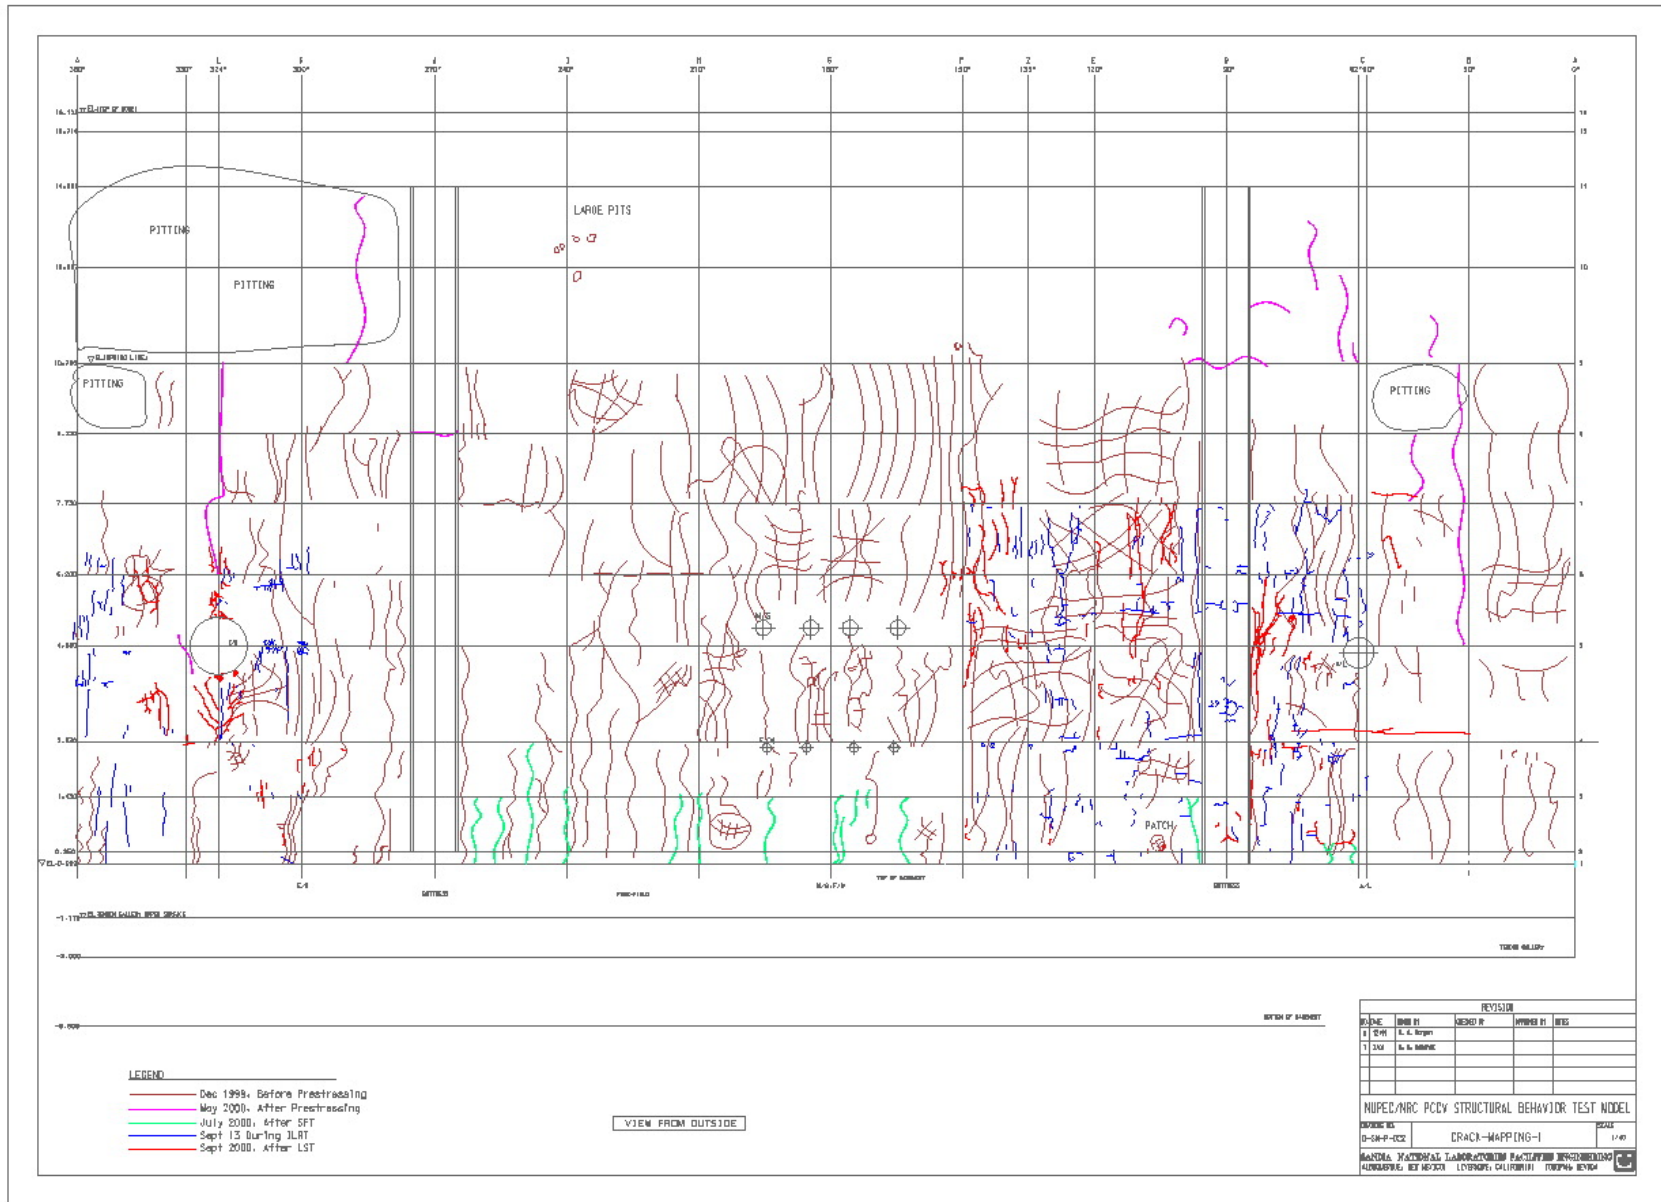
Figure 5.76 Post-LST Concrete Crack Map

A total of 489 cracking events were detected from March 3 to September 27, 2000. Two-hundred twenty nine of these events were recorded during the LST. These cracking events represent distinct acoustic events, as distinguished from the ubiquitous ‘crackling’ which occurred nearly continuously during the period the PCCV was monitored by the acoustic system. This crackling is believed to be the acoustic manifestation of microcracking and shearing in response to environmental and pressure loading. The acoustic events identified as cracking represent the formation or extension of discrete macrocracks in response to the applied pressure or other loads. Figure 5.74 maps the location of the cracking events during the LST, grouped by pressure bands. No obvious pattern emerges from this map except that the majority of cracks occurred in the middle section of the cylinder wall, where the strains and displacements were greatest. A histogram of the cracking events as a function of pressure, shown in Figure 5.75, however, reveals the majority of cracking events occurring in the range of 1.5 to $2.0P_d$ where the initial loss of stiffness, presumed to be due to concrete cracking, was already noted.

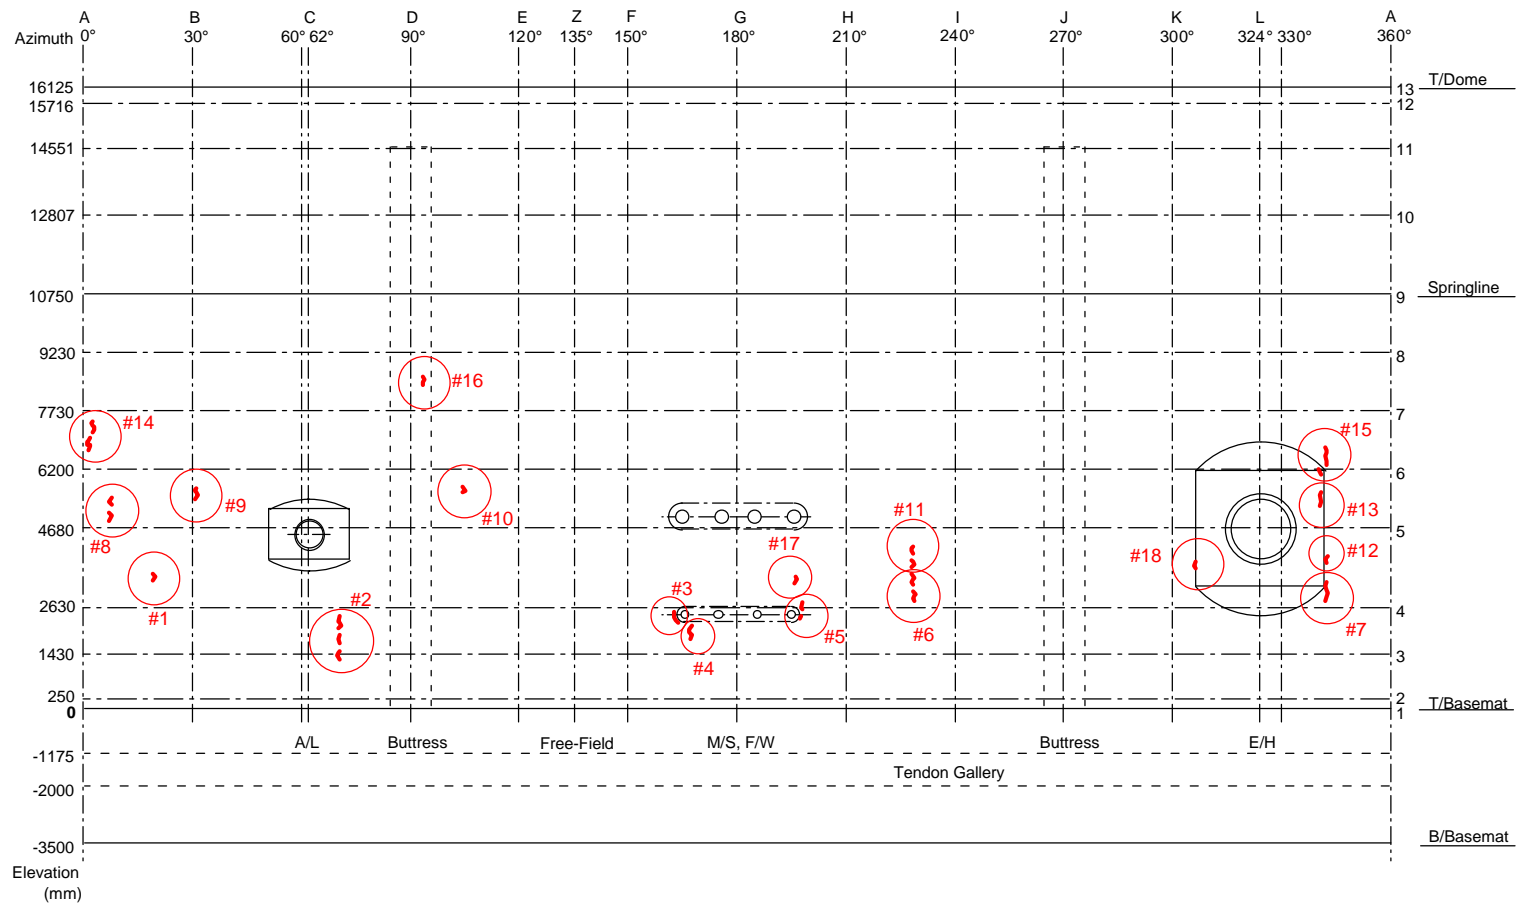
Figure 5.77 Post-LST Liner Tears

1. In-situ examination:
 - a. In addition to the visual/photographic records, ultrasonic thickness measurements were made at each tear location and at several baseline locations where tears did not occur.
2. Destructive examination:
 - a. Twenty-five liner specimens were removed from the model (see Figures 5.87 and 5.88).
 - b. Eighteen of the liner specimens were subjected to metallographic analysis.
 - c. Sample weld specimens were subjected to metallographic analysis.
 - d. After the liner specimens were examined by SNL, the unused portions were sent to NUPEC for further examination. The results of NUPEC's examination have been reported separately.

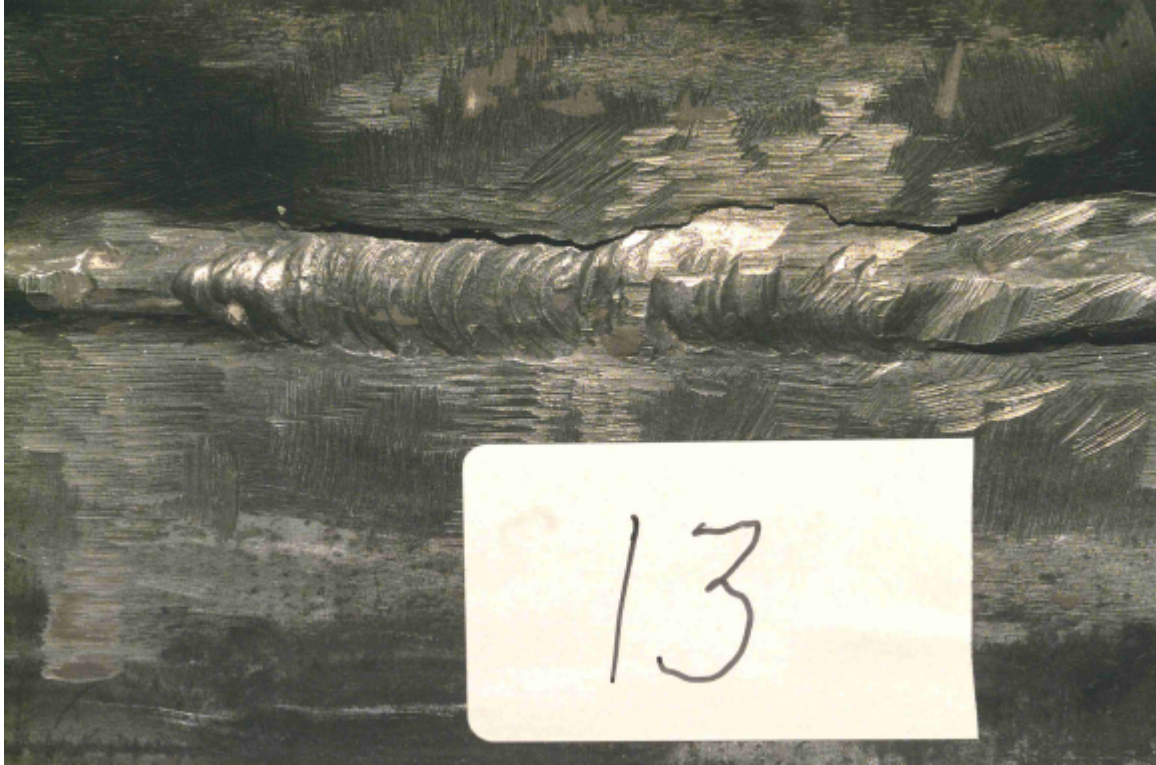
Figure 5.86 Close-Up of Tear #13 after Removal of Paint

6. Only one tear occurred in association with a material or weld defect. A lack-of fusion weld defect was found at the initiation site of tear #1.
7. The specially produced quarter-scale liner material exhibited mechanical properties that may have made it particularly prone to plastic strain localization and tearing. While nearly conforming to the specifications for full-thickness material, the quarter-thickness plate exhibited a yield strength much higher than the specified minimum (383 MPa compared with 225 MPa) and an unusually high yield-to-ultimate-strength (YS/UTS) ratio (0.77). This high YS/UTS ratio is qualitatively consistent with extensive localized plastic strain culminating in ductile tearing in regions where more than ~25% of the liner thickness had been ground off, as was observed near most of the tears.
