# **Assessment of Structural Flood-Control Measures on Alluvial Fans**

October 1993

Hydrologic Engineering Center  
US Army Corps of Engineers  
609 Second Street  
Davis, CA 95616-4687  
(916) 756-1104

Federal Insurance Administration  
Federal Emergency Management Agency  
500 C Street, SW  
Washington, D.C. 20472

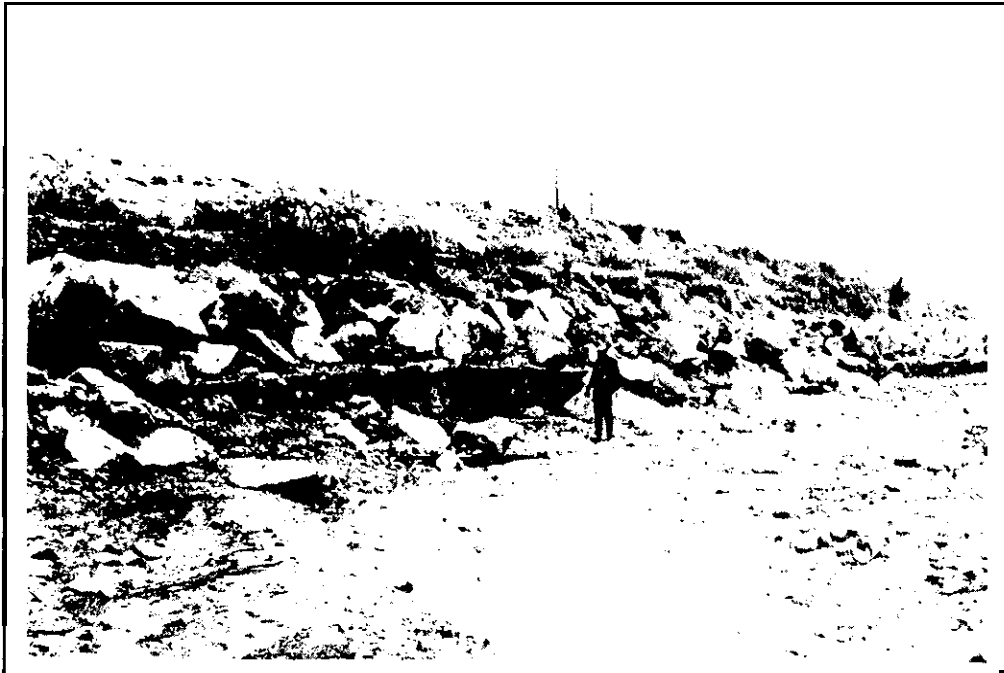
Investigation of effects of earlier floods revealed the ineffectiveness of the triangular-shaped toe protection on the grouted-stone revetment. This type of toe protection was used for the Lytle Creek levee and Muscoy Groin 4, as shown in Figure 2-1. Investigation of these two improvements after the 1969 floods, revealed the streamward displacement of the quarrystone toe protection that had originally been placed on the grouted-stone revetment. The scattering of the displaced quarrystone away from the revetment and the absence of the bulk of the quarrystone in the eroded

Figure 2-1 Scour Adjacent to Muscoy Groin 4 (Photo 36 - Scour depth of about three feet below the toe of grouted-stone facing.)

section at the toe indicated that this design is ineffective in providing additional protection against excessive scour along the toe.

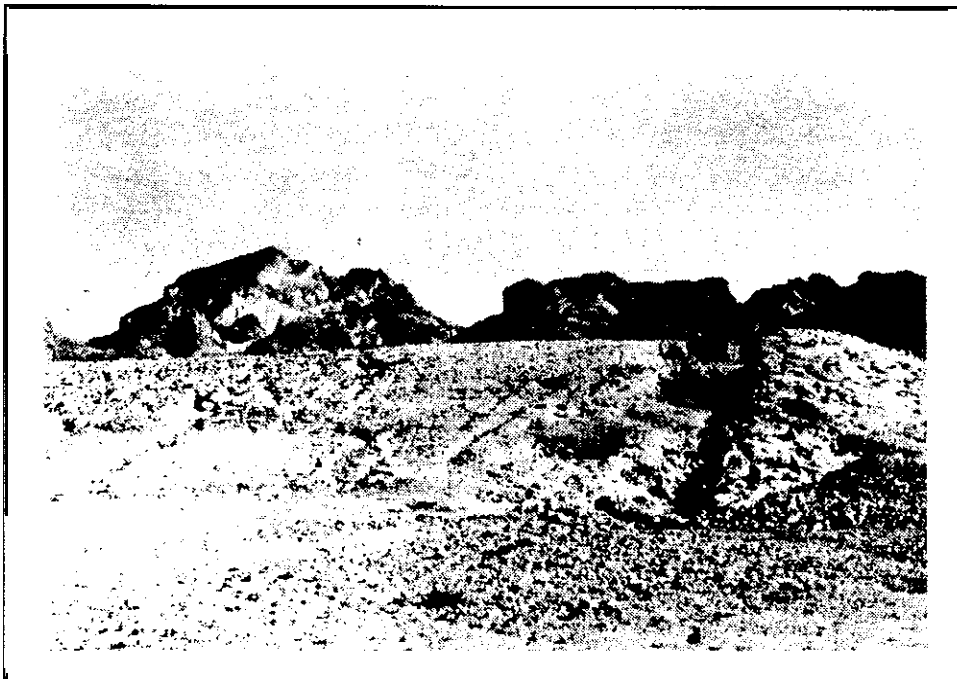
Figure 2-6 Severe Erosion on North Side from Overtopping (photo No. 9 - Station 80+12 /n/et #7)

completely repaired and was in excellent condition when the site was visited on November 3, 1990.

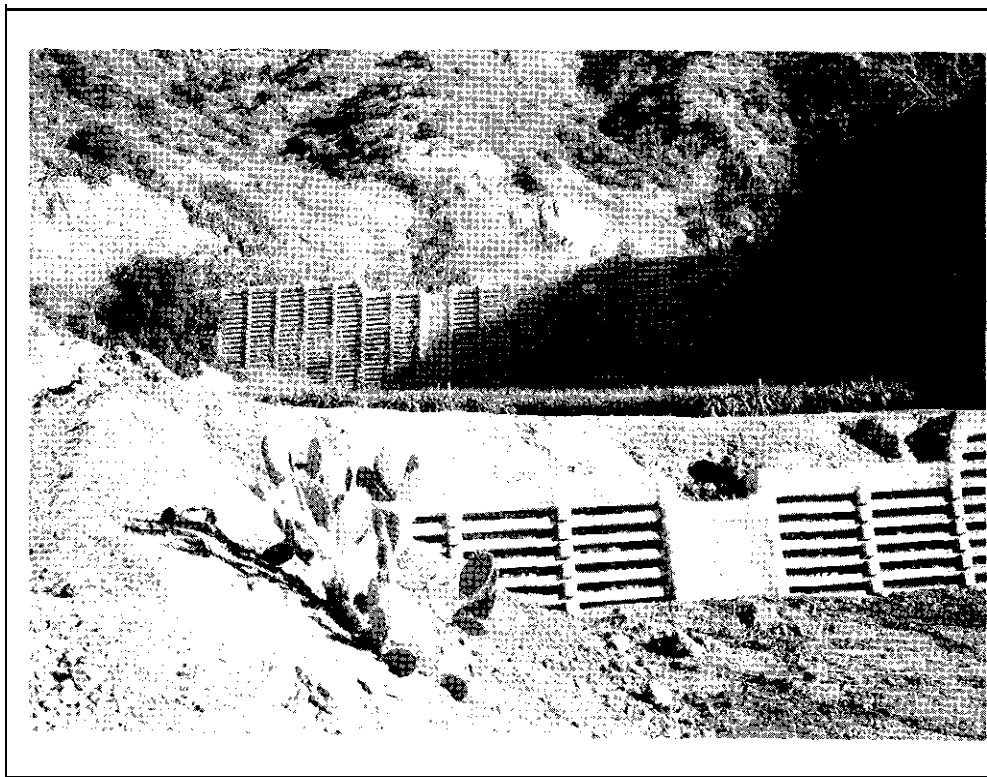
Figure 3-2 Concrete Crib Barriers in Southern California

Experience has shown that the grouted spillway section employed on the earliest structures could be damaged by debris. Recently constructed concrete cribs employ a cast-in-place reinforced spillway section that has proven to be more durable. During the past 40 years, Southern California's experience has demonstrated that properly designed and constructed concrete cribs are an effective and durable type of debris barrier. Another application is crib walls built along highways to trap and block debris from entering the roadway. The California Department of Transportation (CALTRANS) "Standard Plans" has design details for concrete, steel, and timber crib walls (CALTRANS, 1988).

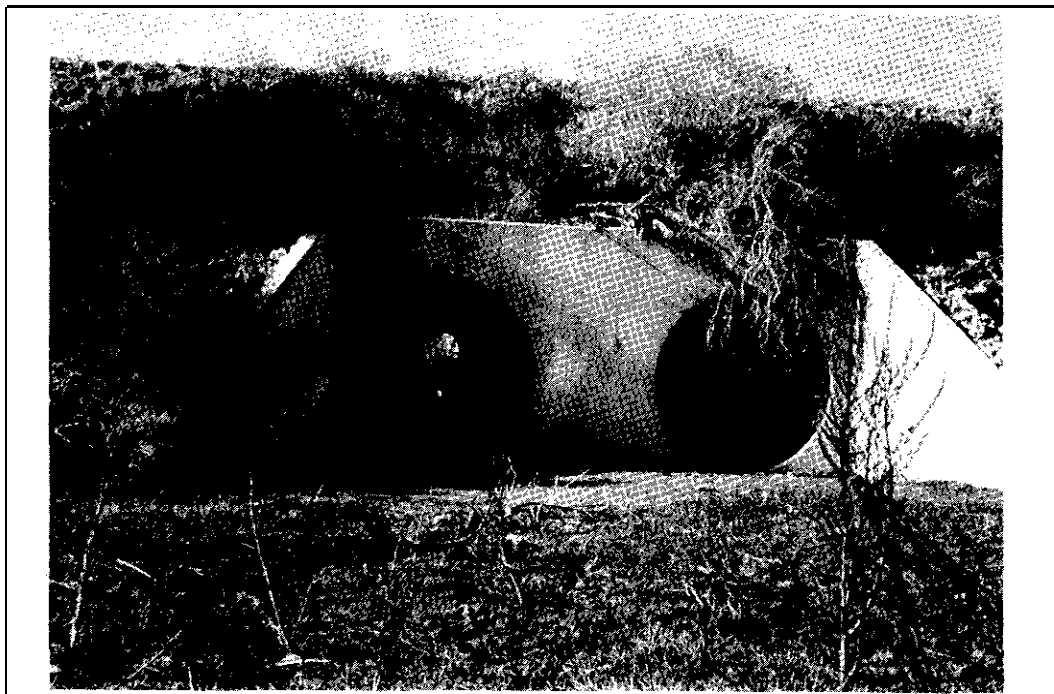
The Central Arizona Project (CAP) canals are protected, in some locations, by a flood-retention structure across fan outwash areas, just above and parallel to the canal. The outlet works are simple culverts (referred to as "overshoots") that carry the flood flow across the canal, preventing contamination of the canal water. Figure 3-6 shows the flood-retention structure and the inlet to a culvert crossing the CAP. The flow is then released into controlled or natural drainage systems below the canal. While the rural locations support using the natural drainage systems, more developed locations typically use a concrete-lined flood channel. The local experience indicated that flood-control performance has been favorable; however, there have been some problems with settlement. The settlement is probably the result of consolidation of fan

Figure 3-6 Flood Retention Structure and Inlet to Culvert Crossing Central Arizona Project, near Scottsdale, Arizona

material caused by flood inundation. Similar problems have occurred along the California Aqueduct in the Central Valley of California. Portions of the aqueduct right-of-way were flooded to consolidate the material prior to project construction.
