THE APOLLO 13 ACCIDENT

HEARINGS
BEFORE THE
COMMITTEE ON
SCIENCE AND ASTRONAUTICS
U.S. HOUSE OF REPRESENTATIVES
NINETY-FIRST CONGRESS
SECOND SESSION

JUNE 16, 1970

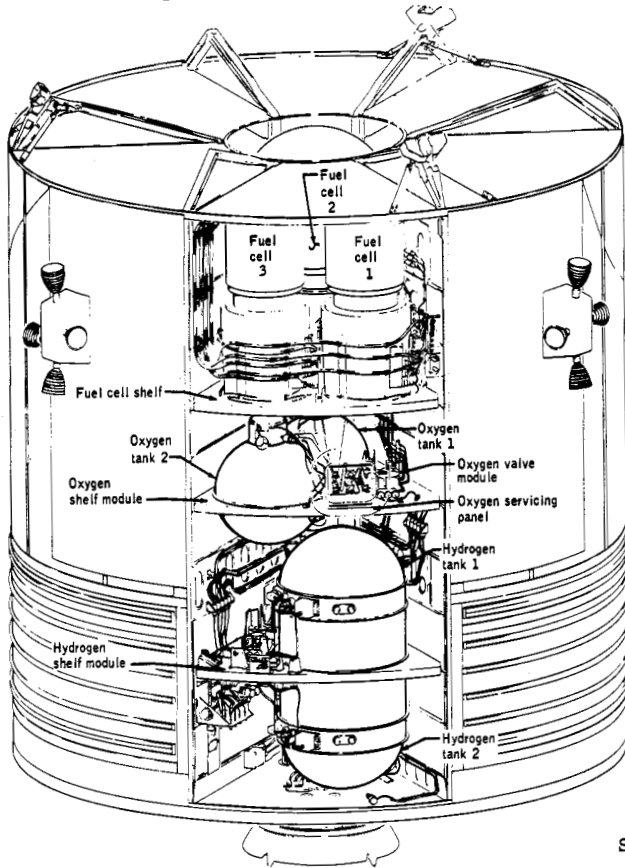
Slide 4

along with another oxygen tank, two hydrogen tanks, three fuel cells and interconnecting lines, and measuring and control equipment.

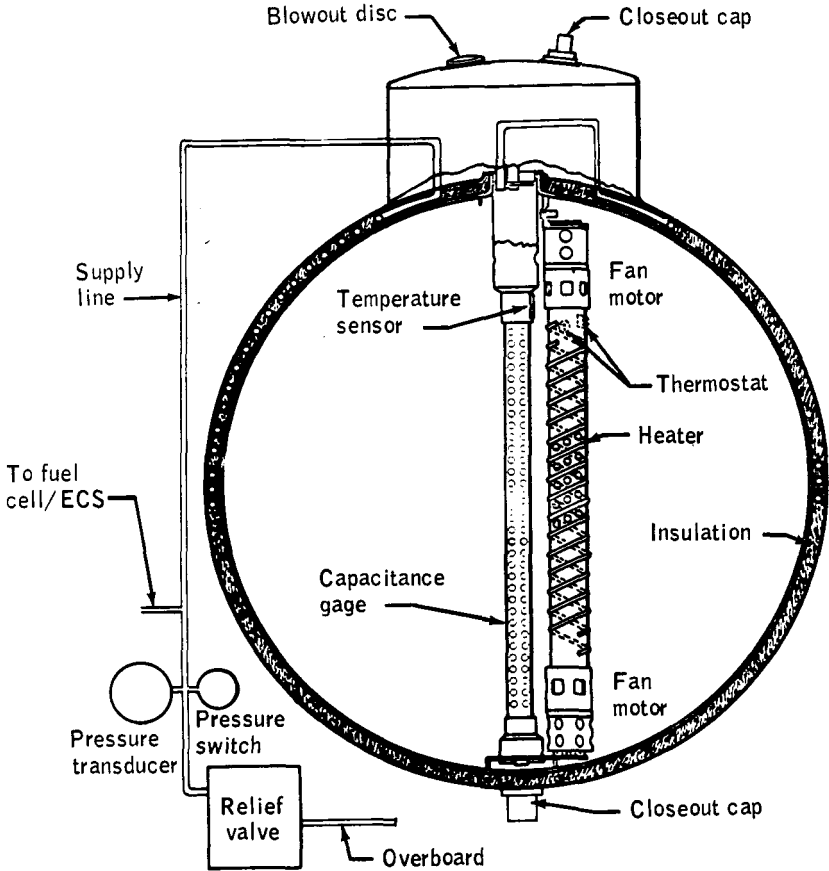
slide 8

As the simplified drawing in Slide 8 indicates, each oxygen tank has an outer shell and an inner shell, arranged to provide a vacuum space to reduce heat leak, and a dome enclosing paths into the tank for transmission of fluids, and electrical power and signals.

The space between the shells and the space in the dome are filled with insulating materials. Mounted in the tank are two tubular assemblies. One, called the heater tube, contains two thermostatically protected heater coils and two small fans driven by 1800 RPM motors to stir the tank contents. The other assembly, called the quantity probe, consists of a cylindrical capacitance gage used to measure electrically the quantity of fluid in the tank. The inner cylinder of this probe is connected through the top of the tank to a fill line from the exterior of the SM and serves both as a fill and drain tube and as one plate of the capacitance gage. In addition, a temperature sensor is mounted on the outside of the quantity probe near the head. Wiring for the quantity gage, the temperature sensor, the fan motors, and the heaters passes through the head of the quantity probe, through a conduit in the dome and to a connector to the appropriate external circuits in the CSM. The routing of wires and lines from the tank through the dome is shown in Slide 9.

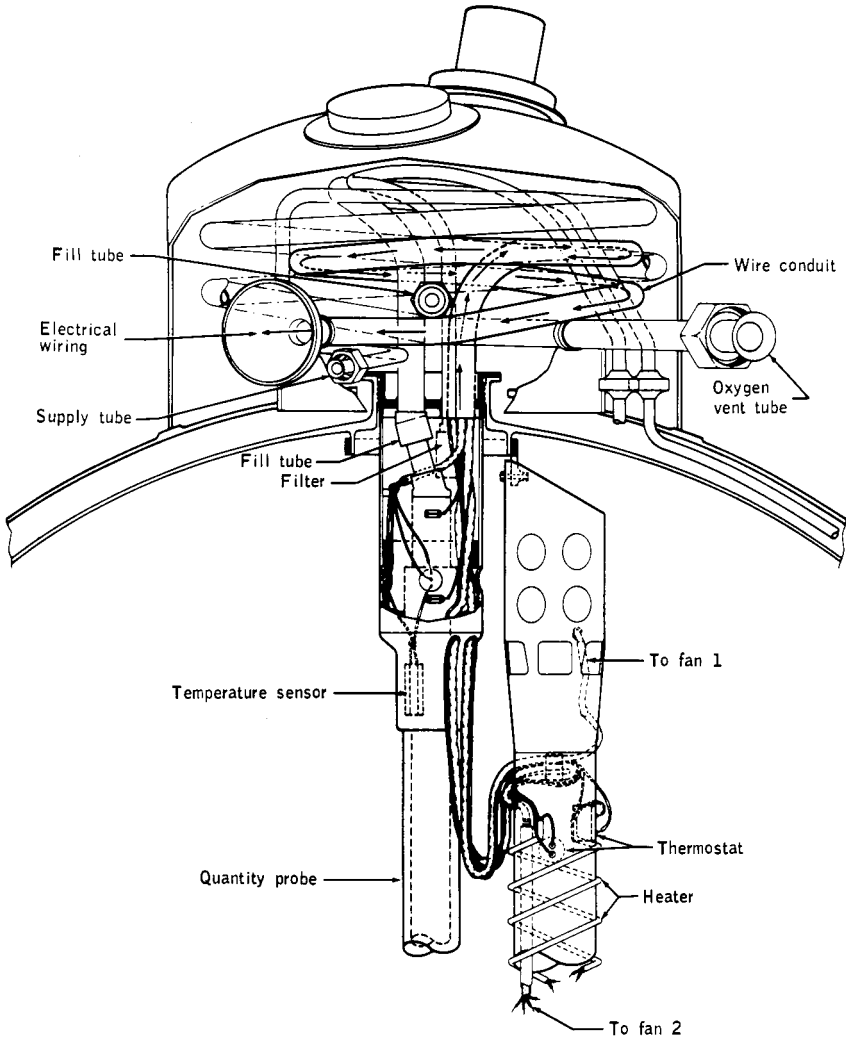
Slide 9

The oxygen tank, as designed, contained materials, which if ignited will burn in supercritical oxygen. These include Teflon, used, for example, to insulate the wiring, and aluminum.

As shown in Slide 9, each heater coil is protected with a thermostatic switch, mounted on the heater tube, which is intended to open the heater circuit when it senses a temperature of 80° F. As I will point out later in tracing the Board's conclusions as to the cause of the accident, when the heaters were powered from a 65 volt DC supply at KSC during an improvised detanking procedure, these thermostatic switches, because they were rated at only 30 V DC, could not prevent an overheating condition of the heaters and the associated wiring. Tests conducted for the Board indicate that the heater tube assembly was probably heated to a temperature of as much as 1000° F during this detanking procedure.

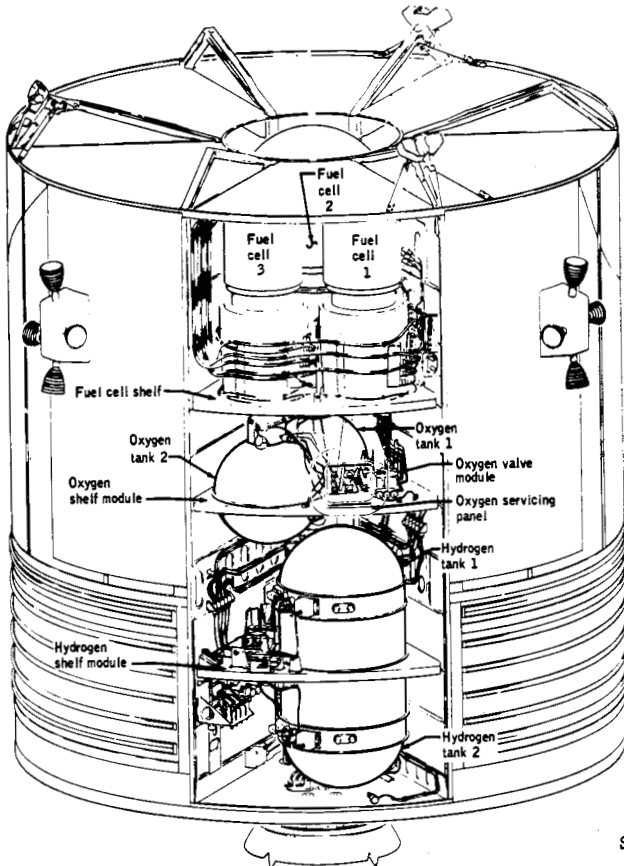
Slide 4

These are two hydrogen tanks with a cylindrical sleeve to fasten them together. The two oxygen tanks sit on this shelf. Oxygen tank 1 is here, and No. 2 is here [indicating]. There is a valve module and servicing panel here. This oxygen tank No. 2 is the one which failed.

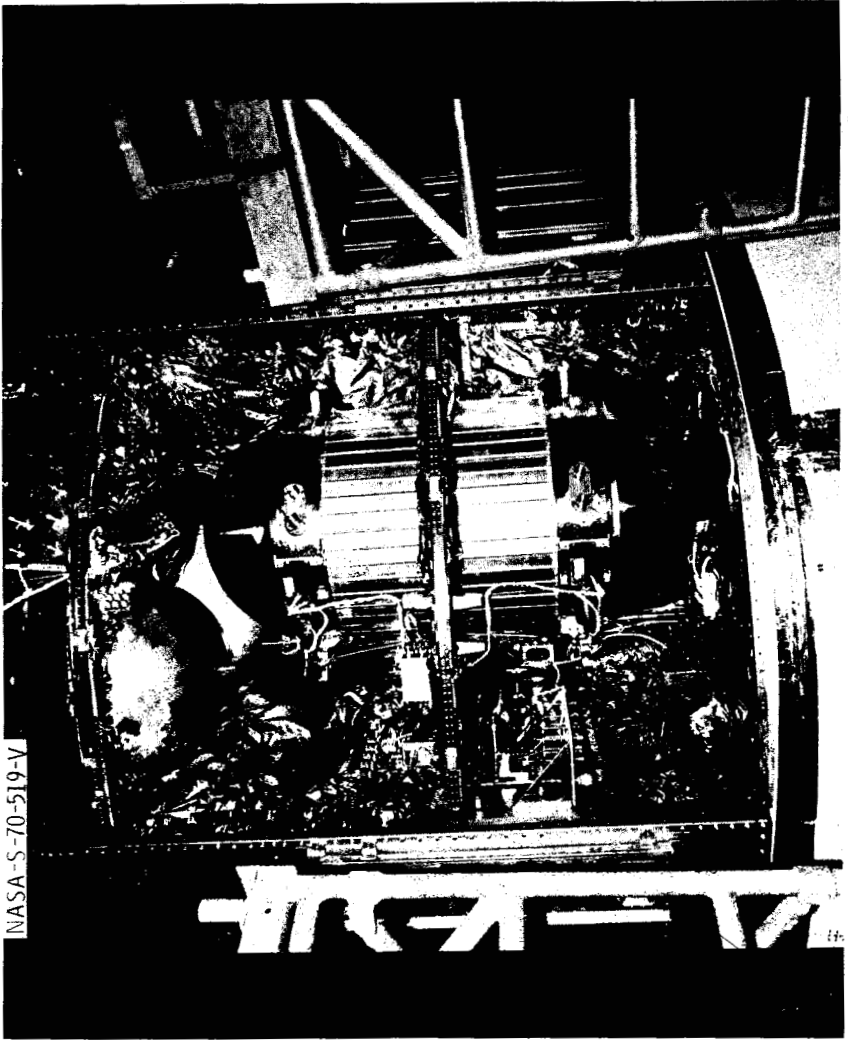
This is the lower section of bay 4 showing the hydrogen tanks and the bottom of oxygen tank 2 which failed. All this crinkly material which looks a little messy, is designed that way. It is a Kapton-coated Mylar insulation.

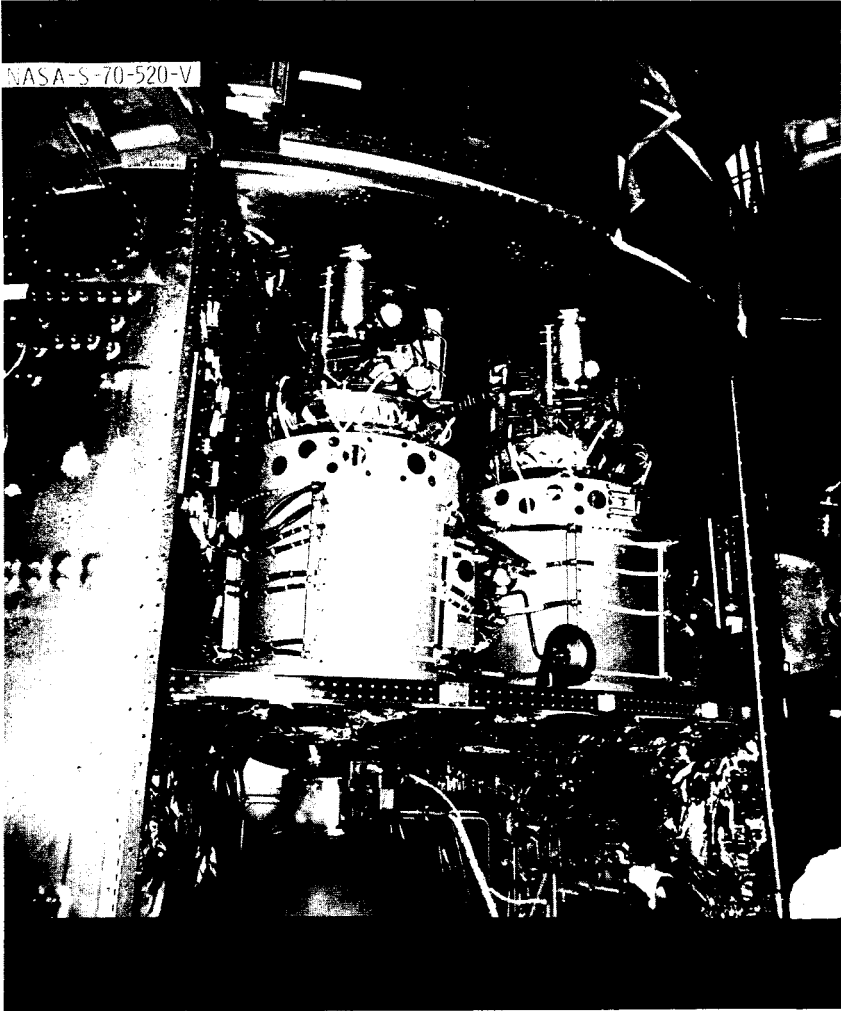
Slide 6

On the right (slide 6) are shown two of the three fuel cells which are on the shelf above the oxygen tanks. This is oxygen tank No. 2 that failed. This is the dome of the tank which covers the spiraling tubes which penetrate the tank and which carry fluid into and out of the tank as well as the electrical wiring.

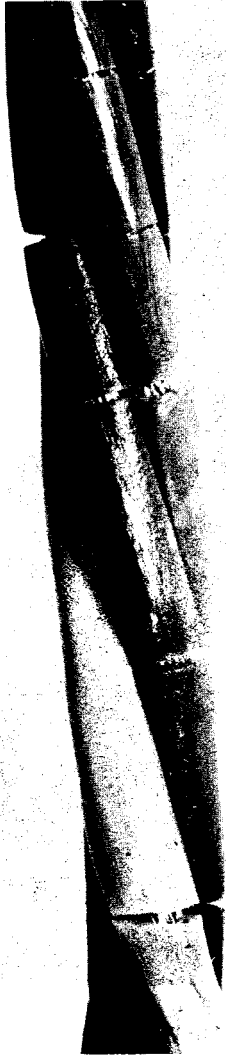
Slide 13

Just to digress for a moment, I would like to show my last three view-graphs (slides 13, 14, and 15) which show the manner in which the contacts of the thermostatic switch can weld together.

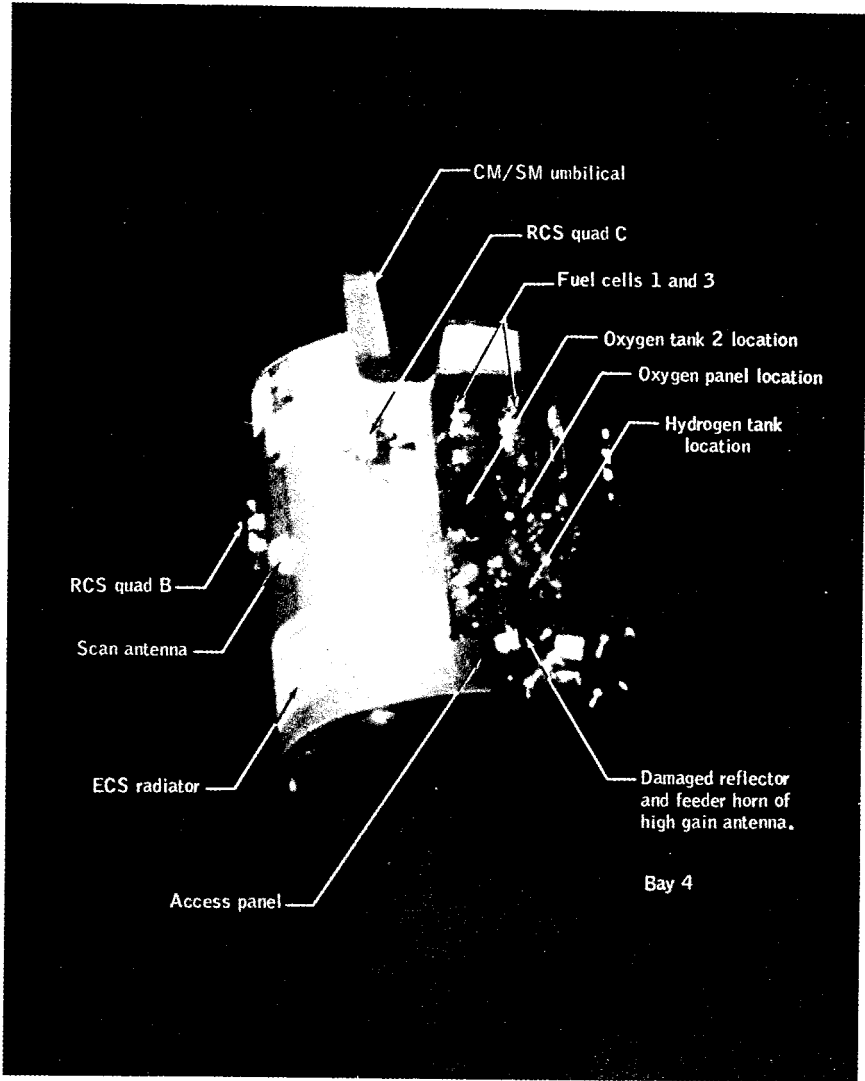
Inflight photograph of service module showing damage to bay 4.
