TALARA AIRPORT RUNWAY REHABILITATION OPTIMIZATION BASED ON
AIRCRAFT-PAVEMENT INTERACTION

Samuel Hautequest Cardoso, Ph.D.
Aerodromes and Ground Aids Officer
ICAO – International Civil Aviation Organization
South American Regional Office
P.O. Box 4127, Lima 100, Peru
Phones: (511) 611-8677; 9793-3706; Fax: (511) 611-8689
E-mail: shautequest@gmail.com

PRESENTED FOR THE
2007 FAA WORLDWIDE AIRPORT TECHNOLOGY TRANSFER CONFERENCE
Atlantic City, New Jersey, USA

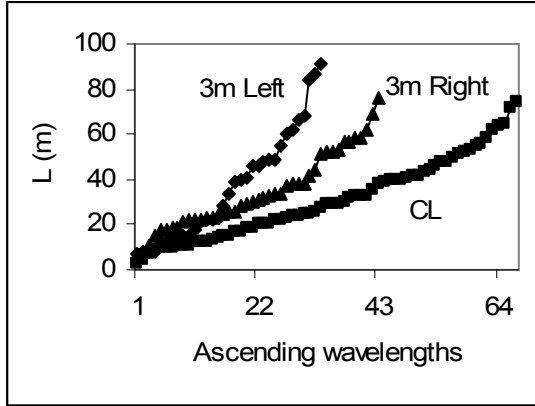
Figure 1. Wavelengths (L).

Figures 1 and 2 show that the centerline has greater number of wavelengths than its right and left sides. However, the centerline left and right sides present longer wavelengths and amplitudes than the centerline. As indicated in Appendix 1, the wavelengths for the runway centerline and its left and right sides were found to be as high as 74 m (243 ft), 91 m (299 ft) and 76 m (249 ft), respectively. Likewise, the amplitudes were found to be as high as 105 mm (4.13"), 120 mm (4.72") and 115 mm (4.53"), respectively.

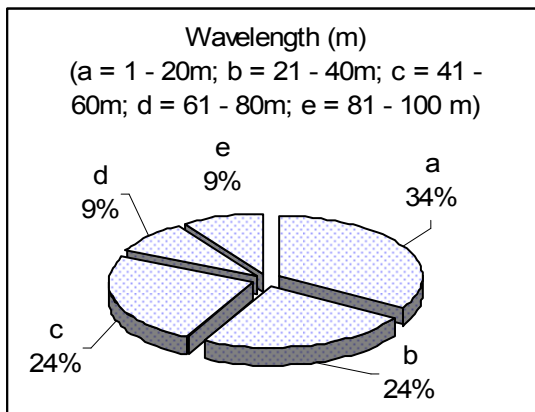
Figure 3. Wavelengths in % (CL left side).

Figures 3 to 5 indicate that 71 %, 58 % and 70 % of the wavelengths at the centerline and at its left and right sides are shorter than 40 m (131 ft), respectively.
