# Investigation of October 27-28, 1985, Structural Failures:

Ocean Drilling & Exploration Company Platforms:  
Outer Continental Shelf Lease 0605,  
South Timbalier Block 86  
& Outer Continental Shelf Lease 0073,  
South Pelto Block 19

Gulf of Mexico,  
off the Louisiana Coast

F. Dyhrkopp  
G. Schonekas  
M. Stewart

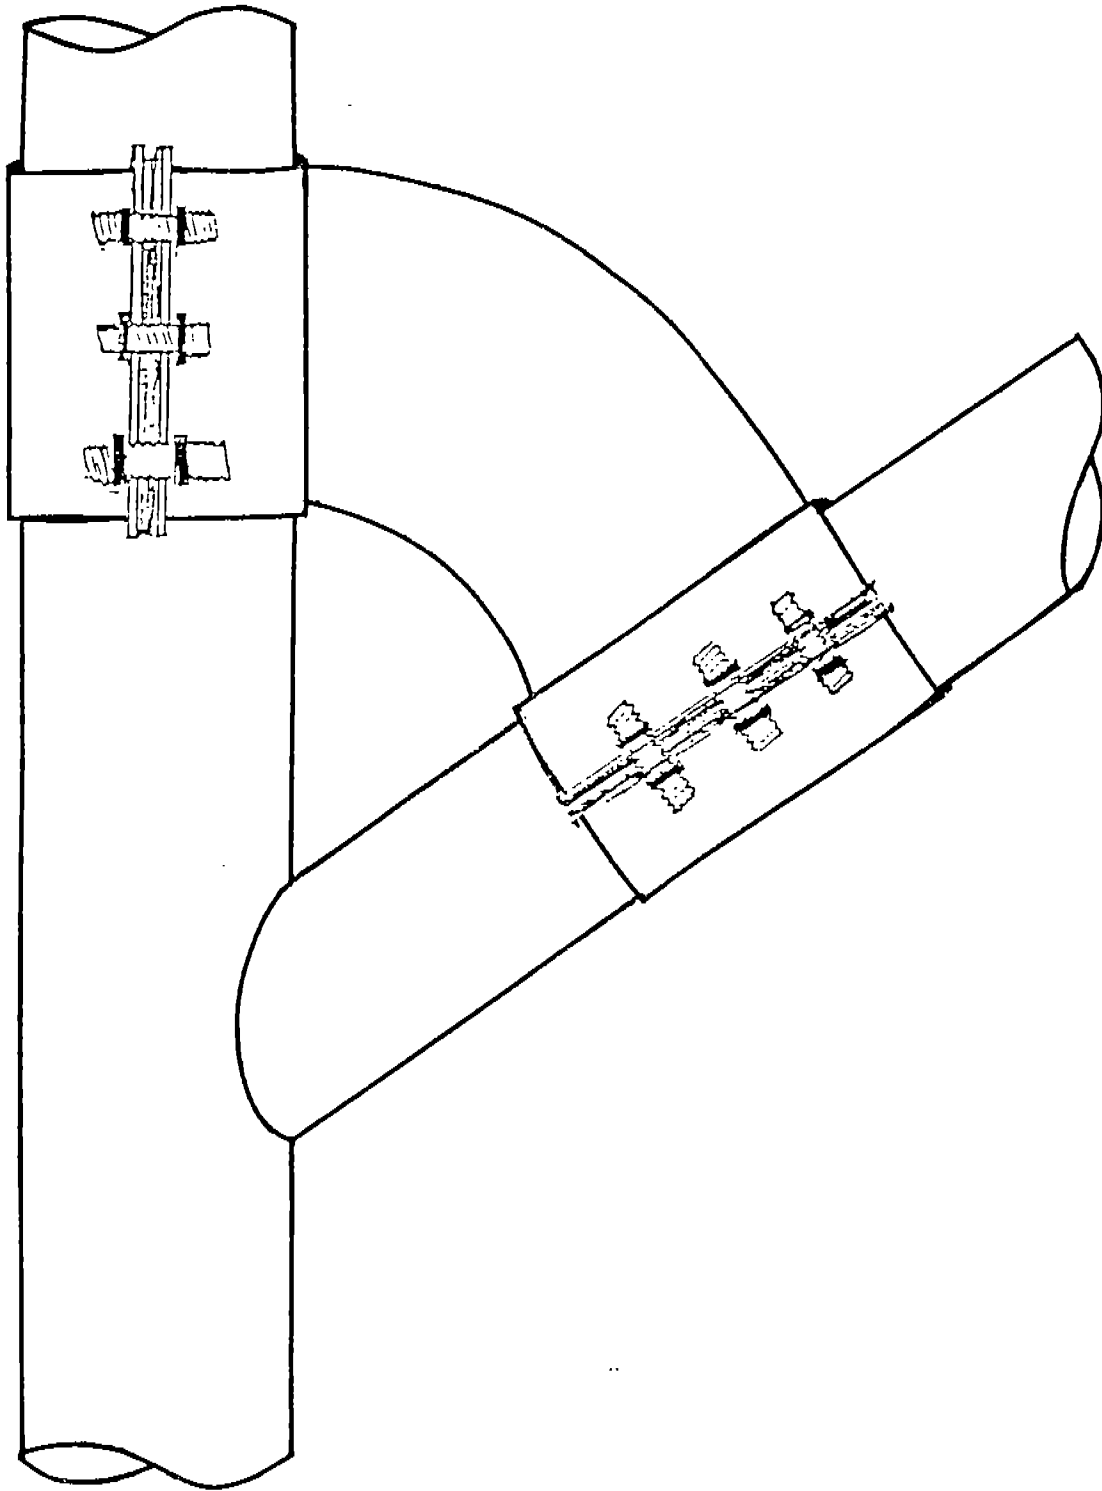
Mechanical clamp

(c) Thirty locations throughout the underwater structure where mechanical clamps had been used to repair brace joints that were badly cracked or corroded were identified. Of these, 13 were located on horizontal braces and 17 were located on vertical braces. Some of these clamps were reported in the limited 1982 survey discussed in section 2 above. It is inferred these clamps were installed before the installation of the wet-welded replacement members, that is, sometime before 1982. For an example of such a clamp, see appendix, attachment 7.

The use of numerous mechanical clamps to repair cracked, corroded, or otherwise parted member connections is a probable contributing cause of platform failure. Analysis of the inspection report data indicates that at some point in time the owner recognized the undesirability of using clamps, for repairs made after the early 1980's were carried out by replacing and rewelding members. Those repairs more appropriately restored the structure to its original design condition in that drastically altered load paths, reduced joint stiffnesses, increased bending moments, and additional stress concentrations were not introduced at the rewelded connections. More importantly, replacement removed the entire member that had been subject to years of corrosion attack, whereas clamps were installed on partially deteriorated members. However, there is no evidence suggesting that an attempt was also made to remove and replace the existing clamped members.
