**Investigation of Blowout and Fire
Ship Shoal Block 354
OCS-G 15312 Well A-2
September 9, 1999**

**Gulf of Mexico
Off the Louisiana Coast**

**U.S. Department of the Interior
Minerals Management Service
Gulf of Mexico OCS Regional Office**

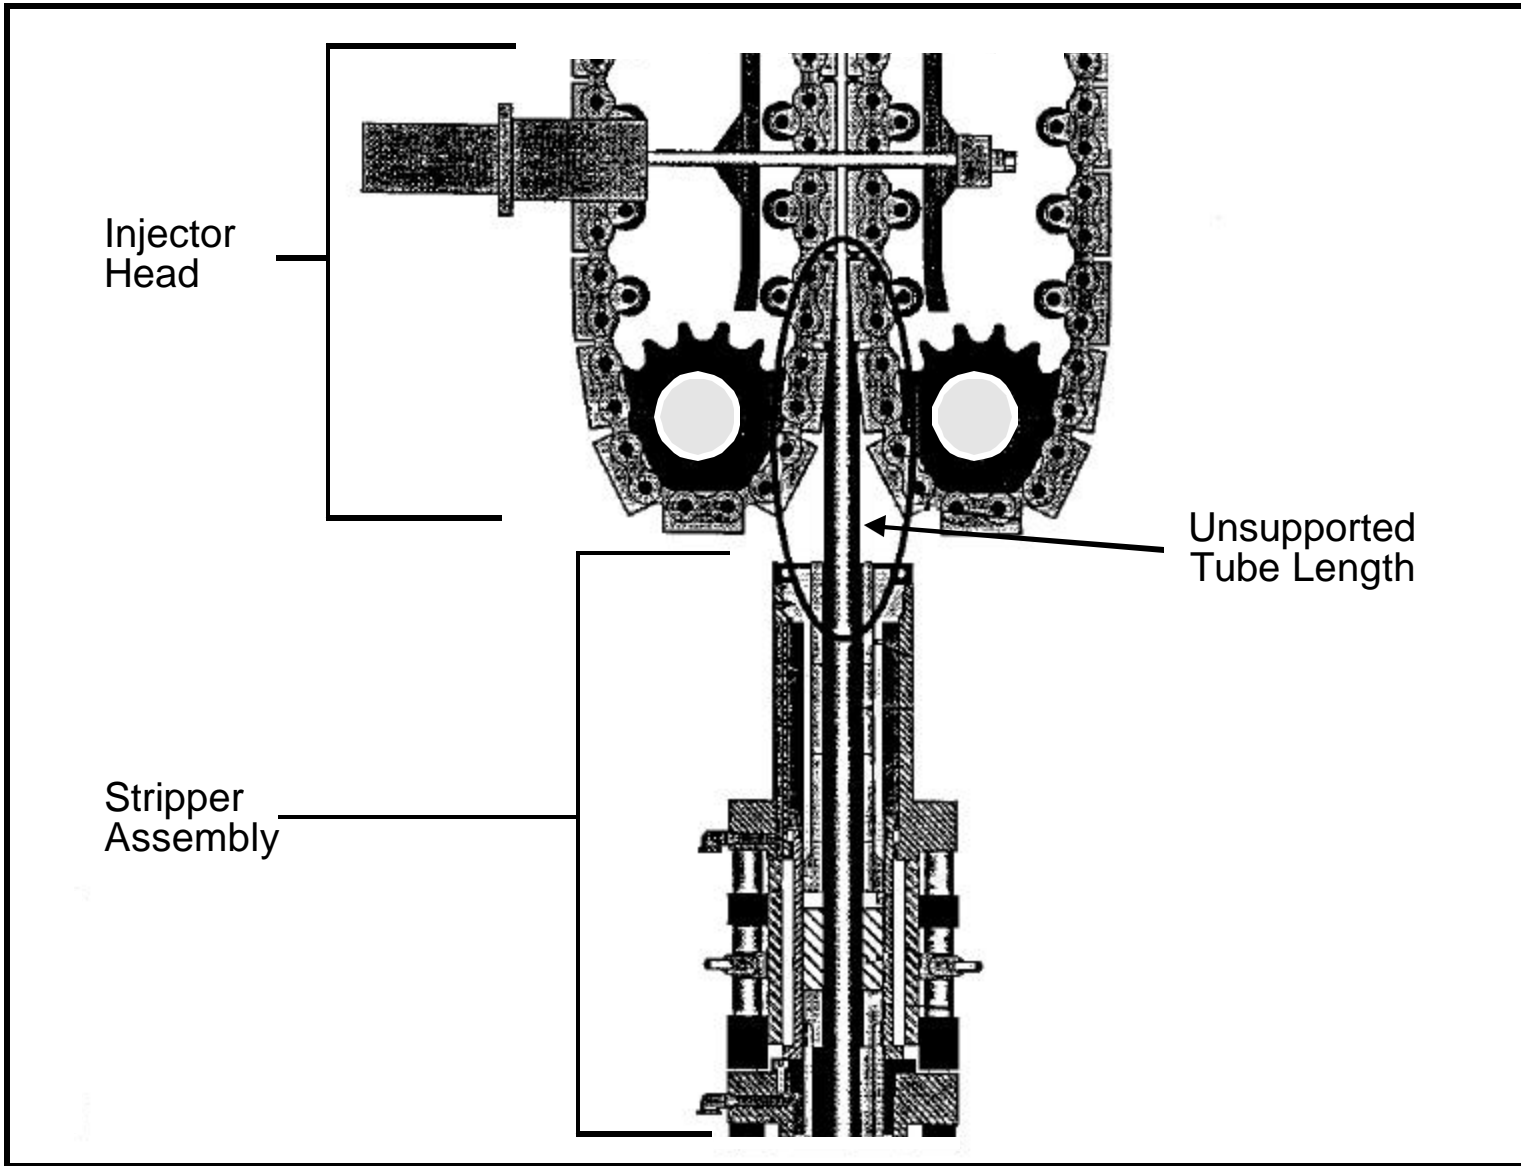
Schematic of Coil Tubing Unsupported Length Between Stripper Assembly and Injector Head

NFX's final report indicates that the 1.25-inch OD, 0.134-inch wall thickness, 100 grade coiled tubing that was being used has a calculated maximum recommended thrust load of 15,423 lbs. The calculation uses the Secant formula and an unsupported length of approximately 13 inches, while assuming a safety factor of 1.25. (*For schematics of unsupported coiled tubing length, see Attachments 3 & 4.*) The report also indicates that for the HR-440B injector in high gear, the calculated maximum pressure setting for the injector hydraulic control pilot valve was 2,150 psi, based on a maximum injector thrust force of 15,423 lbs. The maximum pressure setting for the injector hydraulic control pilot

report also was unable to determine the cause of the sudden stop of the coiled tubing as it was run into the wellbore. Upon coming to an abrupt stop, the coiled tubing experienced an excessive compressive load, which resulted in the buckling and parting of the tubing. The force required to buckle the coiled tubing is a function of several factors, including the coiled tubing geometry and material specifications, the unsupported length of tubing between the stripper and injector, as well as the alignment of the injector chains and stripper. The compressive load or forces were applied to the coiled tubing by the injector chains, which gripped the coiled tubing and thrust the tubing through the stripper and into the wellbore. The magnitude of the forces applied to the coiled tubing by the injector chains is regulated by the injector hydraulic control pilot valve settings. On the basis of the available information, this panel concluded that the pressure settings for the injector pilot valves exceeded the maximum allowable limits for 1.25-inch coiled tubing.

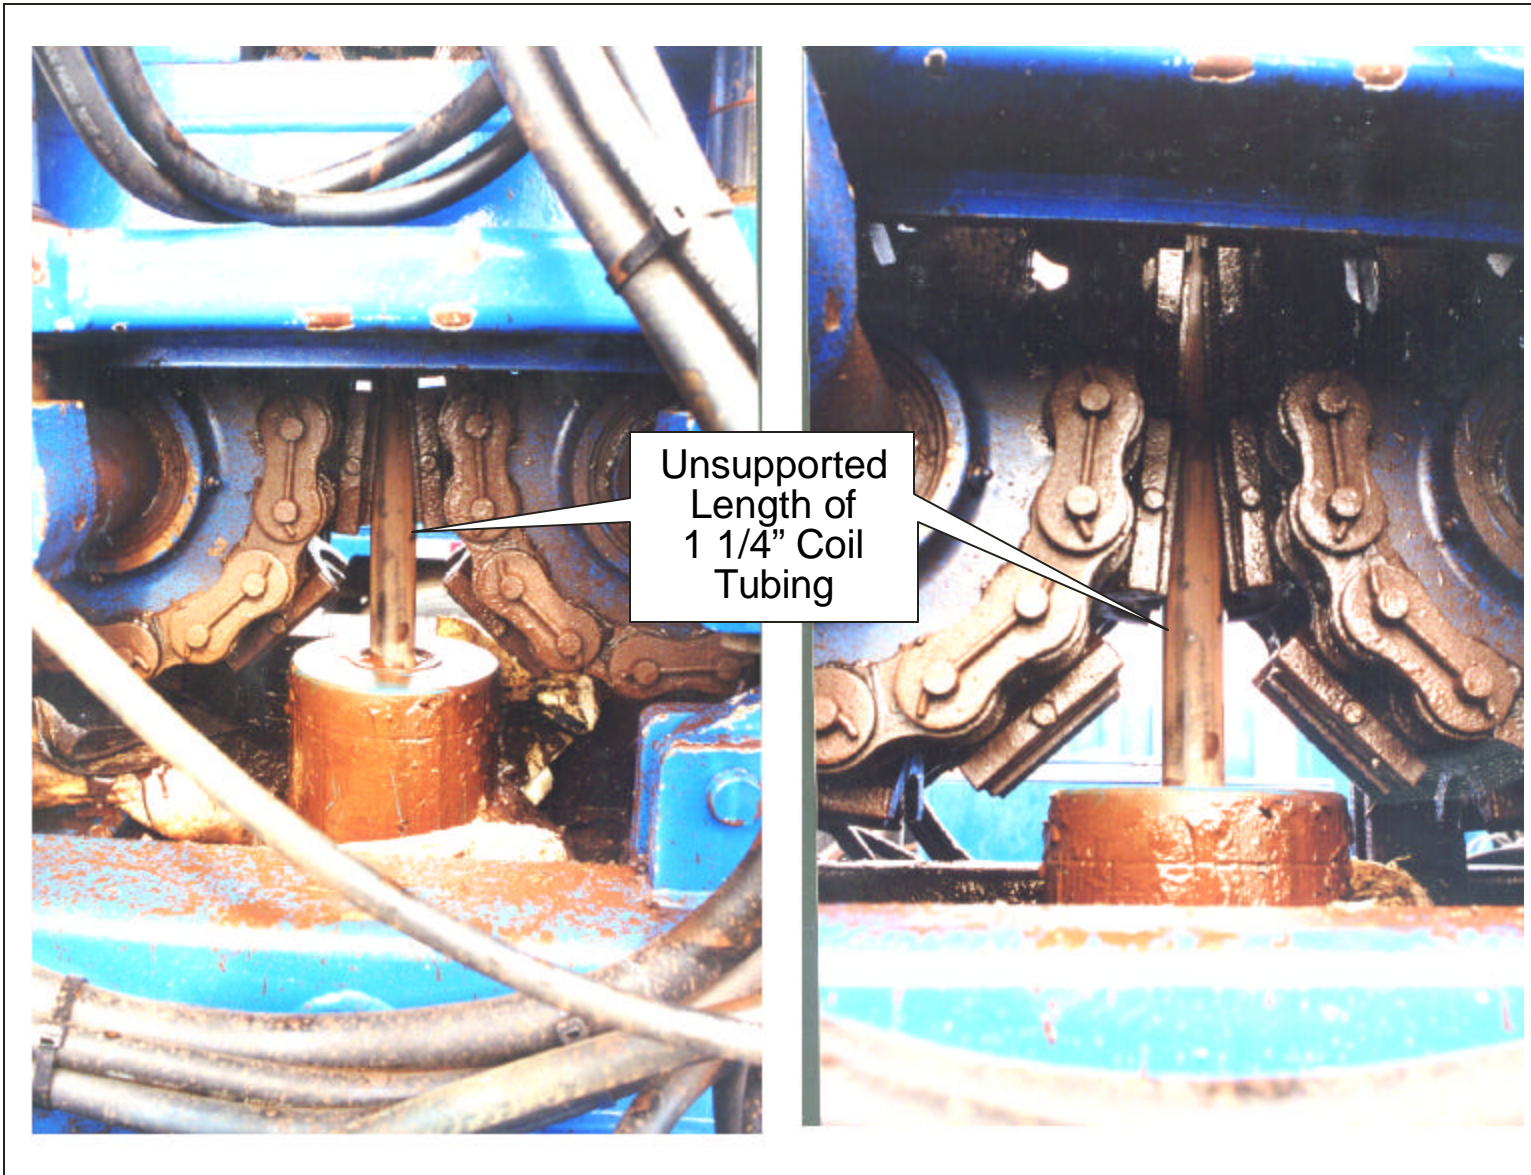
Photographs of Coil Tubing Unsupported Length Between Stripper Assembly and Injector Head

While running in the hole with an HPI Elite bridge plug on its end, the coiled tubing came to an abrupt halt at approximately 915 feet. Upon seeing it come to a stop, the coiled tubing operator attempted to pick up the coiled tubing and observed the weight indicator register zero. The coiled tubing operator then tried to move the pipe back down and observed the weight indicator registering – 4,500 pounds, as it had before coming to a stop. Within minutes, a flow of liquid and gas was detected coming from the vicinity of the bottom of the injector head.

Cause The immediate **cause** of the accident, which led to the uncontrolled flow, was the parting of the coiled tubing above the stripper assembly and the subsequent inability to contain the wellbore fluids.
